## PACP Inspection and Scoring

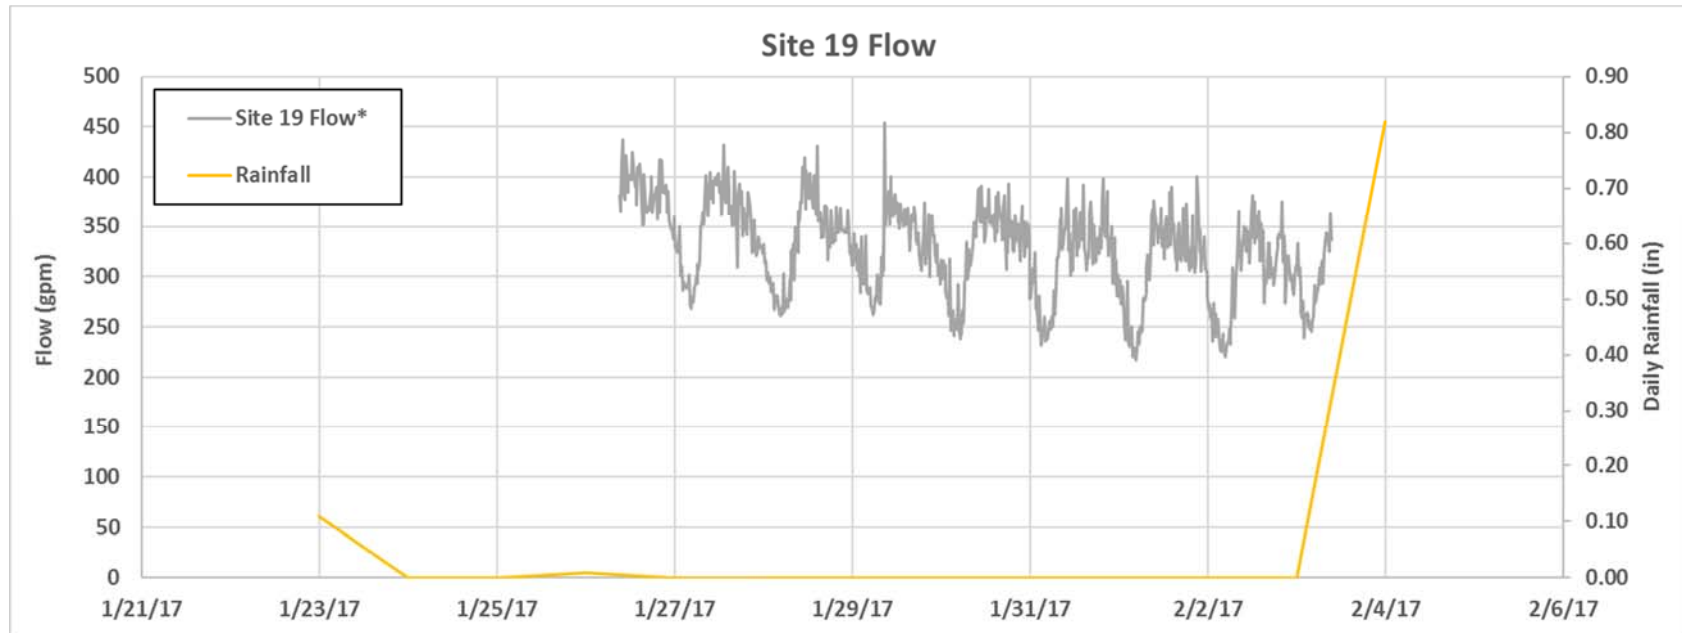
Chart E-10: Site 19 Flow vs. Precipitation

\*Flow meter was surcharged and clogged by rags during the monitoring period and had to be removed. Data later in monitoring period is inaccurate due to rags and was not included in analysis.

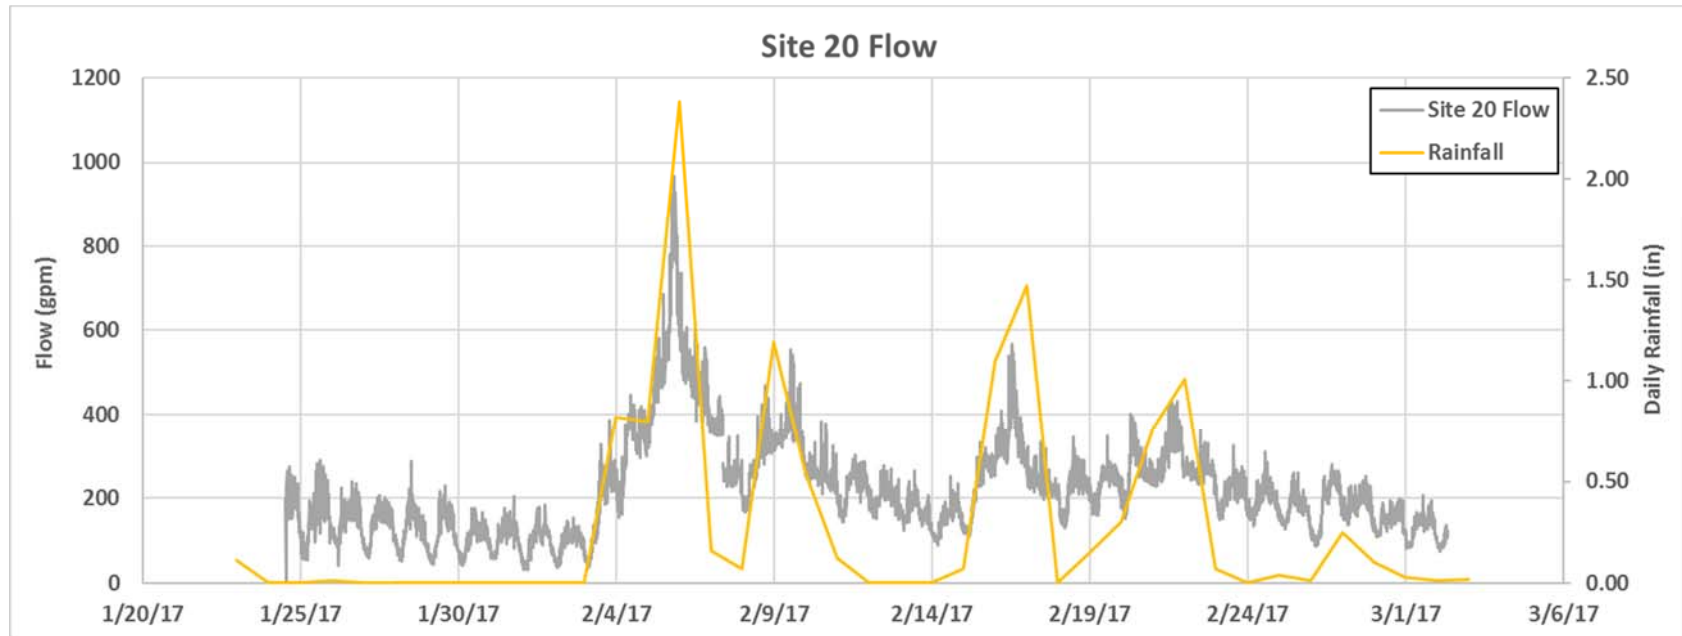
Chart E-11: Site 20 Flow vs. Precipitation

\*Flow meter was surcharged and clogged by rags during the monitoring period and had to be removed. This pipe is known to the City to surcharge and cause backup problems.

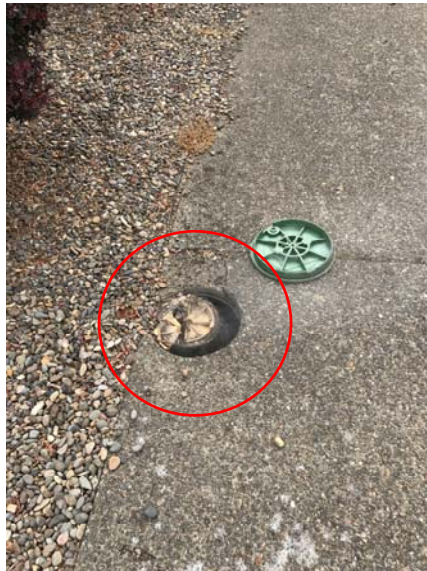
Address: 2200 Thorne St

Description: Broken lateral under yellow irrigation cap; open cleanout.

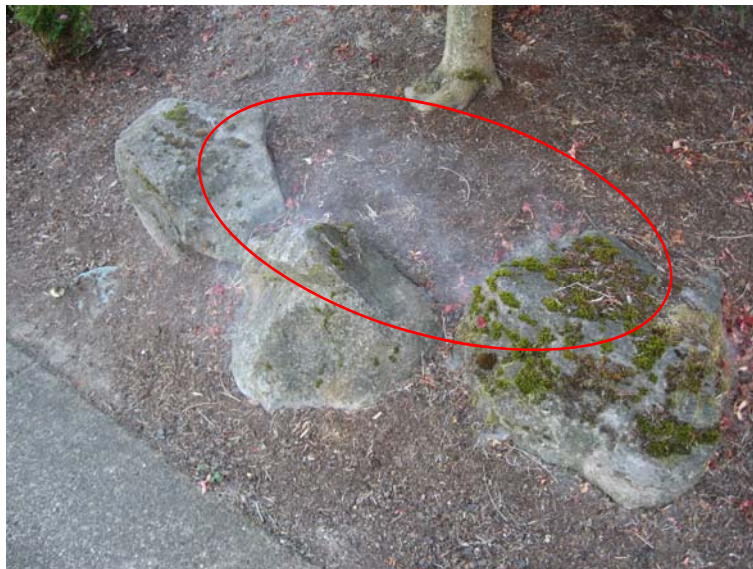
Address: 2219 Thorne St

Description: Broken lateral, bark in front yard smoking.

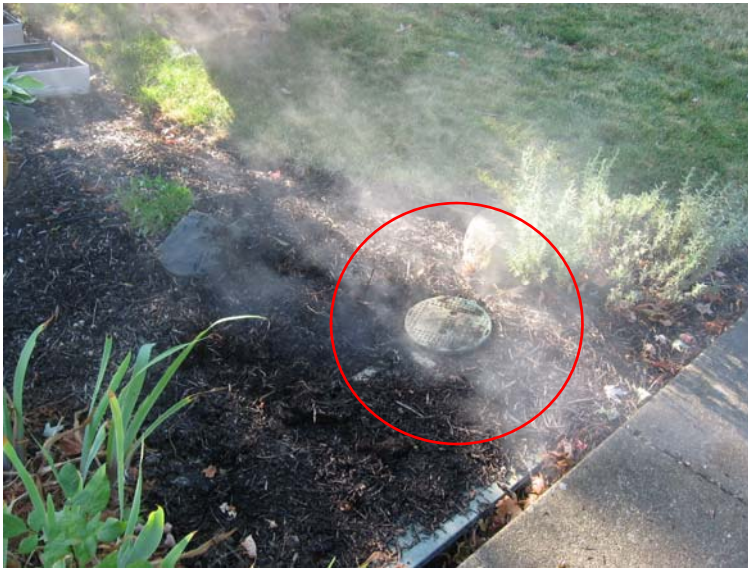
Address: 2210 Thorne St

Description: Open cleanout.

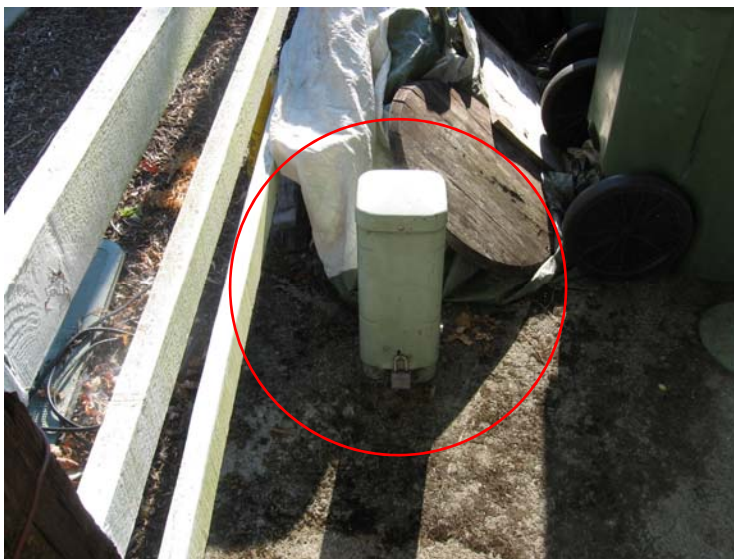
Address: 2220 Thorne St

Description: Open cleanout and phone pedestal smoking from inside.

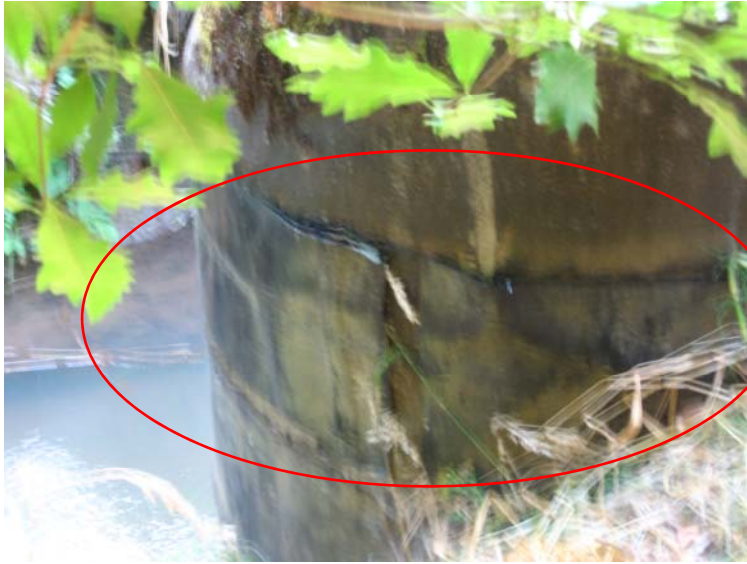
Address: MH H105004

Description: Manhole wrap is smoking.

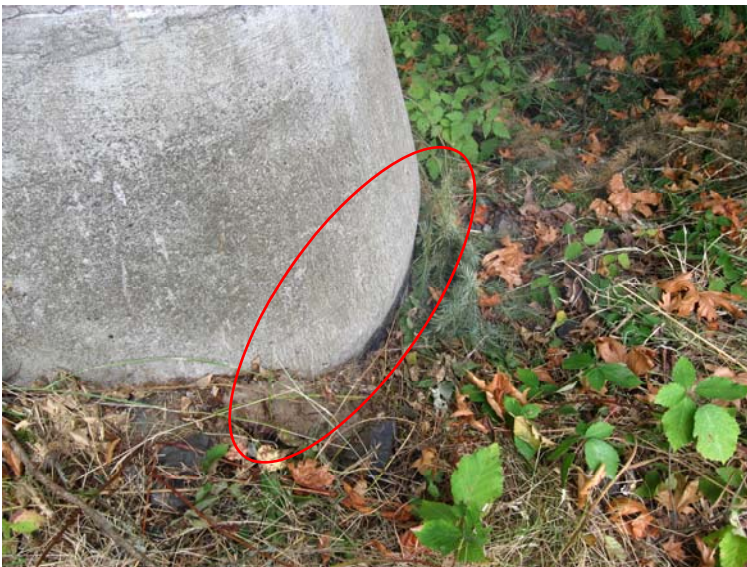
Address: MH H114005

Description: Manhole wrap is smoking.

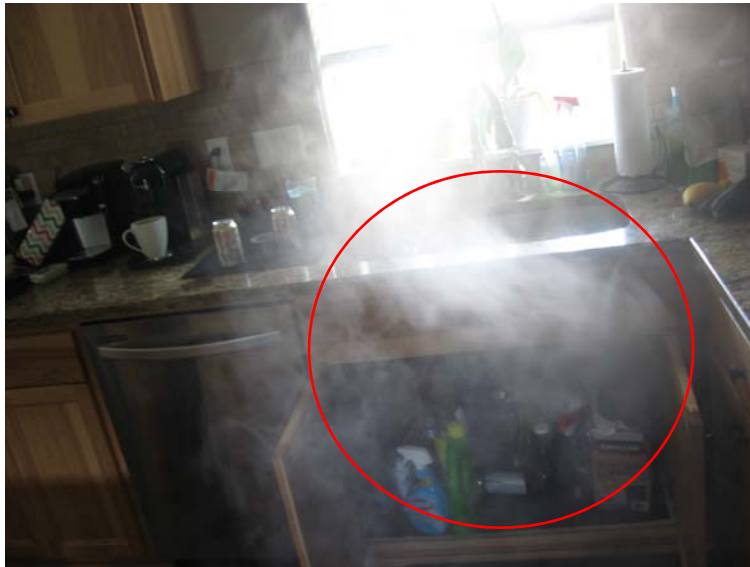
Address: 2340 Thorne St

Description: Smoke emitting from under sink.

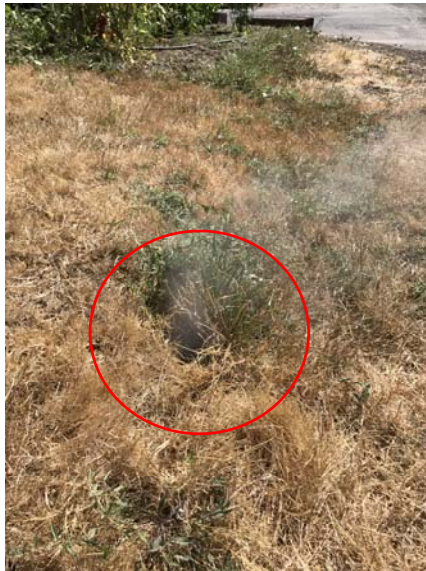
Address: 1104 S Pennington Dr

Description: Cleanout lid missing.

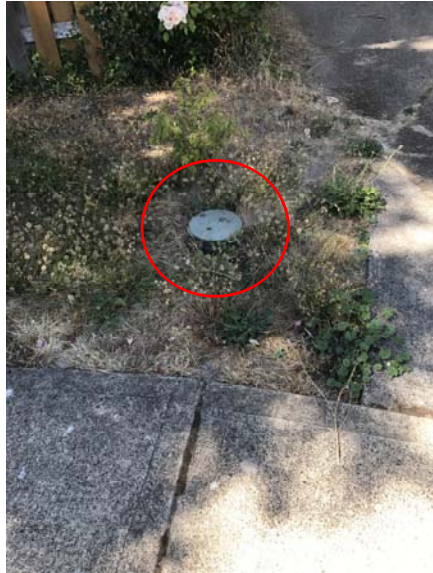
Address: 1011A Pennington Ct

Description: Broken cleanout and cap.

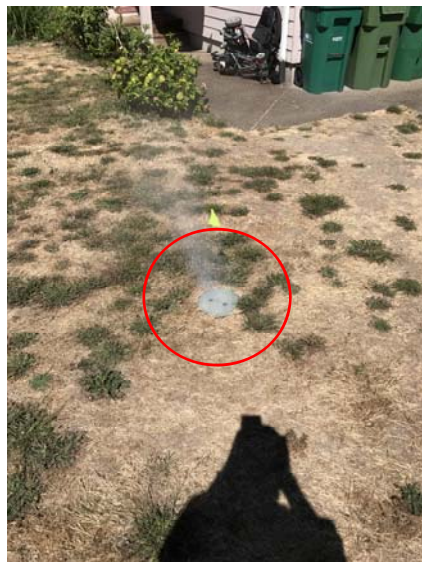
Address: 1021A Pennington Ct

Description: Broken cleanout and cap.

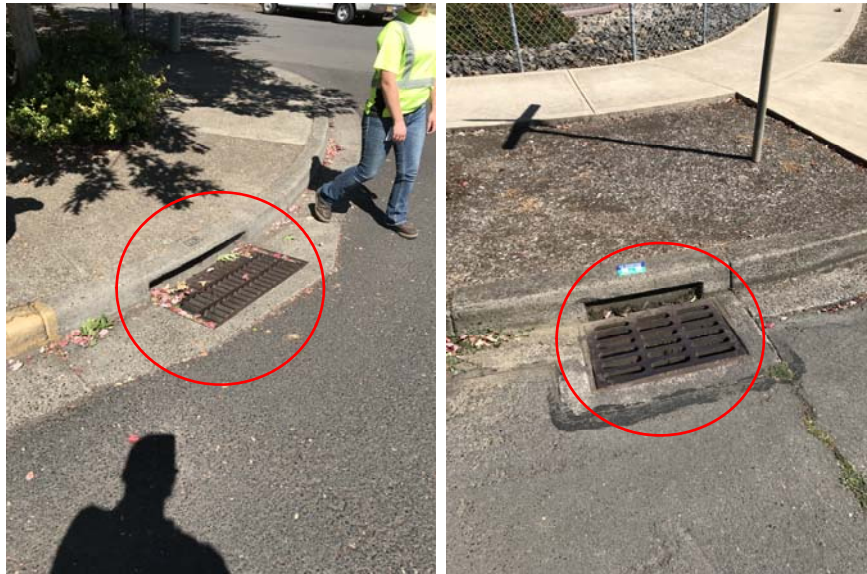
Address: Intersection of S Pennington Dr and Hoskins St

Description: All 4 catch basins smoking.

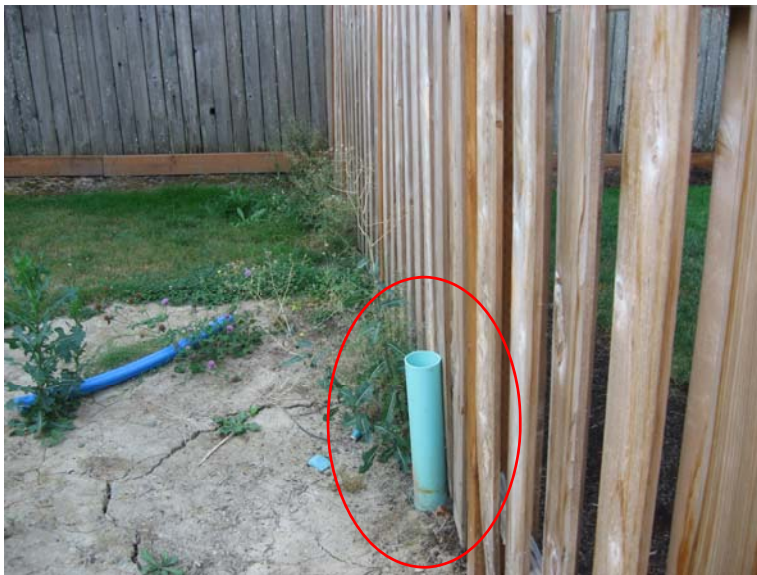
Address: 2215 Prospect Dr

Description: Open cleanout.

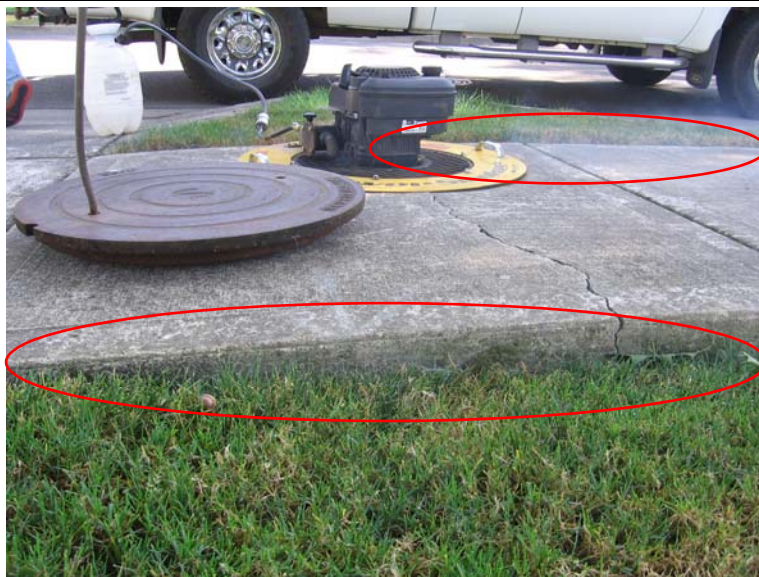
Address: 3891 Oak Meadows Lp

Description: Smoke on either side of sidewalk next to MH.

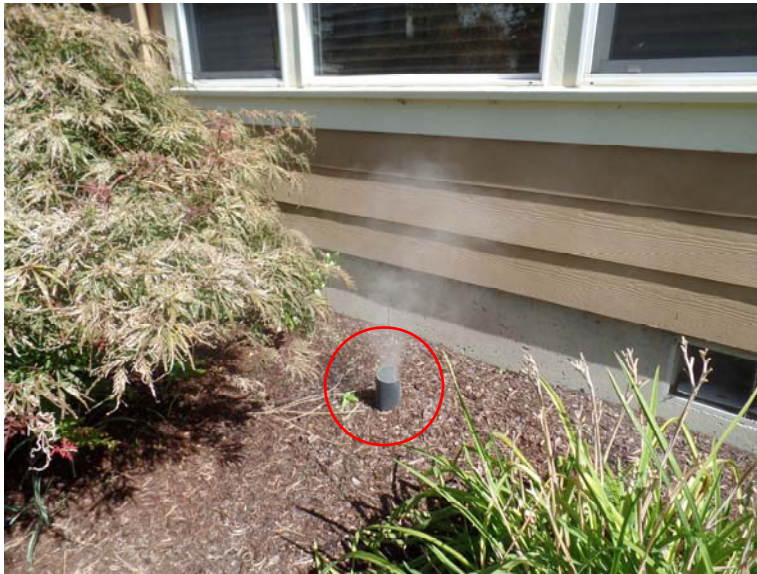
Address: 216 Acorn St

Description: Open cleanout.

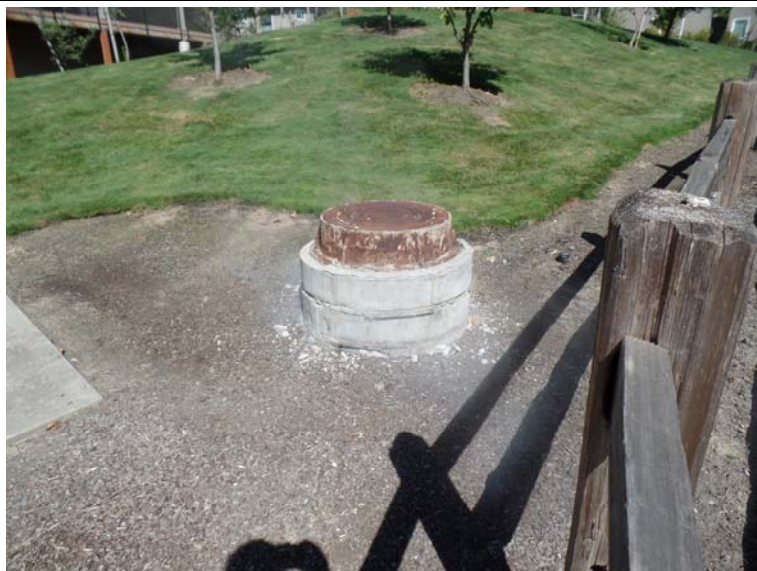
Address: North of MH I113155 (new MH)

Description: No grout, raised MH smoking excessively; on south side of new apartments.

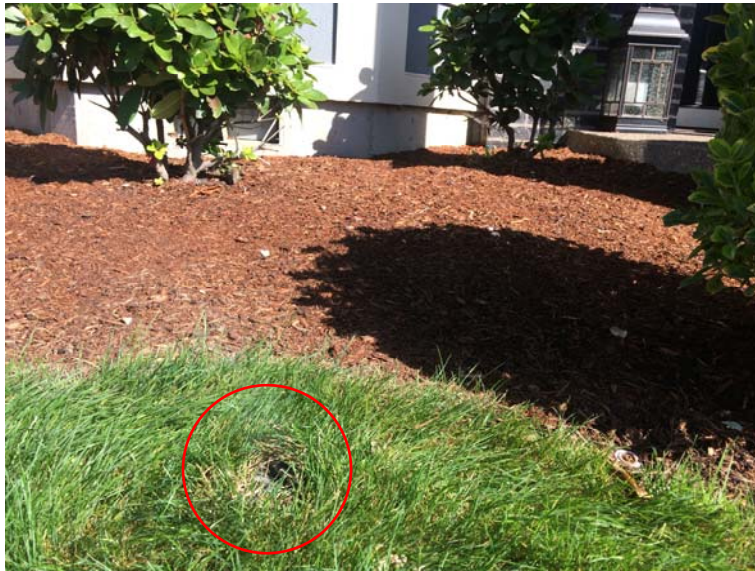
Address: 148 Argyle Ct

Description: Broken cleanout in front yard grass.

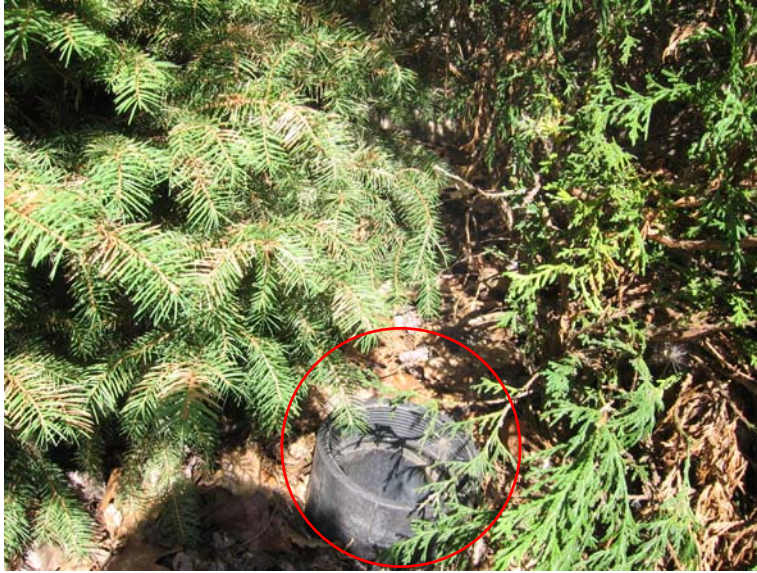
Address: 5217 Fairway St

Description: Open cleanout.

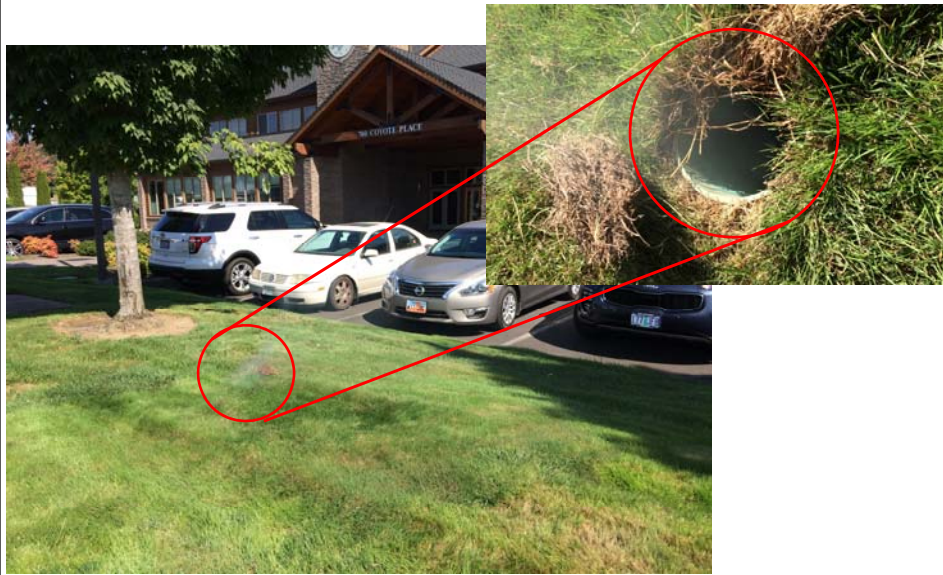
Address: 700 Deborah Rd

Description: Open cleanout in front median strip grass.

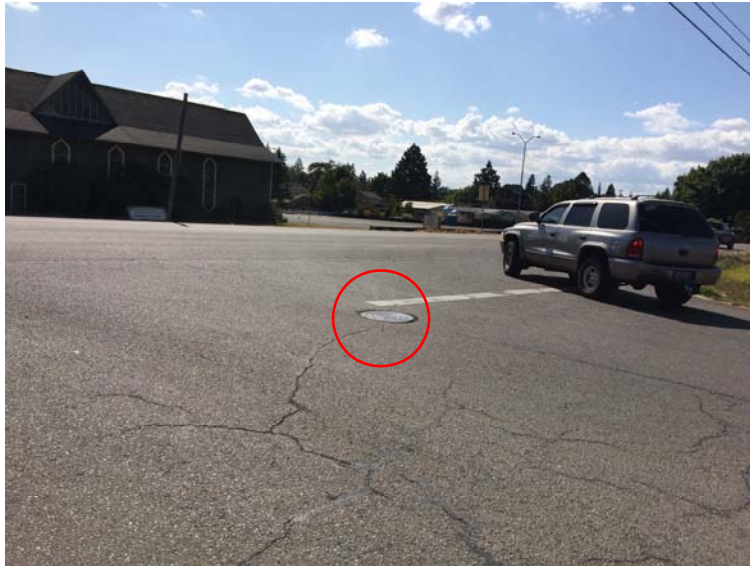
Address: MH H123039

Description: Smoking around rim.

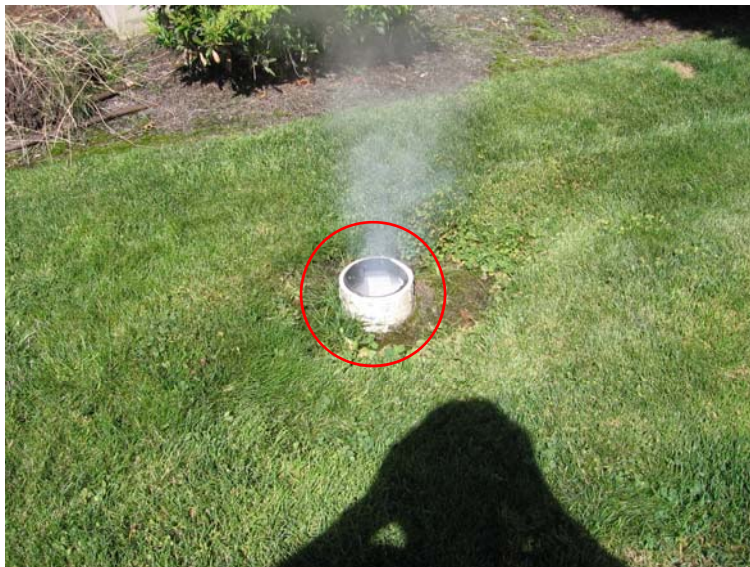
Address: 3411 Hayes St building 7

Description: Open cleanout.

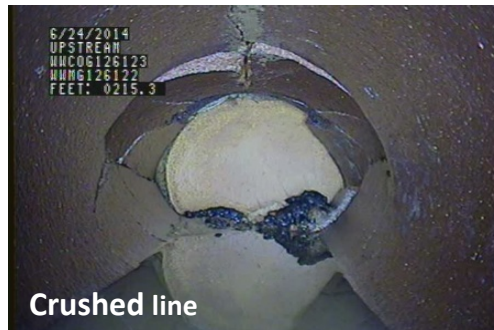
- Line is crushed
- Broken pipe
- Multiple small holes; one with soil visible
- Grade 4 fractures
- Broken tap with offset joint
- Cracked taps
- Leaking around taps
- Scattered roots in joints and laterals

**Crushed line**

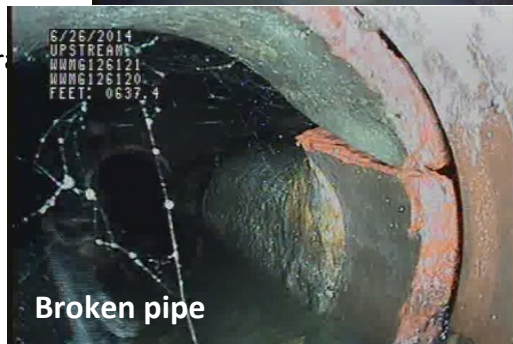
**Broken pipe**

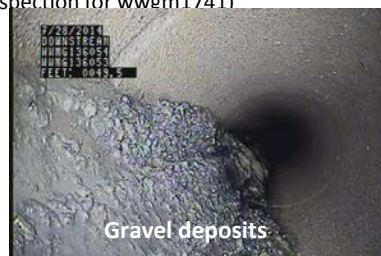
- Lots of lateral issues; majority of laterals are offset or broken and blocked with dirt; may want to investigate if blocked laterals are abandoned
- Segment wwgm1744 has two offset joints and a large hole, all with void visible
- Number of cracks and fractures throughout
- Roots scattered throughout
- Gravel deposits along entire wwgm1323 line

Gravel deposits

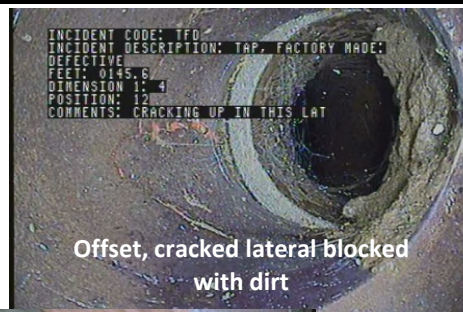
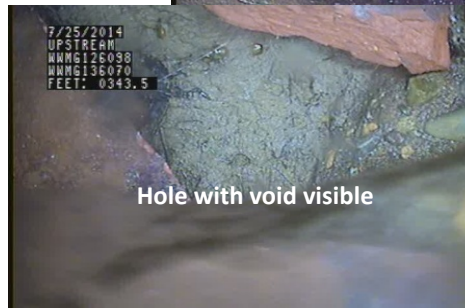
- Approximately 1003' of 1025' video inspected
- Large hole
- Crack that looks like small rips in wall
- Cracks throughout pipeline
- Number of laterals are blocked with dirt; may want to investigate if blocked laterals are abandoned
- Broken lateral cap
- Grout deposits; one joint impassable because of intruding grout or gasket
- Gravel deposits
- Large root ball

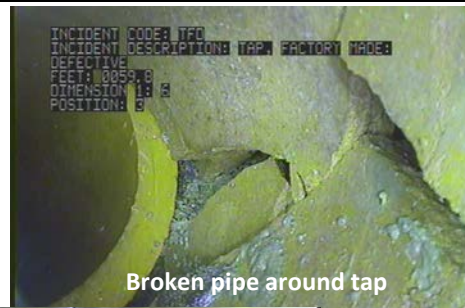
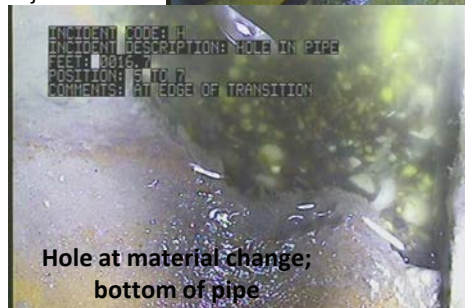
- Approximately 419' of 1087' video inspected
- Broken tee at tap with holes; camera cannot pass; pipe no longer round
- Hole at material transition
- Large root ball; camera cannot pass
- Intruding taps; some camera cannot pass
- Grout deposits
- Roots scattered in pipe segments; some in joints
- At least one separated lateral joint

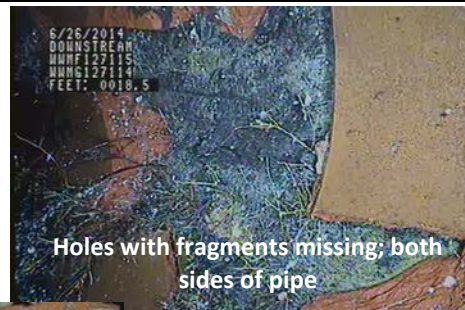
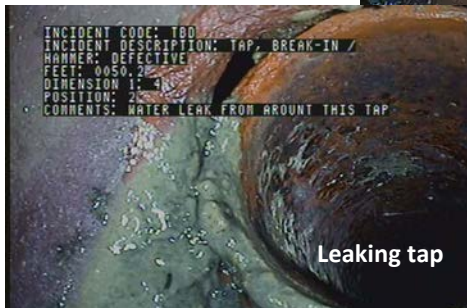
- Large hole with fragments missing; soil visible
- Heavy roots at large hole
- Number of fractures throughout segment
- Multiple cracks throughout segment
- Fine roots in some joints
- Leaking tap

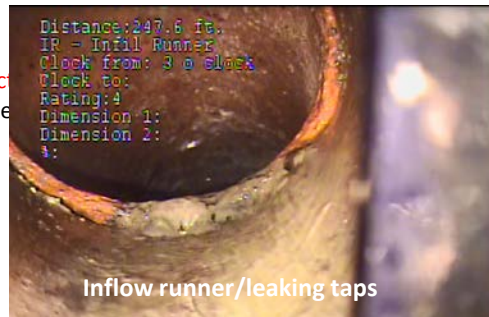
Fractures in pipeline with soil visible

Inflow runner/leaking taps

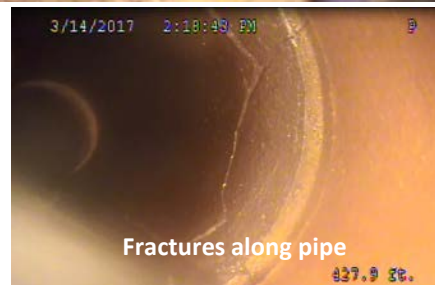
Fractures along pipe

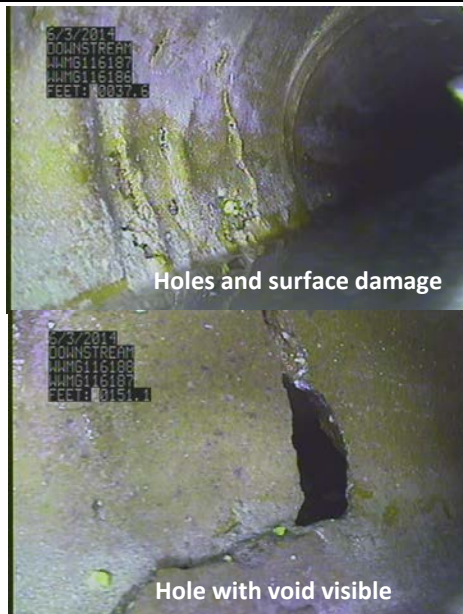
- Approximately 685' of 948' video inspected
- Hole with void visible
- Multiple holes in another segment
- Intruding tap; camera cannot pass
- Angular joint that camera cannot pass
- Surface damage, aggregate visible, in one location
- Leaking lateral
- A few cracks
- One segment may be orangeburg pipe (noted by operator)

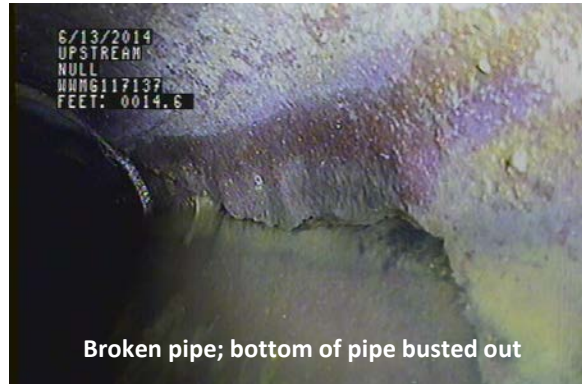
- Approximately 355' of 484' video inspected
- Broken; bottom of pipe busted out
- Fractures
- Fine roots in joints throughout

Broken pipe; bottom of pipe busted out

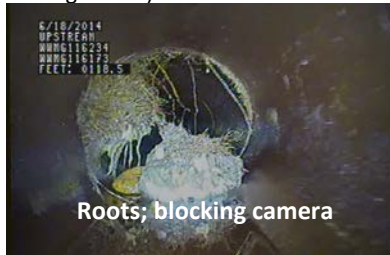
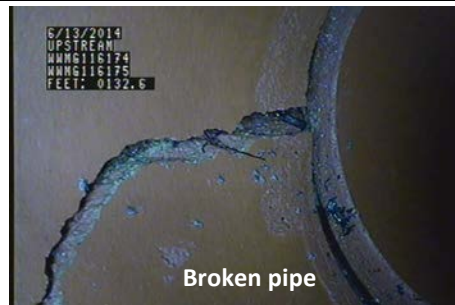
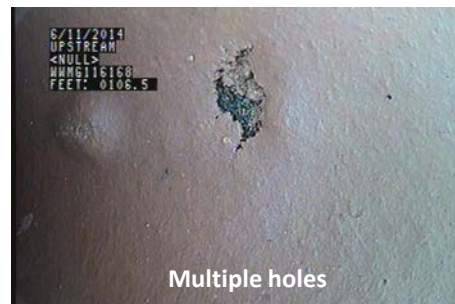
- Broken and hole in wall
- Multiple small holes
- Broken tap
- Intruding taps
- Fine roots scattered throughout
- One tap blocked by roots
- Silt deposits
- wwgm0100 has roots in line that camera cannot pass

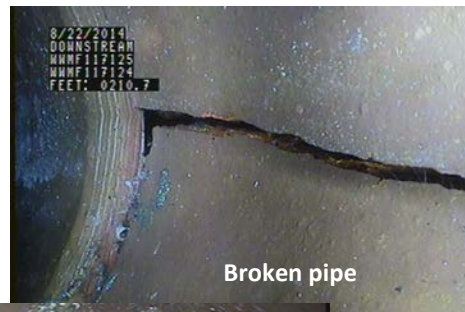
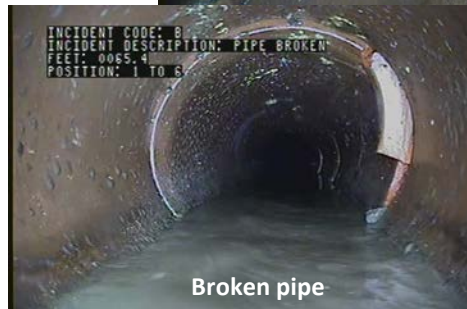
- Two breaks
- Some fractures and cracks
- Small hole
- Root ball camera cannot pass
- Intruding tap

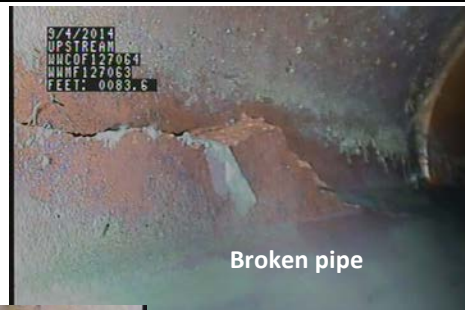
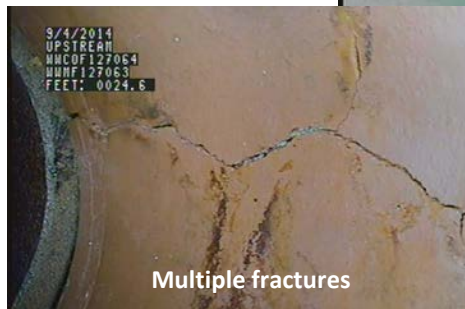
- Approximately 115' of 189' video inspected
- Broken
- Large hole up lateral
- Fracture and crack
- Root balls

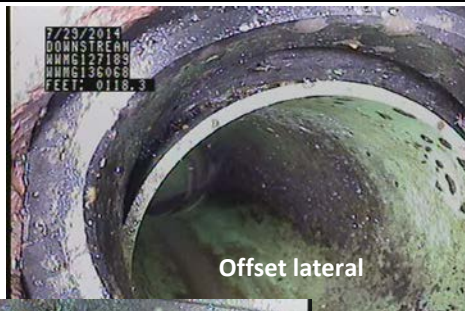
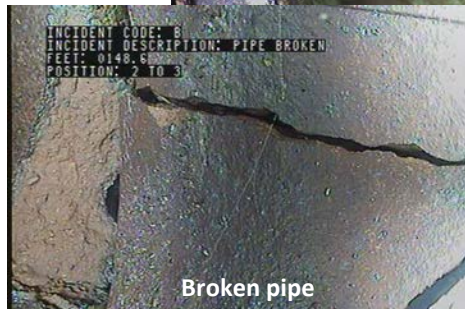
- Broken
- A few cracks
- Offset lateral joint
- Fine roots in joints
- Heavy roots in one lateral
- Need CCTV inspection video for wwgm1883

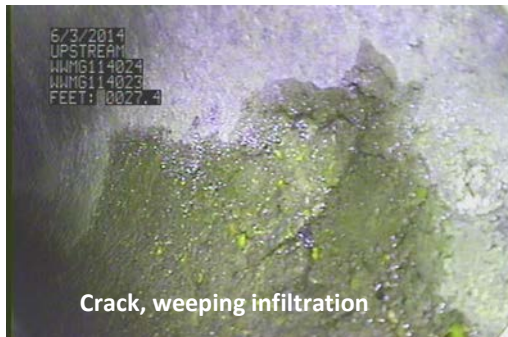
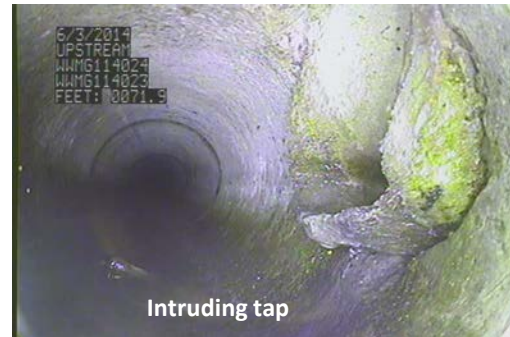
- Approximately 183' of 682' video inspected
- Cracks and infiltration stain from cracks
- Intruding tap camera cannot pass; only about one third of pipe length surveyed
- Root ball and root obstruction camera cannot pass

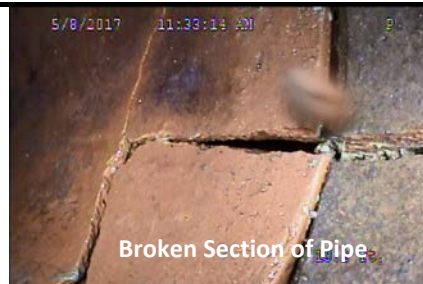
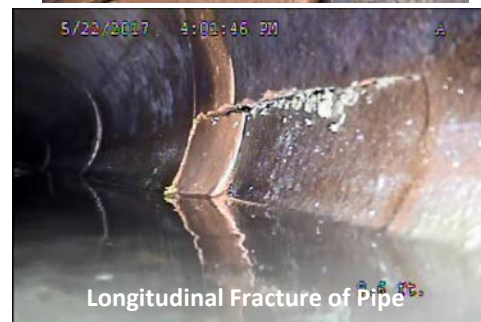
- Reverse inspections completed
- Multiple structural cracks and fractures along length of pipe

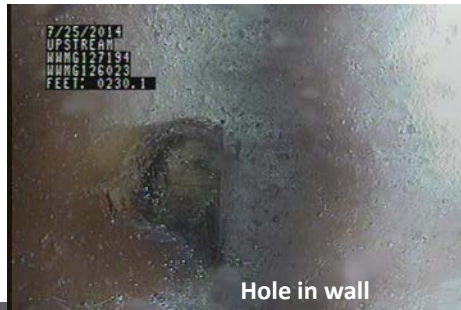
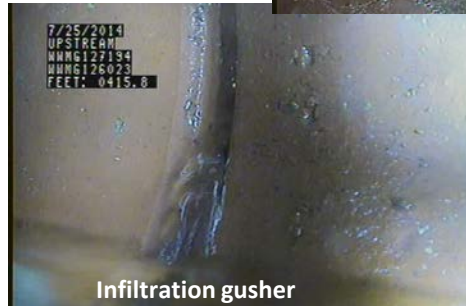
- Approximately 1059' of 1092' video inspected
- Small hole
- Two infiltration gushers (water entering pipe "under pressure")
- Couple of fractures and cracks
- Offset lateral joint
- Fine roots in a few joints
- Heavy mud at end of inspection camera cannot get past

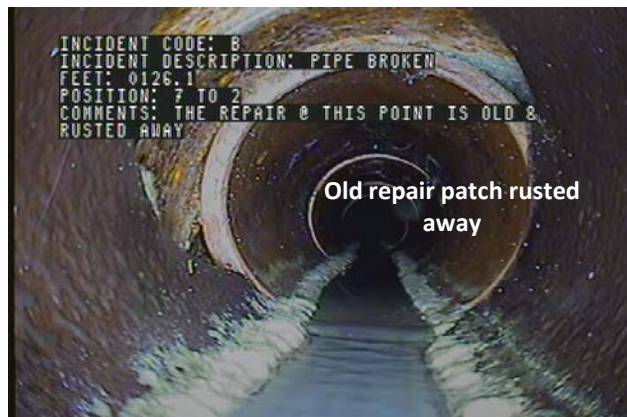
- Approximately 432' of 711' video inspected
- Broken; repair at this location is rusted away
- Minor cracks
- Intruding tap
- Fine roots in a joint

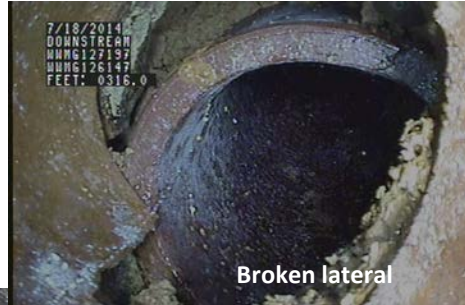
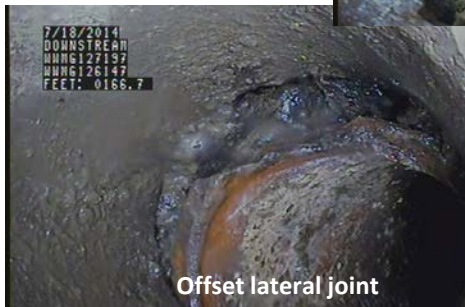
- Approximately 419' of 643' video inspected
- Multiple sags in the line
- Two broken lateral pipes
- Small hole in lateral
- Open lateral joint with dirt and rock
- Separated joint
- Crack
- Intruding tap

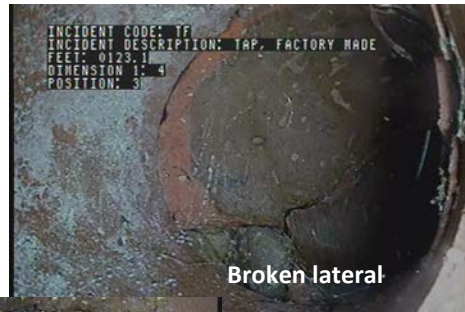
Broken lateral

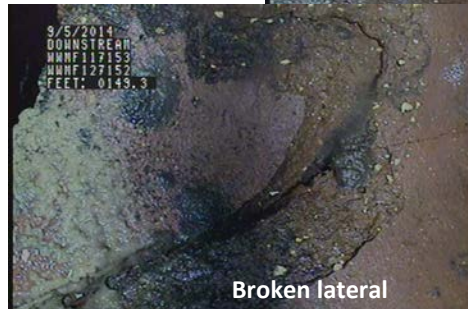
Broken lateral

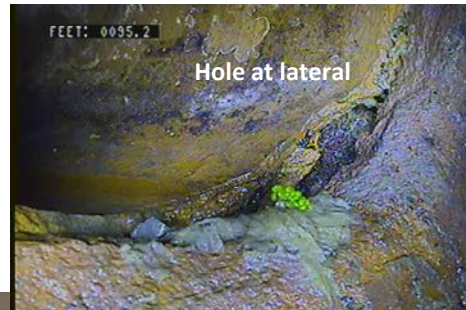
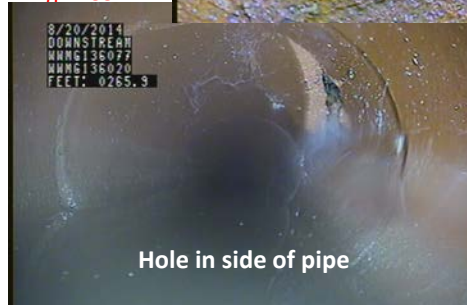
- Broken
- Two grade 4 fractures
- A few other fractures and cracks
- Broken lateral cap
- Hole in lateral
- Intruding tap
- Grout stuck in the joints along wwgm1351
- Need to see CCTV inspection video for wwgm1352

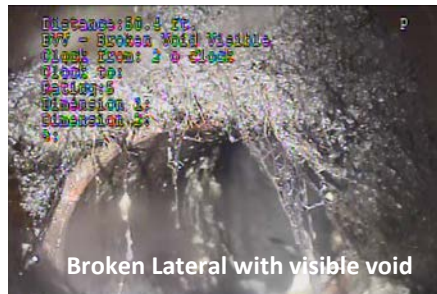
Several inflow gushers and runners within  
wwgm1428

Broken Lateral with visible void
