S. Blaine Street Storm Drain and trees on city property

Arborist Report

To address concerns of safety in regard to proposed infrastructure work that would affect a large Coastal Redwood tree (*Sequoia sempervirens*) and one Oregon White Oak (*Quercus garryana*).

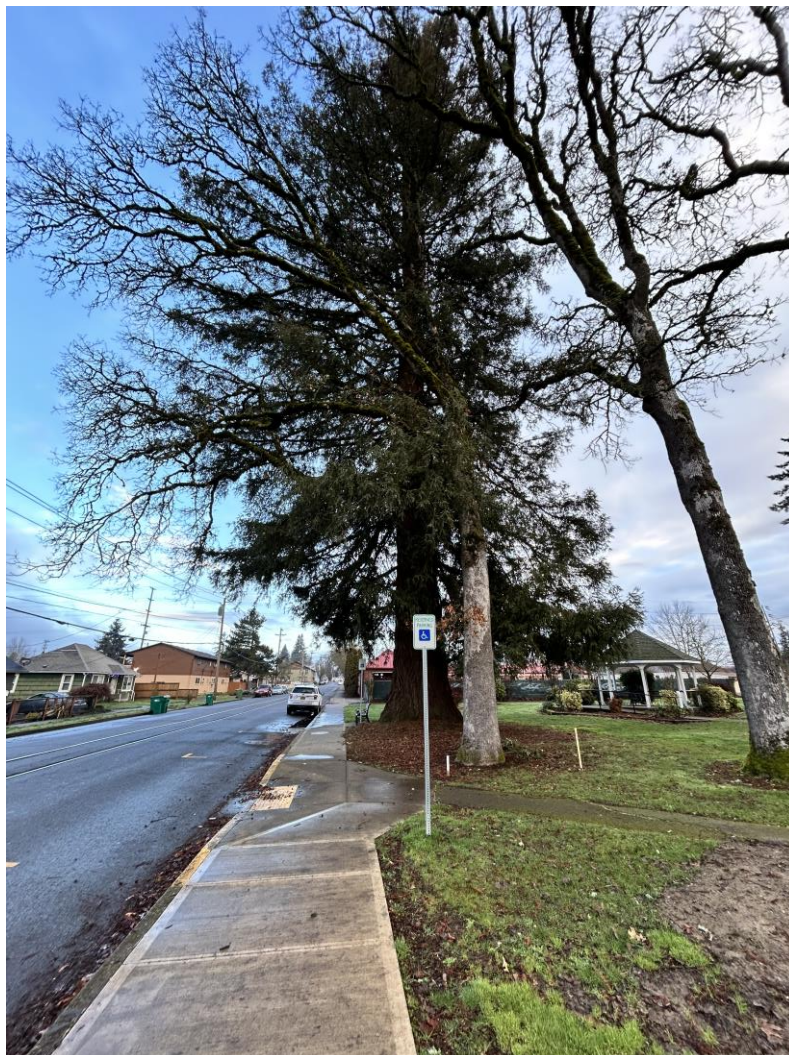
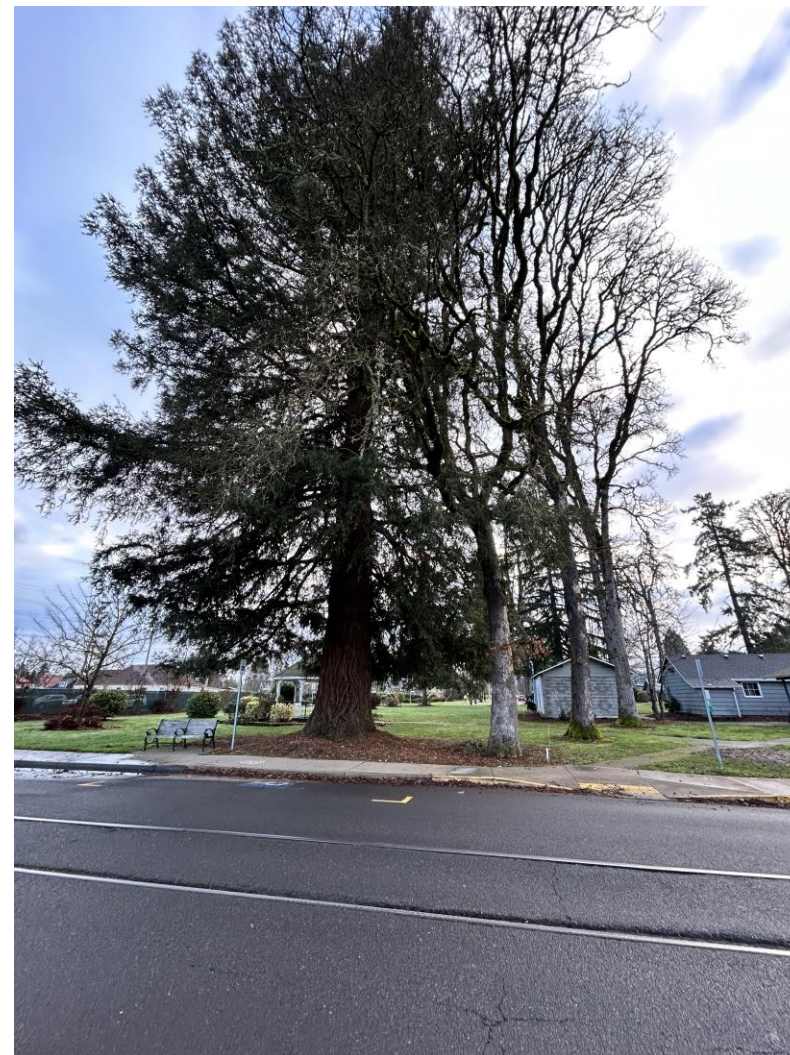
Sequoia & Oak Tree

Sequoia – South Blaine Street

Diameter – 95 Inches \pm

Circumference – 22.5 Feet \pm

Estimated Age – 75 - 80 years

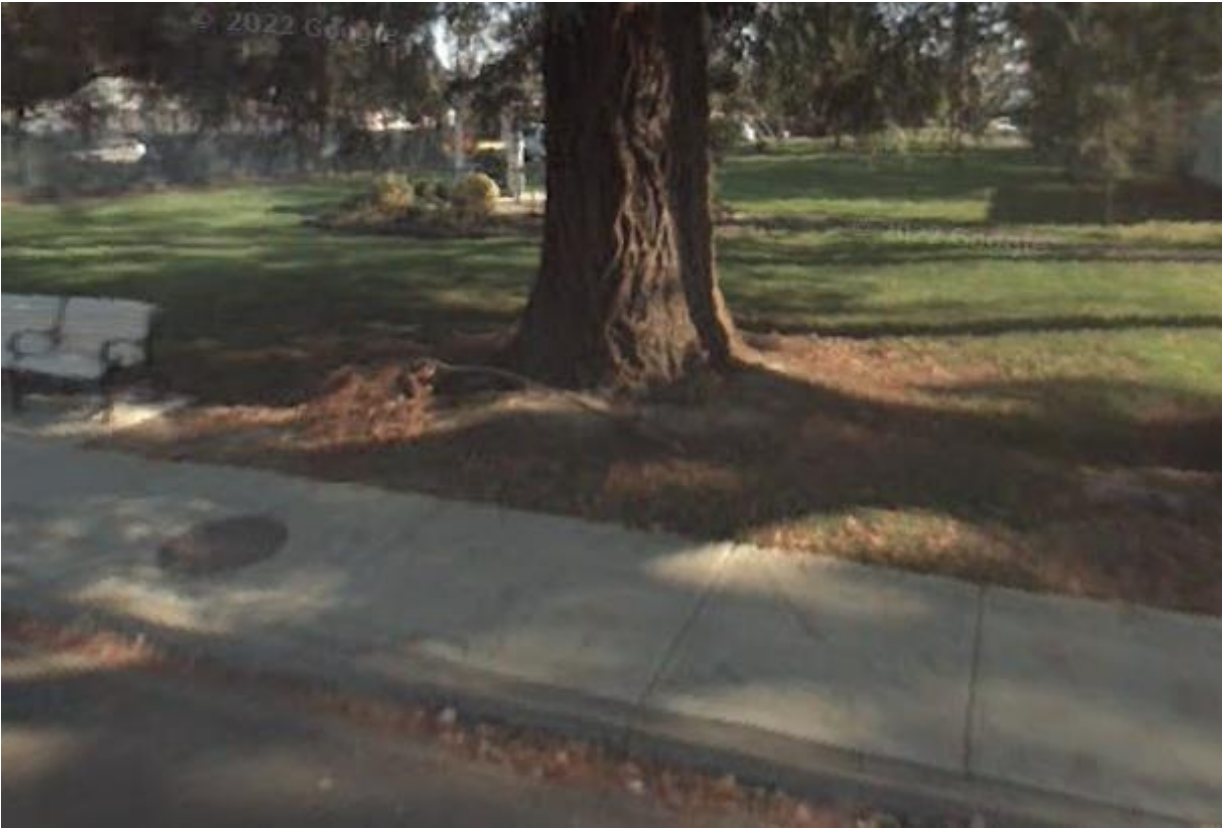
2007 @ Google Maps

Tree Growth

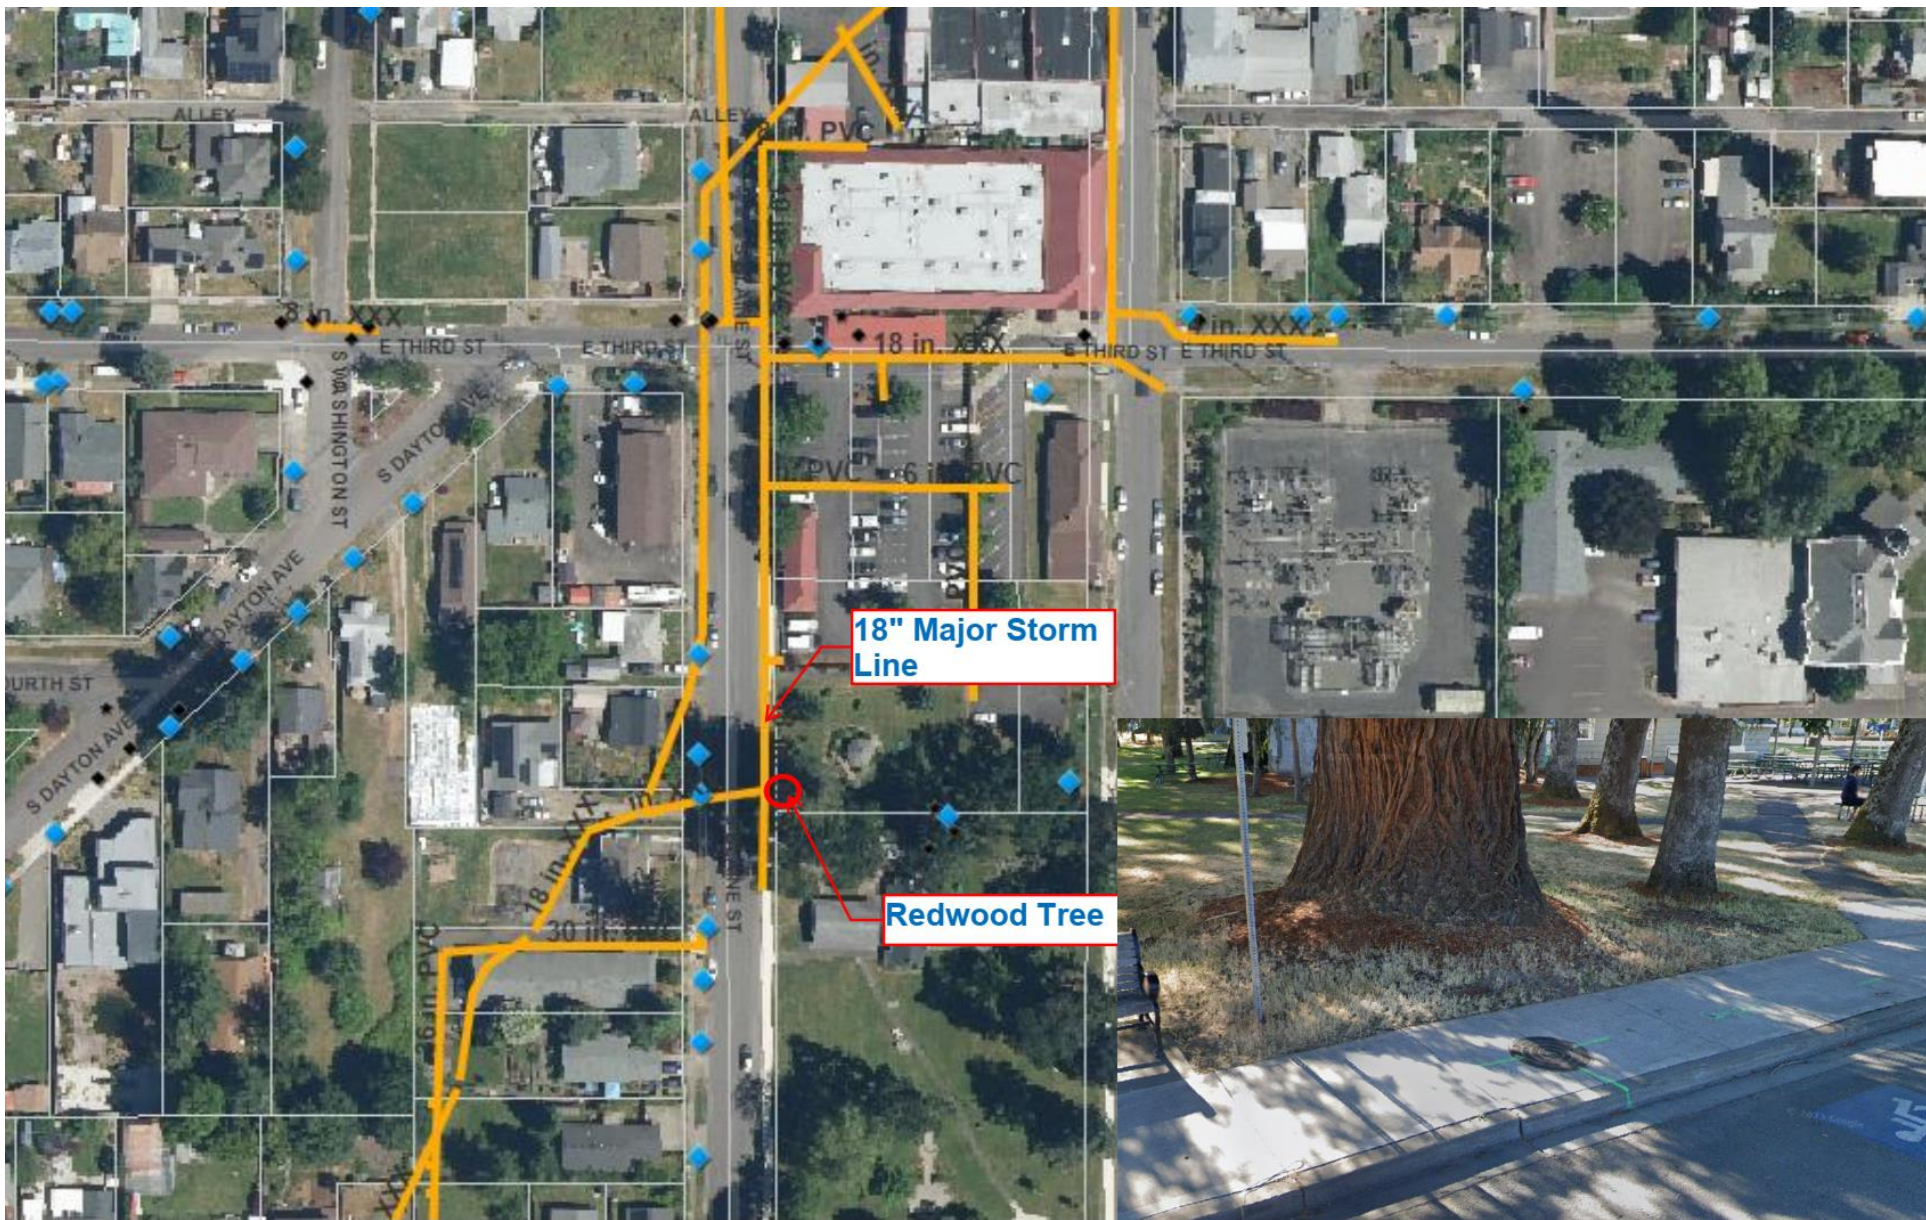
Storm Manhole Section Displaced by Roots

If the proposed road work and grade changes are undertaken, the west side of the root system will be significantly damaged. Large root cuts will be unavoidable in order to achieve the grade changes proposed. The drainage in this area has been affected by the uplift created by the Redwood roots and causes flooding to happen in the street during high precipitation.

I recommend removing the tree prior to the road work, if the work is already planned and in progress. If the road work doesn't happen, I don't see any reason to remove this tree currently. It provides an ecological service to the community and would last for many years to come in that location, if damage to the roots was avoidable.

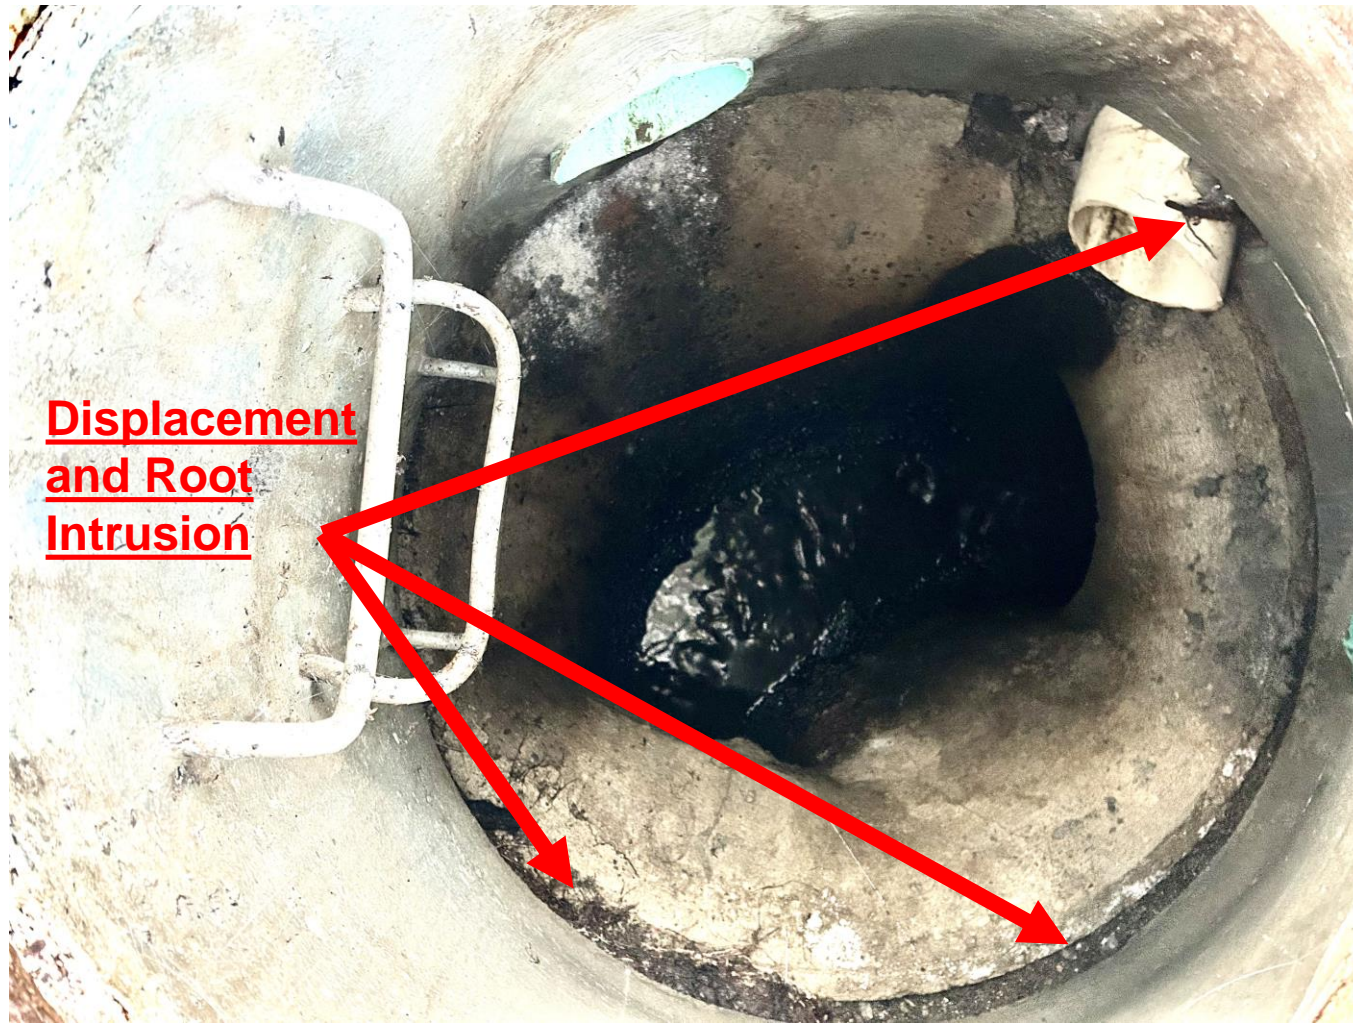
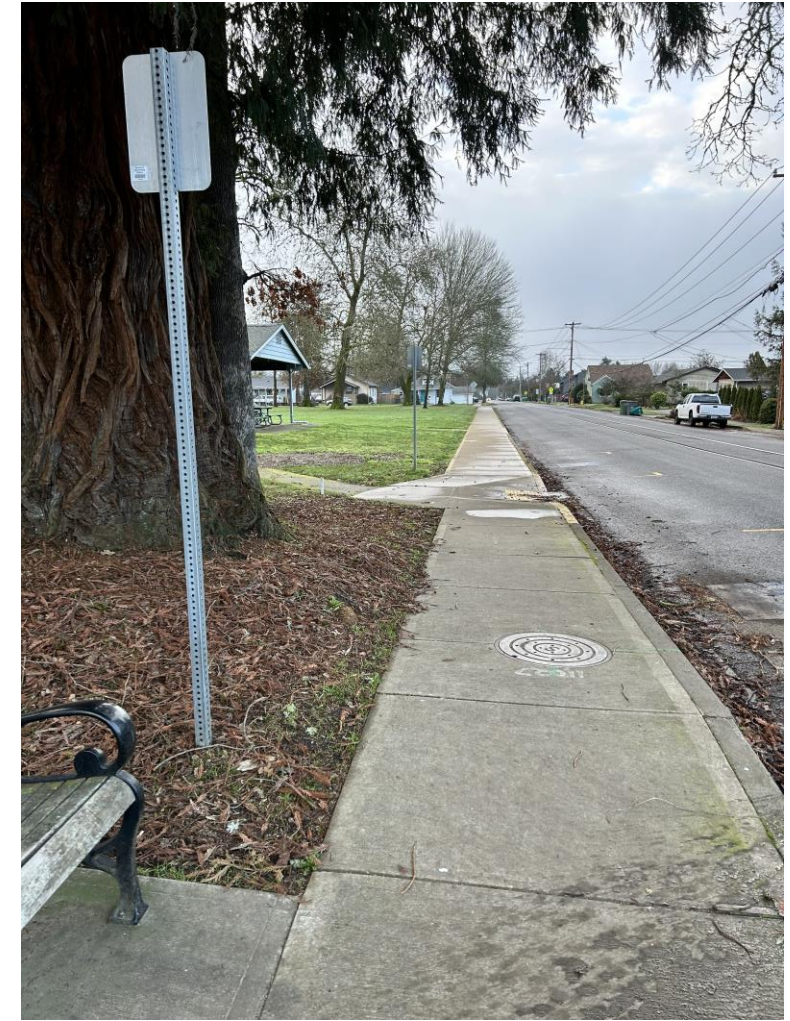
Root Damage to Pipes

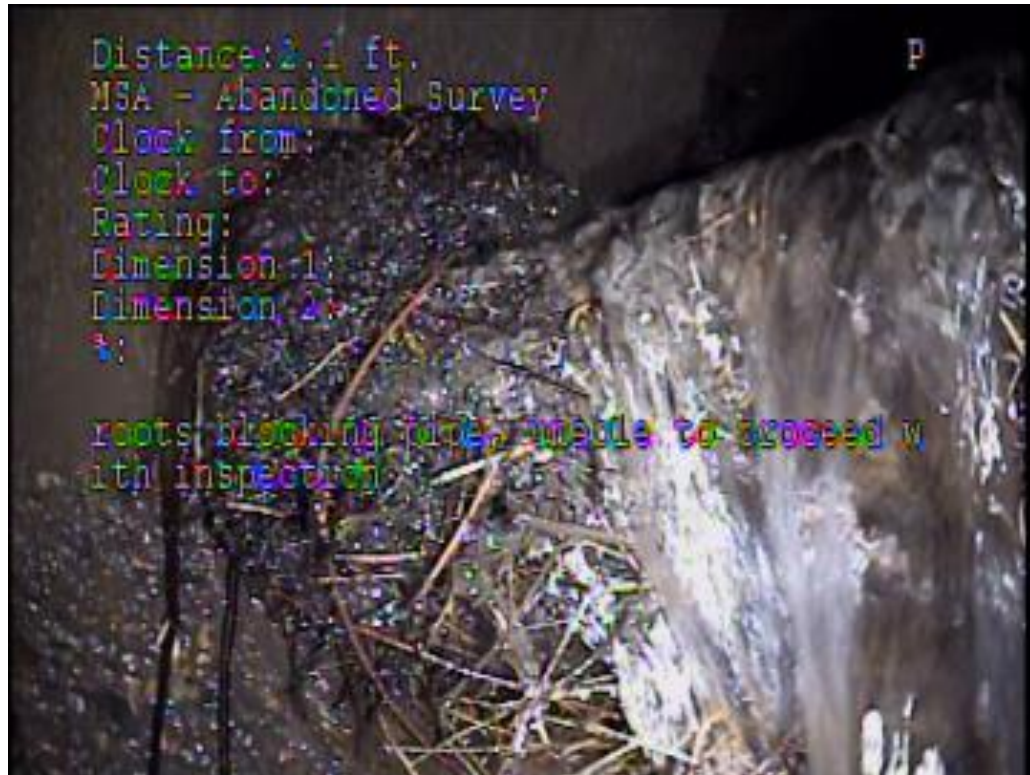
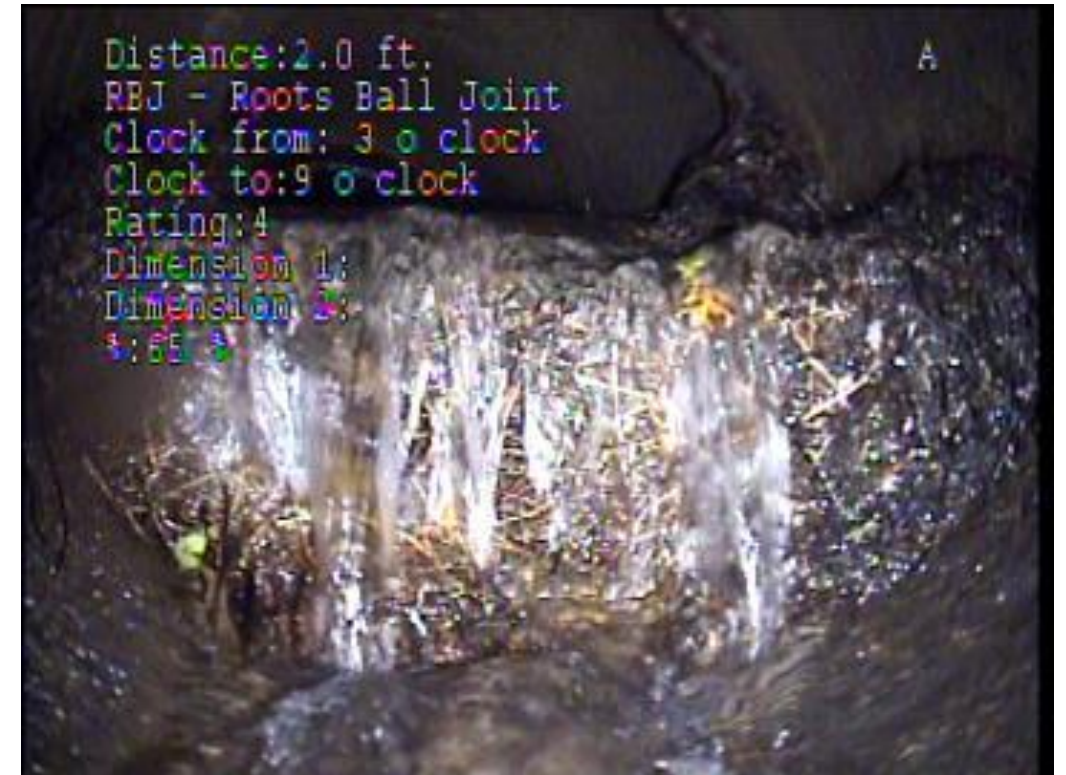
Current Root Damage

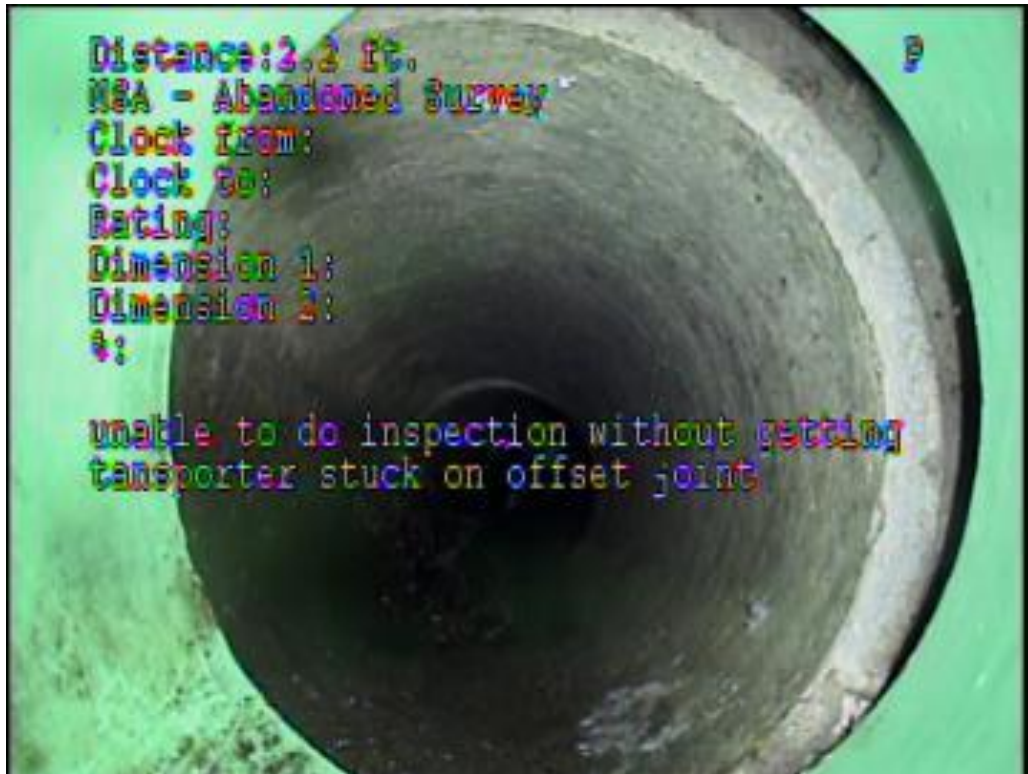
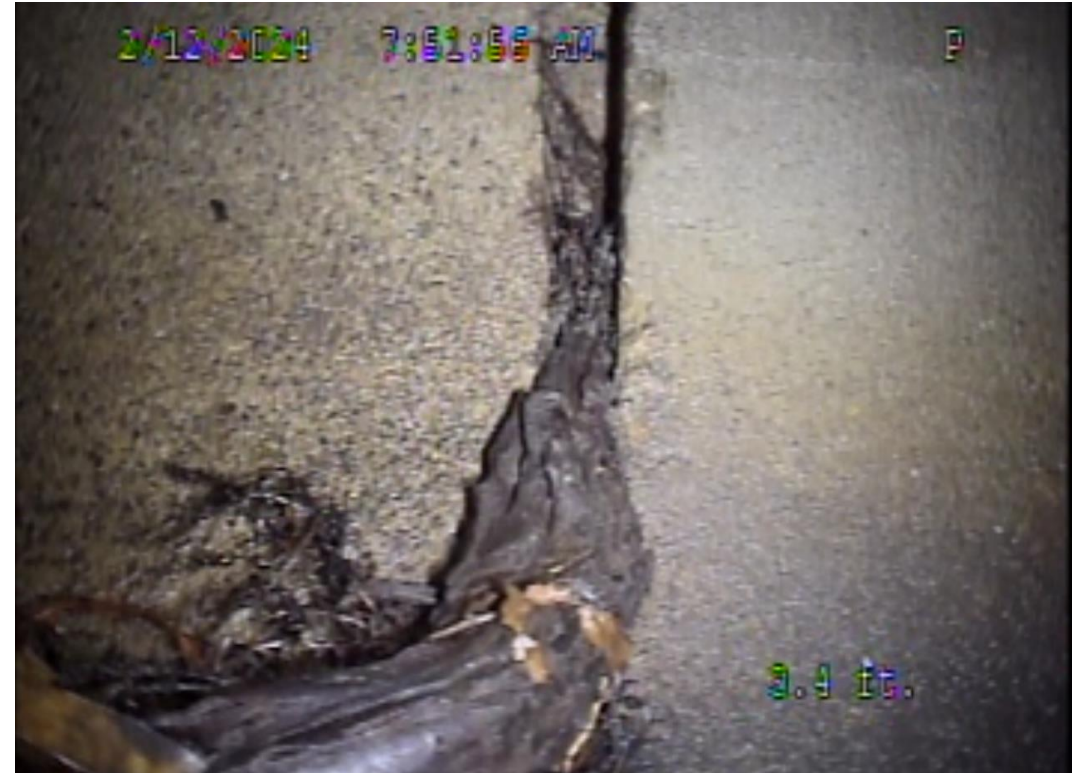
Current Root Damage

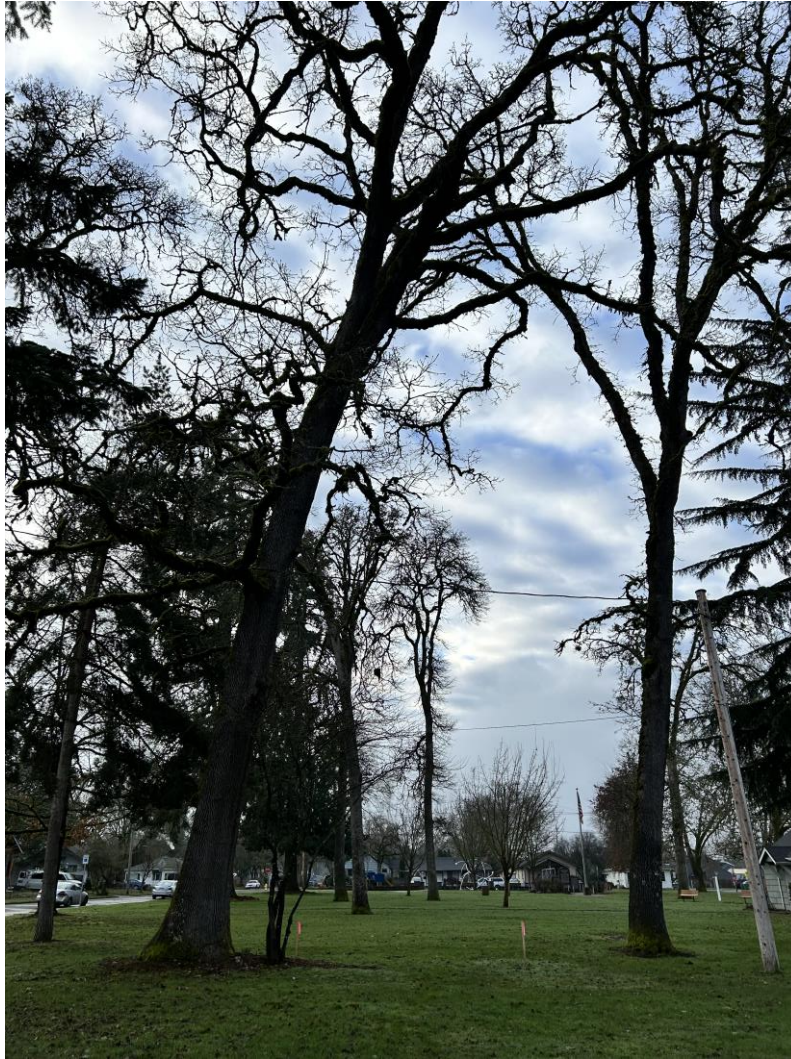
East Oak - 24 Feet Overbalance

Fair. The tree has decent crown vigor and no signs of root/stem decay. It does have an extremely unbalanced crown, given it's proximity to other trees and position at the edge of a grove.

In a 5-year time frame, the likelihood of failure and impact is *Somewhat Likely*. The consequences of failure could be severe if someone is injured or killed in the event of failure. The combination of those two factors yields a **Moderate** risk rating. This scenario is assuming no root cutting is performed.

I recommend removing this tree before the road work is undertaken. Even if the work is not undertaken, the tree should be removed eventually. The risk level will increase as time goes on. There is also a possibility that root damage has been done in the past through the sidewalk multiple replacement projects.

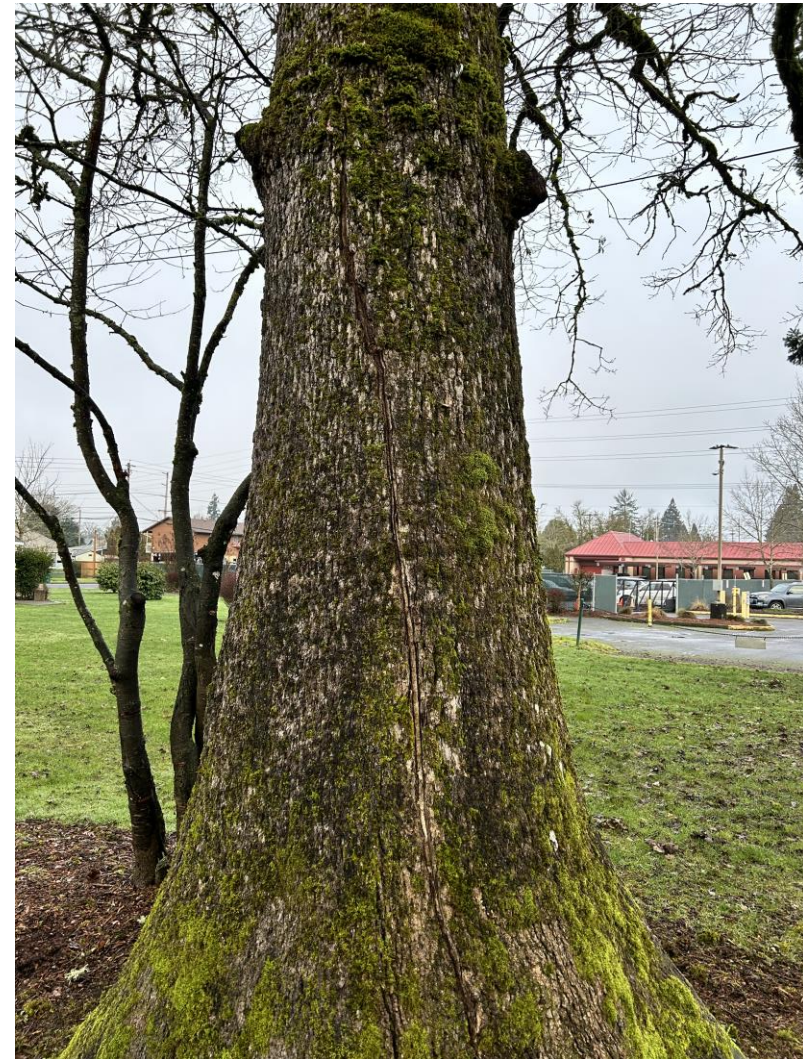
East Oak – Lightning Damage
