# Appendix

#### Facility Condition Assessment Inspection Form – Newberg WWTP

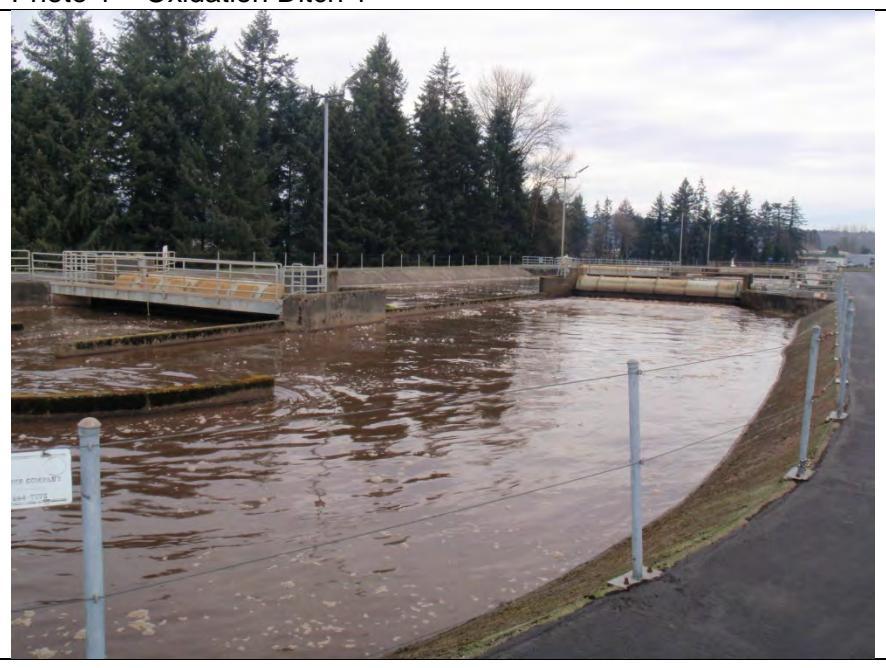
Photo 1 – Oxidation Ditch 1

Rotor seals are in need of replacement.

Rotor seals are in stock and will be replaced as the corresponding rotor assemblies are replaced in the next 2 to 5 years.

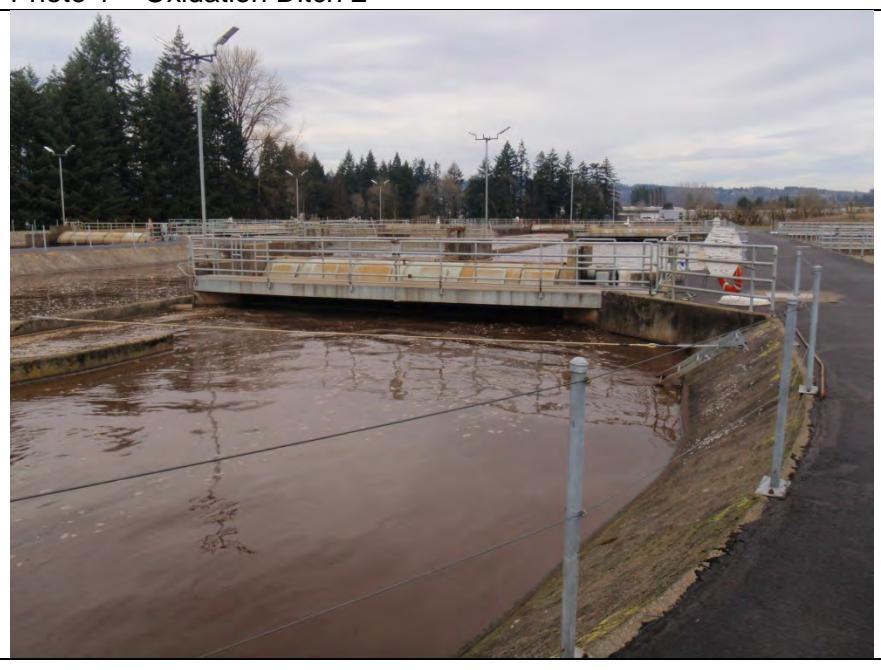
Photo 1 – Oxidation Ditch 2

Rotor seals are in need of replacement.

Rotor seals were replaced in October 2017 with no improvement with seal leaking. Rotor seals will again be replaced as the corresponding rotor assemblies are replaced in the next 2 to 5 years. A new Rotor #8 was installed in October 2017.

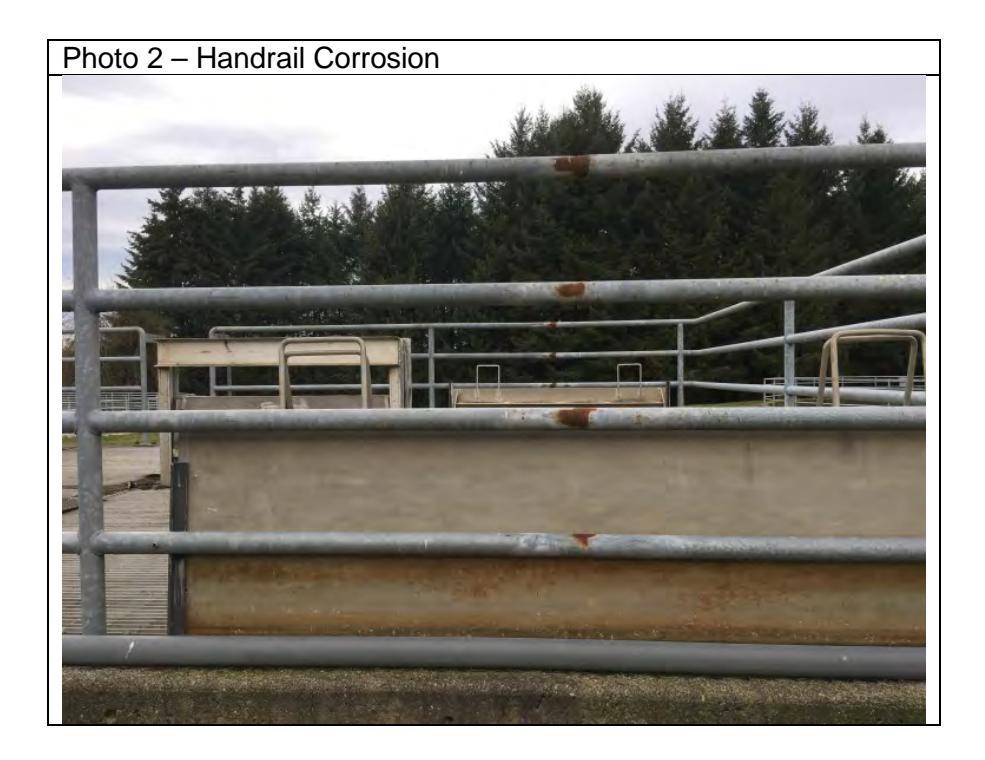
Photo 1 – Clarifier Distribution Box

SYSTEM ASS	ETS	CR			COMMENTS
Civil and Site		2	Differential settlement and some high spots in sidewalk.		
Architectural 2		2	Handrail has localized corrosion due to lack of galvanizing at field welded joints.		
Structural		3	Rating primarily based on age. No major structural deficiencies identified		
Power Distribut	tion	N/A	N/A		
Electrical		N/A	N/A		
Instrumentation Analyzers	ר/	N/A	N/A		
Process or Mechanical Equipment		2	Per discussion with operations staff, the isolation gate into the last segment is not functional.		
Pumping Syste	ems	N/A	N/A		
Piping and Val	ves	1	Sodium hypochlorite piping for disinfection is new. Old air, soda ash, polymer piping on/to the structure are not used.		lisinfection is new. g on/to the structure are not used.
HVAC		N/A	N/A		
Odor Control		N/A	N/A		
Other		N/A	N/A		
Overall Facilit Rating	у	2.0	System asse	et criteria weigl	nted equally
g	0	Unknown		Original Usefu	ul Life (OUL)

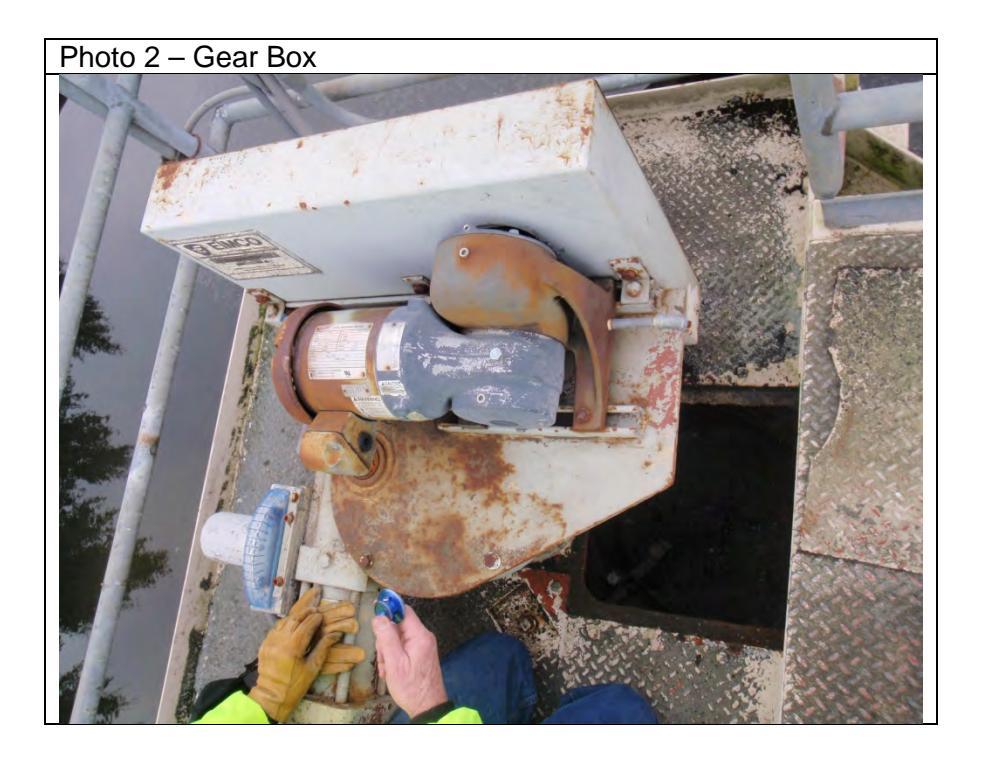
Photo 1 – Secondary Clarifier 1

SYSTEM ASS	ETS	CR			COMMENTS
Civil and Site		2	Some weather	ing of sidewalk, n	o major settlement.
Architectural	Architectural 2		Handrail has localized corrosion due to lack of galvanizing at field welded joints.		
Structural		3	Rating based primarily on age. No major structural deficiencies identified. Some general degradation of paint coating near bottom flanges of support stringers on skimmer drive access walkway		
Power Distribut	tion	N/A	N/A		
Electrical		3	Corrosion was observed on conduit, conduit fittings, and conduit fasteners.		
Instrumentation Analyzers	n/	N/A	N/A		
Process or Mechanical Equipment		3	No oil in upper gear box and exhibited a clicking sound.		
Pumping Syste	ms	N/A	N/A		
Piping and Valv	/es	N/A	N/A		
HVAC		N/A	N/A		
Odor Control		N/A	N/A		
Other		N/A	N/A		
Overall Facilit Rating	у	2.6	System asse	et criteria weigl	nted equally
U	0	Unknown	4	Original Usefu	ul Life (OUL)
	1	New or Excelle	ent Condition	100% OUL	Normal Preventive Maintenance

Note added in January 2018: Gear box seals were replaced in July 2017. The oil has remained in gear box since the replacement.

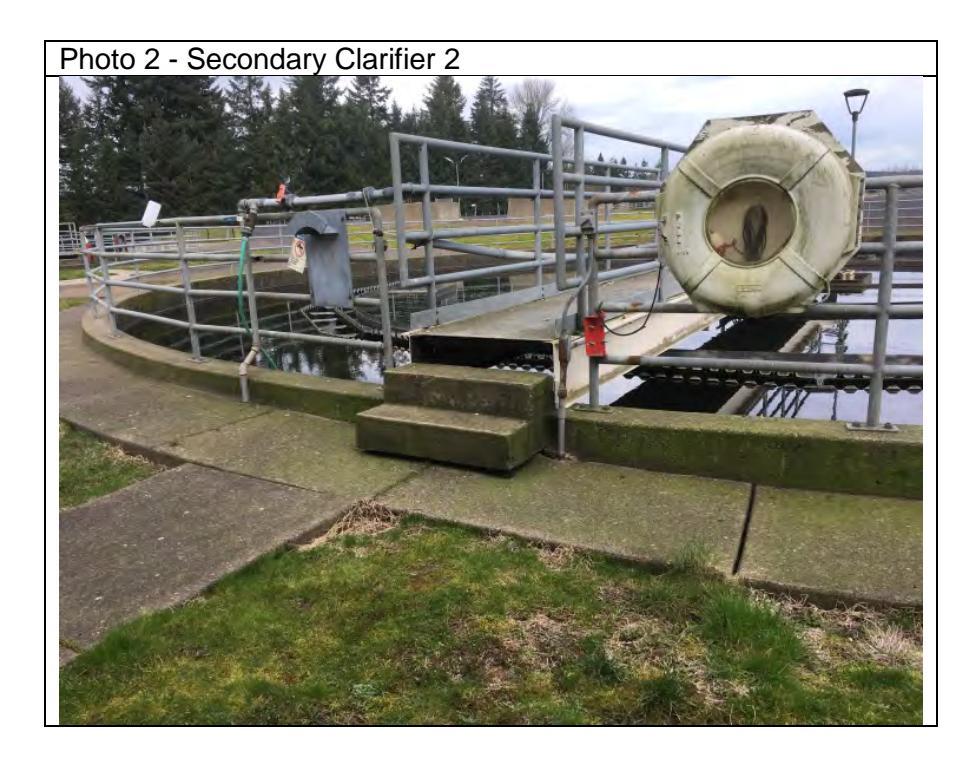
Photo 1 – Secondary Clarifier 2

SYSTEM ASS	ETS	CR			COMMENTS
Civil and Site		2.5	General settlement of sidewalk around perimeter of clarifier (see sidewalk with respect to stairs on maintenance walkway).		
Architectural		2	Handrail has localized corrosion due to lack of galvanizing at field welded joints.		
Structural		3	Rating based primarily on age. No major structural deficiencies identified. Some general degradation of paint coating near bottom flanges of support stringers on skimmer drive access walkway		
Power Distribut	tion	N/A	N/A		
Electrical		3	Corrosion was observed on conduit, conduit fittings, and conduit fasteners.		
Instrumentatior Analyzers	n/	N/A	N/A		
Process or Mechanical Equipment		3	Lower gear box leaks. Operators mentioned that the gear box recently froze. No issues identified with motor.		
Pumping Syste	ms	N/A	N/A		
Piping and Valv	/es	N/A	N/A		
HVAC		N/A	N/A		
Odor Control		N/A	N/A		
Other		N/A	N/A		
Overall Facility Rating	у	2.7	System asse	et criteria weigl	nted equally

Gear box seals were replaced in July 2017. No issues with oil leaking or freezing have been reported since the repairs.

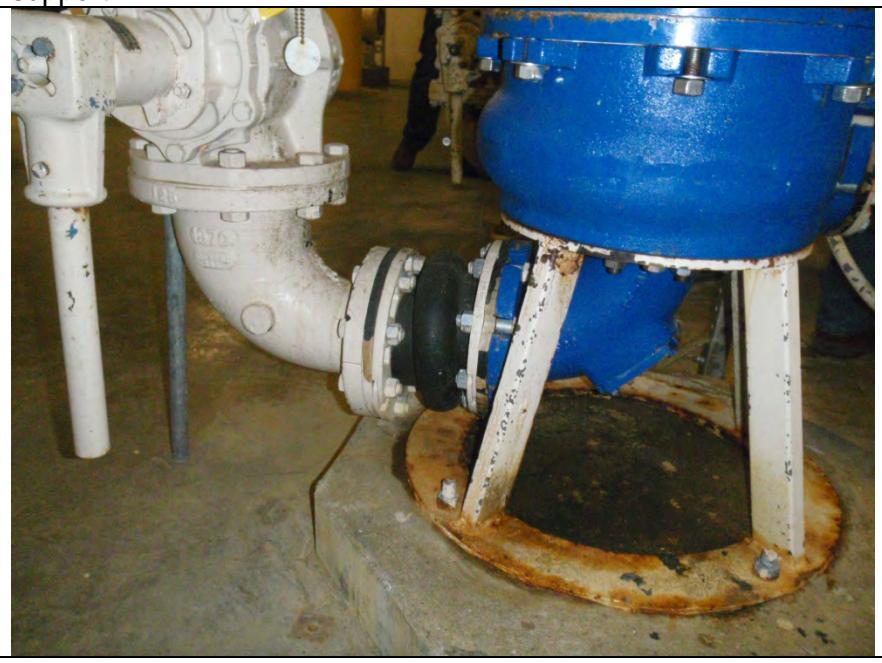
Photo 3 – WAS Pump 3 inlet piping misalignment and poor pipe support

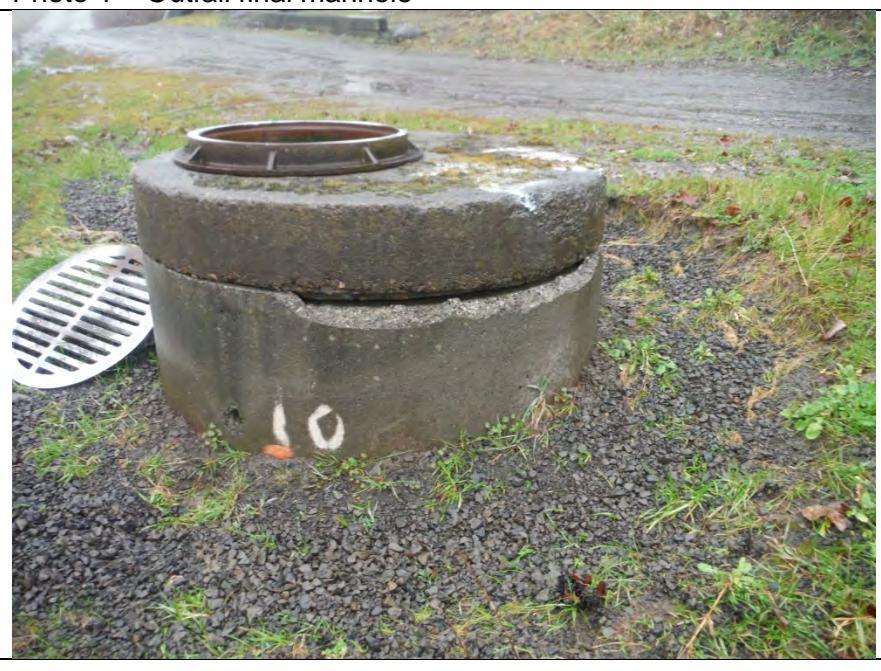
SYSTEM ASS	ETS	CR			COMMENTS	
Civil and Site		2	No site specific	mpacts or areas of concern identified.		
Architectural		N/A	N/A			
Structural		3	Visual damage to manhole lid (see Photo 1). Staff has noted that high flows can cause the entire manhole lid to pop off.			
Power Distribut	tion	N/A	N/A			
Electrical		N/A	N/A			
Instrumentation Analyzers	า/	N/A	N/A			
Process or Mechanical Equipment		N/A	Small amounts of foam spotted in the Willamette River near the outfall location, uncertain if associated with the WWTP.			
Pumping Systems N/A		N/A				
Piping and Valves 2		Minor defects identified per CCTV inspection videos.				
HVAC N/A		N/A				
Odor Control	Odor Control N/A N/A					
Other		N/A	N/A			
Overall Facility 2.3 System asset criteria weighted equally		nted equally				
U	0 Unknown		Original Useful Life (OUL)			
	1	New or Excelle	ent Condition	100% OUL	Normal Preventive Maintenance	
CONDITION RATING LEGEND	2	Minor Defects	Minor Defects Only		Normal Preventive Maintenance, Minor Corrective Maintenance

Adjacent paper mill outfall no longer in operation. Paper mill closed in 2016.
Photo 1 – Outfall final manhole

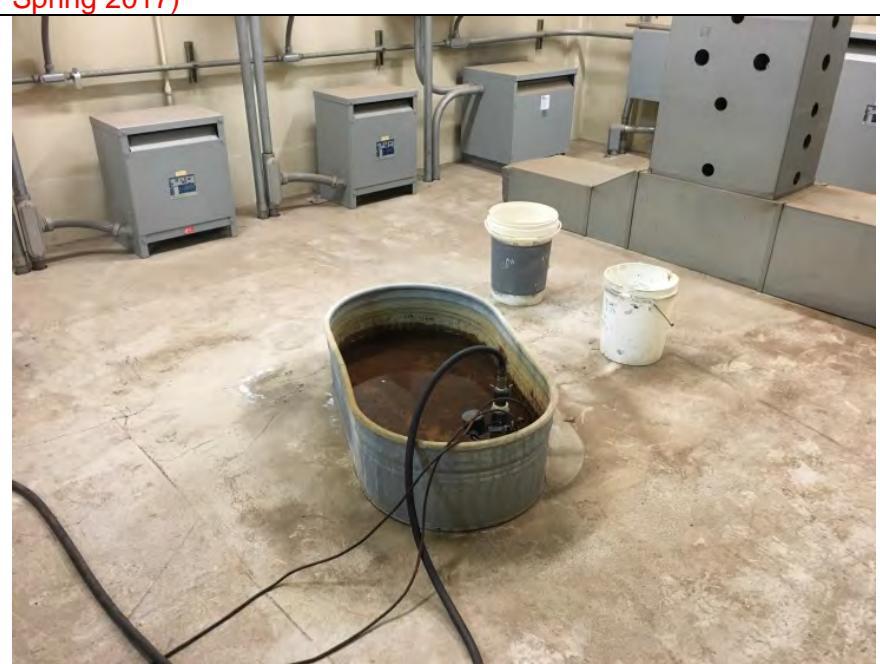
Photo 6 – Collection of water from roof leak (Roof replaced in Spring 2017)

Roof was replaced in Spring 2017.

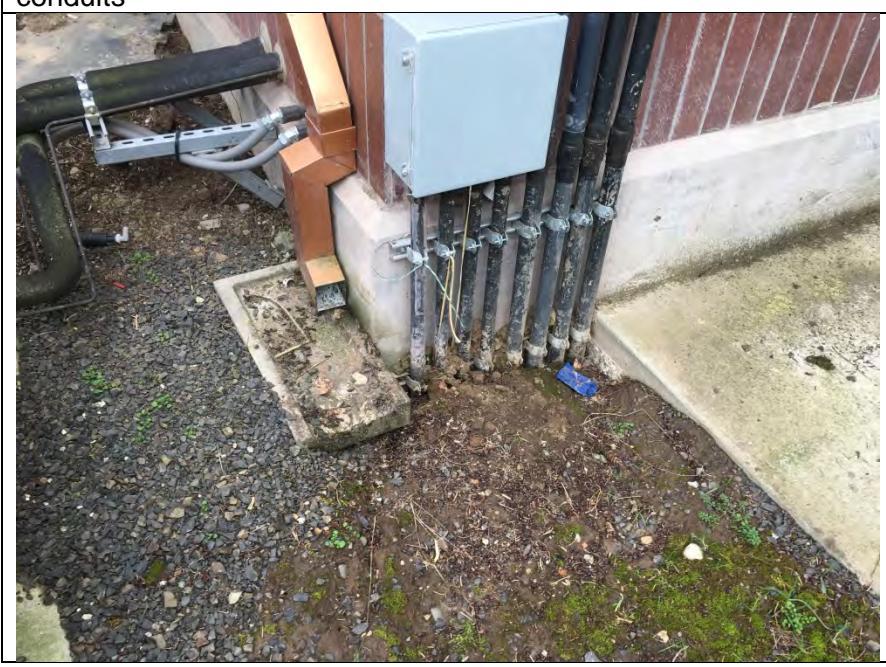
Photo 2 – Gutter splashing causing erosion around electrical conduits
