ORDINANCE No. 2021-2877

**AN ORDINANCE AMENDING THE NEWBERG COMPREHENSIVE PLAN,
X. 2018 WASTEWATER MASTER PLAN INCORPORATING THE
ADDENDUM RIVERFRONT MASTER PLAN 2021 INTO THE NEWBERG
COMPREHENSIVE PLAN**

**WWMP
Technical
Update
May 2021**

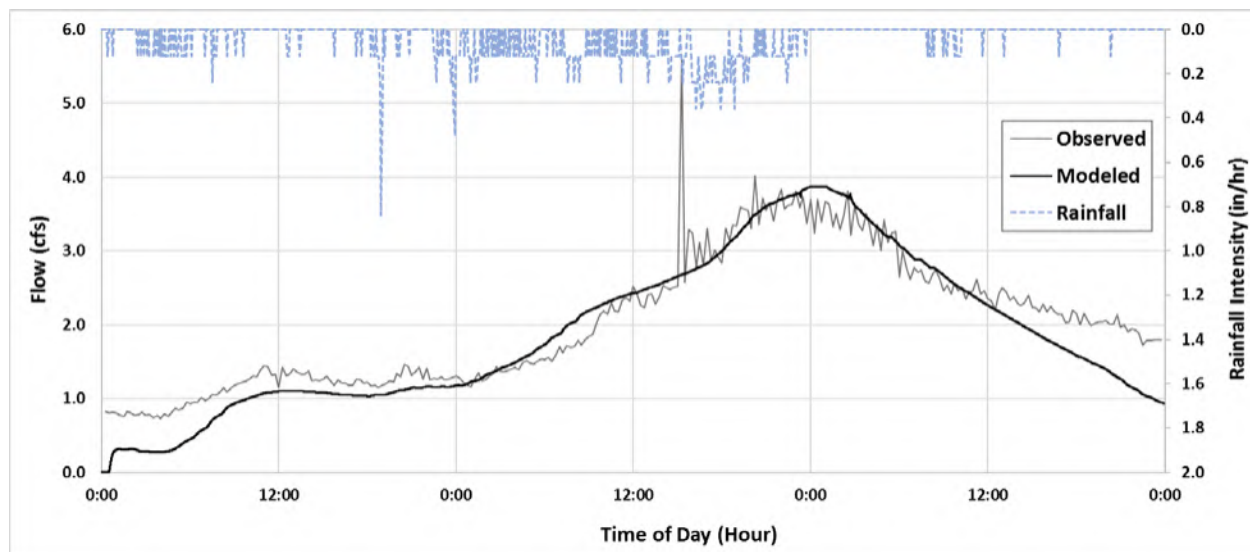
Chart 4-2: Sample WWF Calibration Site 12 – Modeled vs. Observed Flows (WWGM1794)

The RTK method was used for rainfall-derived infiltration and inflow (RDII) prediction. Rainfall data for a 72-hour period with the highest cumulative (3.34 in) and highest intensity (0.84 in/hr) rainfall during the period of flow monitoring was utilized to calibrate wet weather flows. The storm event rainfall was entered into InfoSWMM. RTK parameters were then adjusted to calibrate the model with flow monitoring data. Again, total modeled influent flows at the WWTP were compared to the targeted design average daily flow and influent flow data in addition to calibrating the model at various locations within the collection system and at the WWTP influent lift station. Example calibration is shown in Chart 4-2.

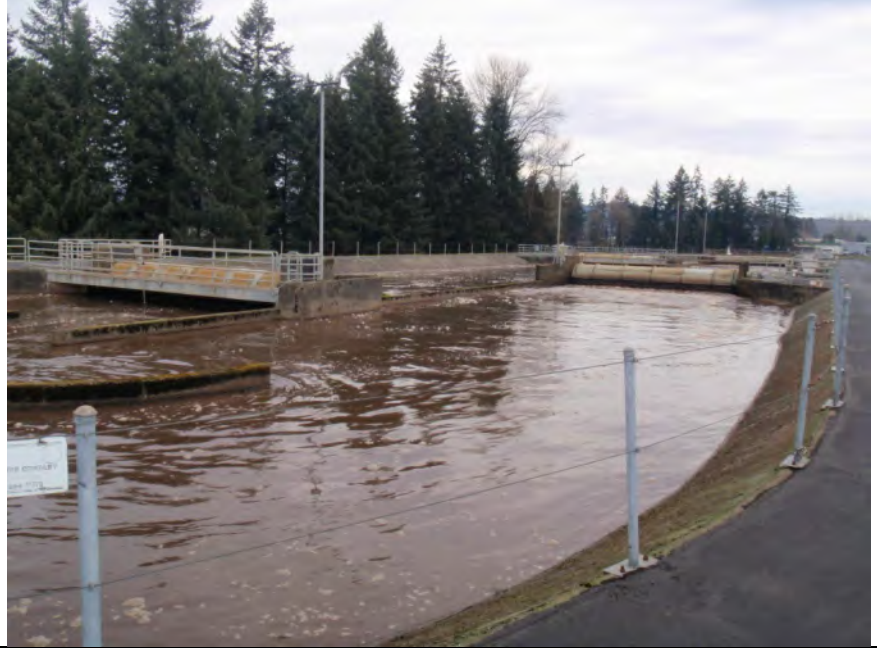
Photo 1 – Oxidation Ditch 1

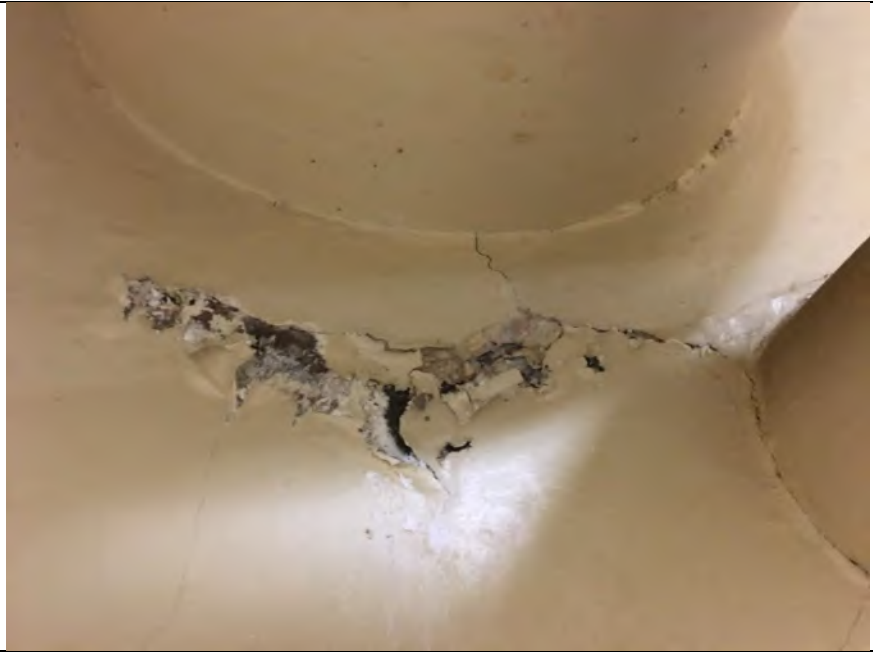
Photo 5 – Wall Crack 1

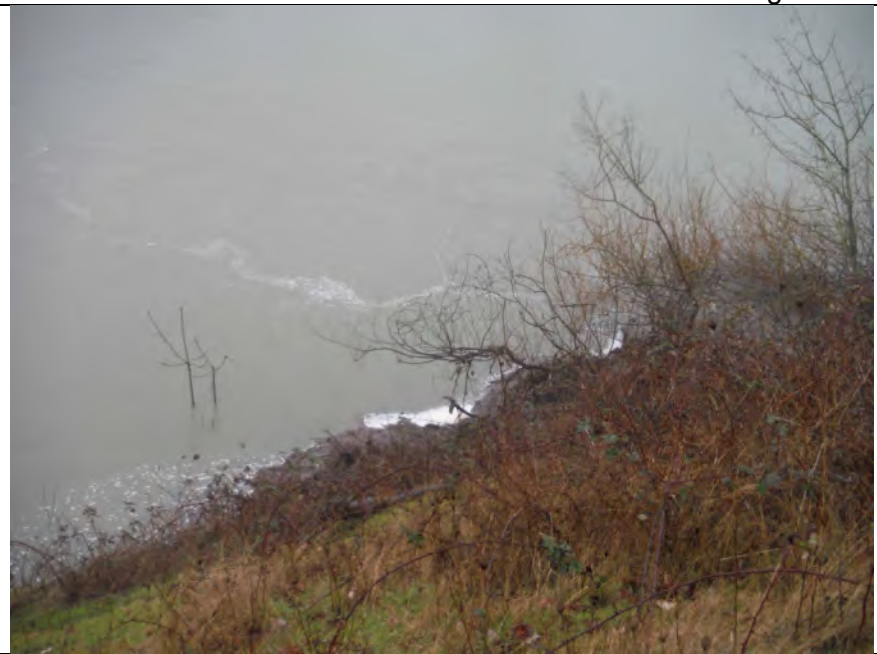
Photo 4 – Trace foam in Willamette River at outfall discharge

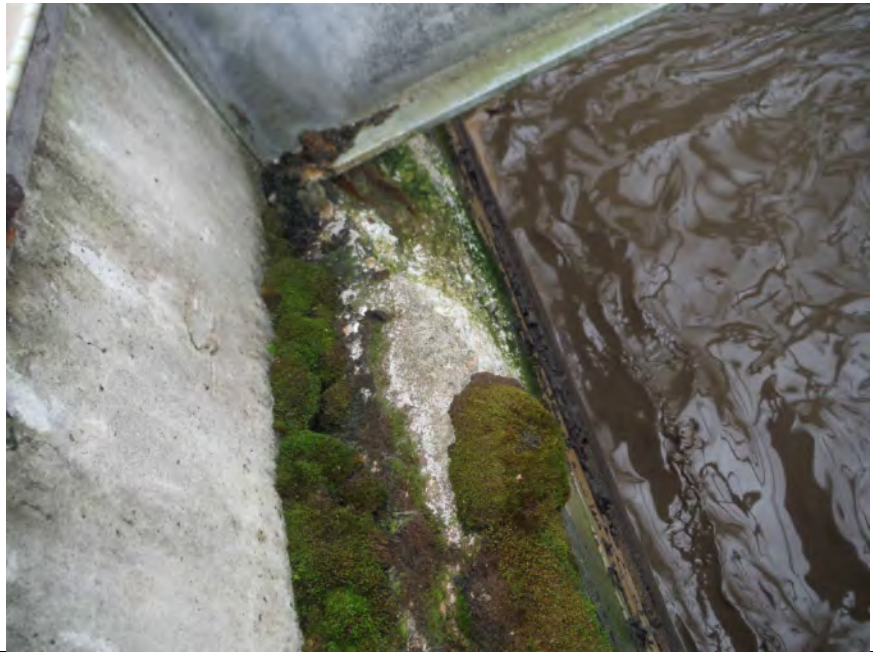
Photo 2 – Portion of concrete missing and buildup of moss

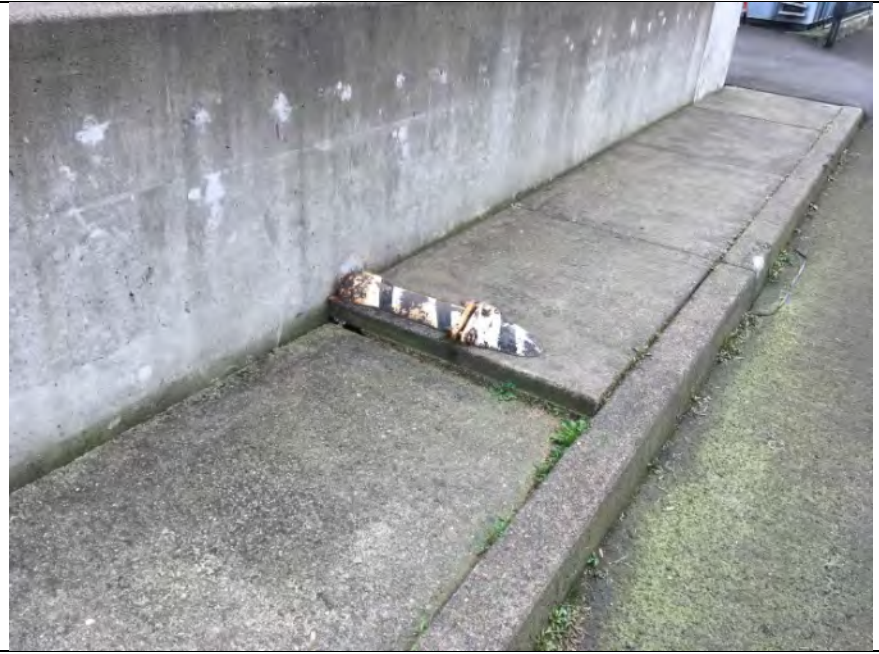
Photo 3 - Sidewalk Settlement

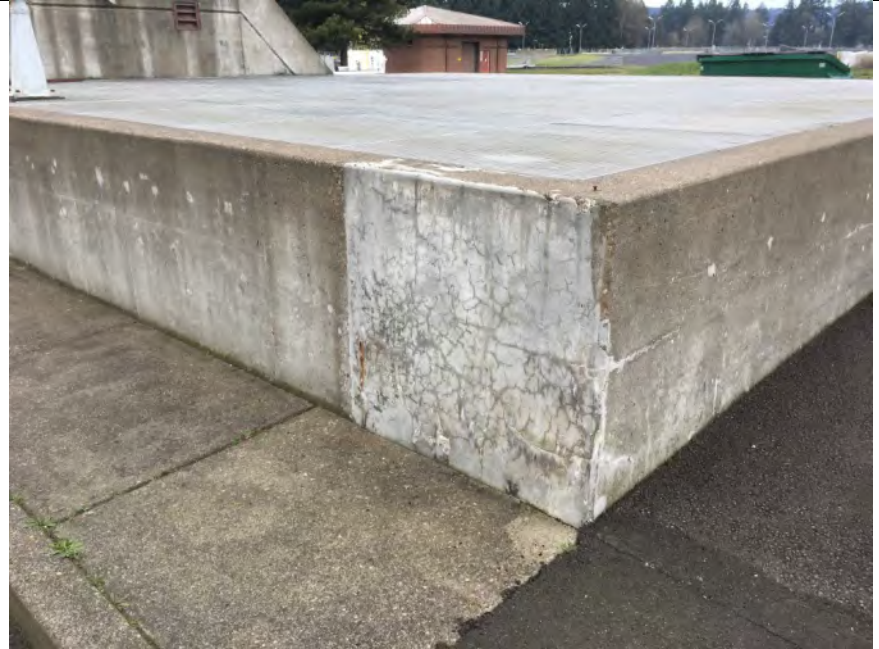
Photo 4 - Concrete Spalling

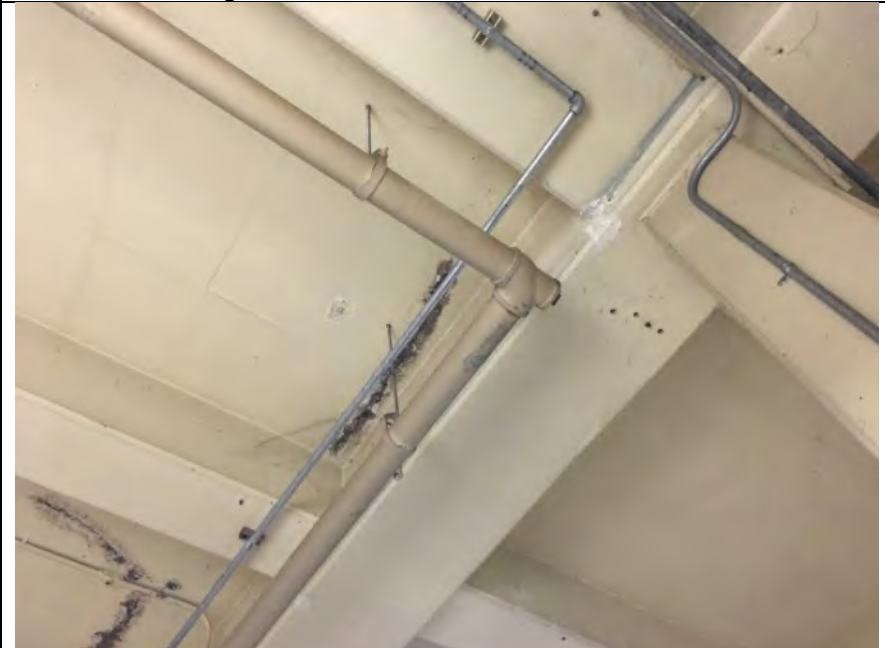
Photo 2 – Ceiling Cracks

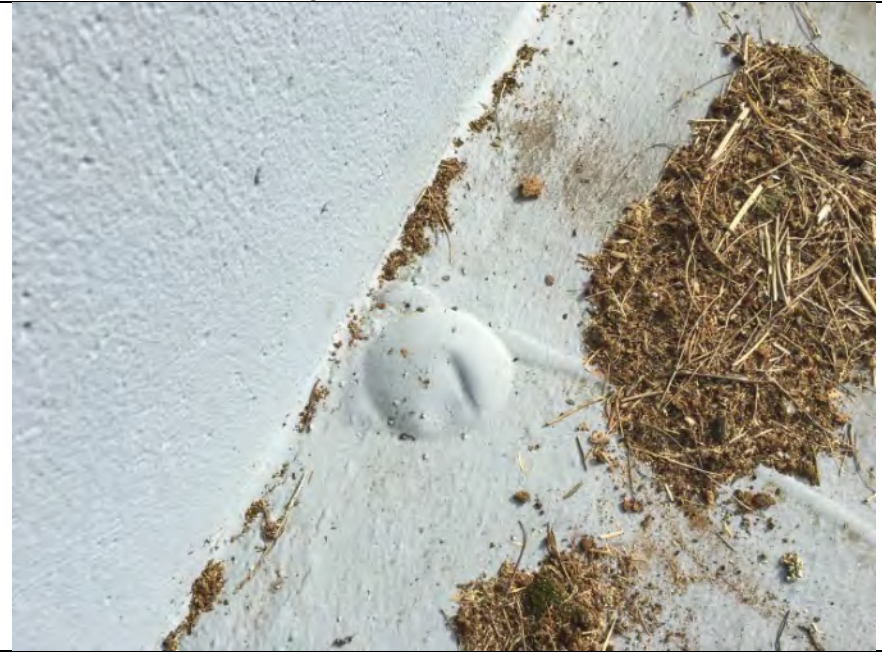
Photo 3 – Floor Coating Bubbles

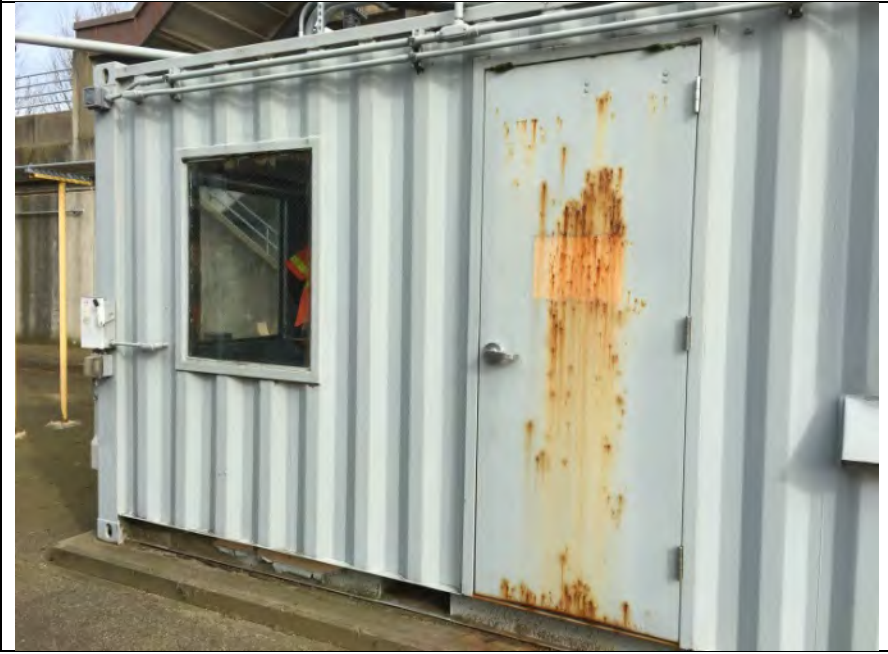
Photo 3 – MCC Container Corrosion

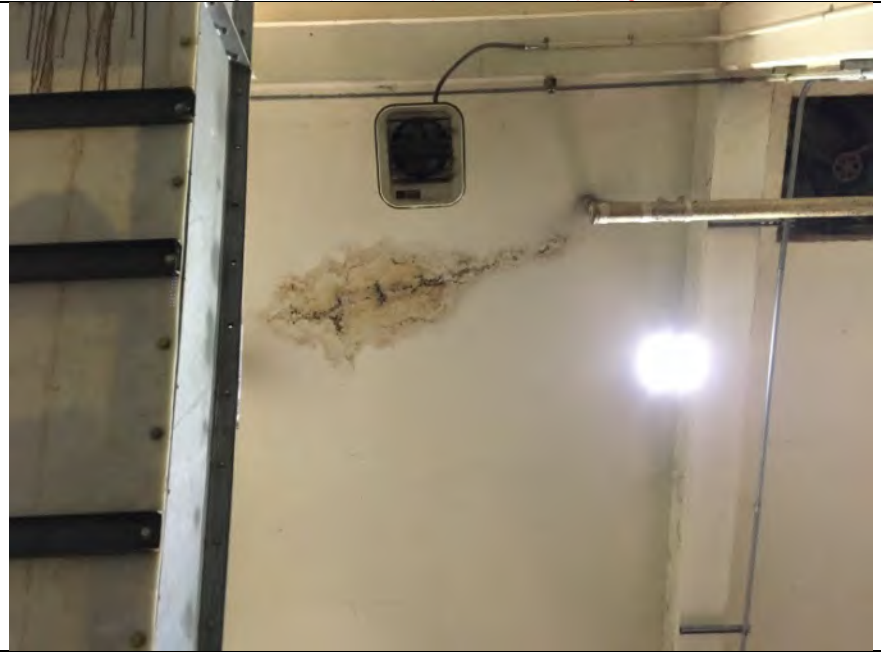
Photo 4 – Leaking Roof (Roof replaced in Spring 2017)

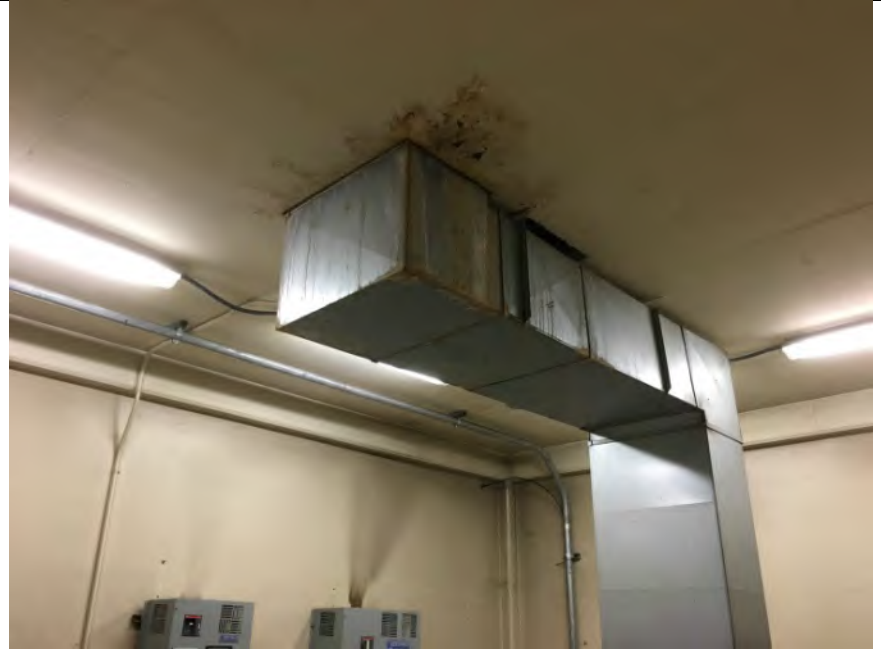
Photo 5 – Leak around HVAC duct (Roof replaced in Spring 2017)

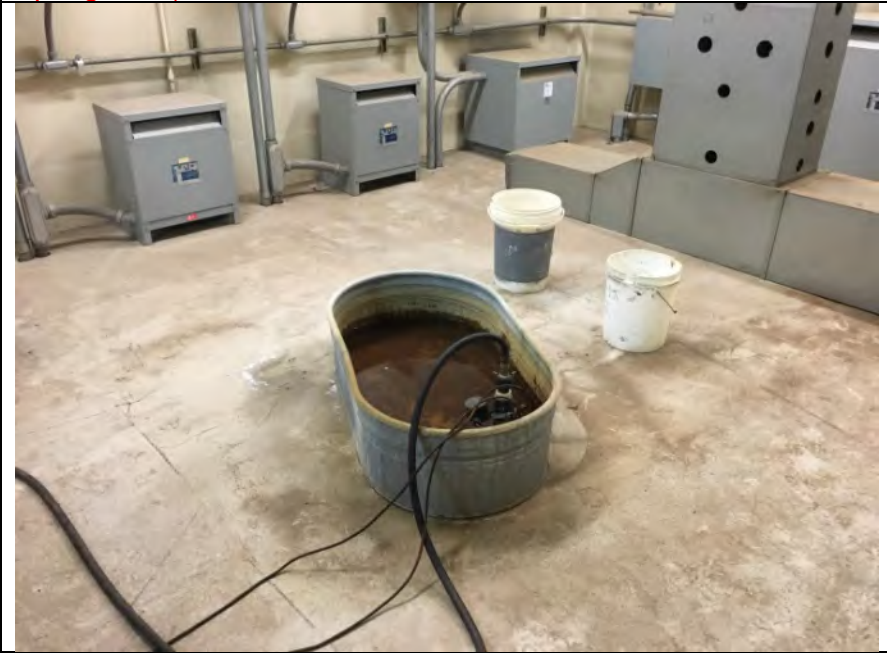
Photo 6 – Collection of water from roof leak (Roof replaced in Spring 2017)

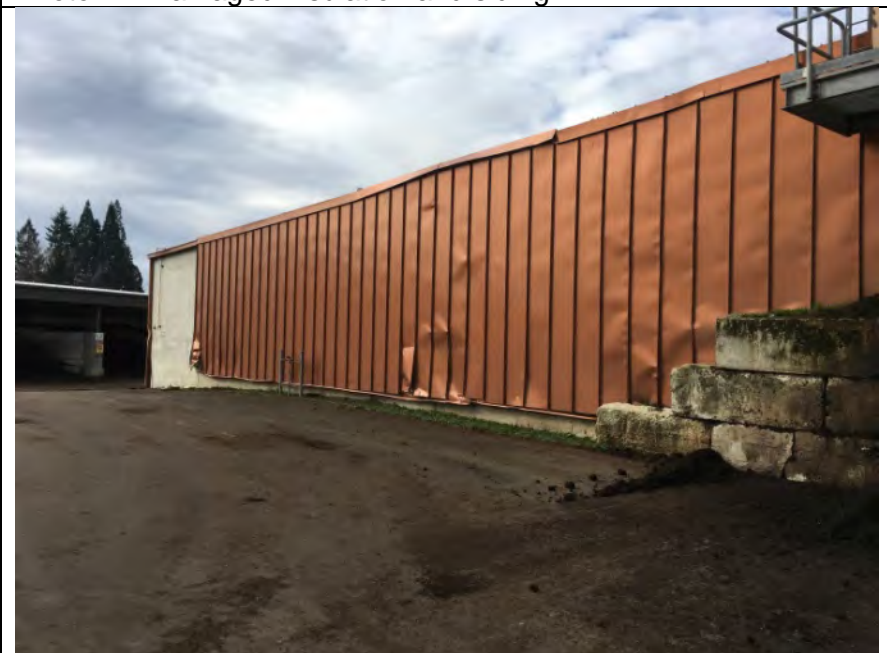
Photo 7 – Damaged insulation and siding

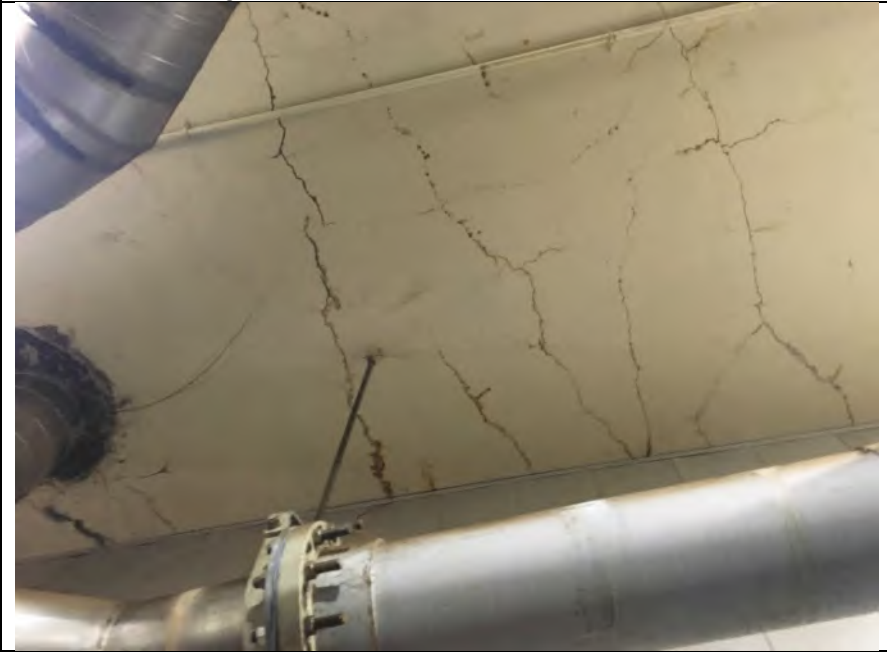
Photo 8 – Ceiling Cracks 1

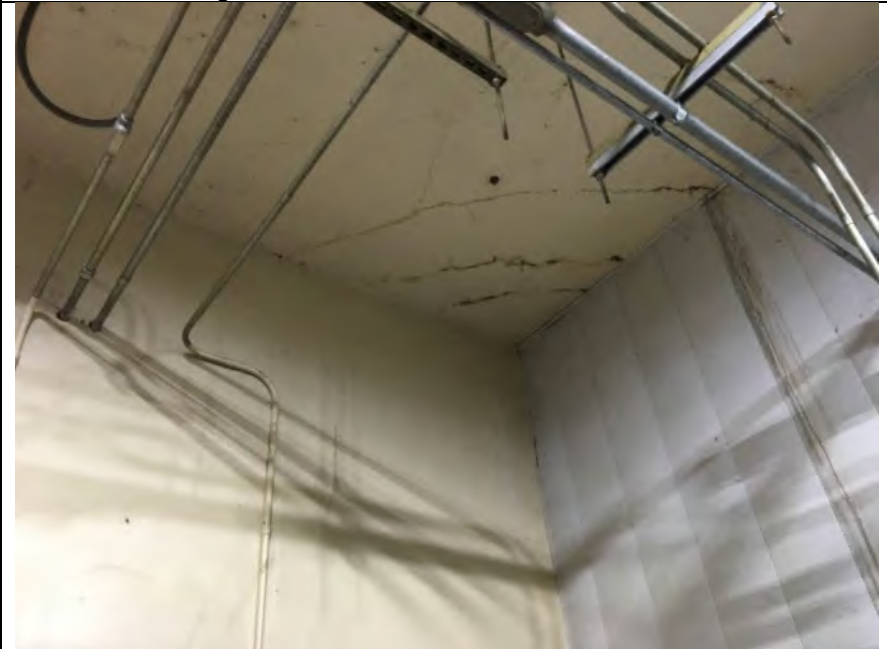
Photo 9 - Ceiling Cracks 2

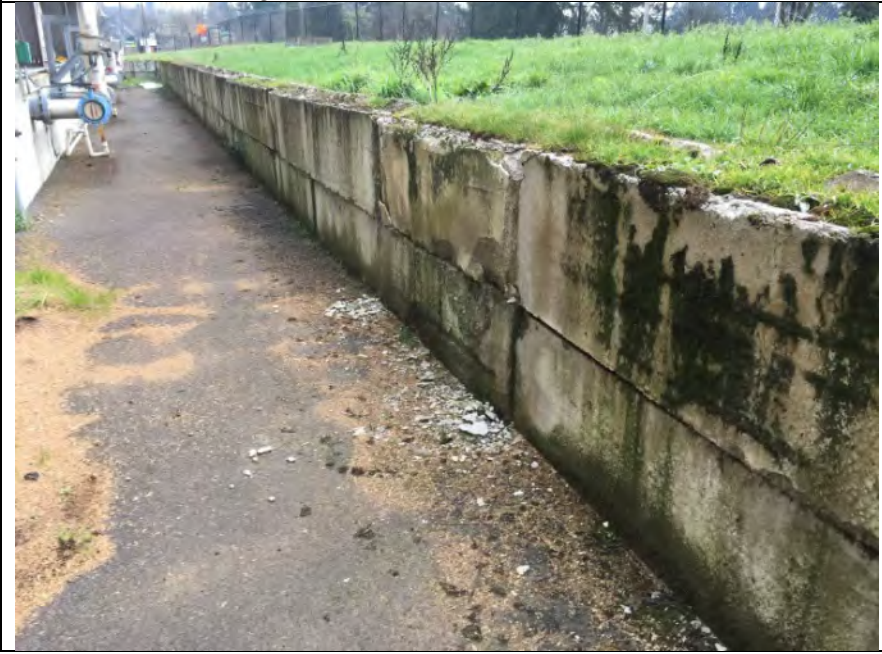
Photo 3 – Retaining wall deterioration

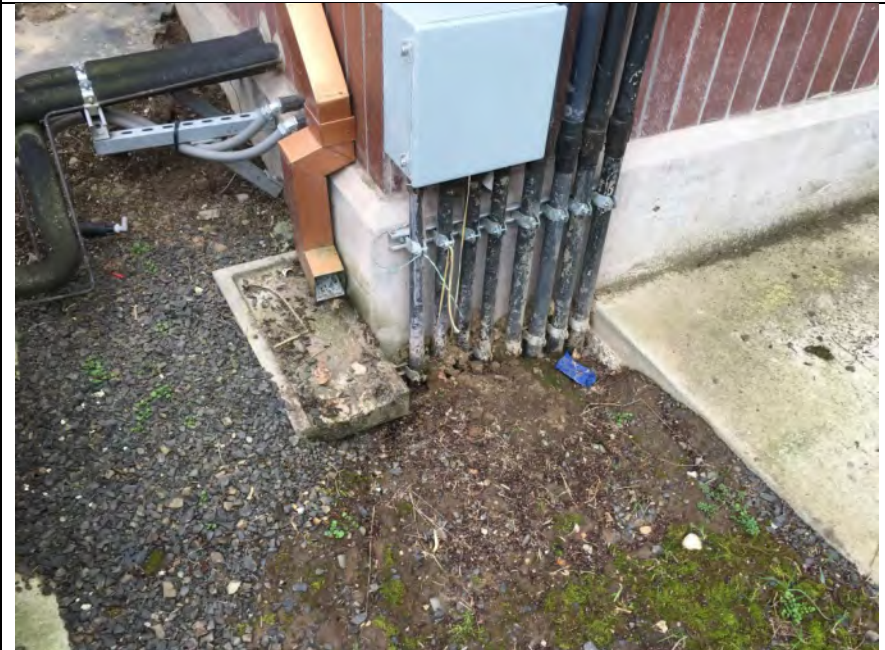
Photo 2 – Gutter splashing causing erosion around electrical conduits
