CRESTVIEW GREEN: STREAM CORRIDOR

4821 E PORTLAND ROAD | NEWBERG, OREGON 97132

TYPE II -
MODIFICATIONS WITHIN THE
STREAM CORRIDOR

**Wetland Delineation
for 4812 & 4813 E. Portland Road,
Newberg, Oregon**

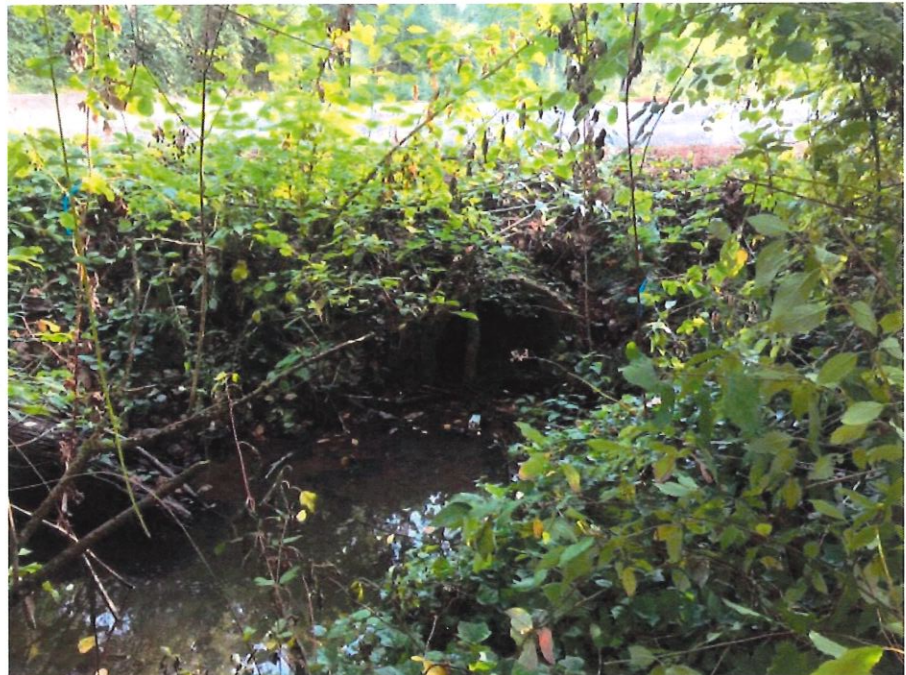
Looking east at Spring Brook (Stream 1) at the NE Benjamin Road culvert.

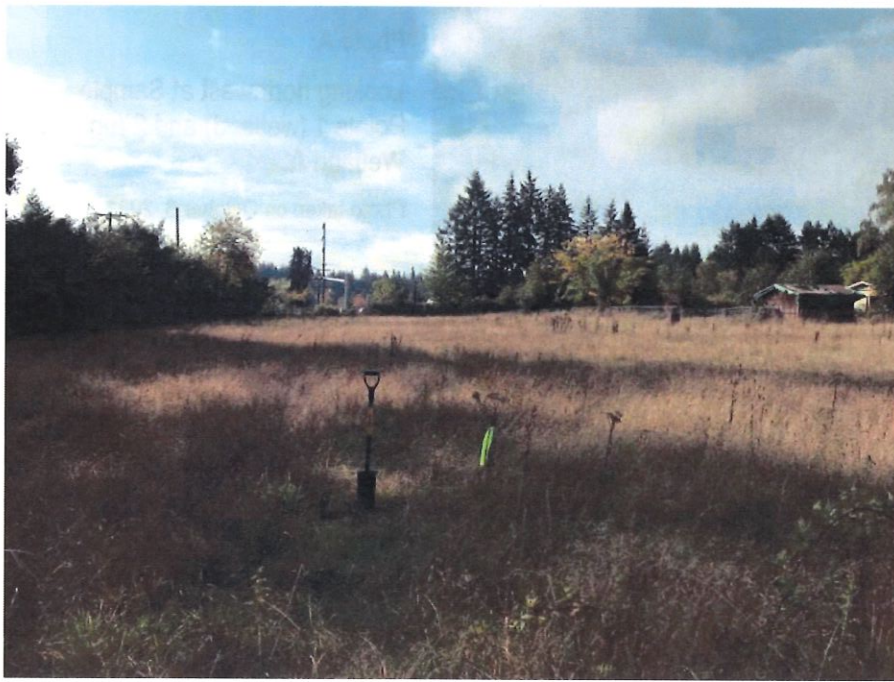
Photo C:

Looking south at Sample Point 3.

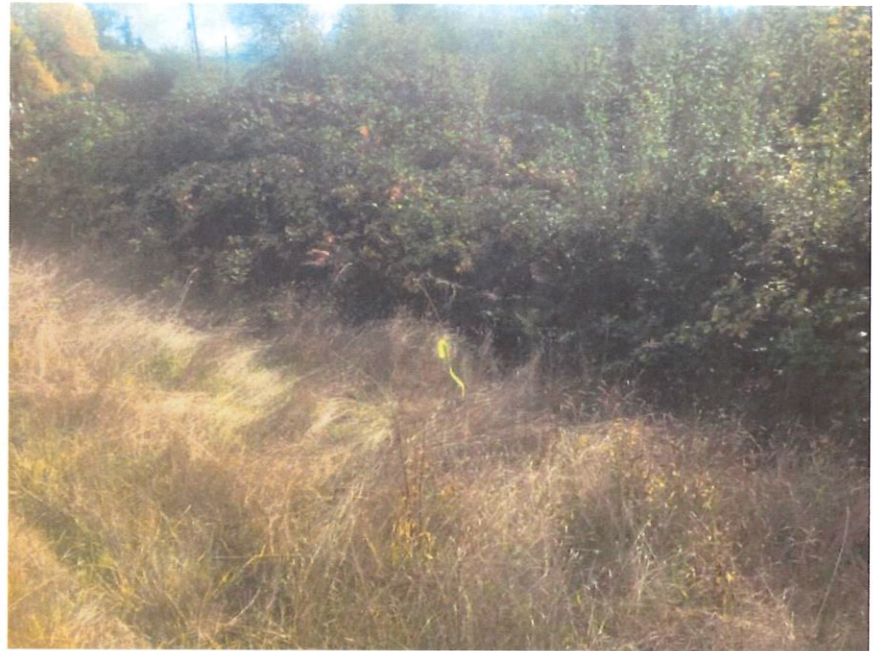
Looking southeast at Sample Point 4.

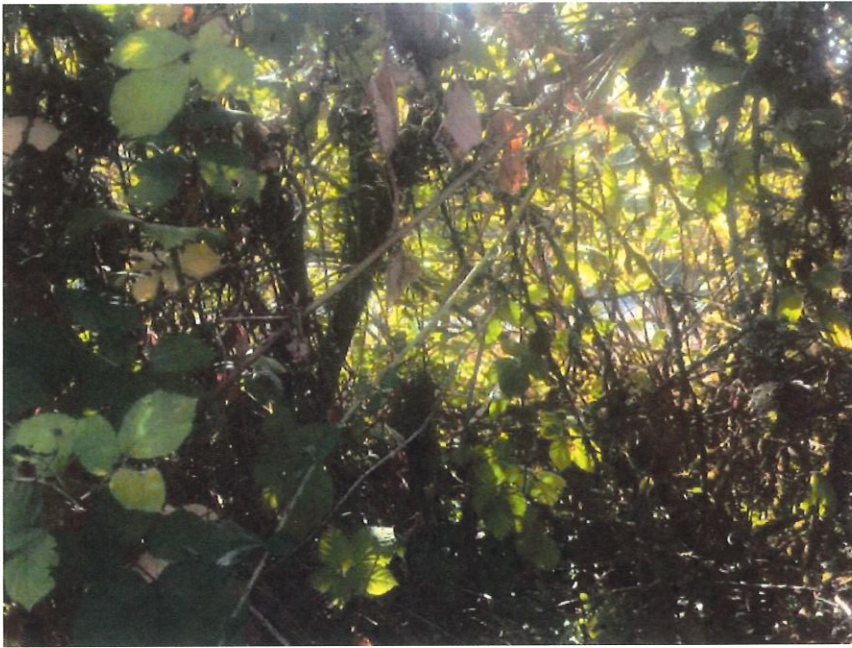
Photo E:

Looking southeast at Sample Point 5.

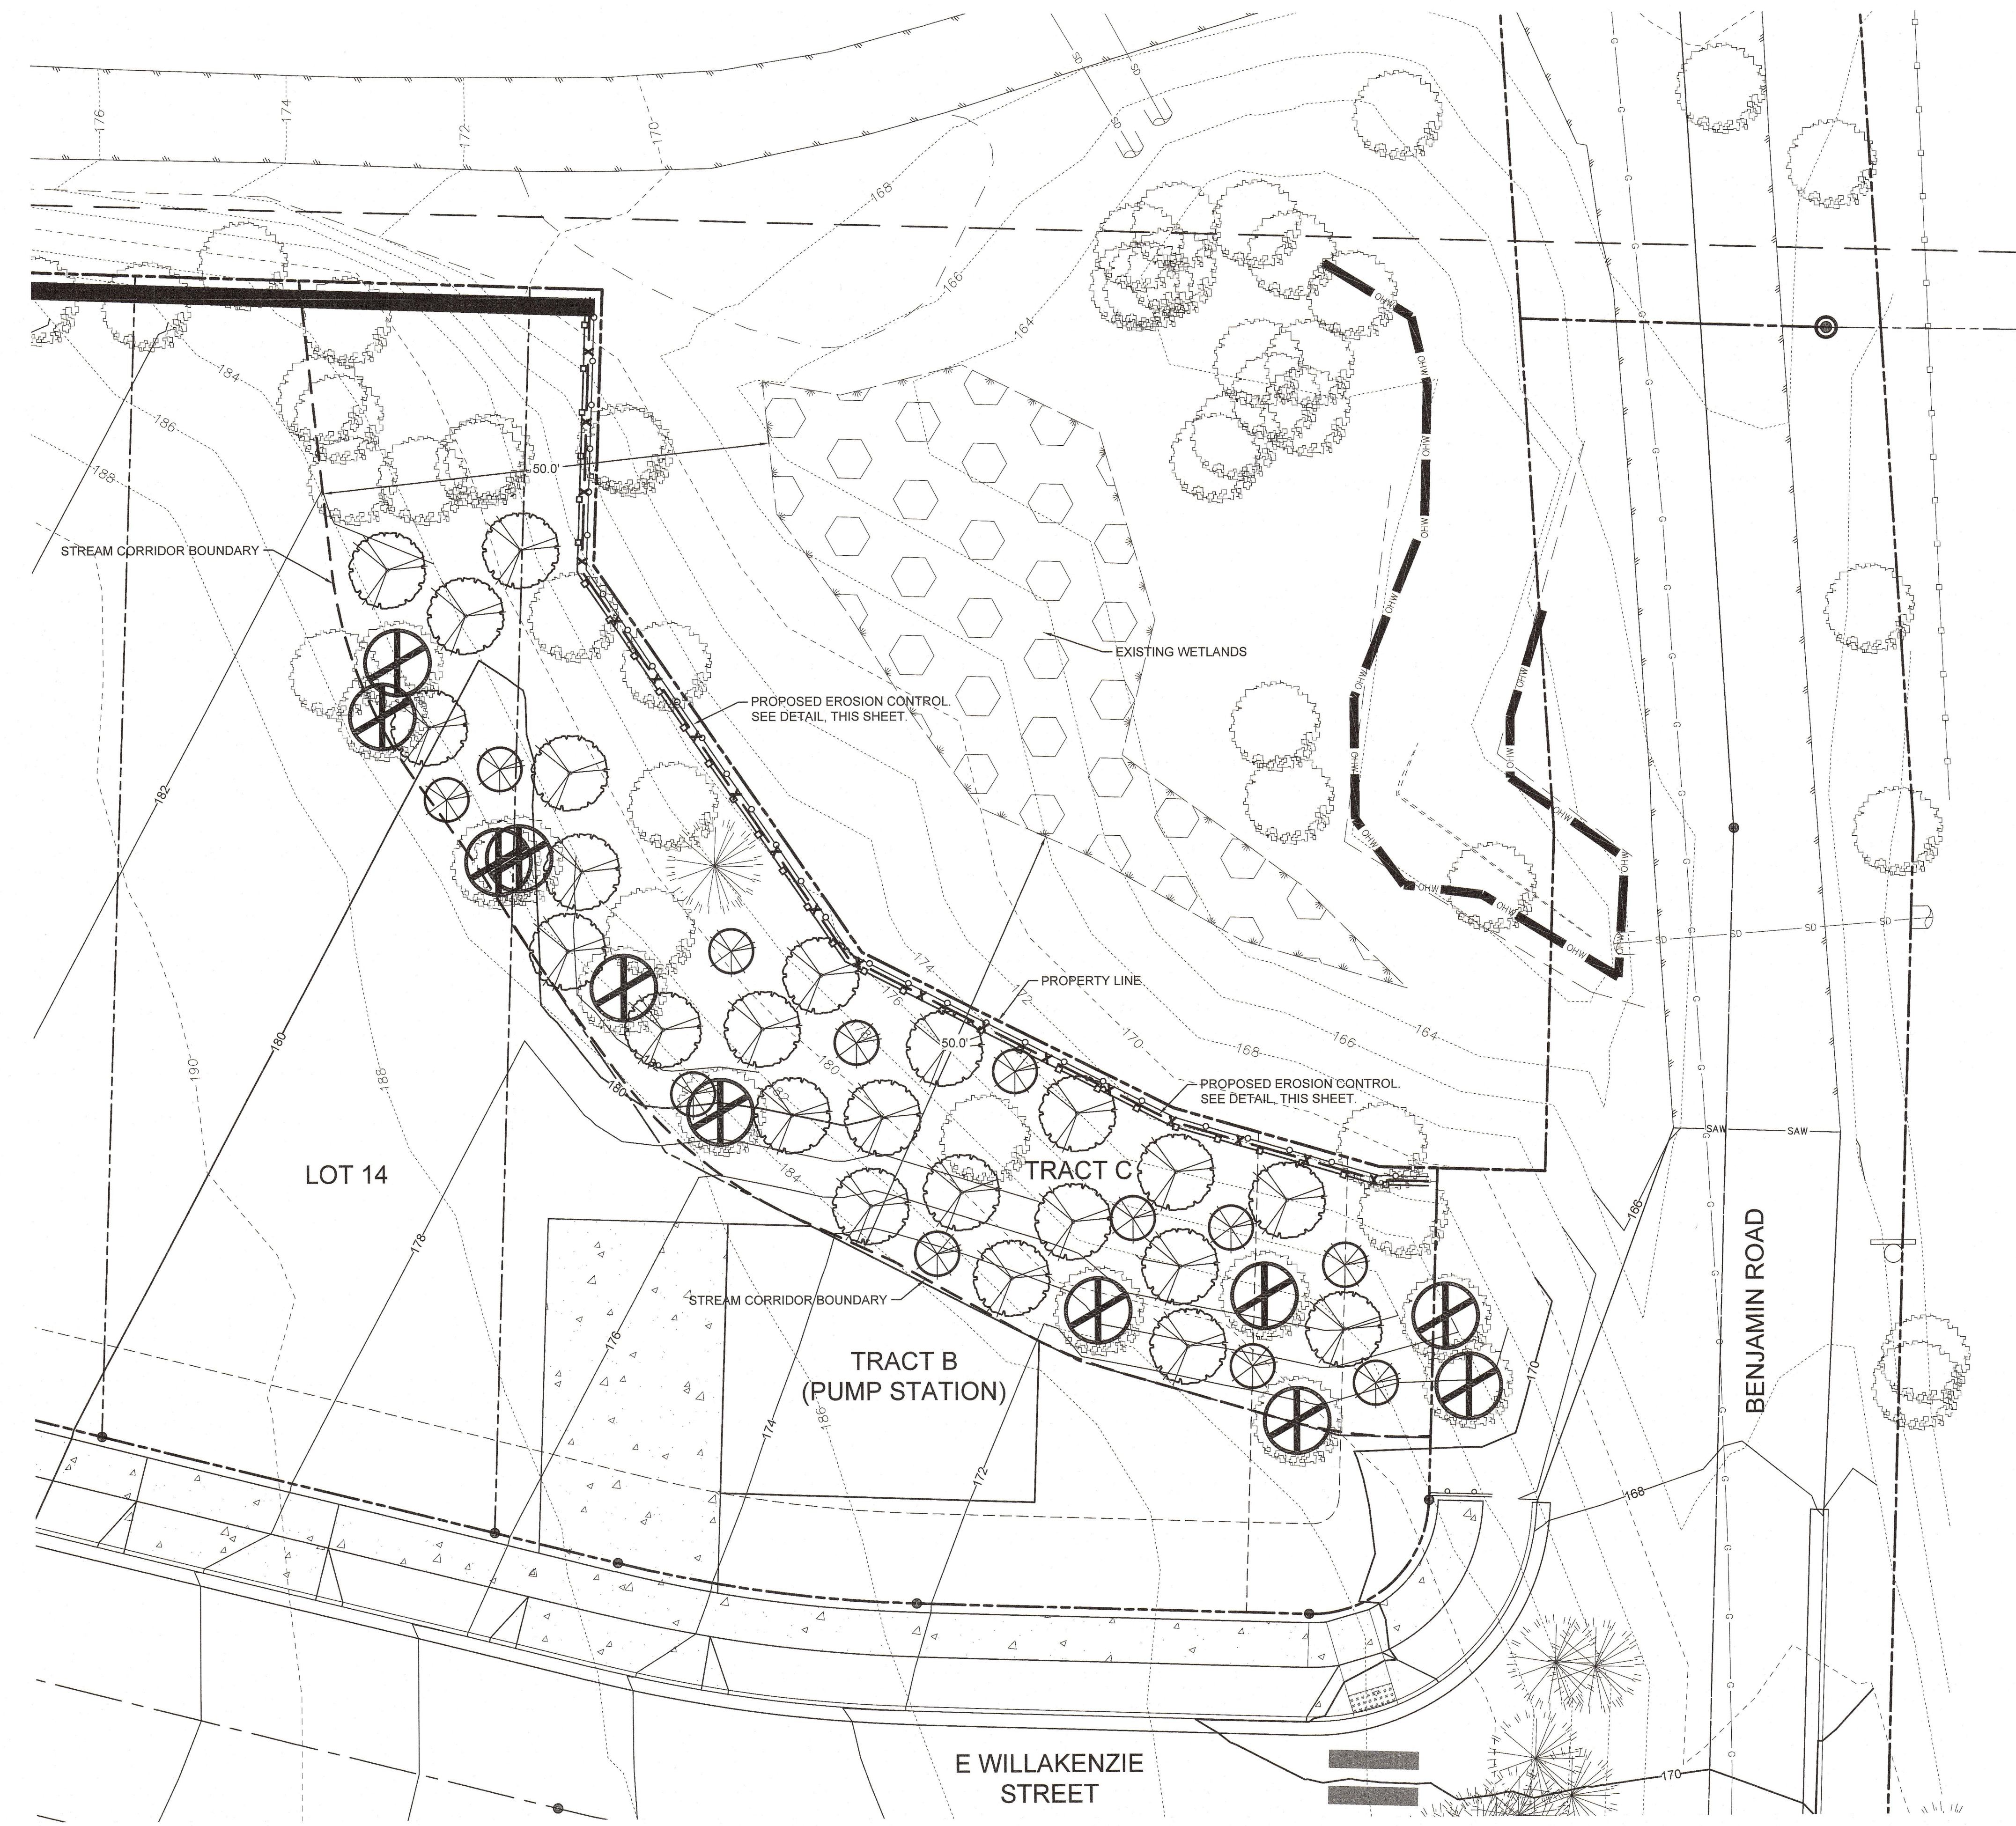
SHEET NUMBER
C001

STREAM CORRIDOR OVERLAY EXHIBIT
CRESTVIEW GREEN
PLANNED UNIT DEVELOPMENT
WESTWOOD HOMES LLC
NEWBERG, OR

Applicant's Findings: All trees removed within the Stream Corridor are shown on Sheet #C001 in Appendix "B". Trees that will be replanted are shown on Sheet #C001, in Appendix "B". There will be 10 trees removed that are from six to 18 inches in diameter and replaced with 30 trees. One tree will be removed that is over 18 inches in diameter,

and will be replaced by 5 trees. All replacement trees will have an average caliper measurement of minimum one inch. This standard is met.

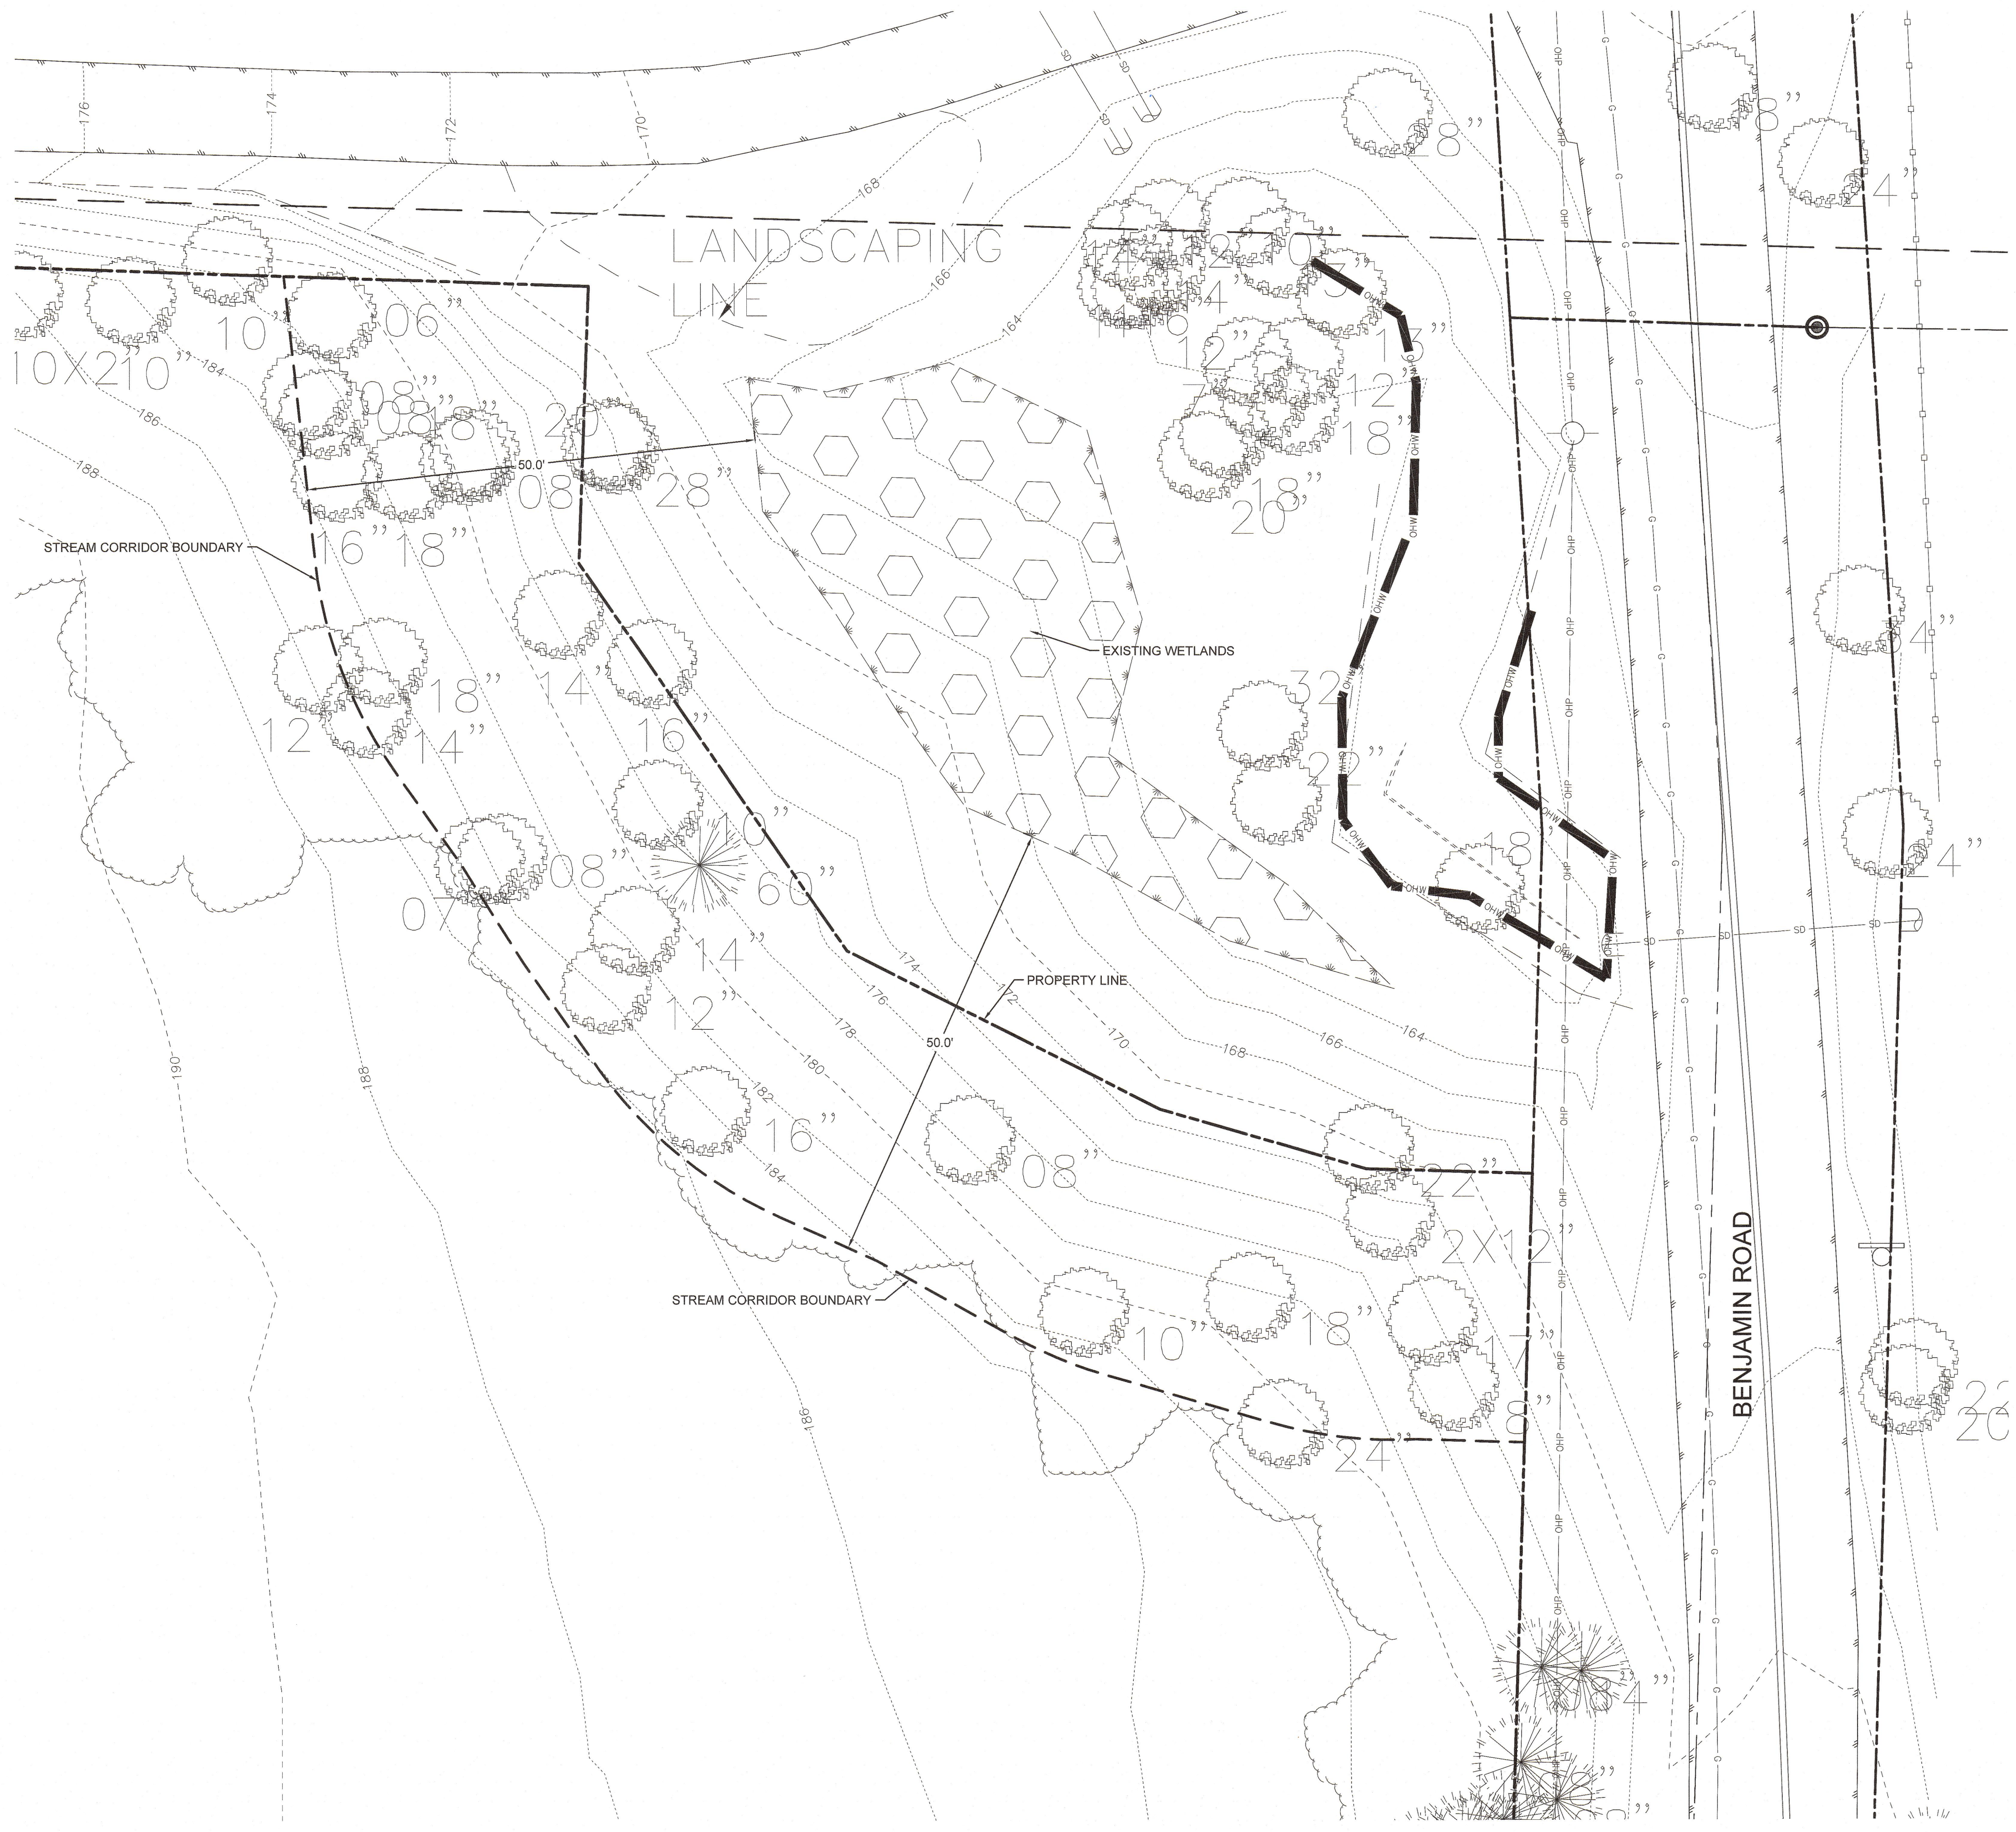
SHEET NUMBER
C000

STREAM CORRIDOR EXISTING CONDITIONS
CRESTVIEW GREEN
PLANNED UNIT DEVELOPMENT
WESTWOOD HOMES LLC
NEWBERG, OR
