Pump Station Information

As requested by the City of Newberg (City), RH2 Engineering Inc., (RH2) has completed its evaluation of the Dayton Avenue Lift Station's (Station) condition and hydraulic performance. This letter is intended to present the findings of this evaluation and to provide recommendations for remedial actions, including alternatives for both rehabilitating and replacing the Station.

RH2 report
for the City of Newberg

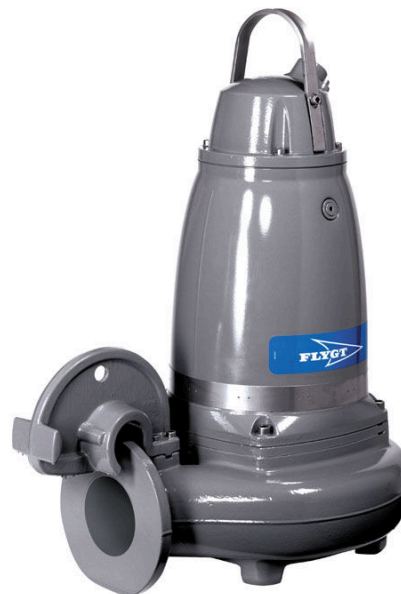
NP 3171 HT 3~ 454

Technical specification

Note: Picture might not correspond to the current configuration.

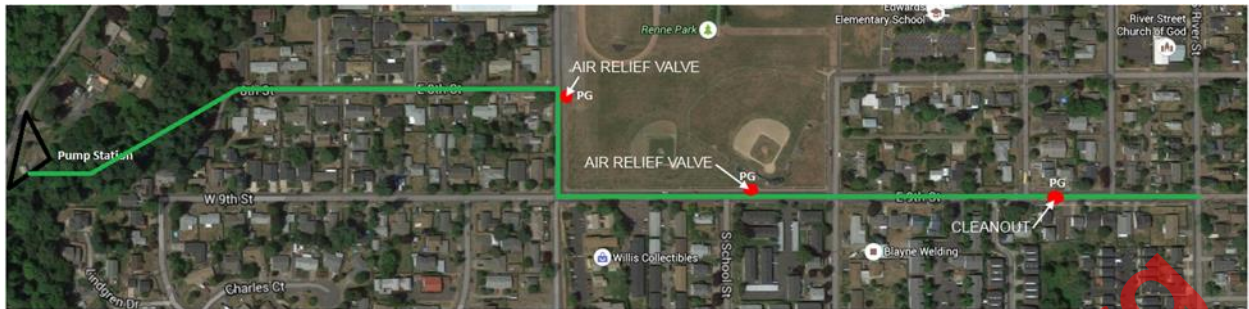
Figure 1
Force Main Alignment and Pressure Gauge Locations

The Station discharge is pumped through an approximately 4,000-foot-long, 12-inch-diameter force main that discharges into a receiving manhole, located near the intersection of East 9th Street and South River Street. The force main rises from an elevation of approximately 105 feet at the Station, to approximately 162 feet at the receiving manhole, and is equipped with two sewage air relief valves and one cleanout along the alignment, as shown in **Figure 1**. Pressure gauges are also installed along the force main at the air relief valve and cleanout locations. The force main materials consist of both ductile iron and SDR 26 PVC pipe. The majority of the force main, which originally served the 8th Street Lift Station, was upgraded in 1985. Approximately 650 feet of ductile iron force main was constructed as part of the Station upgrade in 1993.

According to City records, it appears that the air relief valves were last serviced or replaced in March, 2012. During the condition assessment and performance testing performed on July 23, 2015, City staff observed a minor amount of air and wastewater purging from the second air relief valve along the force main, suggesting it is operating as intended. No such observation was made at the first air relief valve and its condition is unclear.

The pressure gauges installed at the air relief valves, both with a 0 to 30 psi range, appear to be in good condition. The pressure gauge located at the cleanout manhole appears significantly older and is installed with a 0 to 60 psi range. In general, it is recommended that pressure gauges be installed so that the normal operating pressure falls within 25 to 75 percent of the gauge range. Since normal operating pressure at this location is around 4 psi, the installed gauge greatly exceeds this standard recommendation and compromises the accuracy of pressure readings taken at this point. It is recommended that this gauge be replaced with a 0 to 10 or 0 to 15 psi range gauge.

Finally, City staff have reported that, at times, the receiving manhole has been observed in a flooded condition when both pumps are operating in parallel. This would suggest that the receiving gravity sewer line may be undersized to convey higher pumped flows. RH2 did not observe this during the performance testing, and it is unclear if this is a normal or infrequent event. It is recommended that further evaluation and modeling of the downstream system be considered as part of any future design related to the Station or force main.

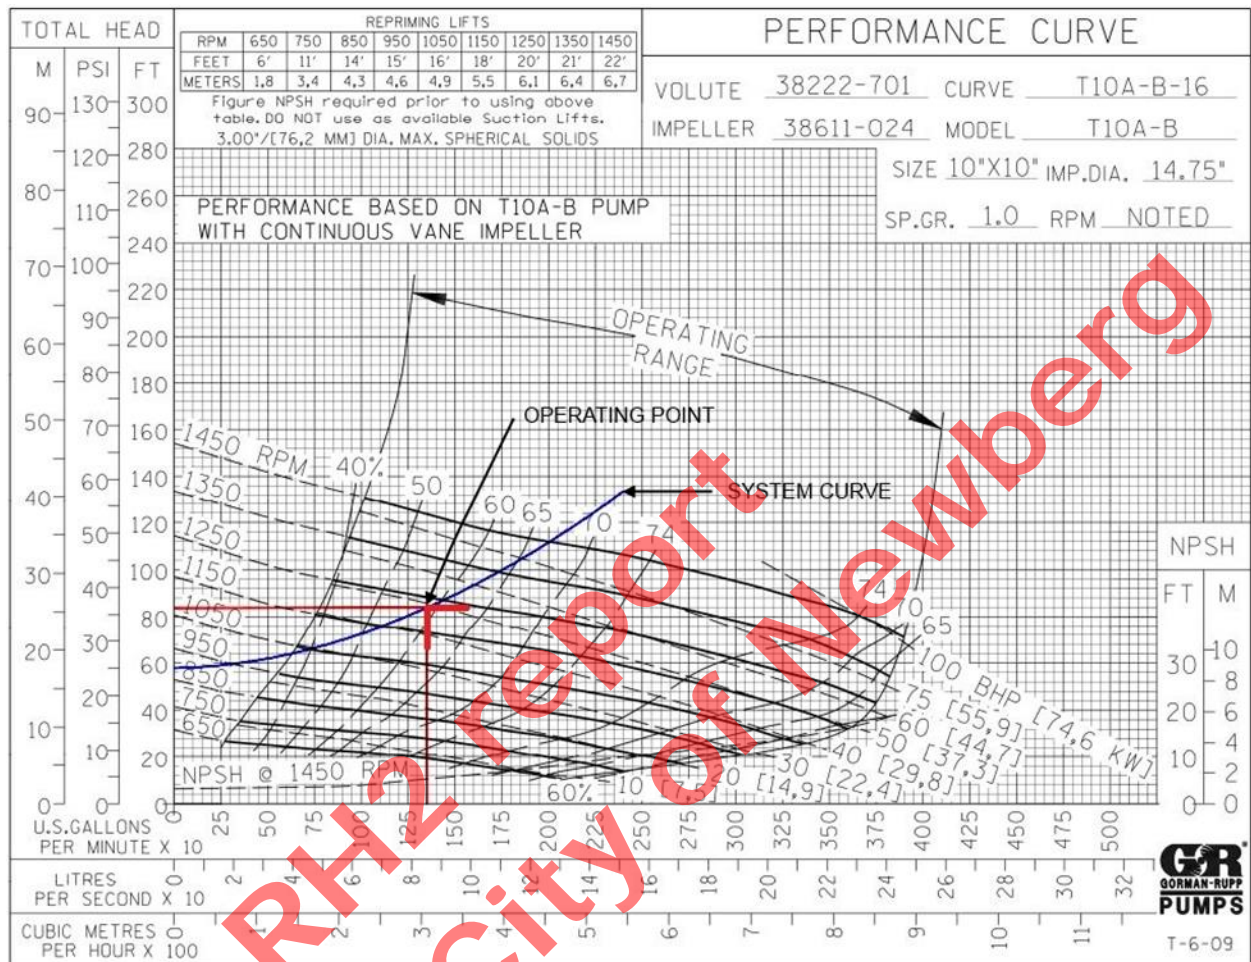
Figure 3
System and Pump Curves

A system head curve for the Station was developed based on as-constructed records, assumed pipeline conditions, and the current operating capacity determined from drawdown testing. During the pump drawdown testing, pressure measurements were recorded at existing gauge locations along the force main alignment and at the pump discharge.

The measured pressure values were then compared to calculated pressure values based on the system head curve for new pipe conditions. The system head curve was then revised and validated to account for age and condition of the pipe by adjusting the roughness coefficient to match calculated pressures in the force main to measured field conditions. The calculated pressures differ from measured values by approximately 2 to 3 psi. This indicates that the system is experiencing a minor increase in headloss over original (new) conditions. The calculations for the system head curve are attached to this report. The system head curve, based on performance testing, was overlaid on the pump curve provided by the manufacturer, which can be seen in **Figure 3**.

The operating point of 1,350 gpm at a TDH of 84 feet obtained from the performance testing is also indicated in **Figure 3**. According to as-constructed records, the pumps are expected to be operating at a speed of 1,315 rotations per minute (rpm). However as shown in **Figure 3**, the system curve and performance testing data would suggest that the pumps are operating on the curve for a speed of approximately 1,250 rpm. A decrease in pumping capacity would typically indicate that the pumps are experiencing an increase in head in the system. However, this does not appear to be the case here as the pumps are operating at a lower head and lower capacity than originally designed. Although this may suggest that the pumps are operating at a lower speed than originally designed, the operating speeds of the pumps were field verified using a tachometer by City staff.

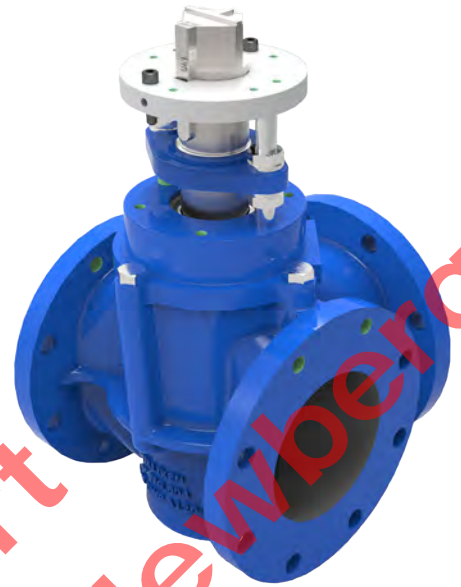
Styling Ring

To provide 90° flow paths only, a double-style plug is available which operates through 90° travel and isolates either straight-through port (Style A90 only).

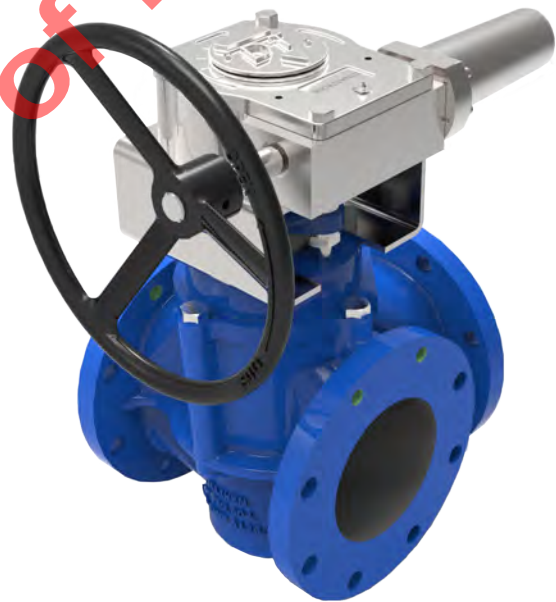
Gear Operator

Shown with 180°/270° Gear

3-Way Valve Port Positions

Where required, gear operators shall be of heavy duty construction with a ductile iron quadrant supported by upper and lower oil-impregnated bronze bearings. The worm gear and shaft shall be manufactured in hardened steel and run in high efficiency roller bearings. Gear operators shall require single handwheel operation only.

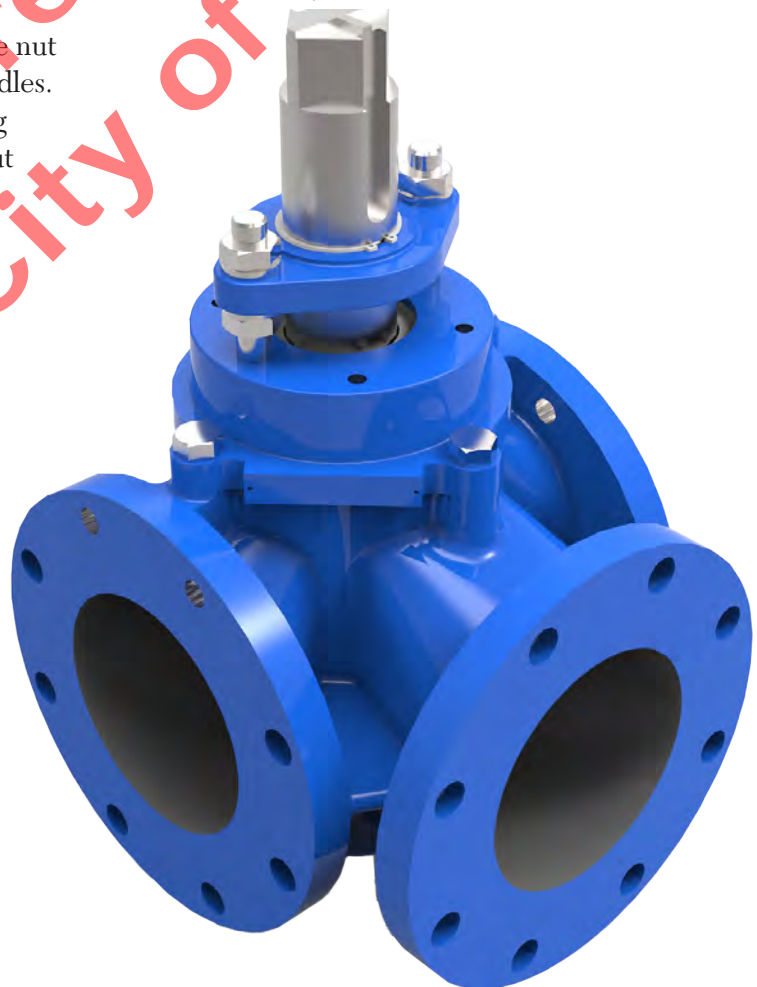
Series 600/601 Eccentric Plug Valve Welded Nickel Seat Stainless Steel Bearings ANSI-B16.1 Flanges Solid Ductile Iron Plug Low Pressure Drop Flanged & MJ Ends Sizes 2"-72" FL Sizes 3"-48" MJ  	Series 601S Eccentric Plug Valve All Stainless Steel Construction ANSI B16.5 Class 150 Flanges Low Pressure Drop Size: 1/2"-24"
