## **PROJECT REPORT**

### **Pavement Management System Implementation**

**City of Newberg**  
414 E. First Street  
Newberg, OR 97132

Project No. 13075

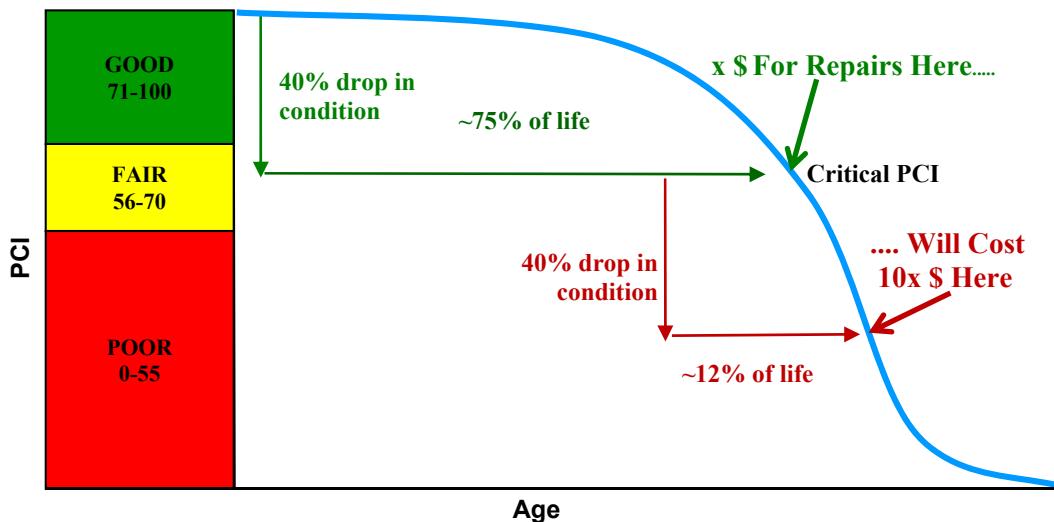
**Figure 2 – Typical Pavement Deterioration Curve**

Depending on design life and preventive maintenance, the typical pavement condition trend is to deteriorate slightly right after construction and then the deterioration levels off. The leveling off period is where the deterioration condition slows relative to time. The location of slower deterioration is the time where the majority of the desired condition, use, and life of the pavement occurs. At the end of the leveling off period, there is a transition point referred to as the critical PCI. After the critical PCI is reached, the pavement condition deteriorates more quickly into a poor condition state. An example of typical pavement deterioration is presented in Figure 2.

Ideally, if preventive maintenance is performed before the critical PCI is reached the life and use of the pavement can be extended in the leveling off period. Also, any major restoration work, such as an overlay, that is done before a pavement deteriorates below the critical PCI usually costs substantially lower due to the better condition of the pavement.

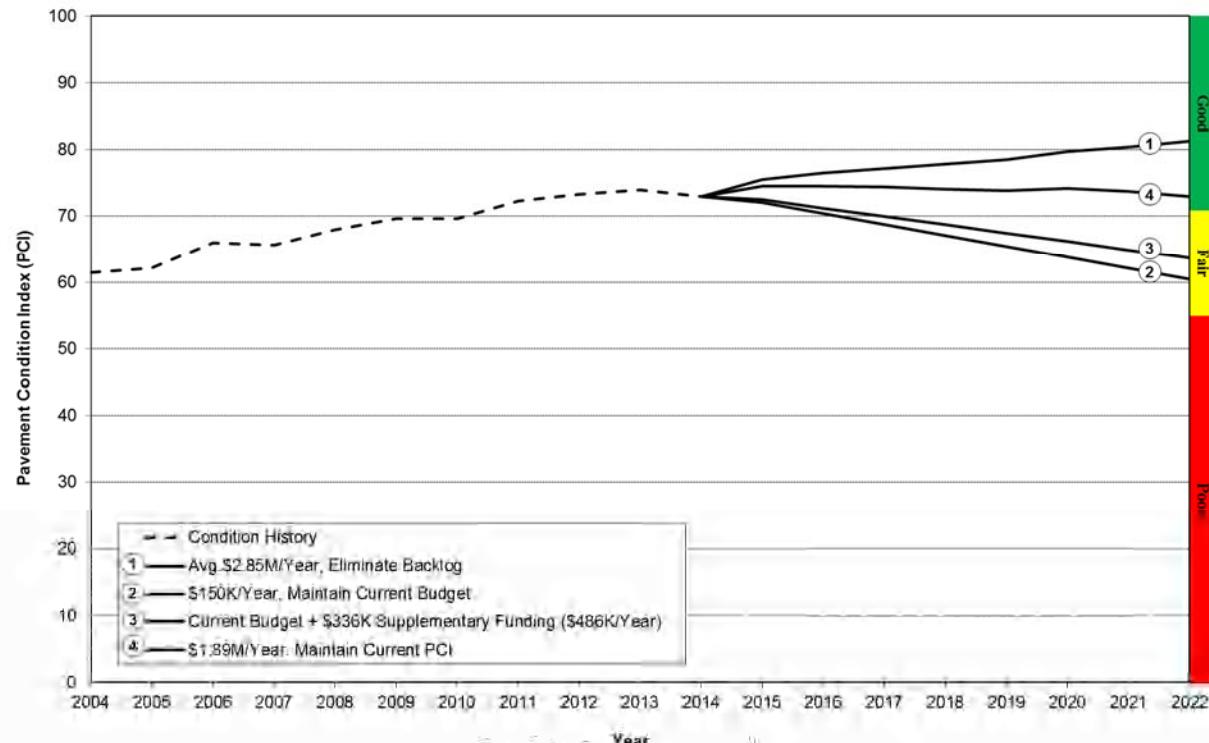
Figure 3 – Various Budget Effects on PCI

Figure 3 shows the effect of the four budget scenarios on the resulting condition of the Newberg street system.

- Scenario 1. An annual expenditure of \$2.8M over the next seven years would eliminate the M&R backlog for the entire street system.
- Scenario 2. At the current funding level of \$150,000 annually, the M&R backlog will grow to \$21.0M by the year 2022.
- Scenario 3. Supplementary funding of \$336,000 per year increases the annual budget to \$486,000. At an annual investment level of \$486,000, the M&R backlog will grow to \$17.9M by 2022.
- Scenario 4. In order to stabilize the condition of the street system at the current PCI of 73, an annual budget of \$1.87M is required during the period of 2014-2022. At

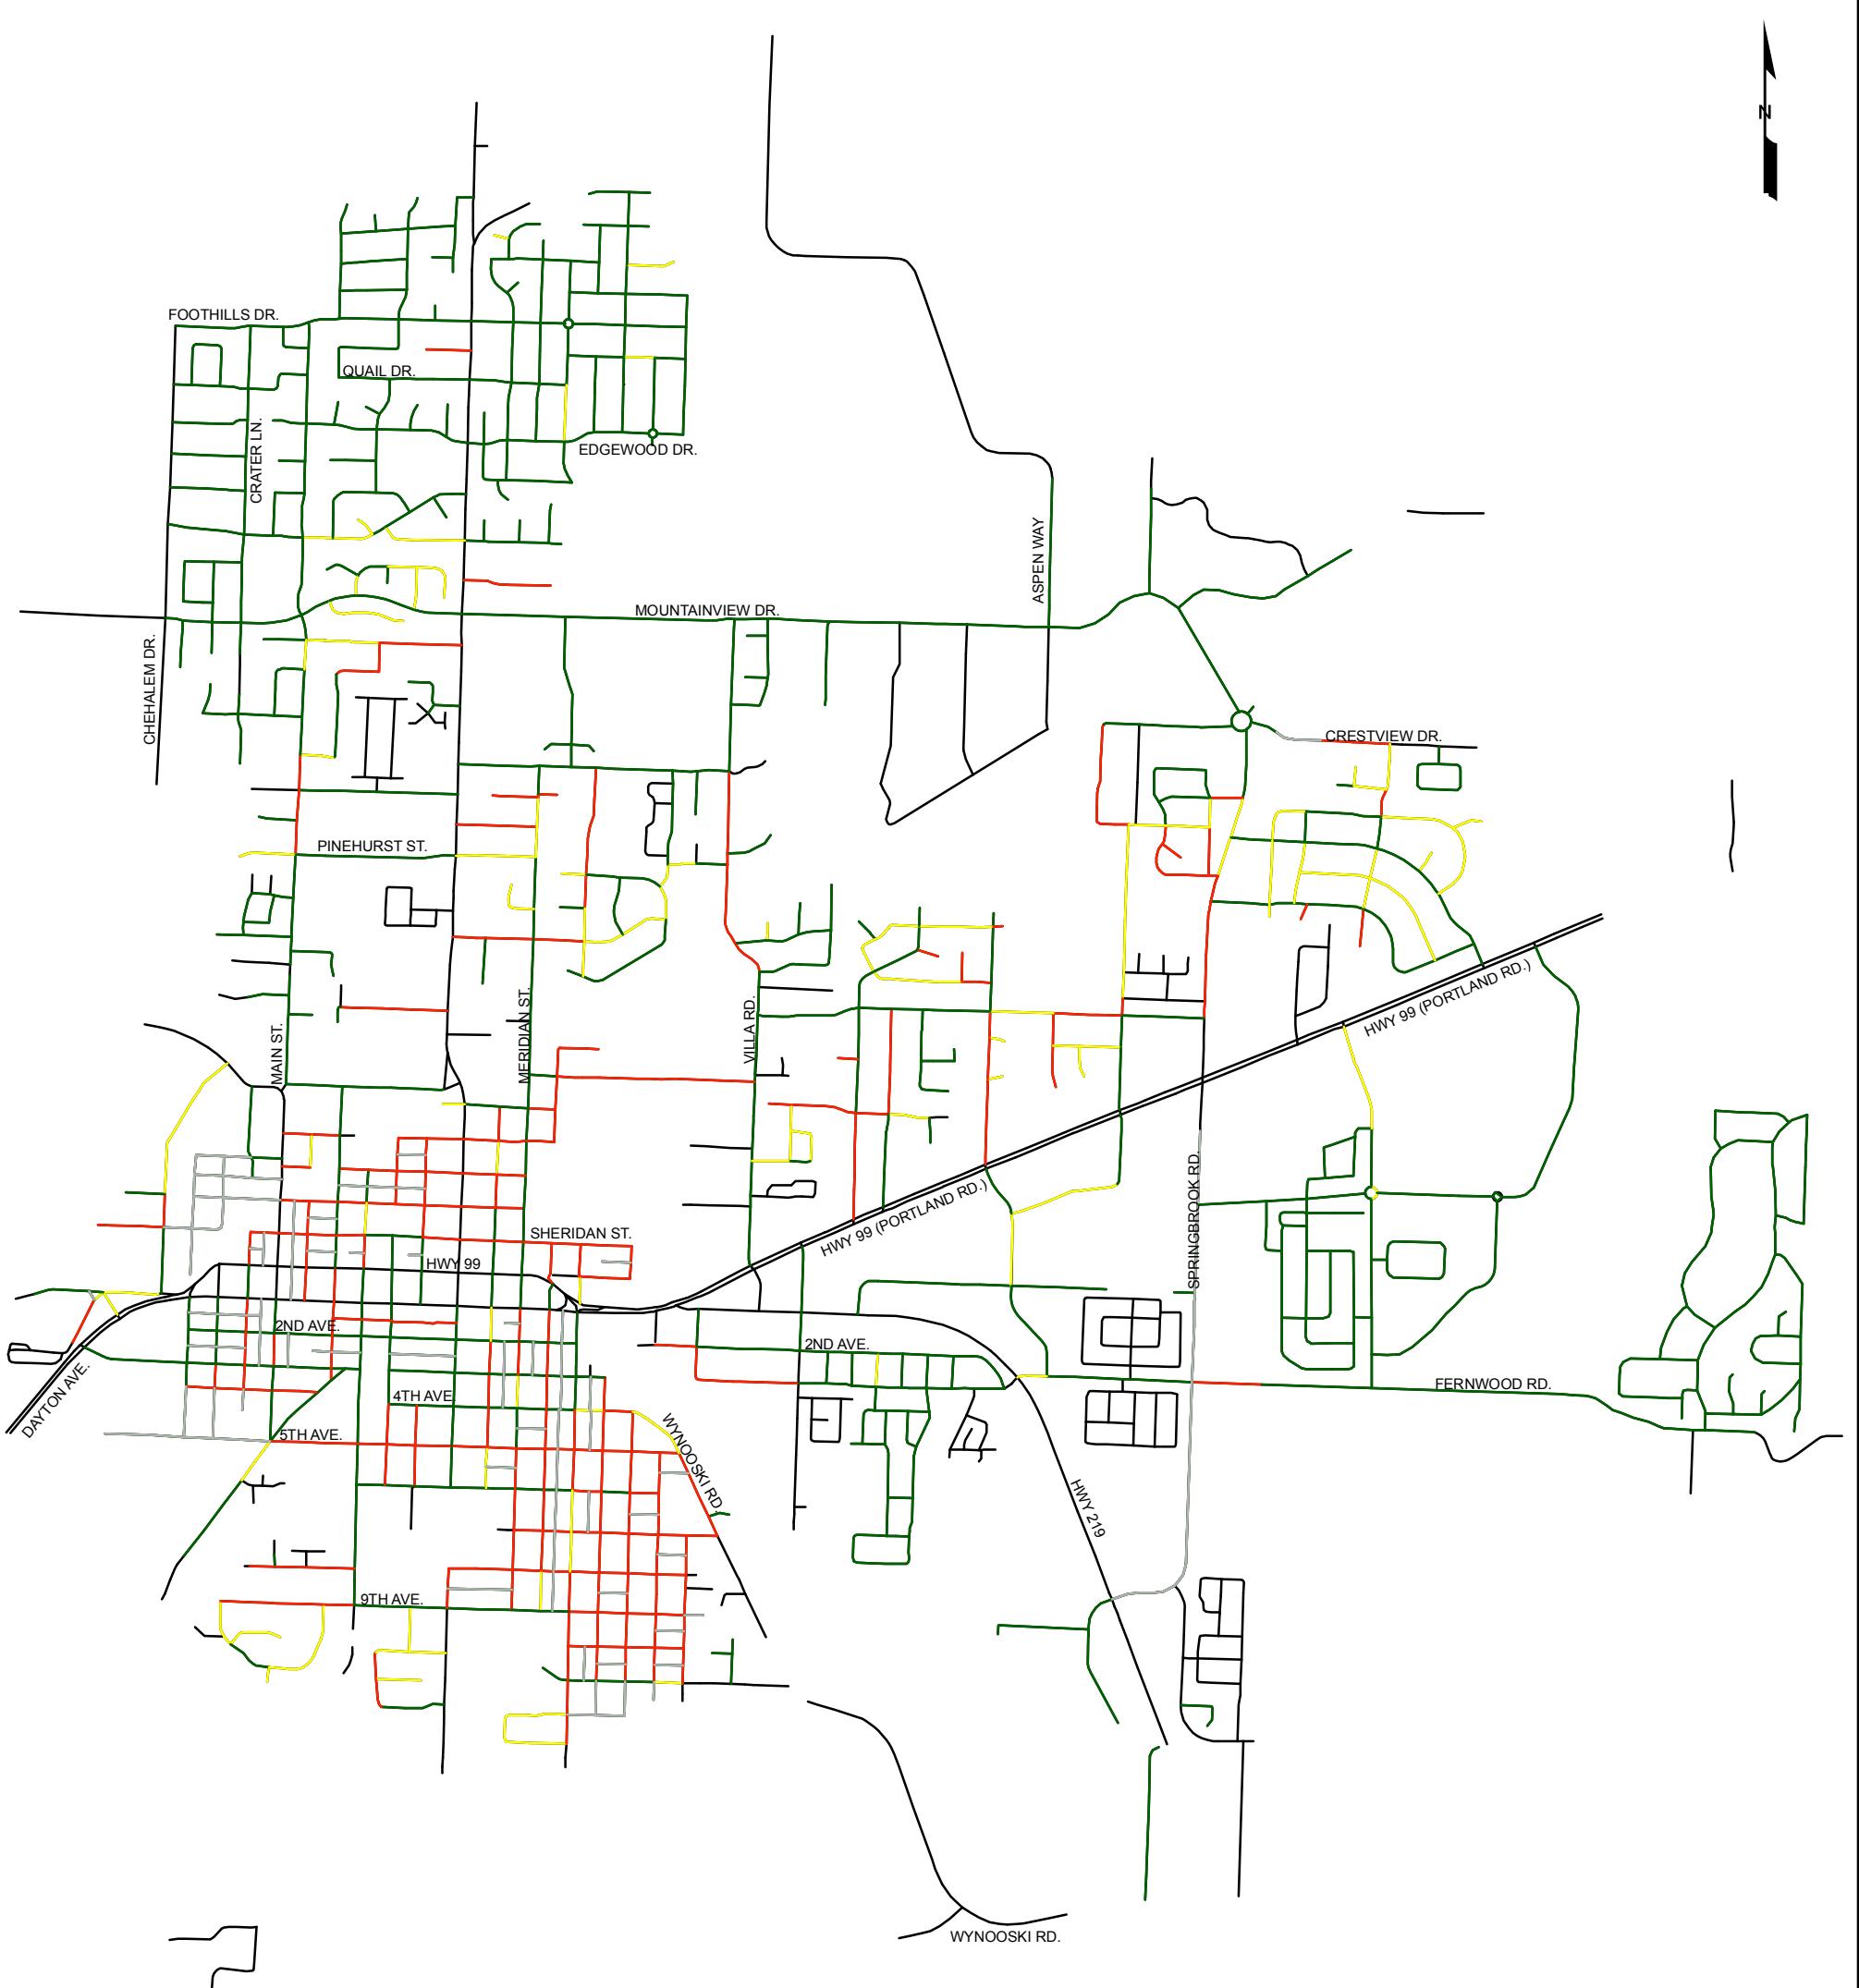
**2014 PAVEMENT CONDITION INDEX  
SURVEY RESULTS**  
**Newberg, Oregon**

The overall area weighted average condition of the Newberg street system is rated as 73 or "Good". The PCI scale used was Good, Fair, and Poor; where Good is from 100 to 71, Fair is from 70 to 56, and Poor is 55 to 0. The pavement condition distribution in Newberg is 66% Good, 12% Fair, and 22% Poor. Figure 1 presents a map with the baseline street condition resulting from the 2014 PCI survey.

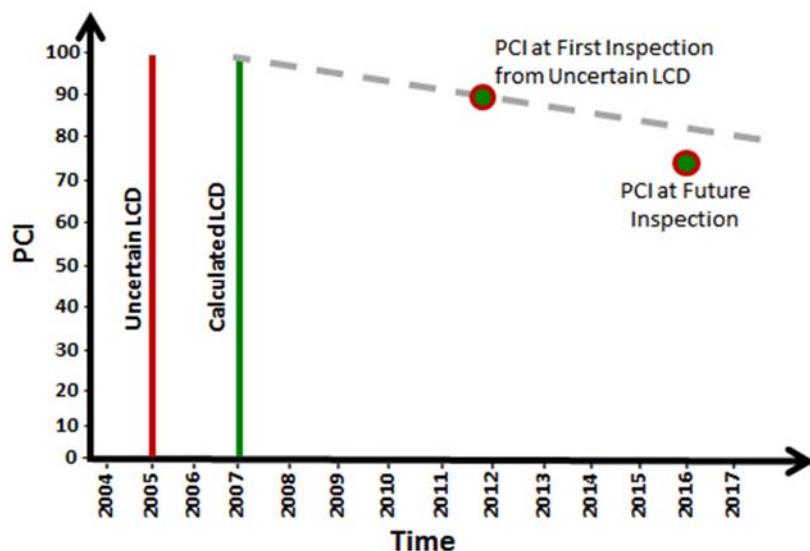
**Figure 4. LCD Backcalculation Process.**

The backcalculation starts from the first inspection following the uncertain LCD, as shown in Figure 4. In this example, a pavement with a PCI of 90 in 2012 would have a backcalculated LCD of 2007, assuming a condition deterioration rate of 2.0 PCI points/year.

Newberg had a large number of sections unknown LCD due to incomplete historical work records. For pavement sections where we didn't have LCD information we were able to use the LCD. For the LCD backcalculation we assumed a deterioration rate of 2.5 PCI points per year for the minor arterials, major collectors, and minor collectors roadway pavements and 1.5 points per year for the residential pavements.

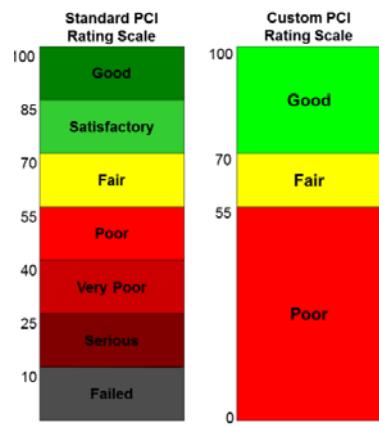
**Figure 5. PCI Rating Scales**

The average PCI of the Newberg street system was 73 on a scale of 0 to 100. Herein, the term average indicates area-weighted average unless otherwise specified. The standard rating scale defines seven PCI categories. This scale can be customized to have as many categories as desired in order to more easily view the distribution of PCI. For Newberg, we used a three-category scale as shown in Figure 5. Having three condition categories allows for quick observation of pavements that are in need of immediate repair (56 to 70), or which pavements have fallen into the poor category (0 to 55) and may require more costly repairs.

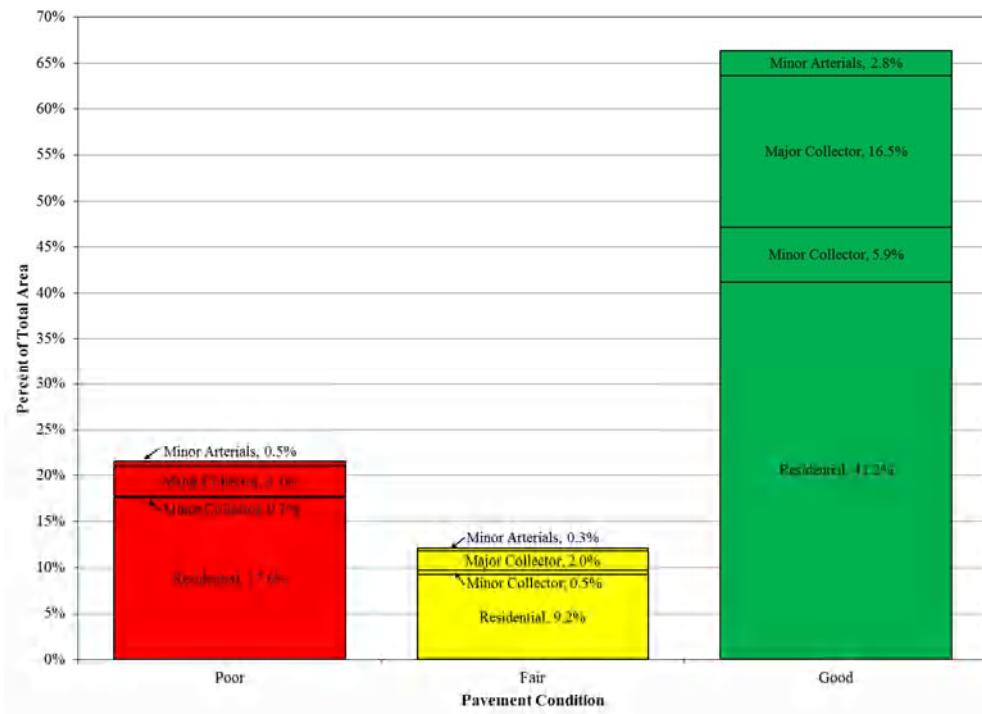
**Figure 10. Overview of the Newberg Pavement Condition in 2014**

Shown another way, Figure 10 presents the overall PCI distribution of the Newberg pavement network.

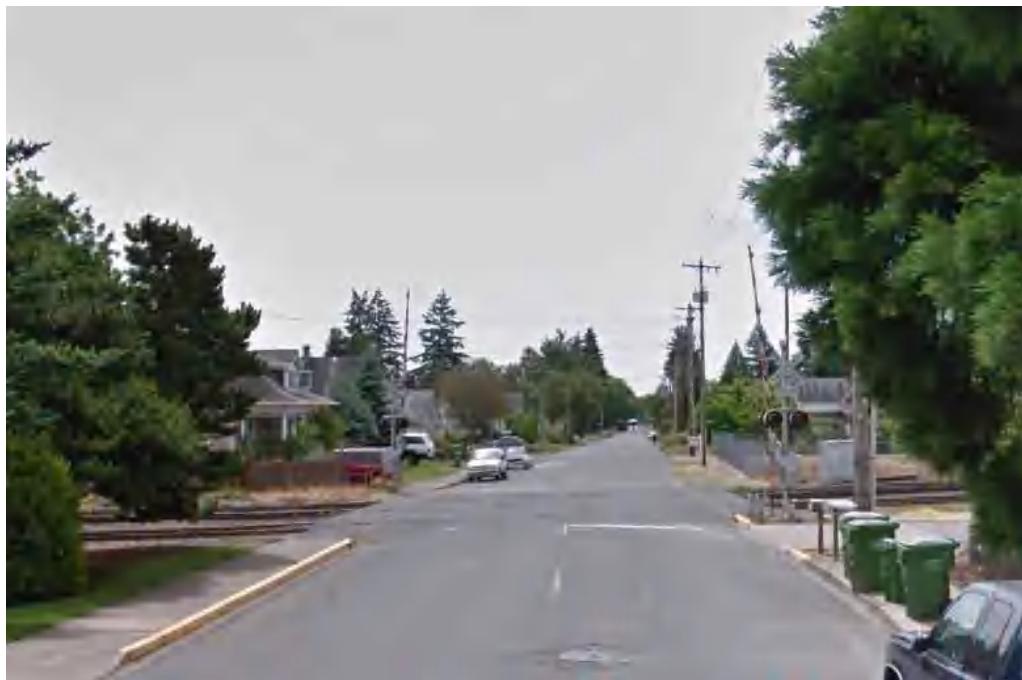
**BranchID:** MERIDIAN  
**Name:** Meridian Street  
**SectionID:** rd2610  
**From:** Fulton Street  
**To:** Jacqui Court  
**PCI Before Project:** 63  
**PCI After Project:** 100  
**Work Type:** Mill & Overlay. Full depth patching.  
**Approximate Cost:** \$28,600  
**Visual Distresses:** Alligator Cracking, Longitudinal/Transverse Cracking, Patching, and Weathering

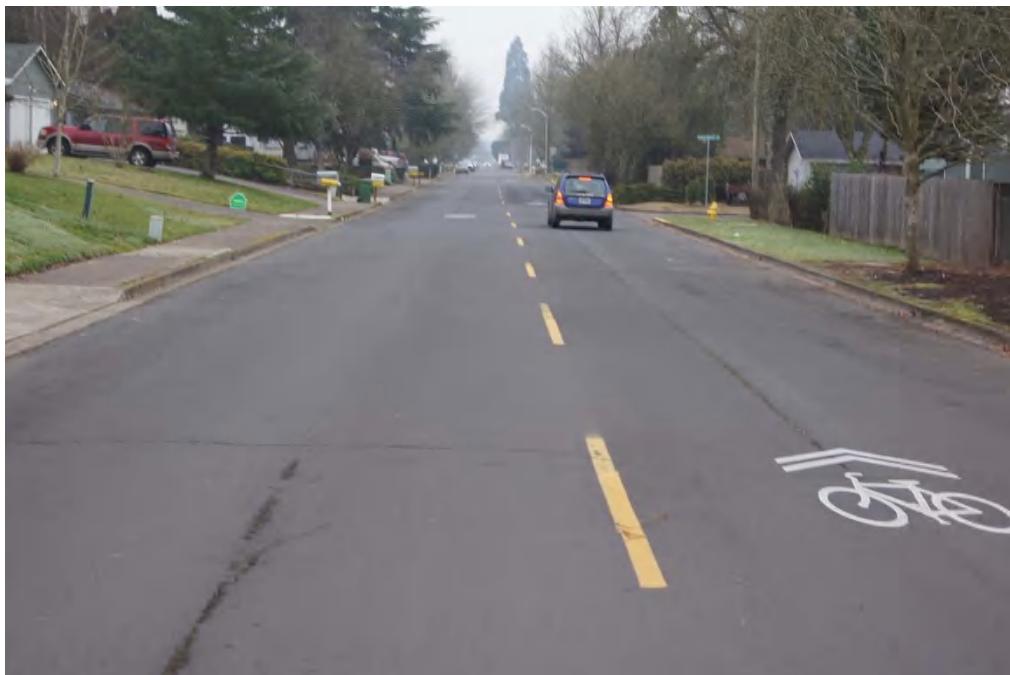
**BranchID:** MERIDIAN  
**Name:** Meridian Street  
**SectionID:** rd1536, rd1620, rd449, rd5005  
**From:** Crestview Drive  
**To:** Pinehurst Drive  
**PCI Before Project:** 65, 65, 70, 49  
**PCI After Project:** 100  
**Work Type:** Mill & Overlay. Full depth patching.  
**Approximate Cost:** \$78,100  
**Visual Distresses:** Alligator Cracking, Longitudinal/Transverse Cracking, Patching, and Weathering

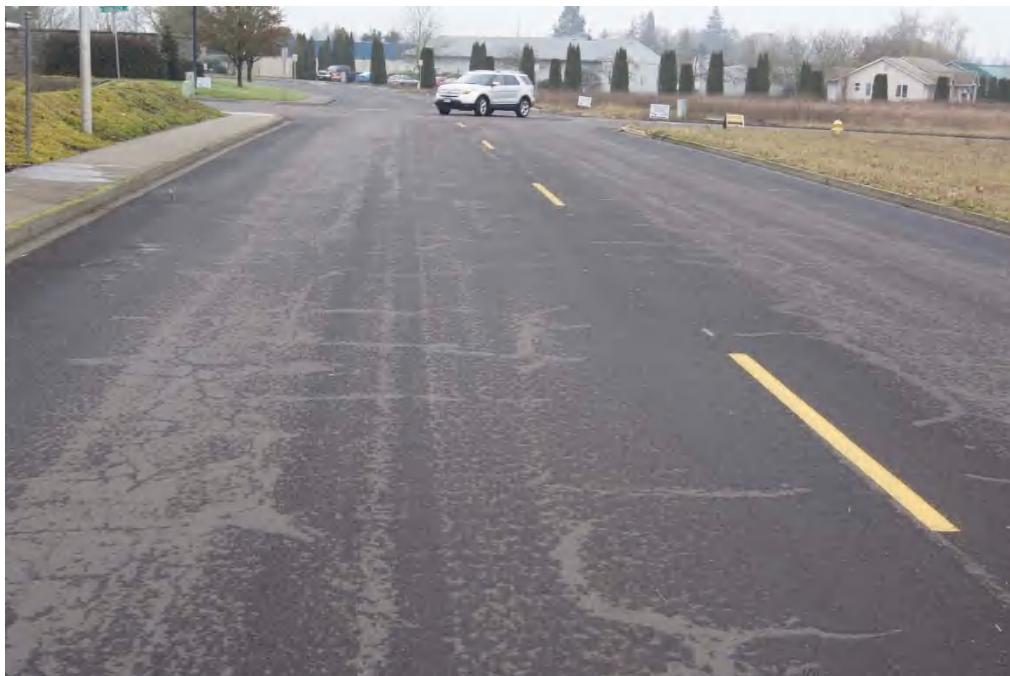
**BranchID:** ELLIOTT  
**Name:** Elliot Road  
**SectionID:** rd2485, rd4883  
**From:** 2<sup>nd</sup> Street  
**To:** Hayes Street  
**PCI Before Project:** 68, 63  
**PCI After Project:** 100  
**Work Type:** Mill & Overlay. Full depth patching.  
**Approximate Cost:** \$157,000  
**Visual Distresses:** Alligator Cracking, Longitudinal/Transverse Cracking, and Weathering

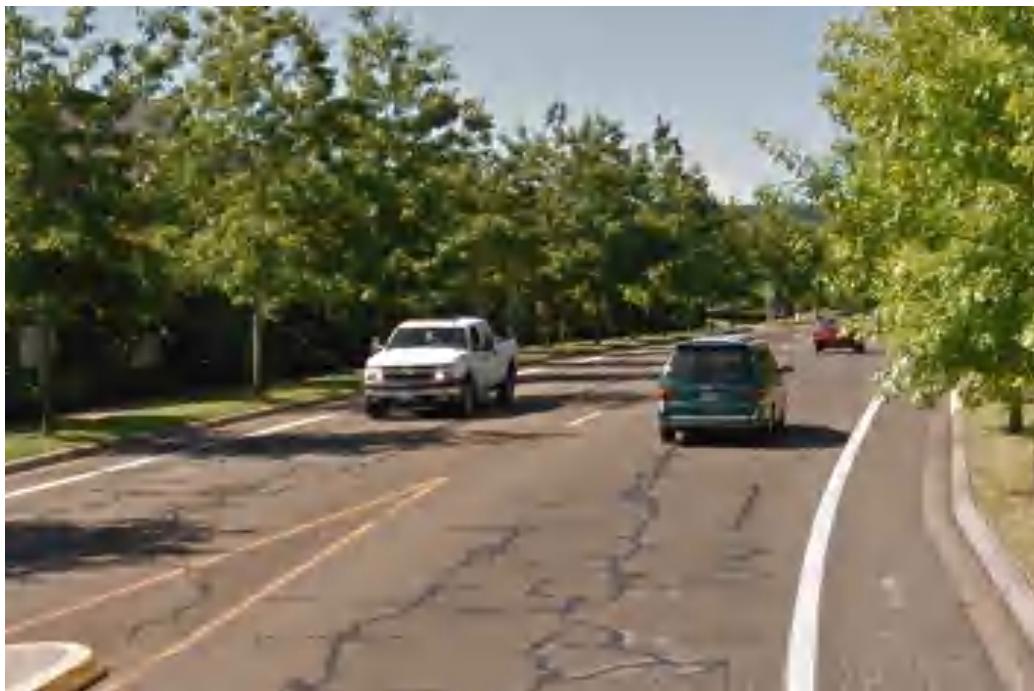
**BranchID:** BRUTSCHER  
**Name:** Brutscher Street  
**SectionID:** rd4902, rd4927, rd4929  
**From:** Little Oak Street  
**To:** Roundabout  
**PCI Before Project:** 71, 66, 65  
**PCI After Project:** 100  
**Work Type:** Mill & Overlay. Full depth patching.  
**Approximate Cost:** \$82,000  
**Visual Distresses:** Alligator Cracking, Longitudinal/Transverse Cracking, Patching, and Weathering

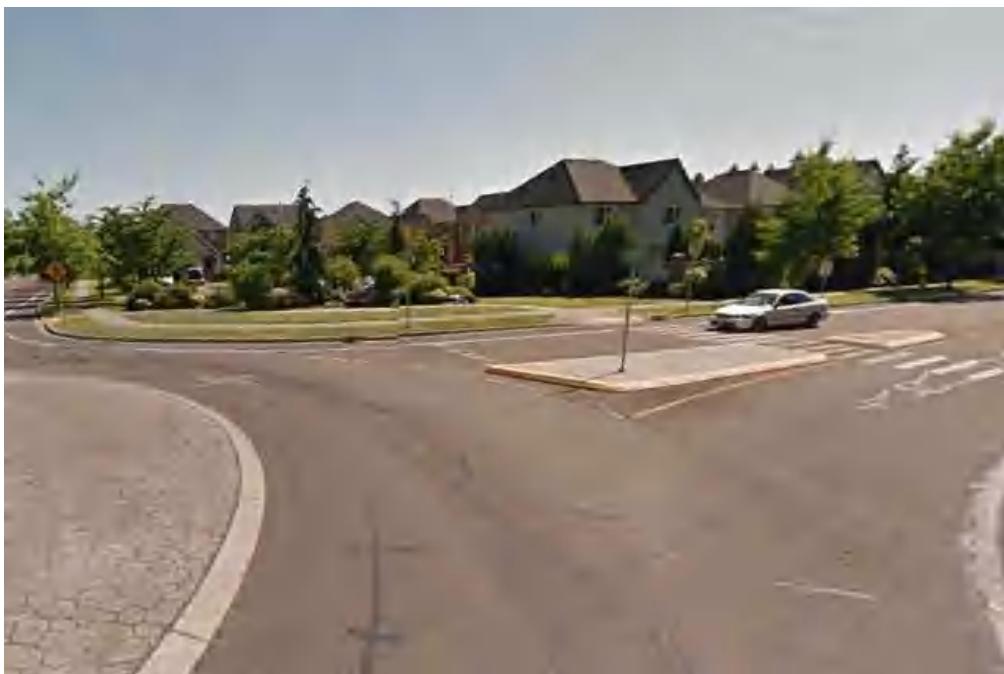
**BranchID:** HAYES  
**Name:** Hayes Street  
**SectionID:** rd4925, rd4920  
**From:** Roundabout  
**To:** Roundabout  
**PCI Before Project:** 69, 64  
**PCI After Project:** 100  
**Work Type:** Mill & Overlay. Full depth patching.  
**Approximate Cost:** \$9,100  
**Visual Distresses:** Alligator Cracking, Longitudinal/Transverse Cracking, and Weathering

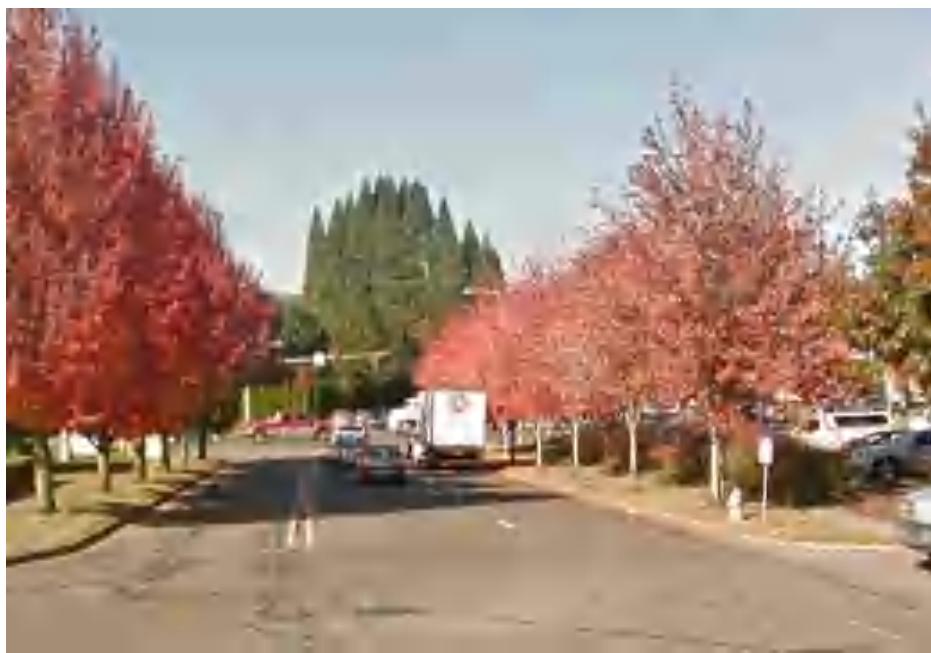
**BranchID:** BRUTSCHER  
**Name:** Brutscher Street  
**SectionID:** rd2608  
**From:** Portland Road  
**To:** Little Oak Street  
**PCI Before Project:** 65  
**PCI After Project:** 100  
**Work Type:** Mill & Overlay. Full depth patching.  
**Approximate Cost:** \$119,000  
**Visual Distresses:** Alligator Cracking, Longitudinal/Transverse Cracking, Patching, Rutting, and Weathering

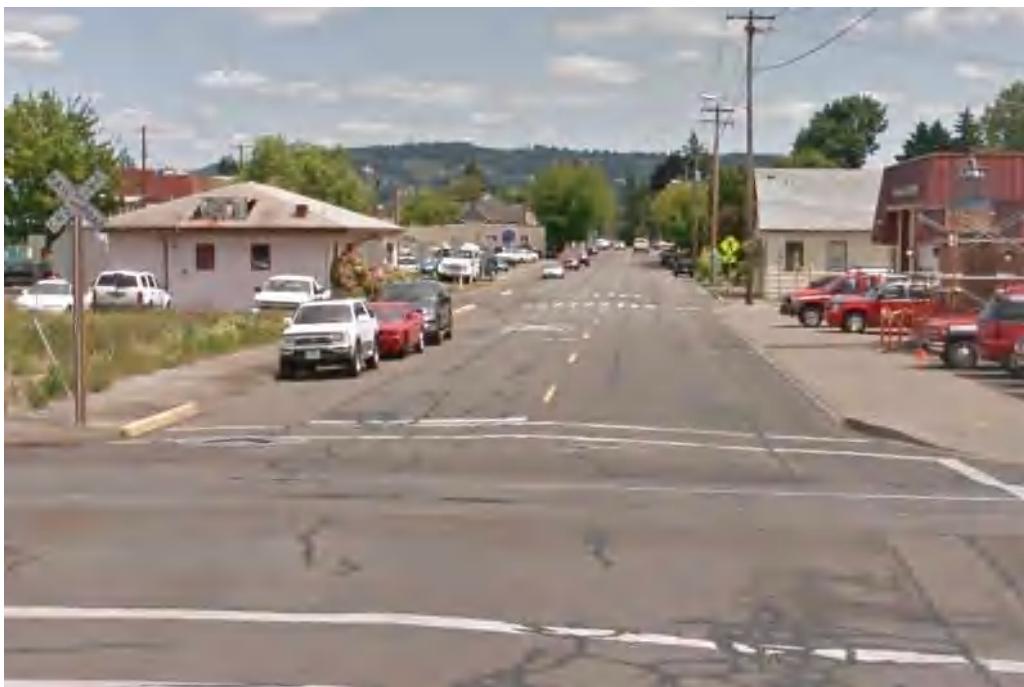
**BranchID:** 2ND  
**Name:** 2<sup>nd</sup> Street  
**SectionID:** rd1578, rd1705  
**From:** Washington Street  
**To:** Howard Street  
**PCI Before Project:** 72, 70  
**PCI After Project:** 100  
**Work Type:** Mill & Overlay. Full depth patching.  
**Approximate Cost:** \$65,500  
**Visual Distresses:** Alligator Cracking, Longitudinal/Transverse Cracking, Rutting, and Weathering

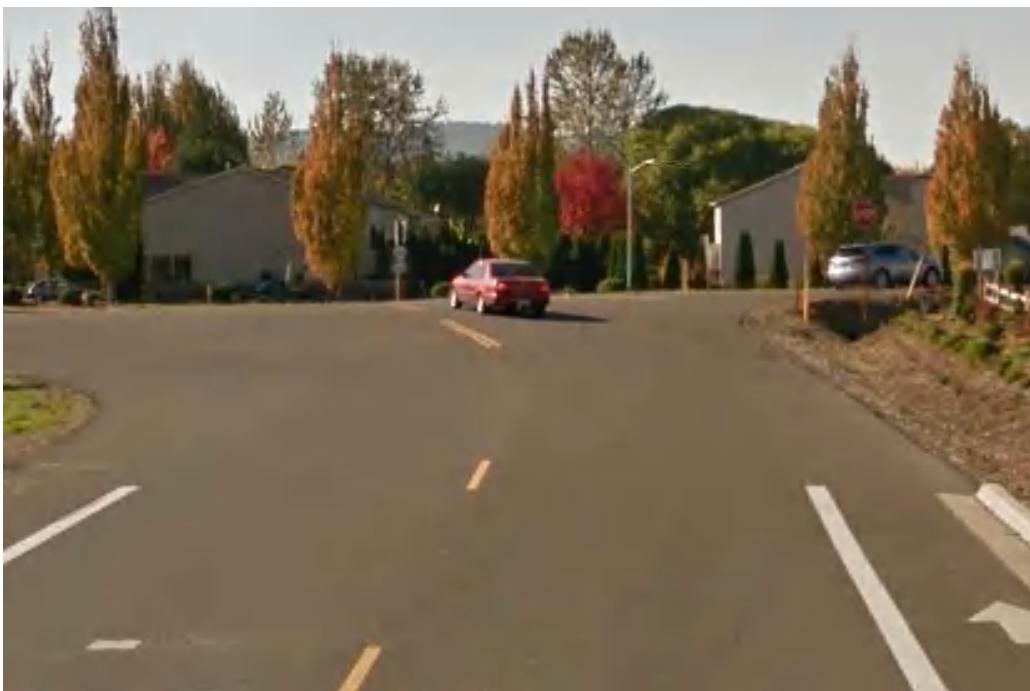
**BranchID:** 2ND  
**Name:** 2<sup>nd</sup> Street  
**SectionID:** rd1648  
**From:** HWY 219  
**To:** Elliott Road  
**PCI Before Project:** 60  
**PCI After Project:** 100  
**Work Type:** Mill & Overlay. Full depth patching.  
**Approximate Cost:** \$21,000  
**Visual Distresses:** Alligator Cracking, Longitudinal/Transverse Cracking, and Weathering

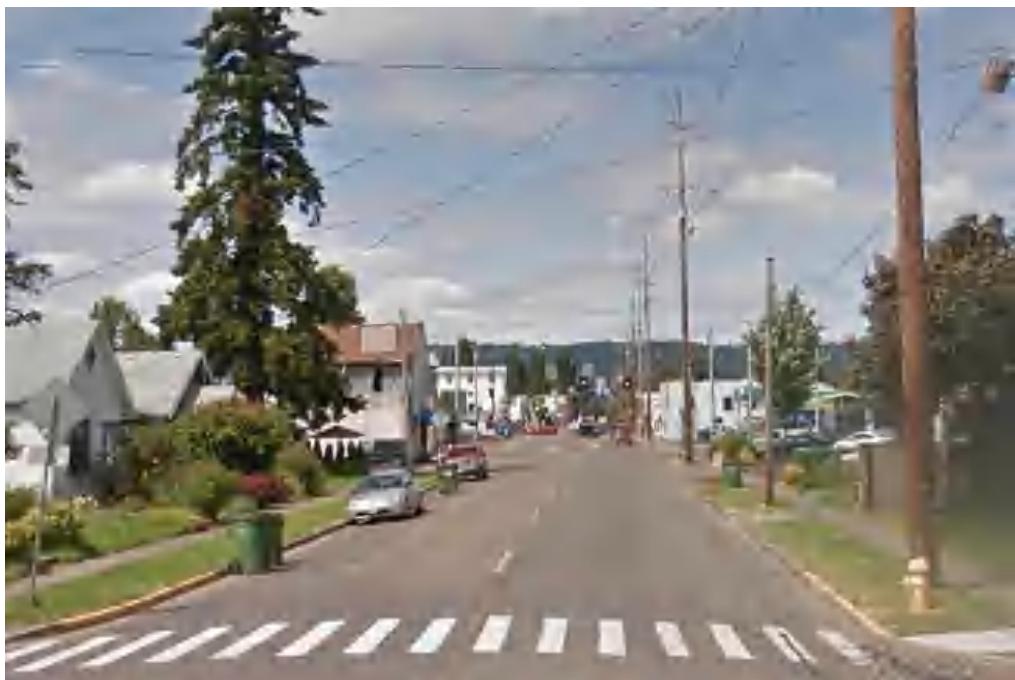
**BranchID:** MAIN  
**Name:** Main Street  
**SectionID:** rd4871  
**From:** 2<sup>nd</sup> Street  
**To:** 1<sup>st</sup> Street  
**PCI Before Project:** 61  
**PCI After Project:** 100  
**Work Type:** Mill & Overlay. Full depth patching.  
**Approximate Cost:** \$31,100  
**Visual Distresses:** Alligator Cracking, Longitudinal/Transverse Cracking, and Weathering

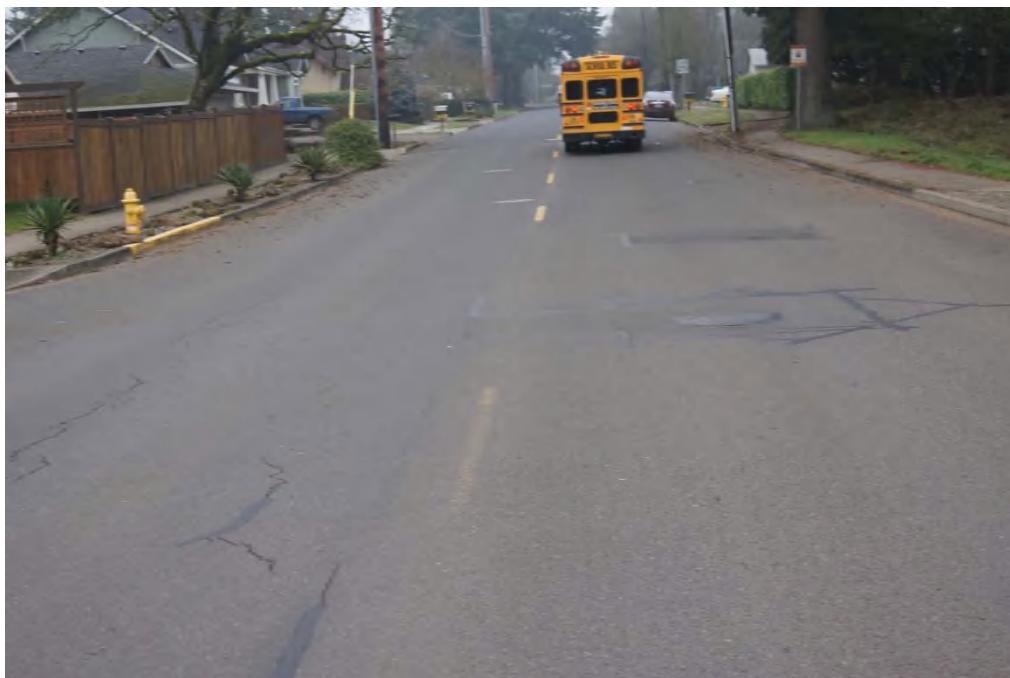
**BranchID:** MAIN  
**Name:** Main Street  
**SectionID:** rd2627, rd4686, rd5006, rd5007  
**From:** Clifford Court  
**To:** Emma Lane  
**PCI Before Project:** 68, 69, 61, 62  
**PCI After Project:** 100  
**Work Type:** Mill & Overlay. Full depth patching.  
**Approximate Cost:** \$56,500  
**Visual Distresses:** Alligator Cracking, Longitudinal/Transverse Cracking, Patching, and Weathering

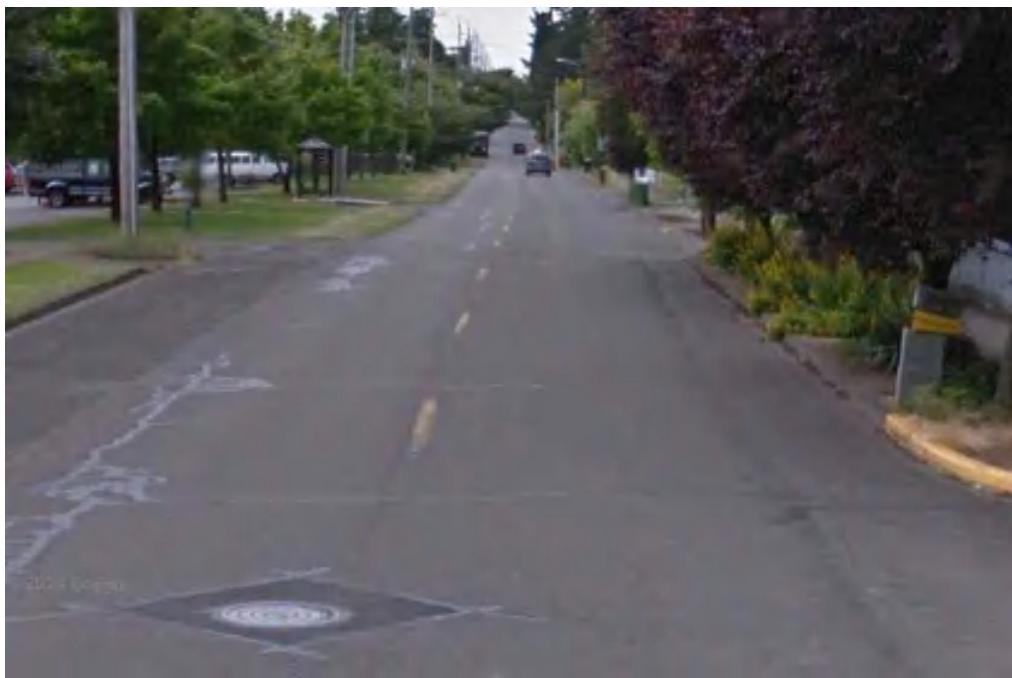
**BranchID:** MAIN  
**Name:** Main Street  
**SectionID:** rd5009  
**From:** Creekside Lane  
**To:** Pinehurst Drive  
**PCI Before Project:** 58  
**PCI After Project:** 100  
**Work Type:** Mill & Overlay. Full depth patching.  
**Approximate Cost:** \$42,100  
**Visual Distresses:** Alligator Cracking, Longitudinal/Transverse Cracking, Patching, and Weathering

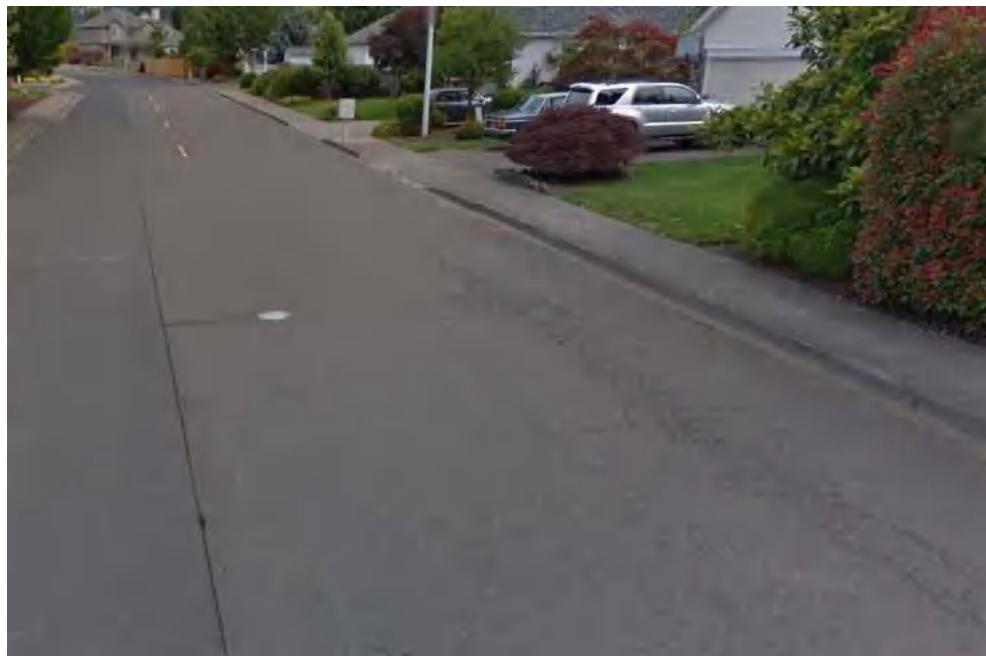
**BranchID:** MAIN  
**Name:** Main Street  
**SectionID:** rd2818  
**From:** Nugget Lane  
**To:** Melody Lane  
**PCI Before** 55  
**Project:**  
**PCI After** 100  
**Project:**  
**Work Type:** Mill & Overlay. Full depth patching.  
**Approximate** \$24,500  
**Cost:**  
**Visual** Alligator Cracking, Longitudinal/Transverse Cracking, and Weathering  
**Distresses:**

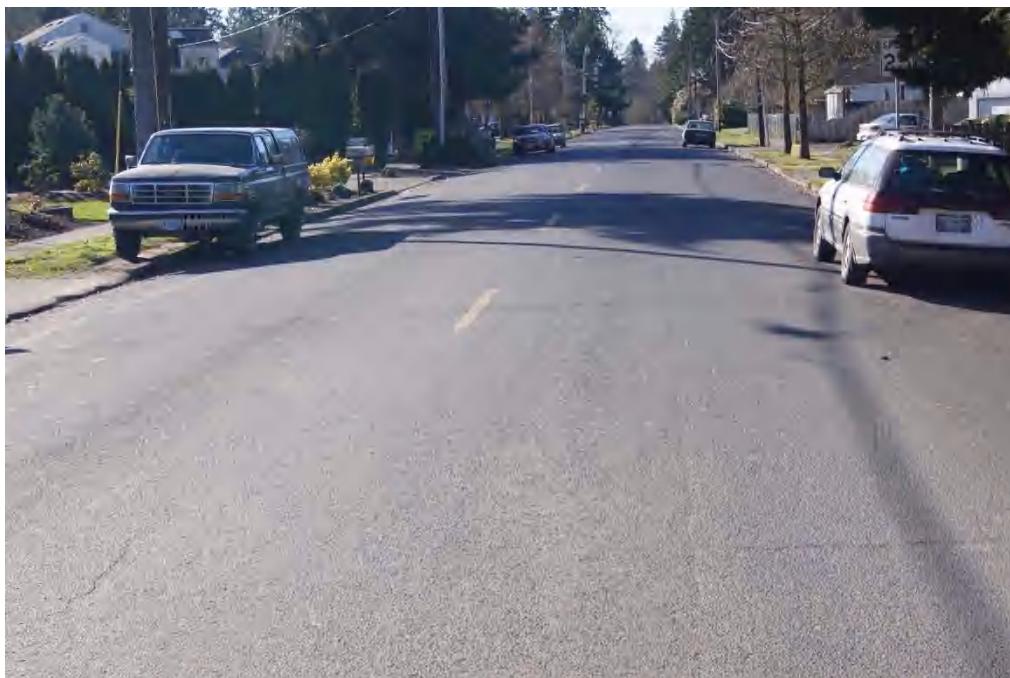
**BranchID:** DAYTON  
**Name:** Dayton Street  
**SectionID:** rd2294, rd2317  
**From:** 5<sup>th</sup> Street  
**To:** Stevenson Road  
**PCI Before Project:** 59, 49  
**PCI After Project:** 100  
**Work Type:** Mill & Overlay. Full depth patching.  
**Approximate Cost:** \$124,500  
**Visual Distresses:** Alligator Cracking, Longitudinal/Transverse Cracking, Patching, and Weathering

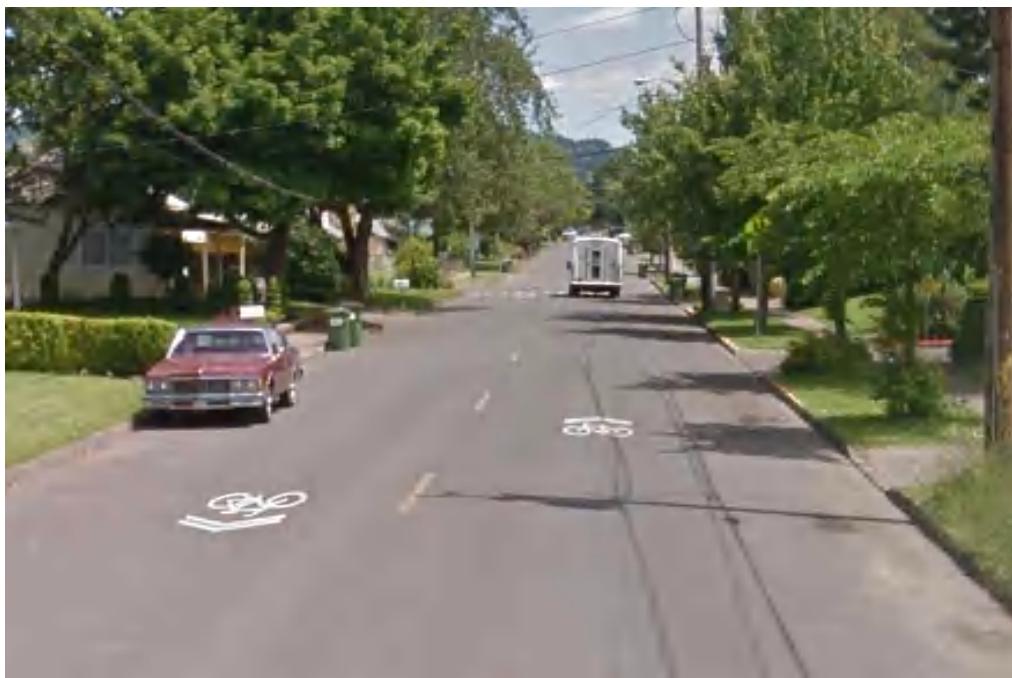
**BranchID:** 9TH  
**Name:** 9<sup>th</sup> Street  
**SectionID:** rd1567, rd1570, rd2247  
**From:** College Street  
**To:** River Street  
**PCI Before Project:** 69, 59, 62  
**PCI After Project:** 100  
**Work Type:** Mill & Overlay. Full depth patching.  
**Approximate Cost:** \$99,200  
**Visual Distresses:** Alligator Cracking, Longitudinal/Transverse Cracking, and Weathering

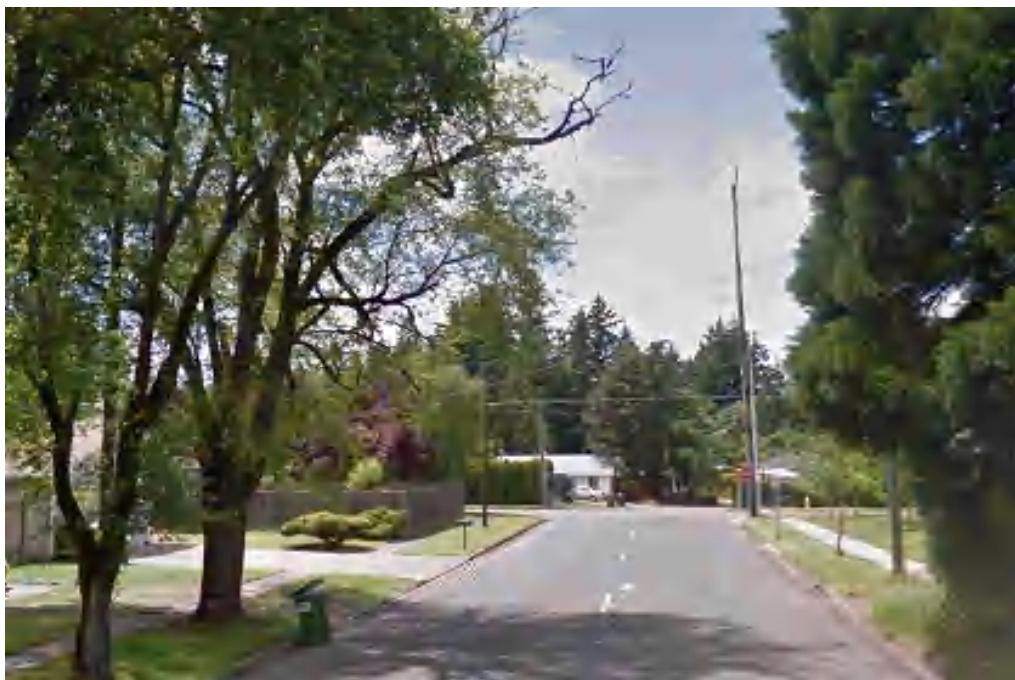
**BranchID:** 11TH  
**Name:** 11<sup>th</sup> Street  
**SectionID:** rd1681  
**From:** River Street  
**To:** Chehalem Street  
**PCI Before Project:** 55  
**PCI After Project:** 100  
**Work Type:** Mill & Overlay. Full depth patching.  
**Approximate Cost:** \$25,000  
**Visual Distresses:** Alligator Cracking, Edge Cracking, Longitudinal/Transverse Cracking, and Weathering

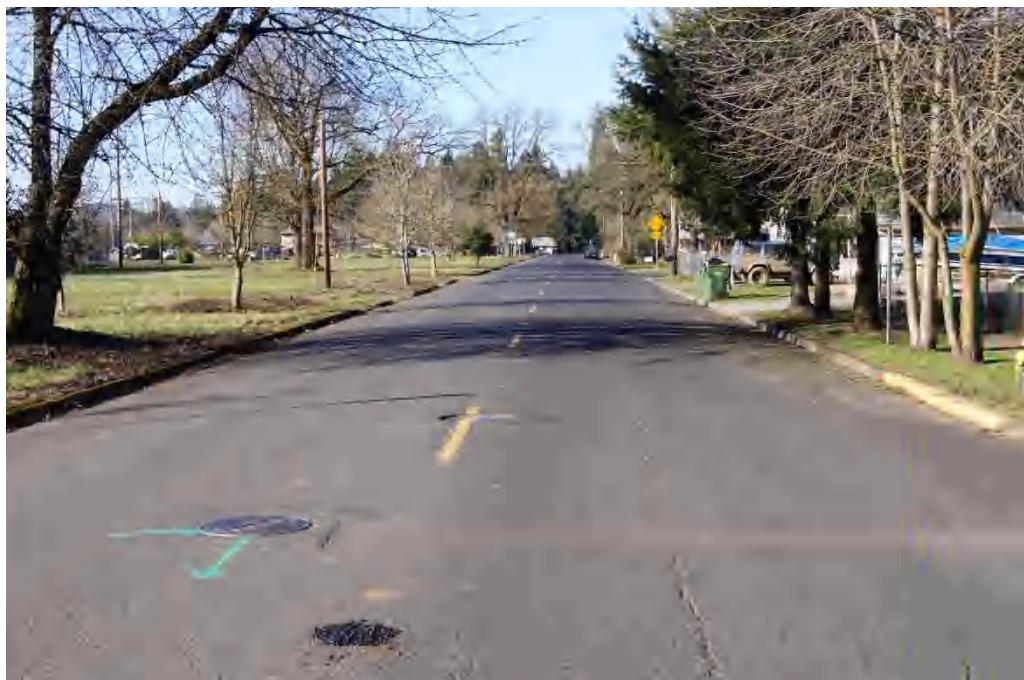
**BranchID:** 11TH  
**Name:** 11<sup>th</sup> Street  
**SectionID:** rd1895  
**From:** Columbia Street  
**To:** Pacific Street  
**PCI Before Project:** 51  
**PCI After Project:** 100  
**Work Type:** Mill & Overlay. Full depth patching.  
**Approximate Cost:** \$21,500  
**Visual Distresses:** Alligator Cracking, Longitudinal/Transverse Cracking, Patching, and Weathering

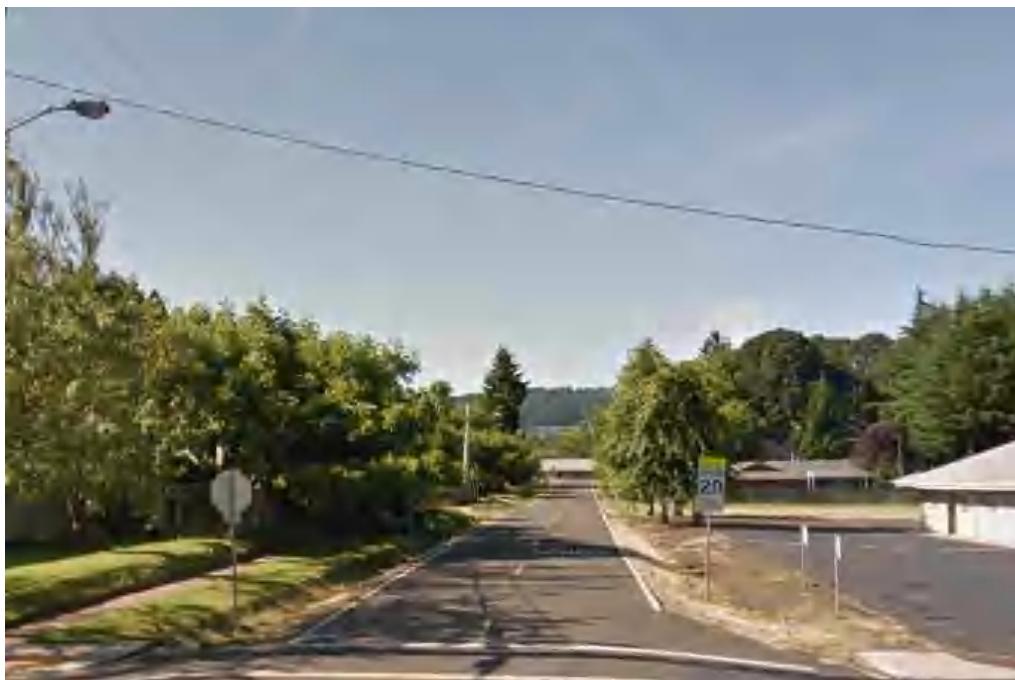
**BranchID:** ELLIOTT  
**Name:** Elliott Road  
**SectionID:** rd4767  
**From:** Haworth Avenue  
**To:** Willow Drive  
**PCI Before Project:** 67  
**PCI After Project:** 100  
**Work Type:** Mill & Overlay. Full depth patching.  
**Approximate Cost:** \$13,800  
**Visual Distresses:** Alligator Cracking, Longitudinal/Transverse Cracking, and Weathering

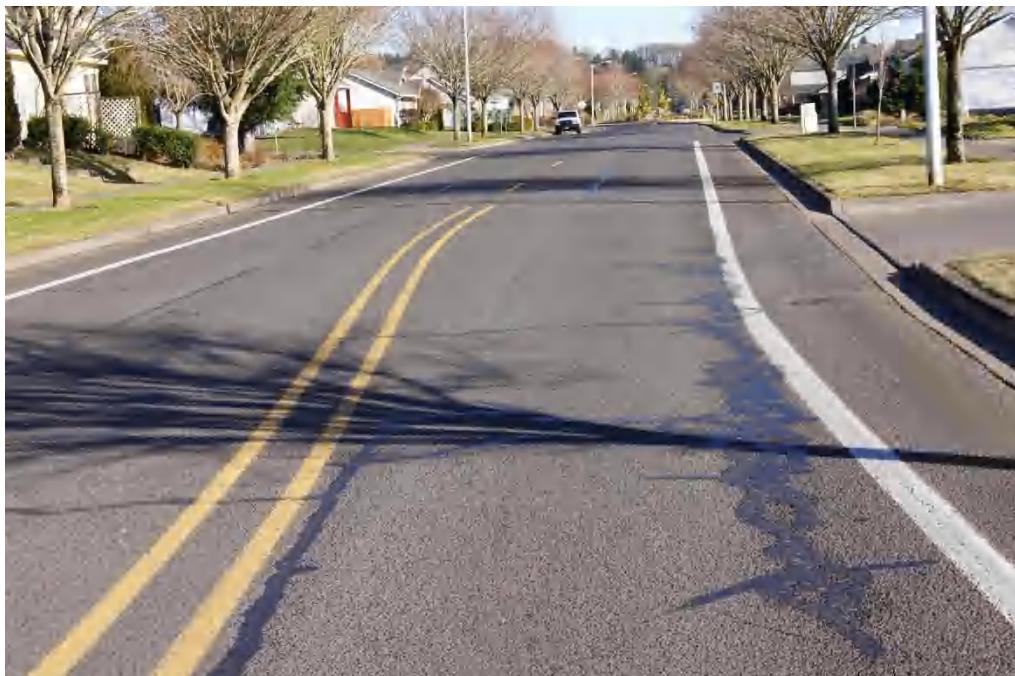
**BranchID:** FOOTHILLS  
**Name:** Foothills Drive  
**SectionID:** rd1936  
**From:** College Street  
**To:** Burlington Drive

**Visual Distresses:** Alligator Cracking, Longitudinal/Transverse Cracking, and Weathering

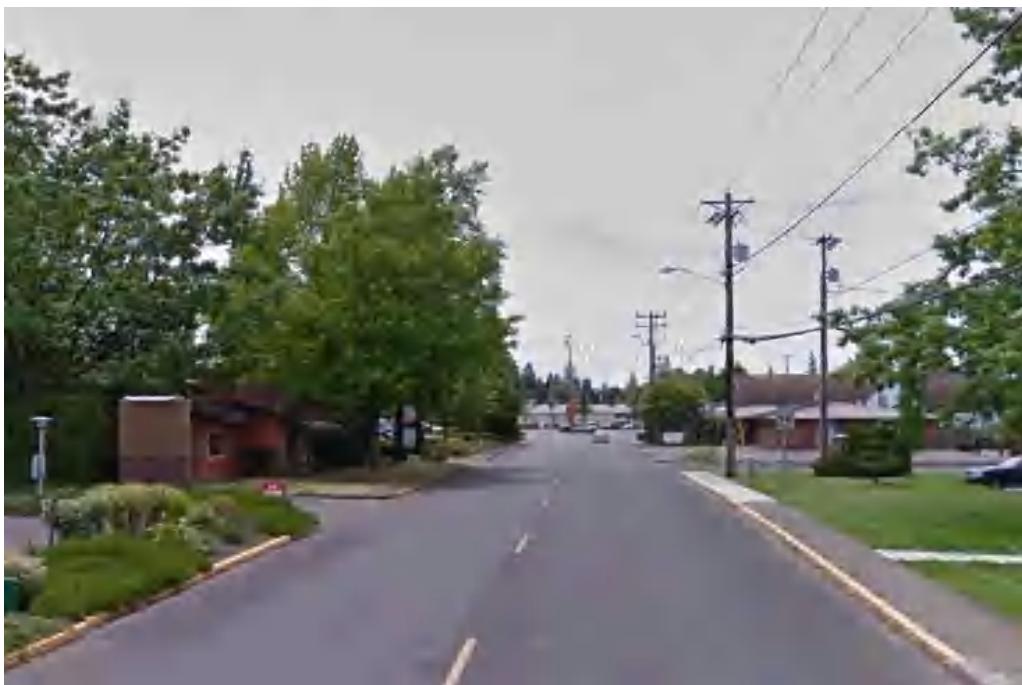
**BranchID:** VILLA  
**Name:** Villa Road  
**SectionID:** rd2368  
**From:** Sherman Street  
**To:** Laurel Drive

**Visual Distresses:** Alligator Cracking, Longitudinal/Transverse Cracking, Patching, and Weathering
