## **PROJECT REPORT**

### **Pavement Management System Implementation**

**City of Newberg**  
414 E. First Street  
Newberg, OR 97132

Project No. 13075

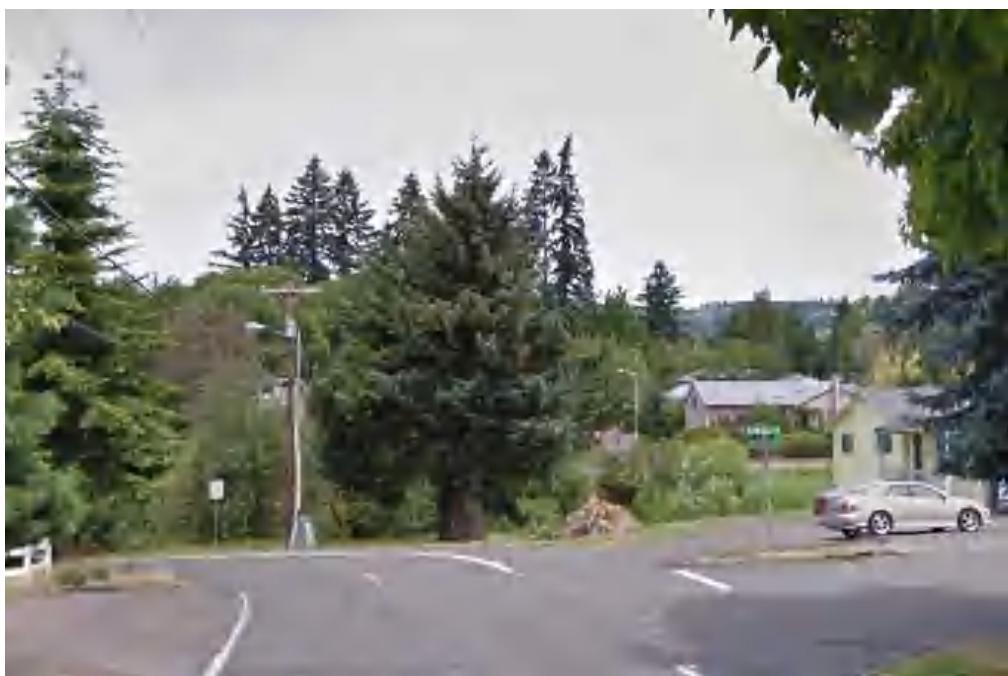
**BranchID:** VILLA  
**Name:** Villa Road  
**SectionID:** rd4780  
**From:** Orchard Drive  
**To:** Carol Avenue

**Visual Distresses:** Alligator Cracking, Longitudinal/Transverse Cracking, and Weathering

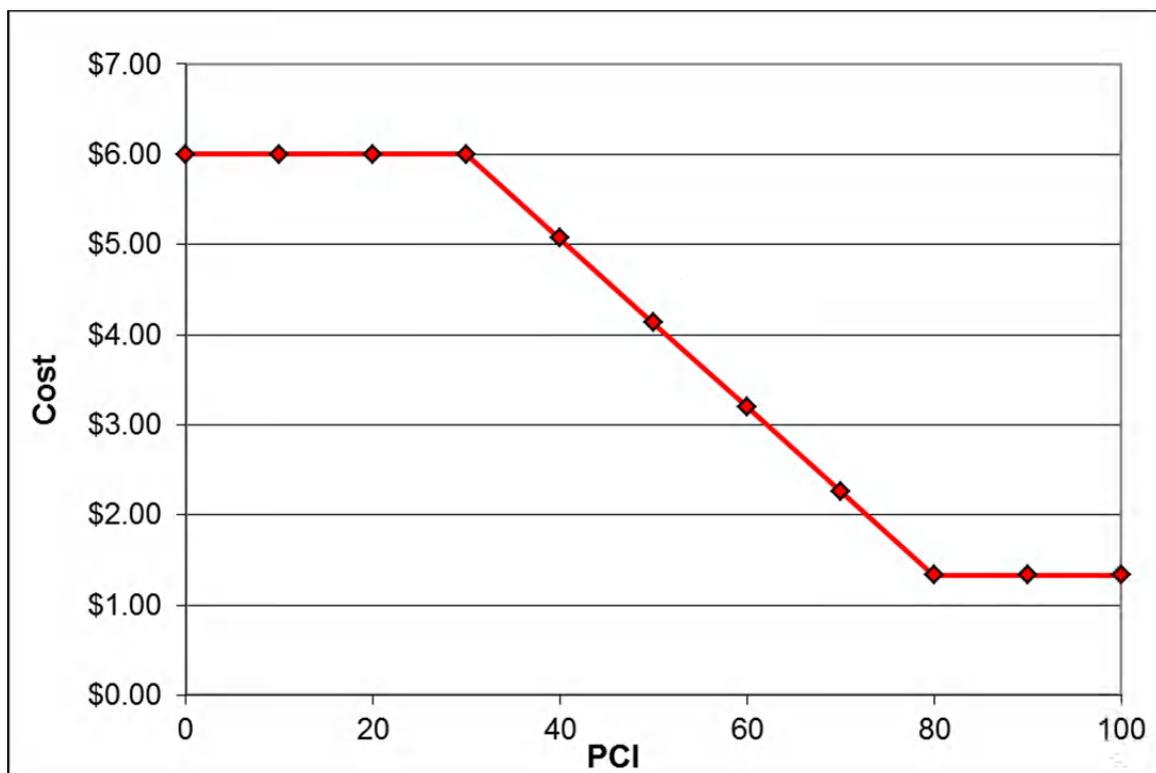
**Figure 1 – Major M&R Cost by Condition Data**

PCI	Non-Residential Streets	Residential Streets
	AC Localized Preventive M&R Cost	AC Localized Preventive M&R Cost
0	\$3.15	\$4.54
10	\$2.79	\$3.64
20	\$2.42	\$3.29
30	\$1.55	\$1.94
40	\$0.68	\$0.85
50	\$0.37	\$0.25
60	\$0.09	\$0.13
70	\$0.06	\$0.03
80	\$0.01	\$0.01
90	\$0.00	\$0.00
100	\$0.00	\$0.00
