Downtown Existing Conditions

Newberg Downtown Improvement Plan

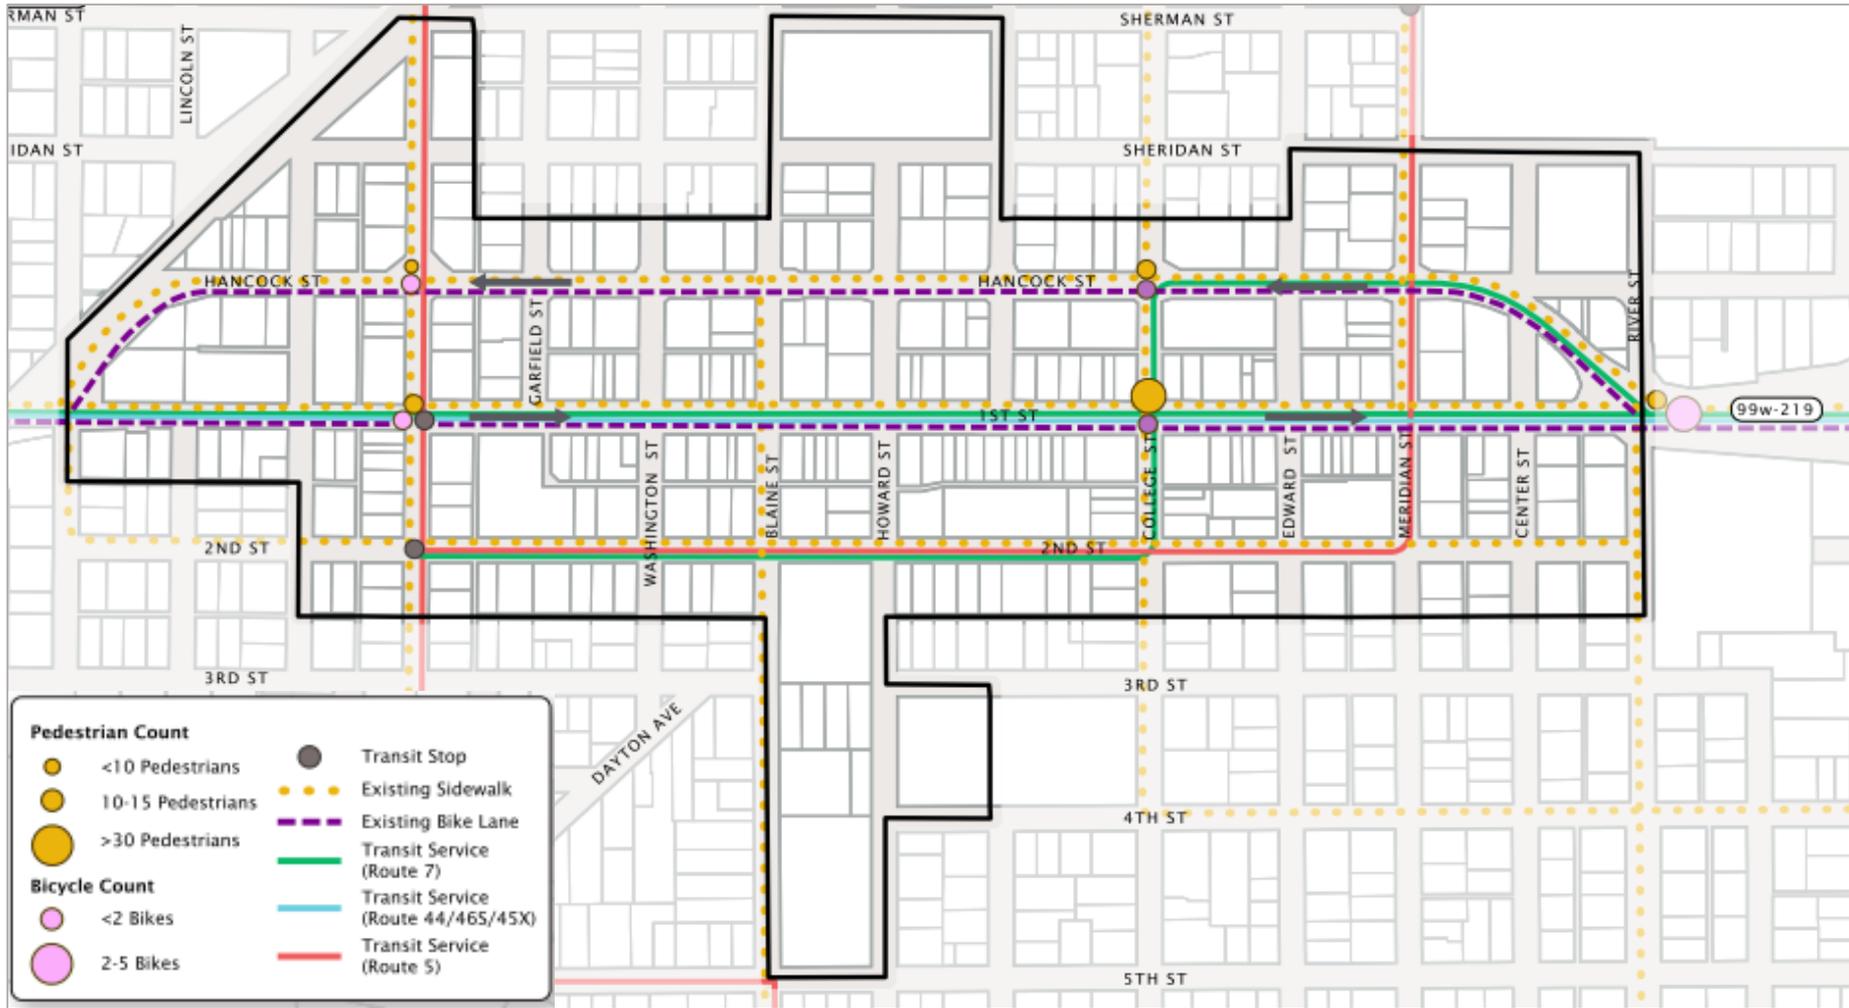
Transportation System

Issues

- Sidewalk condition and width vary
- Pavement conditions on 1st Street
- Hard to cross 3 lane couplet at unsignalized intersections
- Phase 1 Bypass will reduce traffic volumes

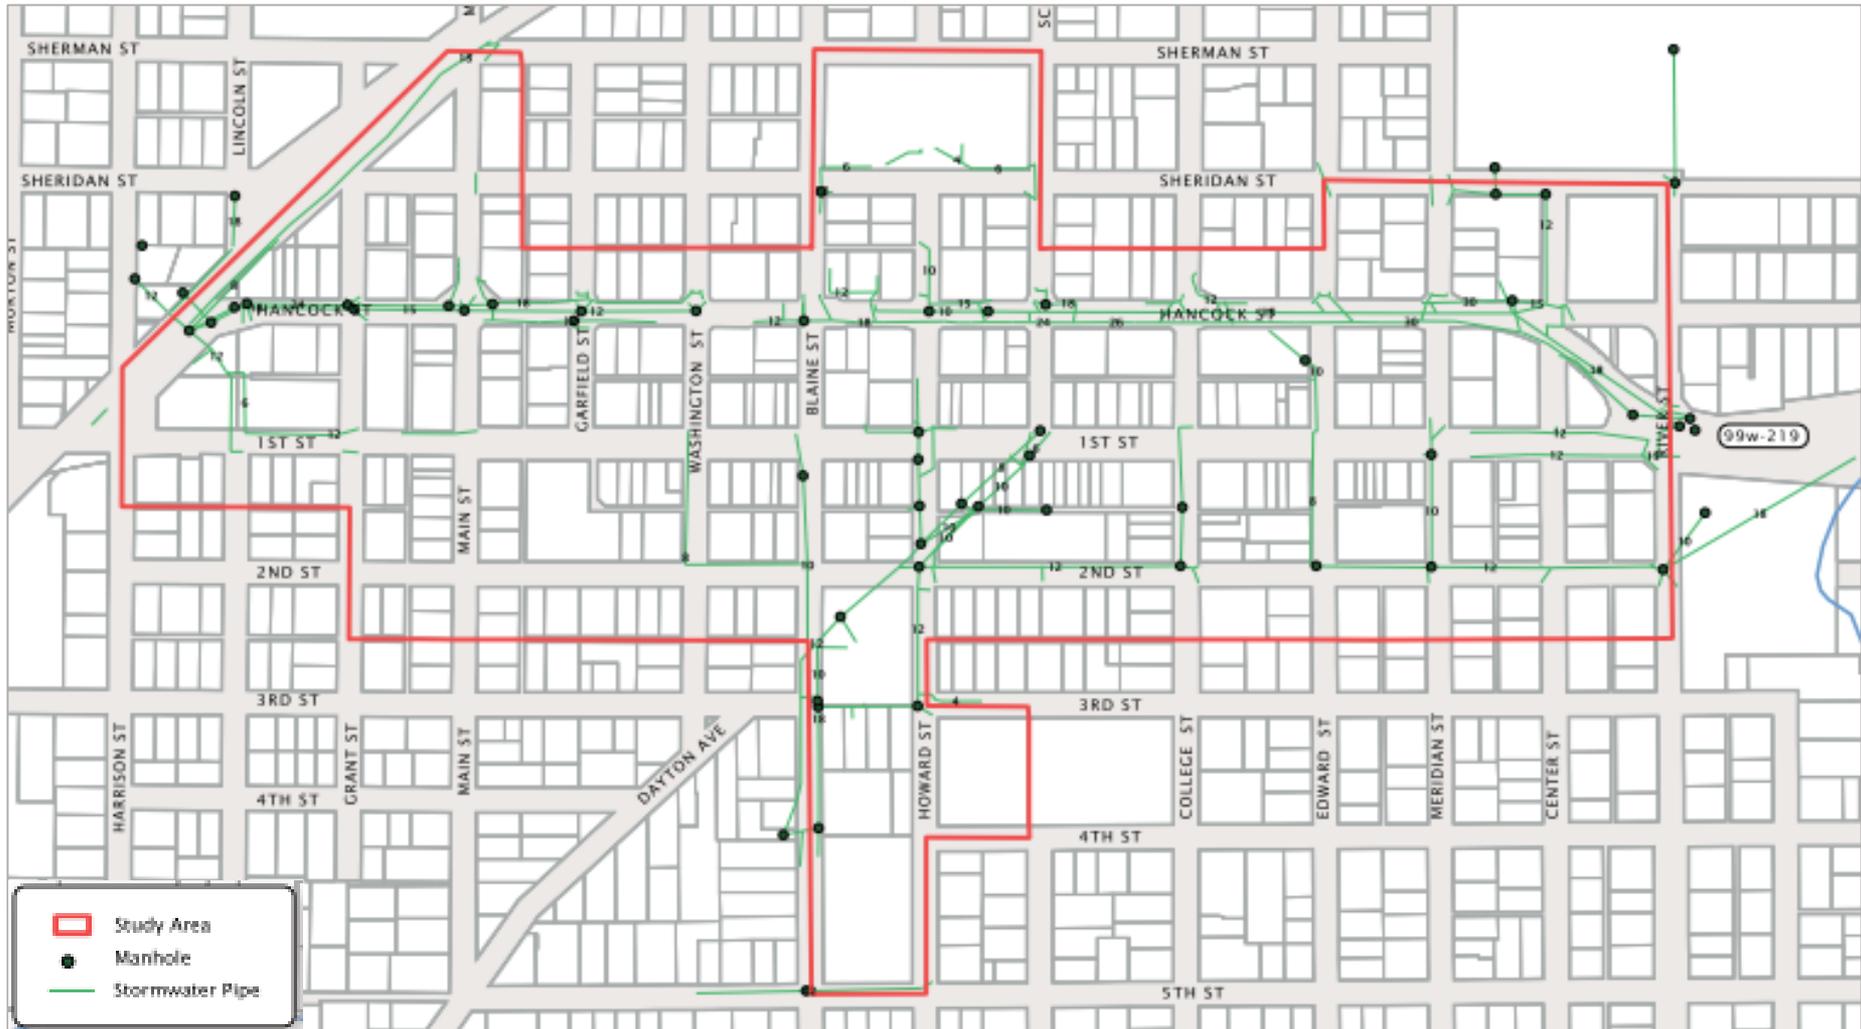
Stormwater System

Storm Sewer System

- Established system on Hancock St., 1st St., and Howard St.
- Stormwater Master Plan points to drainage problem areas
- No stormwater quality treatment in study area

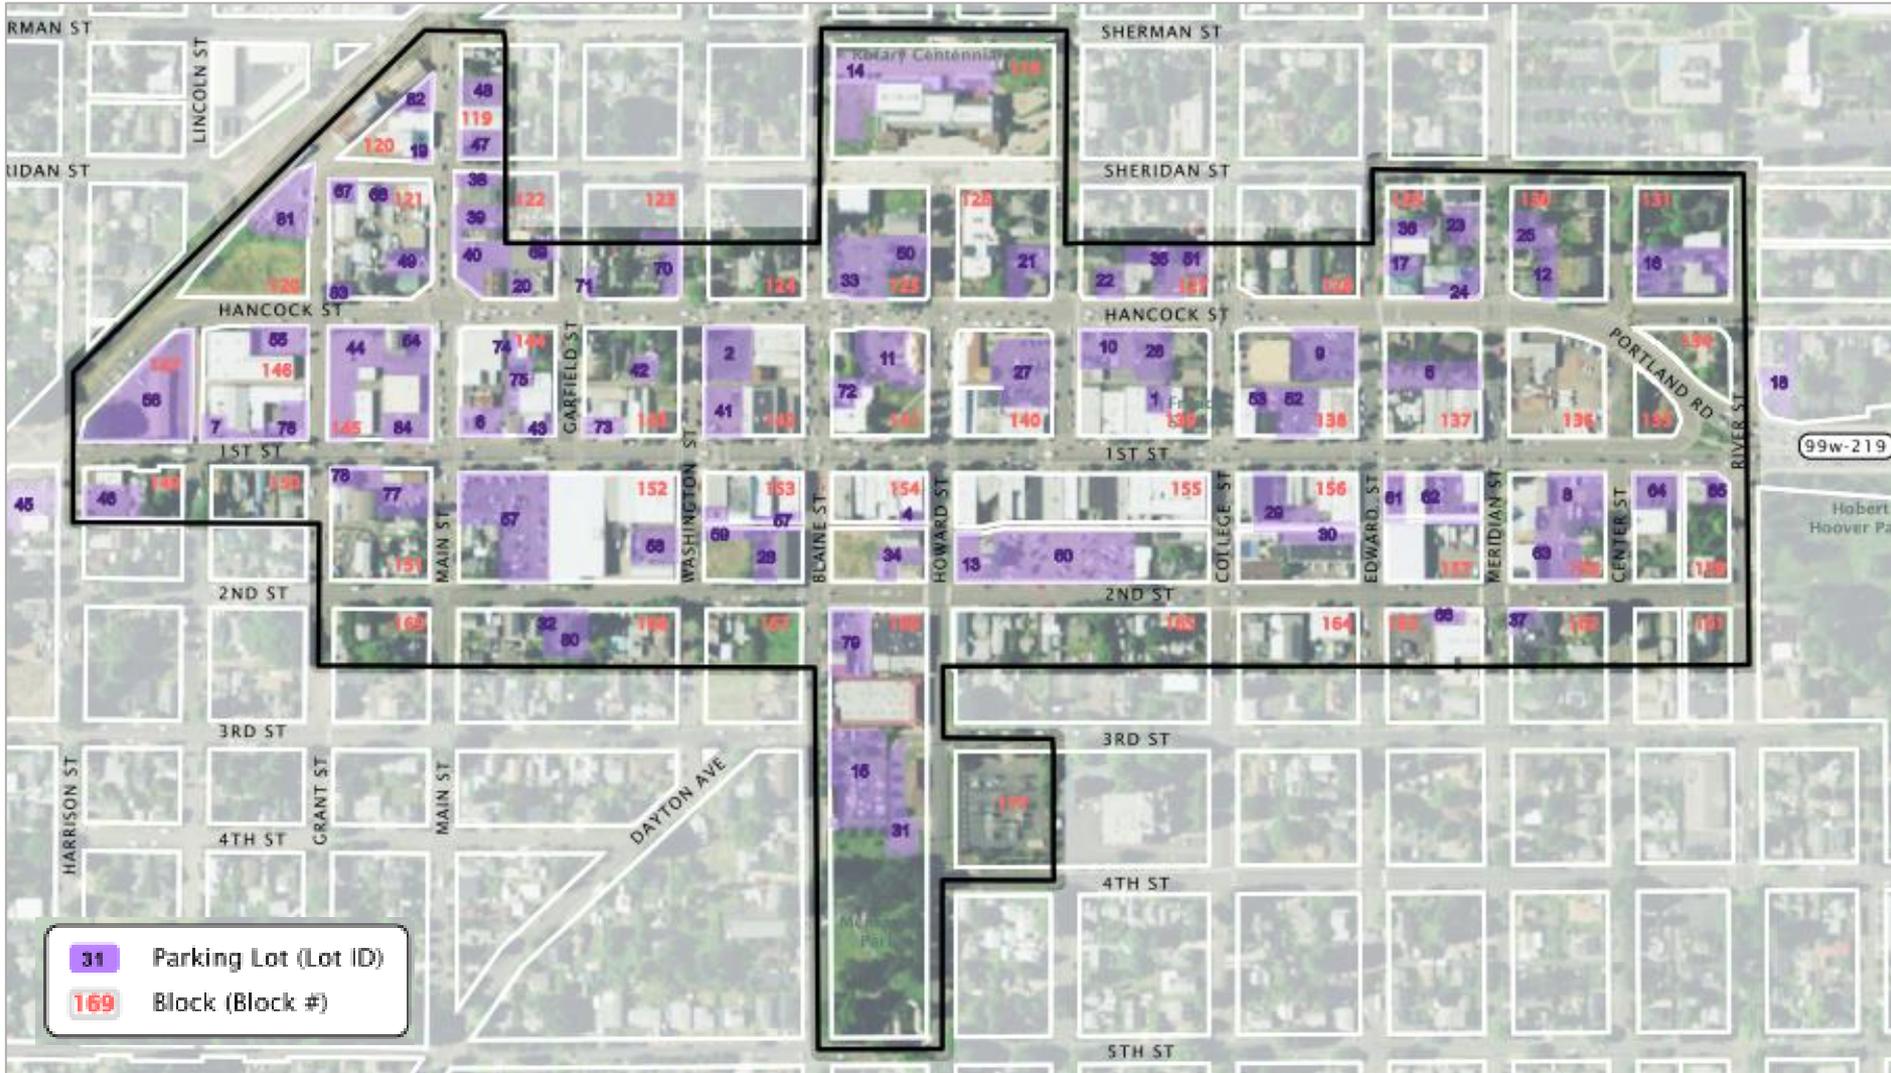
Parking Off-Street

- Conducted inventory for on- and off-street parking
- Total of **2,090 parking stalls**
 - 45% on-street (944)
 - 55% off-street (1,146)
- Several off-street lots present opportunities for shared lots or developable parcels.

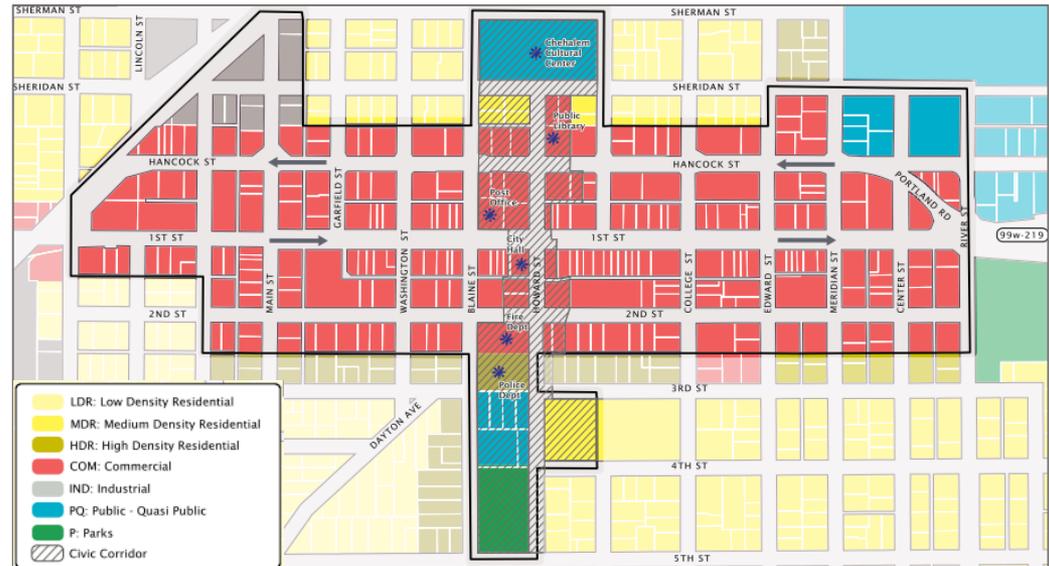
- Study area is approximately **65 acres**
- There are nearly **12 acres of parking lots** and vacant properties
- Primary land use: commercial (**C-3 Zoning**)
- Most uses comply with Comprehensive Plan and Zoning designations
 - Several lots are non-conforming

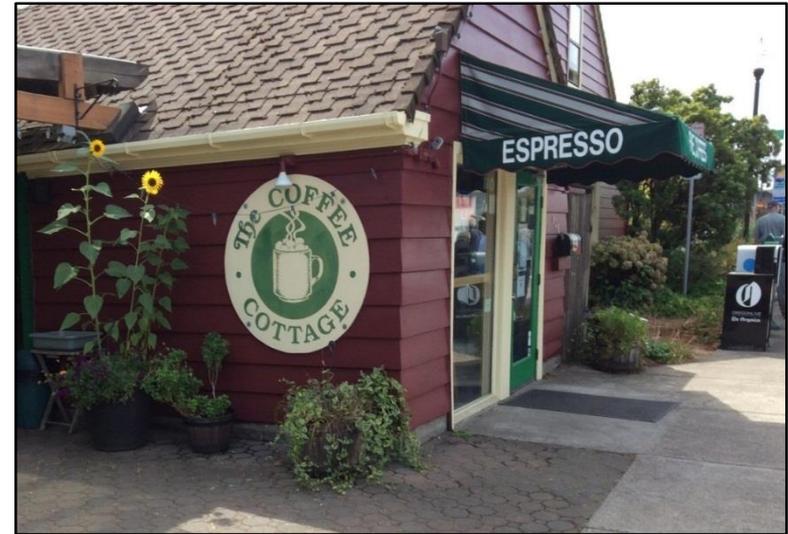
Building Environment

- One- and two-story heights
- Pedestrian scale on 1st St
- Less density and accessibility on Hancock St
- Re-use of buildings with original facades and details

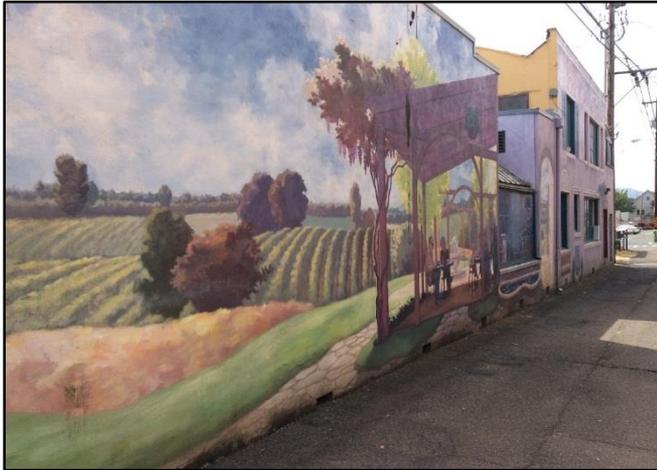
Pedestrian Amenities

- Sidewalks mostly curbed; look and feel is inconsistent
- Street lighting: mix of styles & color
- Street trees: mix of species and spacing; some gaps
- Street furnishings: not coordinated w/in downtown; more opportunities for sitting/resting needed
