# Appendix

#### Facility Condition Assessment Inspection Form – Newberg WWTP

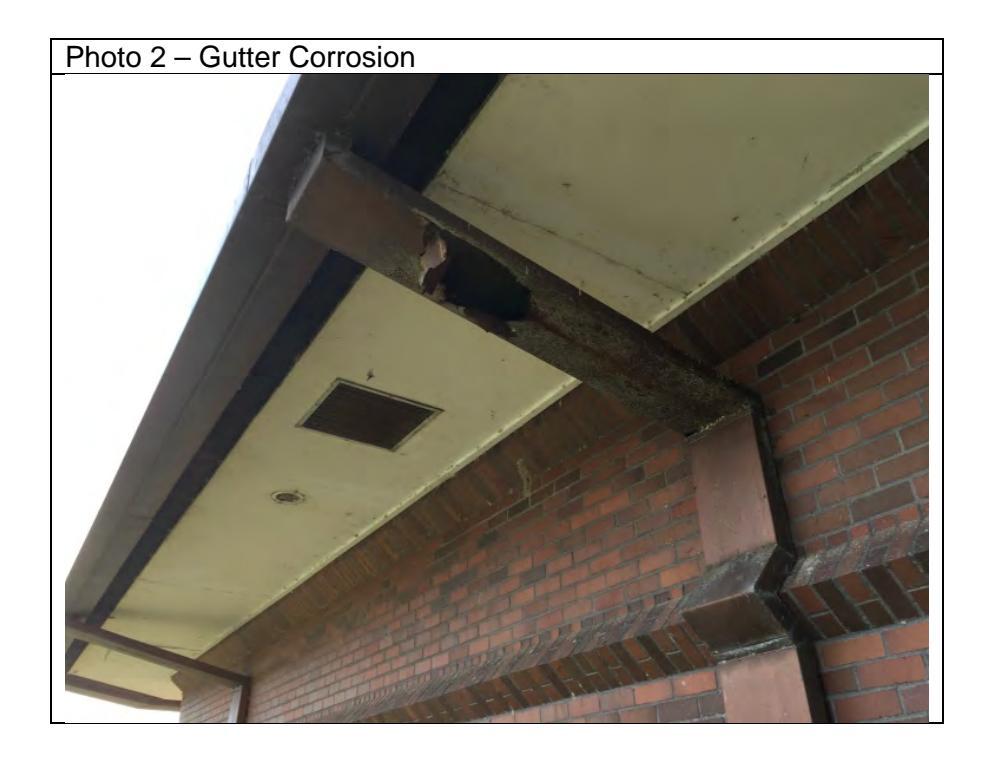
Photo 1 – Secondary Building

SYSTEM ASS	ETS	CR			COMMENTS	
Civil and Site		1.5	Some sidewalk sidewalk sectio Some overgrov	is weathered but ns have been pu vn vegetation but	t overall good condition. A few areas where new t in. good condition overall	
Architectural		4	Rating based primarily on age of major components (roof and gutter system). Building scheduled for roof and gutter replacement in near future. Gutter downspouts with significant corrosion – not in serviceable condition in some areas where downspouts are completely corroded through. (see Photo 2) Some pipe / conduit penetrations into ceiling are unsealed and have a large gap. Soffit gypsum board has failing taped joints and general degradation Doors in generally good condition.			
Structural		3	See comments	under RAS/WAS	Pump Station Inspection Form.	
Power Distribution N/A N/A						
Electrical		2	See comments under RAS/WAS Pump Station Inspection Form.			
Instrumentatior Analyzers	ו/	N/A	N/A

Roof, gutter, and soffit replacement scheduled for fiscal year 2020/2021.

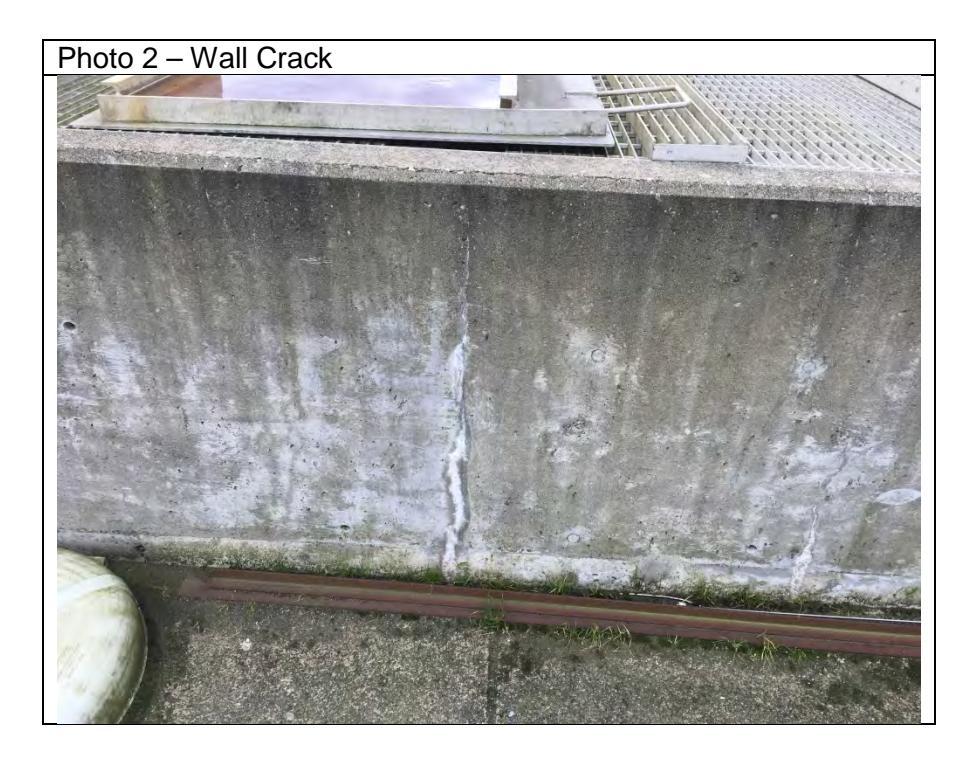
Photo 1 – RAS Distribution Box

SYSTEM ASS	ETS	CR			COMMENTS
Civil and Site		2	Concrete sidewalk surface weathered but OK otherwise.		
Architectural		N/A	N/A		
Structural		3	Rating based primarily on age. Fair condition overall. Rating of 2 based on condition alone. Some vertical cracks with efflorescence. (See Photo 2) Several snap tie pockets appear to have lost grout filler.		
Power Distribut	tion	N/A	N/A		
Electrical		N/A	N/A		
Instrumentation Analyzers	n/	N/A	N/A		
Process or Mechanical Equipment		2	Condition rating based on age, no issues observed in field.		
Pumping Syste	ms	N/A	N/A		
Piping and Valv	/es	N/A	N/A		
HVAC		N/A	N/A		
Odor Control		N/A	N/A		
Other		N/A	N/A		
Overall Facilit Rating	у	2.3	System asse	et criteria weigl	nted equally
	0	Unknown		Original Usefu	ul Life (OUL)
	1	New or Excelle	ent Condition	100% OUL	Normal Preventive Maintenance
CONDITION RATING LEGEND	2	Minor Defects	Only	75% OUL	Normal Preventive Maintenance, Minor Corrective Maintenance

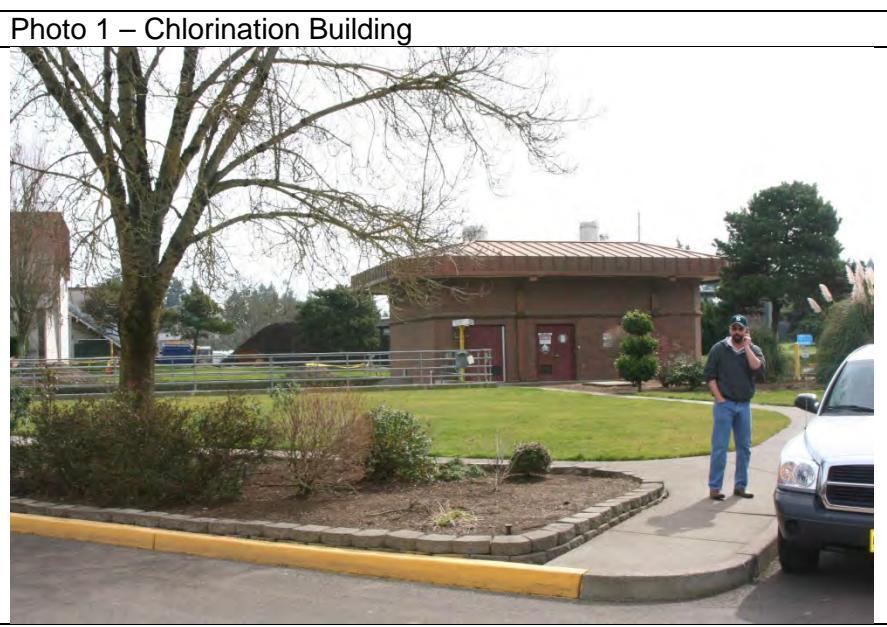
SYSTEM ASS	ETS	CR	COMMENTS		
Civil and Site		2	Good condition overall, a few cracked sidewalk panels		
Architectural		4 1	Rating based primarily on age of major components (roof and gutter system). Buildir scheduled for roof and gutter replacement in near future.   Gutter downspouts with significant corrosion.   Multiple areas of ceiling with evidence of roof leakage and water damage. (See Photo 2)   Soffit gypsum board has failing taped joints and general degradation   Roof, gutters, and soffit replaced in Spring 2017.		
Structural		3	Rating based p Good condition	primarily on age.	e localized cracks in CMU wall
Power Distribut	tion	N/A	N/A		
Electrical		N/A	N/A		
Instrumentatior Analyzers	n/	N/A	N/A		
Process or Mechanical N/A N/A Equipment					
Pumping Systems N/A		N/A			
Piping and Valves N/A		N/A	N/A		
HVAC		N/A	N/A		
Odor Control		N/A	N/A		
Other		N/A	N/A		
Overall Facility Rating		3.0 2.0	System asset criteria weighted equally		nted equally

Notes added in January 2018: Roof, gutter, and soffit replaced in Spring 2017. No leaks roofs now existing. Several fans that were no longer necessary were removed ahead of the roof replacement. Water damaged sheetrock (Photo 2) has been replaced.

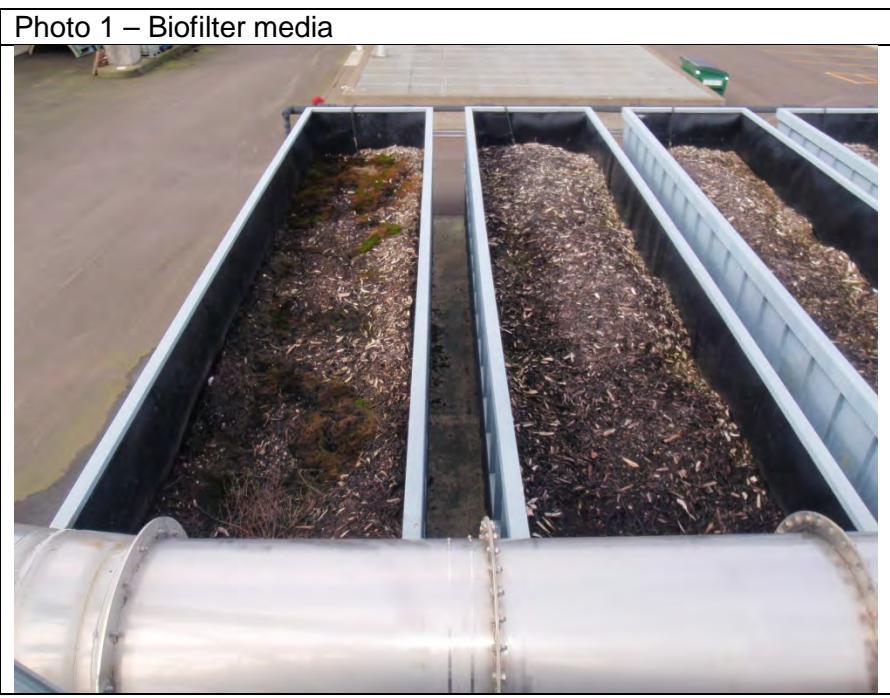
SYSTEM ASS	ETS	CR			COMMENTS
Civil and Site		2	Condition rating based on age, no issues observed in field.		
Architectural		N/A	N/A		
Structural		2	Condition rating based on age, no issues observed in field. Modular tanks and scrubber in good condition.		
Power Distribut	tion	N/A	N/A		
Electrical		2	Corrosion obse	erved on conduit,	conduit fittings, and conduit fasteners.
Instrumentatior Analyzers	ח /	4	The biofilter control system is essentially defunct. A significant amount of dirt, debris, and moisture was observed in the control panel and junction boxes. Corrosion observed on pressure transmitter housing.		
Process or Mechanical Equipment		5	Biofilter media in poor condition. Media is spent and is compacting - approximately 2ft below the top of the tank (see Photo 1). Recommend full replacement of media. No issued observed with scrubber.		
Pumping Syste	ems	N/A	N/A		
Piping and Valv	ves	3 2	Water pressure regulator broken. Piping insulation needs replacement. See Photo 3. Water piping and insulation replaced in Summer 2017.

Notes added in January 2018: Broken water line and insulation replaced in Summer 2017. Odor control media replacement planned for in 2018/2019 fiscal year budget proposal.

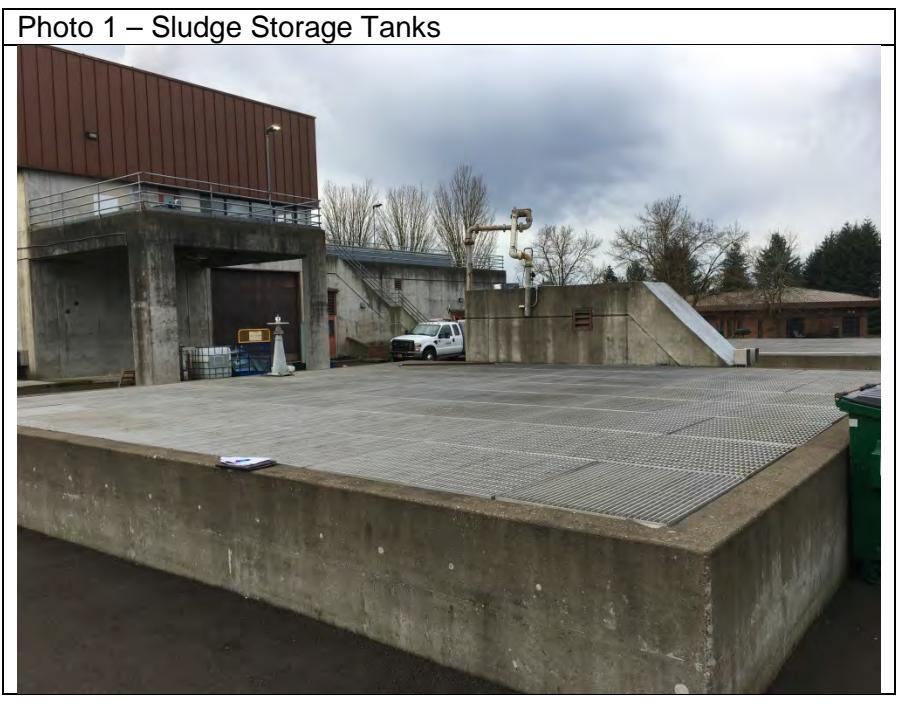
SYSTEM ASS	ETS	CR			COMMENTS
Civil and Site		3	Settlement / he	eaving of concrete	e sidewalk sections around both tanks (See Photo 3)
Architectural		N/A	N/A		
Structural		3	Primarily based on age. Moderate to severe corrosion of steel anchor bolts at grating support beam seats. One area with spalled concrete in wall below beam seat – likely due to concrete delamination due to corrosion of anchor bolts. (See Photo 4)		
Power Distribut	tion	N/A	N/A		
Electrical		N/A	N/A		
Instrumentatior Analyzers	n /	N/A	N/A		
Process or Mechanical Equipment		2	Rating based on City descriptions. Equipment not inspected.		
Pumping Syste	ms	N/A	N/A		
Piping and Valv	/es	2	Rating based on City descriptions. Equipment not inspected.		
HVAC		N/A	N/A		
Odor Control		N/A	N/A		
Other		N/A	Heavy buildup level. (See Pho	of sludge / moss oto 2)	limited visual inspection of concrete walls above water
Overall Facilit Rating	у	2.5	System asse	et criteria weigh	nted equally

Note added in January 2018: Sidewalk issues (Photo 3) will be addressed when a new catwalk along the South side of the tanks is added.

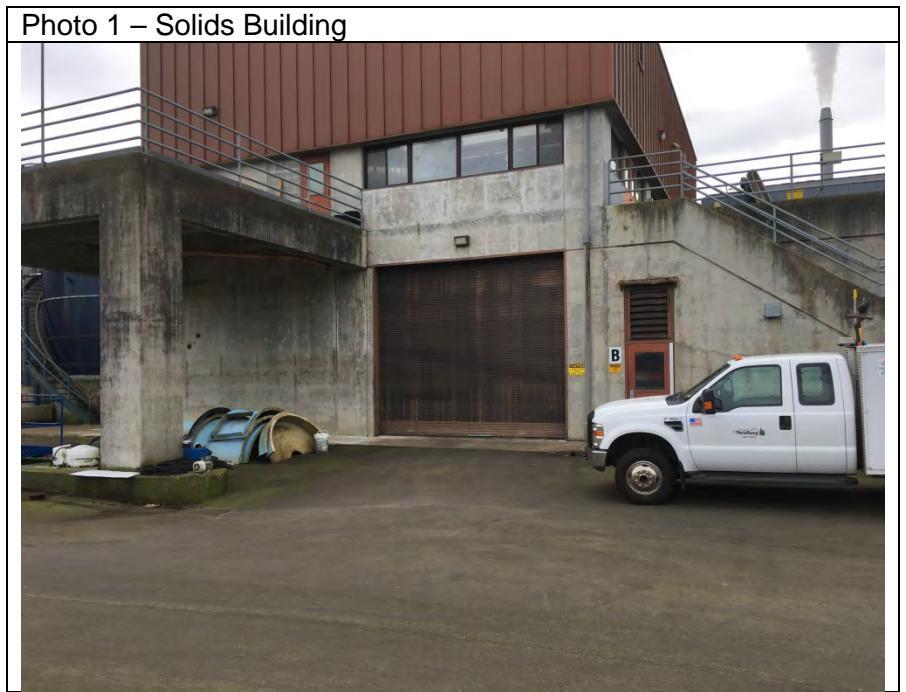
SYSTEM ASS	ETS	CR			COMMENTS
Civil and Site		2	Generally good slabs due to dif	condition with lo ferential settleme	calized areas of moss buildup and uneven sidewalk nt
Architectural		3	Based on age and general condition. Some areas of corrosion / rust staining on doors and door frames. Window seals beginning to degrade in some areas Floor coating in dewatering area (upper level) is chipped out in areas and has degradation around some of the equipment base grout pads		
Structural		3	<ul> <li>Rating based on age and condition. Floor slab of dewatering area leaks into maintenance shop below.</li> <li>Maintenance shop: roof slab has several cracks with signs of past water leakage (including efflorescence and rust staining due to rebar corrosion. Recommend rout and seal cracks after removal of floor coating in dewatering area. (See Photo 2)</li> </ul>		
Power Distribut	tion	2	A moderate lev	el of dust found in	n some of the MCC cubicles.

There was noticeable improvement in upper level floor leaking from floor coating and screw press installation, but it has not completely solved the problem. Floor washing in the upper level will result in water leaking into the lower level maintenance shop.

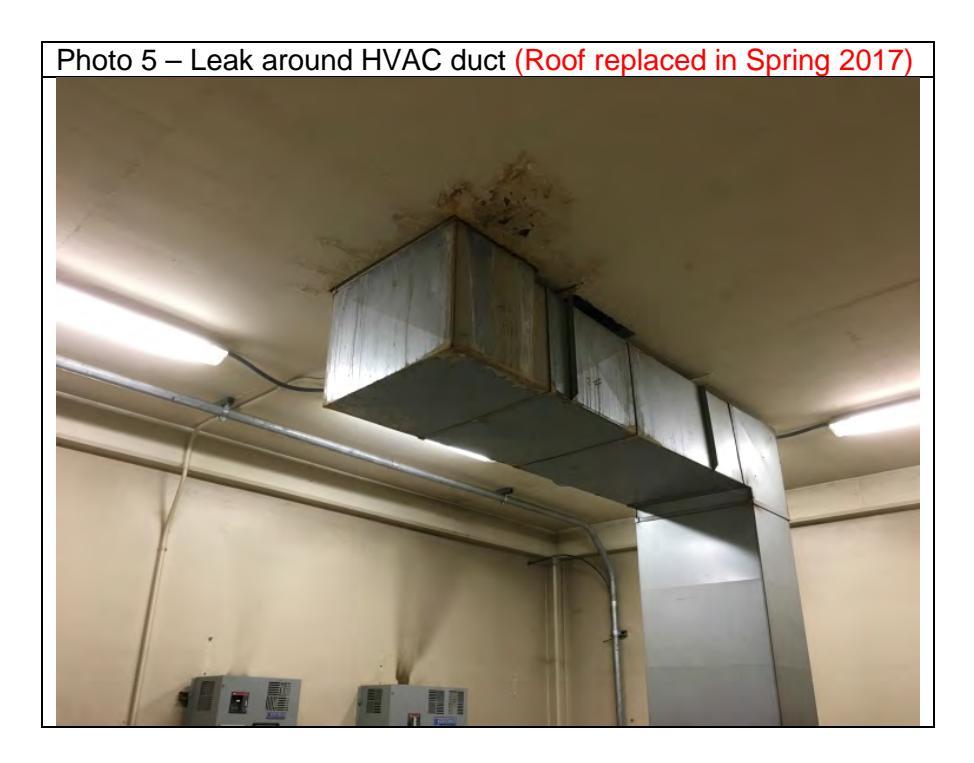
Photo 6 – Collection of water from roof leak (Roof replaced in Spring 2017)

Roof was replaced in Spring 2017.

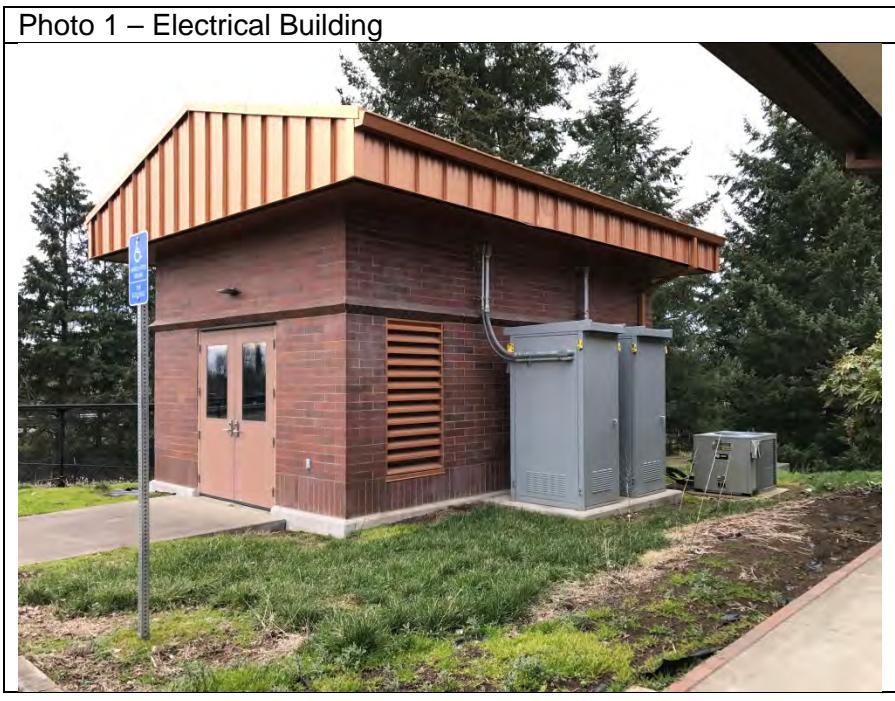
SYSTEM ASS	ETS	CR	COMMENTS			
Civil and Site		2	Splash blocks at downspouts should be re-configured as they are not completely functional and allow for water to erode the surrounding area. (See Photo 2)			
Architectural	rchitectural 1 No major issues identified					
Structural	Ictural 1 No major issues identified					
Power Distribution 2 no comments						
ElectricalA significant amount of dirt and debris observed in the room (on floor and o electrical cabinets. Should be cleaned to help keep it from being transferred electrical equipment causing premature failure. There are 3 Robicon VFD's that are still functional but appear to be beyond estimated QUI			debris observed in the room (on floor and on top of eaned to help keep it from being transferred into the emature failure. are still functional but appear to be beyond their			
Instrumentatior Analyzers	n/	N/A	N/A			
Process or Mechanical Equipment		N/A	N/A

Photo 2 – Gutter splashing causing erosion around electrical conduits
