REQUEST: A Resolution recommending City Council amend the 2018 Wastewater Master Plan incorporating the 2021 Riverfront Addendum into the Newberg Comprehensive Plan

Wastewater Master Plan

May 2018

*Technical Update May 2021
Addendum - Riverfront
Master Plan (Appendix K)*

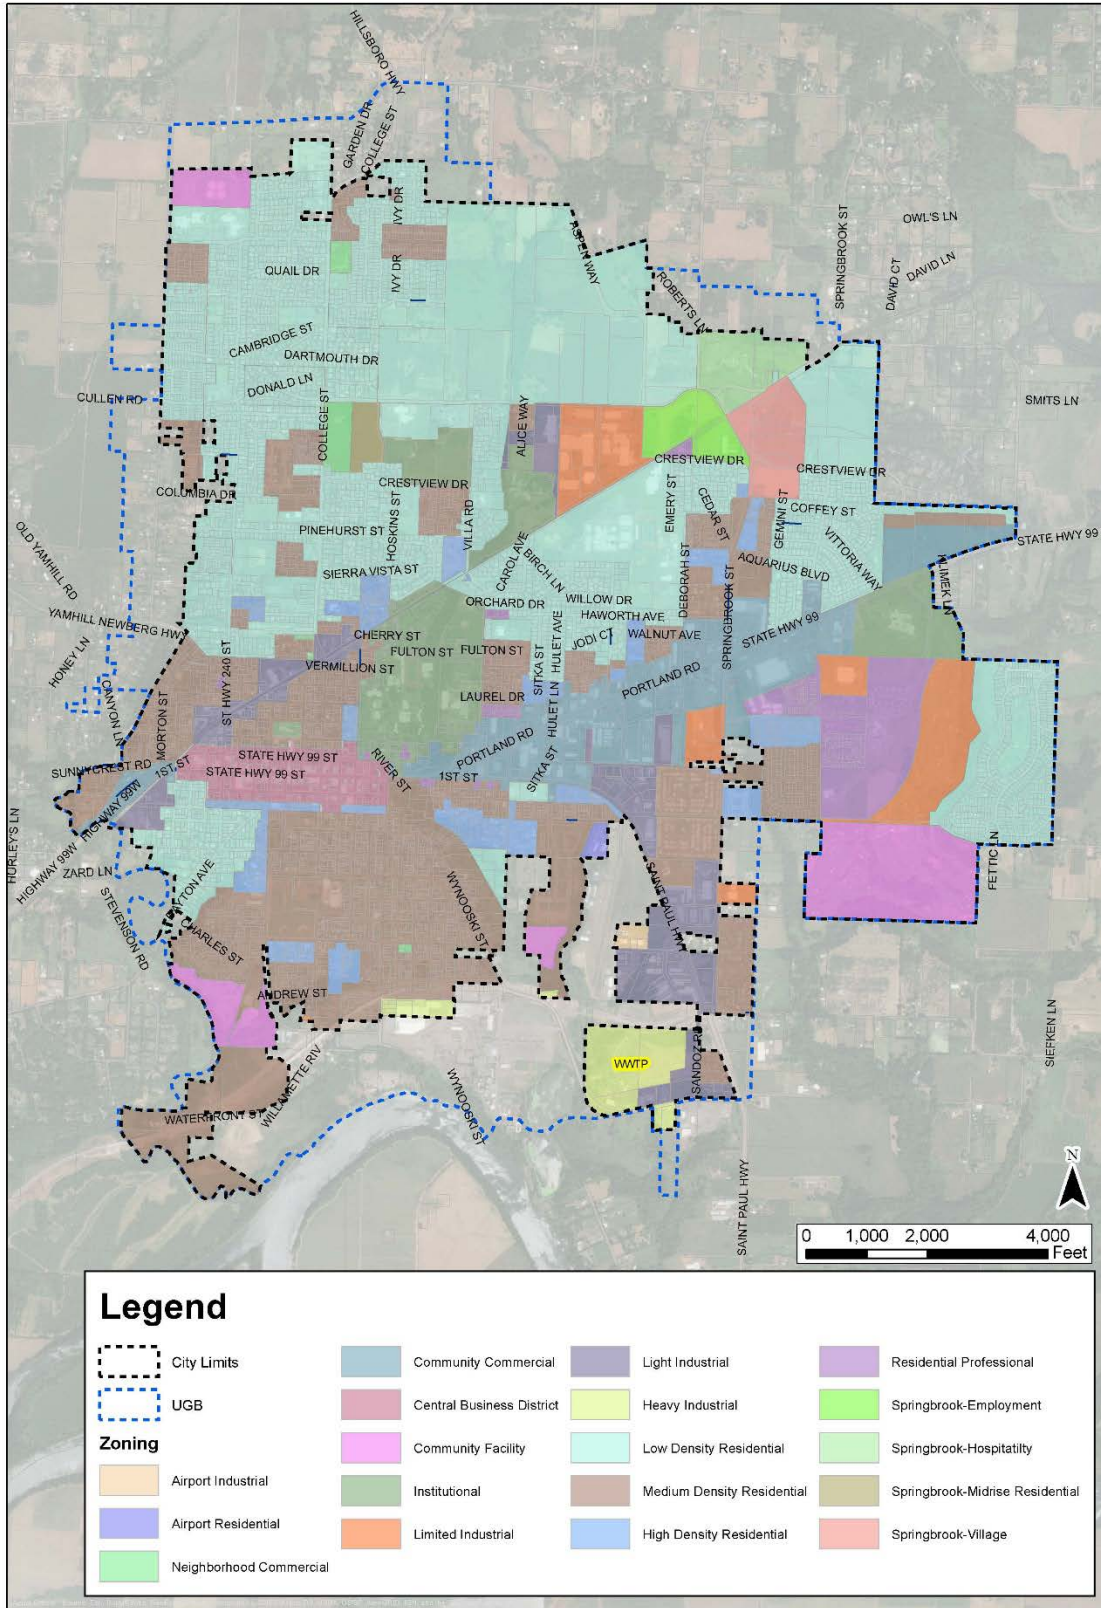
Figure 1-1: Study area and land use including UGB areas

The study area, consisting of the urban growth boundary (UGB), is shown in Figure 1-1 on the following page. The study area slopes generally to the south toward the WWTP and eventually to the Willamette River. Figures 2-4 in Appendix A present the mapped floodplains, soils, and wetlands. The wastewater system currently serves only areas within the UGB. Further expansion of the UGB was not considered in this report. It is recommended that future development and capital improvements within the UGB provide adequate conveyance for the full build-out of the upstream sewer basins within the UGB.

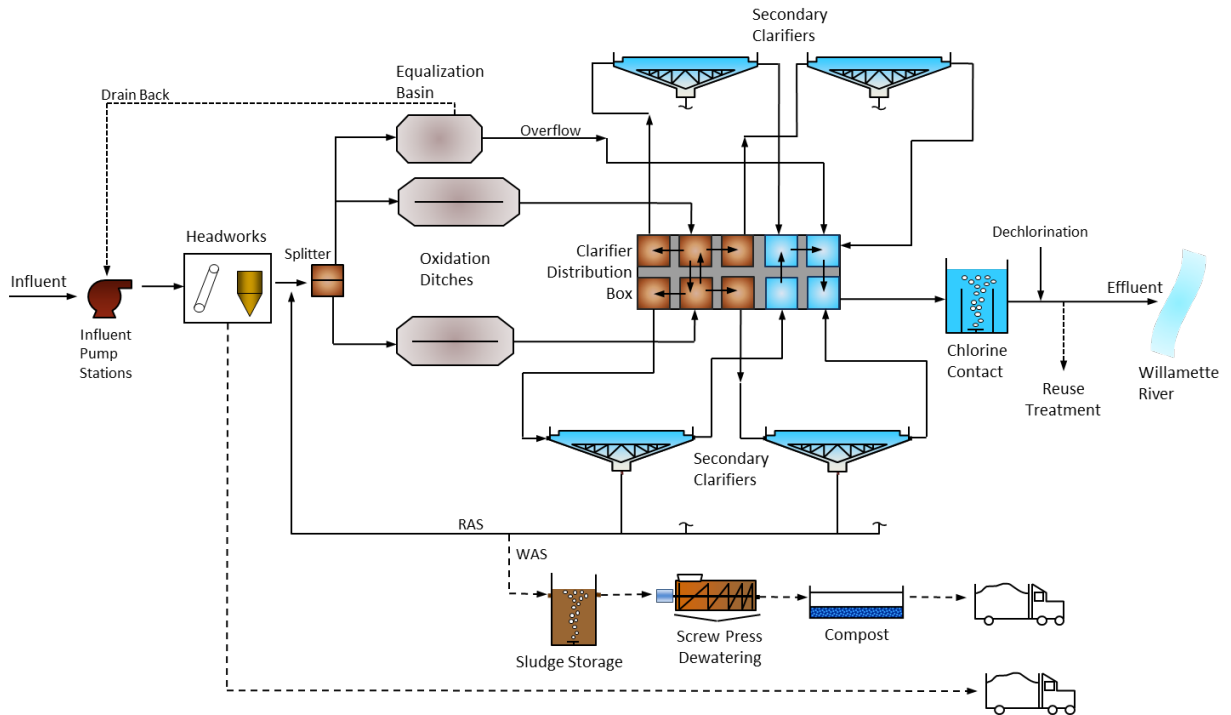
Figure 1-2: Process Flow Schematic

Influent pumping is located at the end of Hess Creek trunk line, approximately 500-ft west of the main campus. In 2015 a new IPS expansion wet well (referred to as New IPS) was constructed adjacent to the existing wet well (referred to as Existing IPS) to meet future projected influent flows. A new Headworks was built in 2015 to handle future peak flows. The Headworks handles preliminary treatment processes, including screening and grit removal. Secondary treatment system consists of two oxidation ditches and four secondary clarifiers. A new onsite sodium hypochlorite generation system was installed in 2017. Hypochlorite is injected at the CDB as secondary effluent flows to the Chlorine Contact Basins (CCB). After disinfection, the bulk of effluent is discharged to the Willamette River.

The City of Newberg (City) owns and operates the Newberg Wastewater Treatment Plant (WWTP) located at 2301 Wynooski Street. The WWTP is an oxidation-ditch type, activated sludge plant. It consists of raw influent pumping; Headworks facility with influent flow measurement, screening, and grit removal; activated sludge oxidation ditches; equalization basin; secondary clarifiers; hypochlorite disinfection; dechlorination, membrane reuse; effluent outfall; sludge storage; solids dewatering; and Class A biosolids composting. There is also a septage receiving station that accepts various loads from septage trucks as well as residential RV owners.

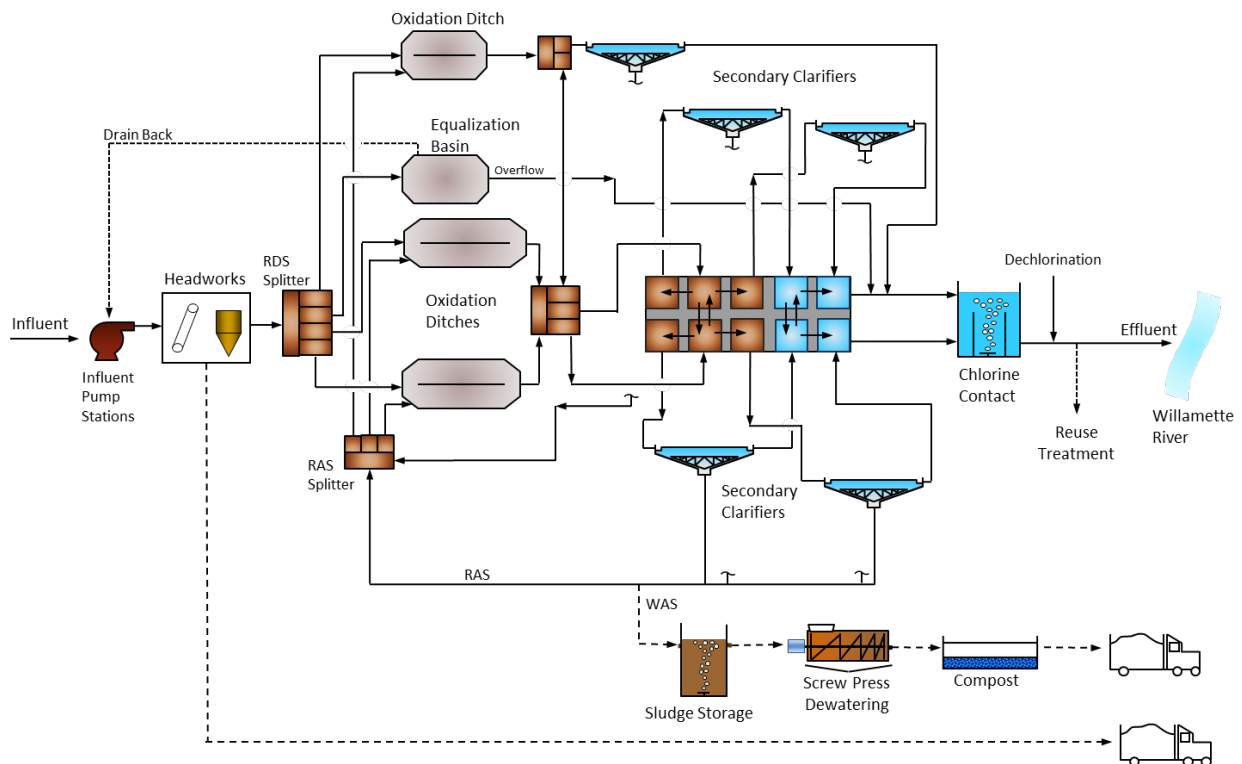
Figure 1-3: Proposed Newberg WWTP Process Schematic

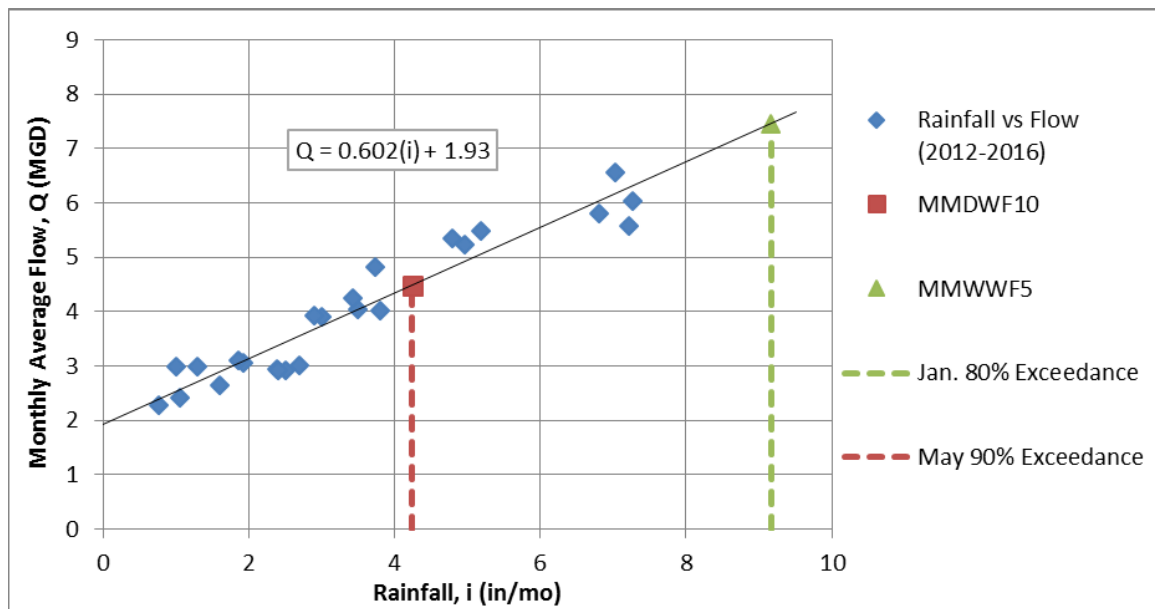
Chart 2-1: Monthly Average Flow vs Rainfall (MMDWF₁₀ and MMWWF₅)

MMWWF₅ is developing a graph of January–May average daily flows vs. monthly precipitation, then reading MMWWF₅ from the trend line at a precipitation equal to the January 80% precipitation exceedance value (9.17 inches for Newberg), also obtained from the National Oceanic and Atmospheric Administration’s Summary of Monthly Normals. Since DEQ states that January is typically the maximum monthly flow for wet-weather, selecting the January 80% precipitation exceedance most likely corresponds to the maximum monthly flow during the wet-weather period for a 5-year event. This result is illustrated in Chart 2-1 and broken down in Table 2-2.

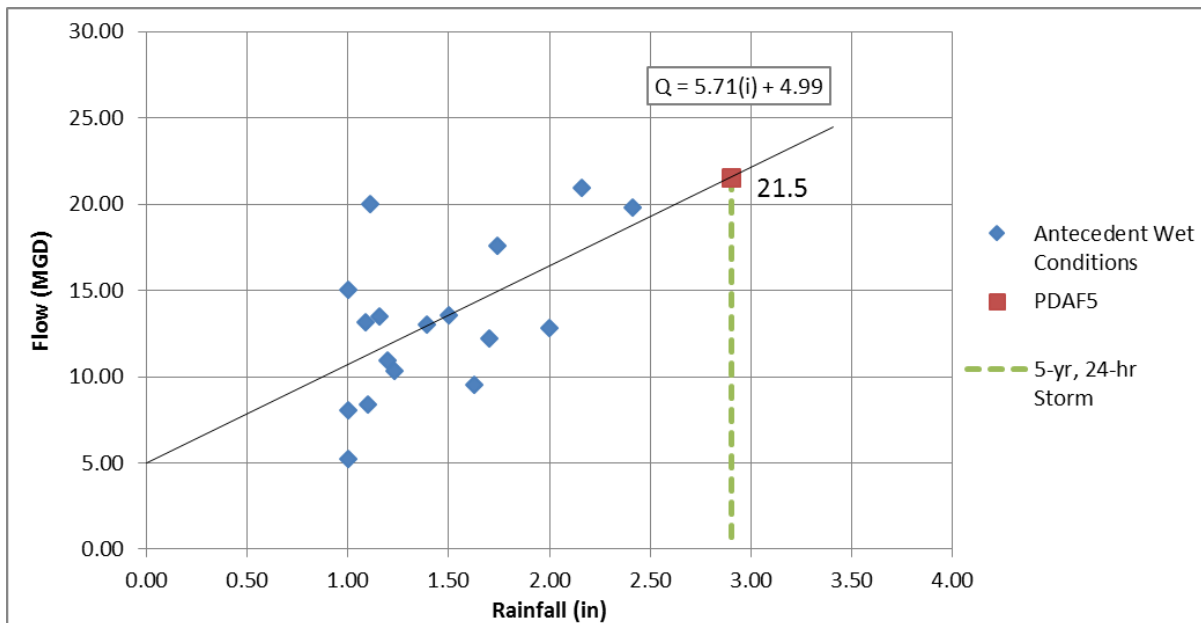
Chart 2-2: Flow vs Rainfall (PDAF₅)

In analyzing the data, peak flows for a storm event were found to occur most frequently on the same day the precipitation reading was recorded. Therefore, rainfall for a specific day was associated with flow for the day of storm occurrence. The PDAF₅ produced from the previous analysis was compared with the top five flow events for 2012–2015 (see

As outlined by DEQ, the peak daily average flow (PDAF₅) corresponds to the 5-year storm event, and is calculated as the flow resulting from a 5-year storm event during a period of likely high groundwater (January–April). DEQ’s method for determining PDAF₅ is plotting daily plant flow against daily precipitation for large storm events over several years, using data only for wet-weather seasons when groundwater is high. A trend line is fitted to the data, which the PDAF₅ is then read from at the 5-year, 24-hour storm event (2.9 inches per the NOAA isopluvial maps for Oregon). For the purpose of this analysis, a large storm event is considered more than 1-inch in 24-hours. Antecedent conditions were evaluated on a case-by-case basis, and were considered wet if any day in the preceding three had a storm event of 0.5-inches or larger. Data points were also added or excluded based on cumulative rainfall for 30 days prior to the storm event. The cutoff for 30-day cumulative rainfall (for purposes of this analysis) is 5.5-inches. Some data points that did not fit general trends were investigated using either larger or smaller cumulative rainfall windows. Chart 2-2 below shows the results of the analysis.

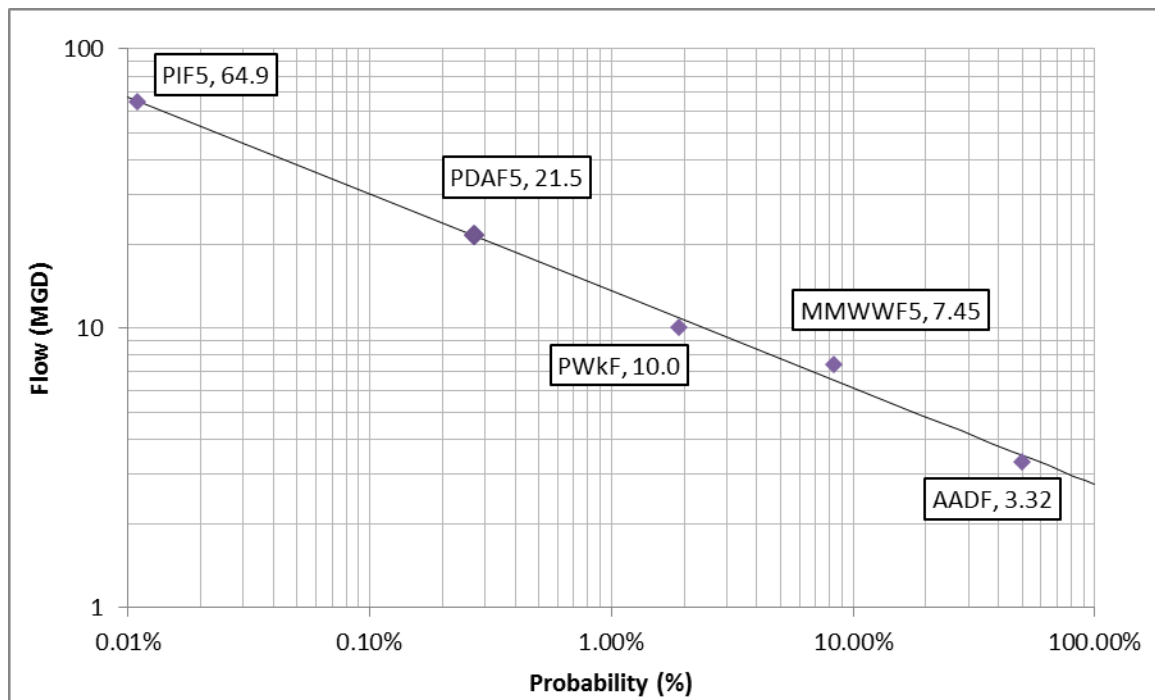
Chart 2-3: DEQ Graph #3

The peak instantaneous flow (PIF₅) represents the peak instantaneous flow (or peak hourly flow) associated with the PDAF₅. In the absence of hourly flow data, DEQ recommends obtaining the PIF₅ by extrapolation from their own chart titled Graph #3. PDAF₅, MMWWF₅, PWkF, and AADF are graphed (on specific log-probability scale) versus their probability of occurrence (Chart 2-3). A best-fit line between these known points is drawn. The PIF₅ is located where that best-fit line crosses the 0.011% probability.

The City has SCADA records, which provide continuous flow data that can be compared against the PIF₅ produced by the DEQ method. The DEQ PIF₅ represents a peaking factor of approximately 3, with respect to a PDAF₅ of 22.1 MGD (which is very large

even for peak flows so heavily influenced by I/I). When groundwater is very high after a large storm event, the effect of I/I is more or less constant, which dampens the peaking that occurs. A peaking factor of approximately 1.3 was observed in the City’s SCADA data for previous peak events (see Appendix B) and was used to estimate a more realistic PIF₅ of 28.7 MGD.

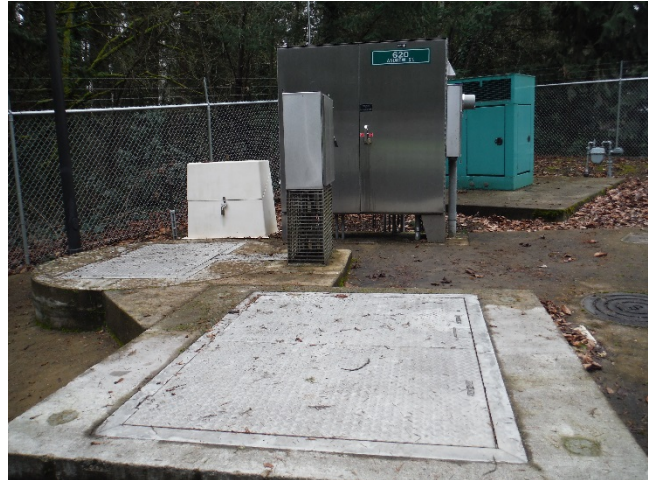
The lift station facility has a duplex submersible pump system installed in a circular wet well. One of the pumps in the wet well has a mixing valve that discharges part of its flow through a fitting to mix the wet well and help prevent settling of solids. The City has found these mixing valves to be inefficient, as they do not significantly improve lift station cleaning. The site does not have a building; electrical equipment is mounted outside in weatherproof enclosures. Wash-down water for

Andrew Lift Station

the wet well is supplied by a backflow preventer connected to the water supply. The level in the wet well is monitored with a conductive level sensor and a high-level float backup system. A Flygt Multitrode duplex pump controller is used for pump operation. The pumps are constant-speed, mounted on steel pipe rails in the wet well to allow removal of the pumps without entering the wet well.

Andrew Lift Station is located at 620 Andrew Street, with access to the site from Andrew Street. The lift station was installed in 2000, and no major upgrades have been performed since installation. The site is completely surrounded by chain-link fence with barbed-wire top strands. The electrical enclosure has a Yagi antenna for its SCADA system, as well as a low-mounted outdoor light nearby.

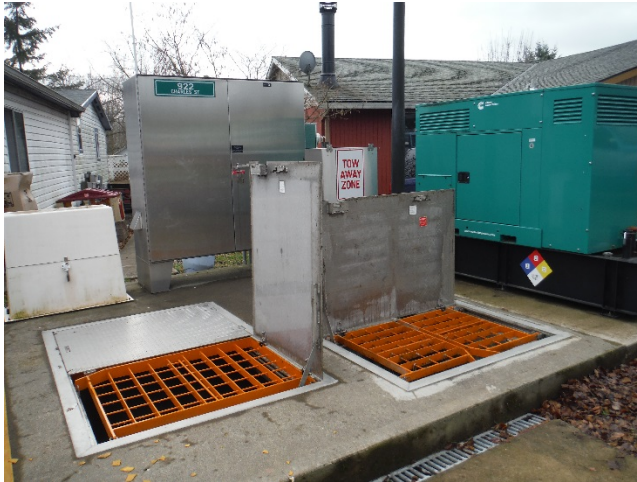
Charles Lift Station

The lift station facility has a duplex submersible pump system in a wet well, with the valve vault attached directly to the wet well wall. One pump is equipped with a mixing valve similar to the Andrew Lift Station. The City has found that these are inefficient and unnecessary at the lift stations. Electrical equipment is mounted outside in weatherproof enclosures.

The Charles Lift Station was installed in 2000 at 922 Charles Street. The lift station is located on an elevated concrete slab in a very tight space between two residential houses and uses a shared driveway with one of the houses. The driveway has removable steel bollards between it and the lift station. Operators often experience difficulty getting crane trucks onto the lift station site because of the narrow driveway and tree in the median. The site is unfenced. Fencing should be installed to protect the public and prevent security problems; however, it doesn't appear adding a fence is practical due to the limited space available. There is a low-mounted outdoor light at the site.

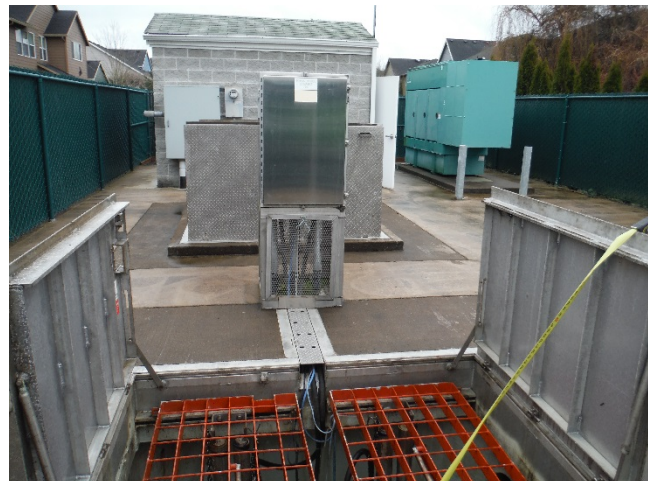
The level in the wet well is monitored with a transducer level sensor, a backup conductive level sensor, and a high-level float backup system. At the time of the site evaluation, the transducer level sensor was not operating. A new transducer had been ordered but not yet arrived. A Flygt MultiSmart duplex pump controller is used to control the pump operation. The pumps run through starters in the motor control center. Pumps are mounted on steel pipe rails in the wet well to allow for their

Chehalem Lift Station

removal without entering the wet well. The interior of the wet well and piping is lined with protective coating.

Chehalem Lift Station is located at 2900 NE Chehalem Drive and was installed in 2004. The site has a small building, wet well, and generator. The site is fenced with access to the site through a gate. Electrical equipment is located inside the building. The exterior of the building contains the electric meter and enclosure for the meter transformers. The site is covered with a concrete slab, including the entrance access. The wet well cover is raised above the surrounding concrete with a double access floor door. There are two floor door covers; the one close to the building is the valve vault, and the second is the wet well. Flow into the lift station is from Chehalem Drive into the wet well. The discharge is out the opposite side into the valve vault. Both wet well and valve vault have steel safety grates over their openings when the covers are open. The disconnect switches for the wet well pumps are located next to the wet well in a weatherproof enclosure. Wash-down water for the wet well is supplied by a backflow preventer connected to the water supply. The water supply backflow preventer is located in an insulated housing with an electric heater in the enclosure. The onsite storm drain is piped directly into the wet well.

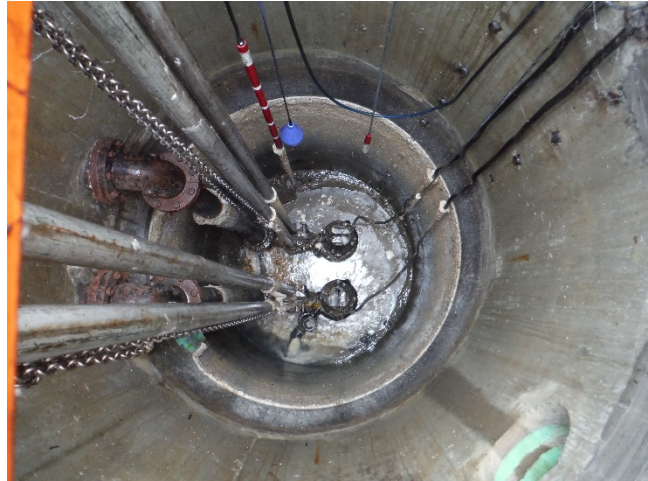
Check and isolation valves for the pumps are located aboveground in an insulated enclosure. The valve enclosure also has an old air release valve that has been capped. There is no flow meter or pressure gauge installed in the discharge pipe. Wash-down water for the wet well is supplied by a backflow preventer connected to the water supply and located a few inches off the ground in an insulated housing with a piece of heat tape in the enclosure to prevent freezing.

Creekside Lift Station

The level in the wet well is monitored with a conductive level sensor and a high-level float backup system. A Flygt Multitrode duplex pump controller is used for pump operation. Each pump runs with inverters to control its speed, while protecting it from feedback from the controls. Pumps are mounted on steel pipe rails in the wet well to allow for their removal without entering the wet well. One of the pumps in the wet well has a mixing valve, which the City has found to be inefficient and unnecessary in the lift stations. The electrical panel still has a motor starter for an air compressor, which the site had at one time, but has since been removed.

Creekside Lift Station is located at 1379 Creekside Court between two residential houses and was installed in 1998. There have been no major upgrades to this lift station, though the impellers on the pumps were replaced with N-impellers in 2010. This site has neither a building nor a generator and is unfenced. Electrical equipment is located in weatherproof enclosures. The site, including the entrance access, is covered with a concrete slab. The wet well cover is raised above the surrounding concrete with a double access floor door. There is one low-mounted area light. The SCADA omni antenna is mounted on the electrical enclosure.

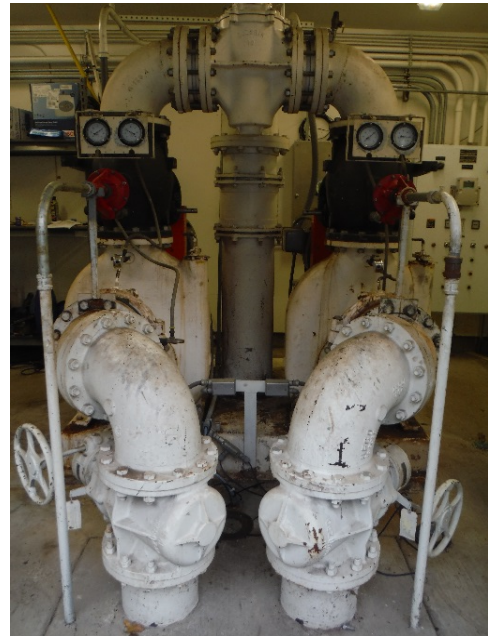
Dayton Lift Station was installed in 1993 and is located at 830 Dayton Avenue. This lift station is an old, self-priming pump configuration and is planned for replacement in the near future. It currently has a building over a wet well, with the piping and pumps in the building. The building, which is metal with a coiling door for access to the pumps and piping, houses the electrical equipment. The suction pipes for the pumps pass through the floor and into the wet well. Near the building is a natural gas standby generator, which was replaced in 2010; the PLC was upgraded from Multitrode to MultiSmart at this same time. The site is fenced with access through a gate. A second gate leads to the access road along the force main alignment.

Dayton Lift Station

The level in the wet well is monitored with an ultrasonic level sensor and a high-level float backup system. A Flygt MultiSmart duplex pump controller is used for pump operation. There are pressure gauges on the discharge pipes.

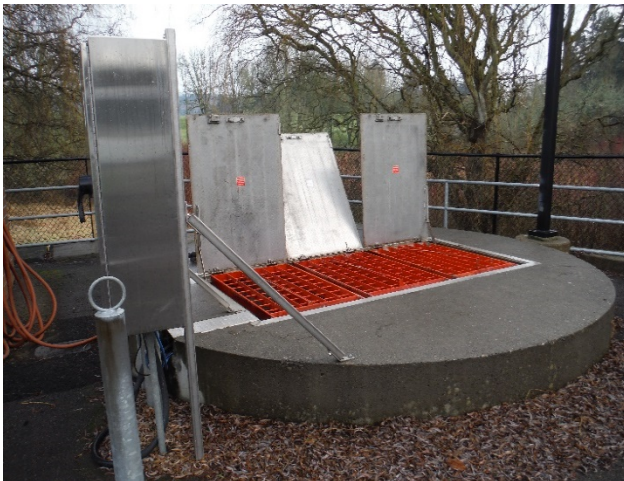
The lift station was built as a duplex system with necessary space, piping, electrical, and other provisions to expand to a triplex system. The third pump was installed in 2010, and the valving was adjusted to utilize the larger force main that had been installed in 2001 with the station. The smaller force main was 6-inch, the larger is 12-inch. The

Fernwood Lift Station

level in the wet well is monitored with transducer level sensor and a high-level float backup system. A Flygt MultiSmart pump controller is used for pump operation. Pumps are mounted on steel pipe rails in the wet well to allow for their removal without entering the wet well. The interior of the wet well and piping is lined with protective coating.

Fernwood Lift Station is located at 4651 Fernwood Road and was installed in 2001. The fenced site has a small brick building, wet well, and generator. Electrical equipment is located inside the building, which also contains old equipment that is no longer used. An electric meter and enclosure for the meter transformers is located on the building’s exterior. The site, including the entrance access, is covered with a concrete slab. The wet well cover is raised above the surrounding concrete with a triple access floor door. The wet well has steel safety grating over the opening when its access doors are open. The valve vault has two access doors but no steel safety grating.

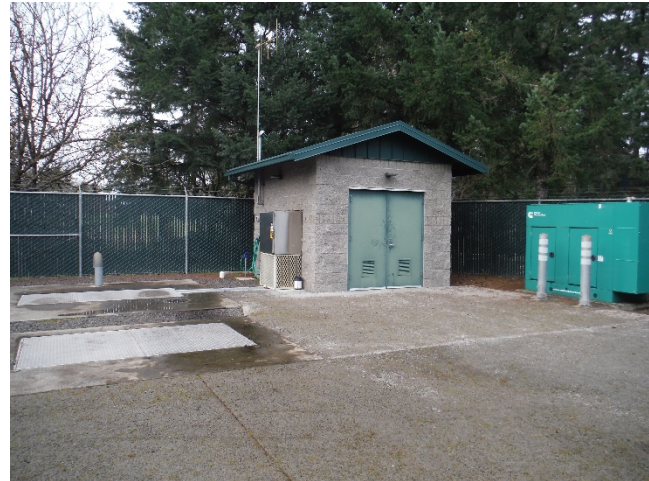
Highway 240 Lift Station is located at 319 W. Illinois Street and was installed in 2009. The lift station was intended to remove up to 600 gpm from the Dayton Lift Station basin to help alleviate overflow problems at Dayton (Master Plan Update, 2007). The fenced site has a small masonry building with prefinished metal trim. A valve vault, wet well, and generator are also located at the site. Electrical equipment is located inside the building, while an electric meter and enclosure for the meter transformers are on the building's exterior. Connection points for the pumps are located in an enclosure on the side of the building. The building has a Yagi antenna for the SCADA system. The site, including the entrance access, is covered with a concrete slab. The wet well cover is raised above the surrounding concrete with a triple access floor door. The wet well has steel safety grating over the opening when its access doors are open. The valve vault has two access doors, but no steel safety grating. The site has a flow meter in a single access door vault, which also does not have steel safety grating. The flow meter transmitter is located inside the building. There is a force main valve vault with double access doors, but not steel safety grating. The water supply has a backflow preventer inside the building with a surge tank installed.

Highway 240 Lift Station

The station is a triplex system. The level in the wet well is monitored with a transducer level sensor and a high-level float backup system. A Flygt MultiSmart pump controller is used for pump operation. Pumps are mounted on steel pipe rails in the wet well to allow for their removal without entering the wet well. The interior of the wet well is lined with protective coating, and piping is corrosion-resistant metal.

The influent sewer discharges behind the three-pump system in the wet well. This configuration causes frequent plugging of the outer pump by sucking up debris; this can be corrected by redirecting the influent sewage flow, or by installing a grinder on the influent. Typically, the best approach is to redirect the flow away from the pump suction.

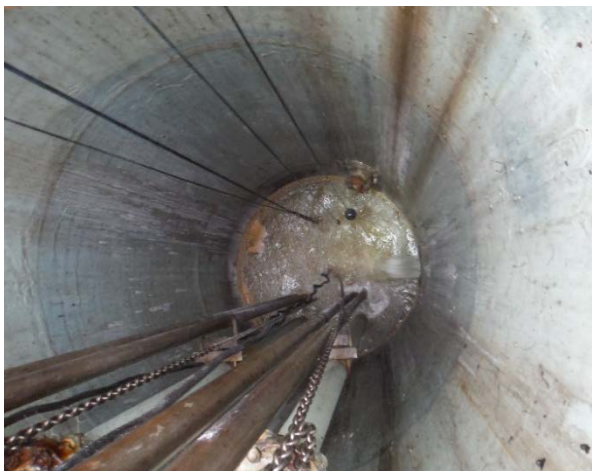
Sheridan Lift Station

Sheridan Lift Station was installed in 2001 and is located at 610 W. Sheridan Street, with access to the site directly off Sheridan Street. The wet well is located near the street and has steel bollards to protect vehicles from running into the wet well top. The drainage water from the site slab and street flows to a drain trench near the street. The valve vault is located near the wet well. Flow into the wet well goes through a manhole, with multiple inflows combining before they flow to the wet well. The electrical enclosure is a weatherproof steel enclosure and has an

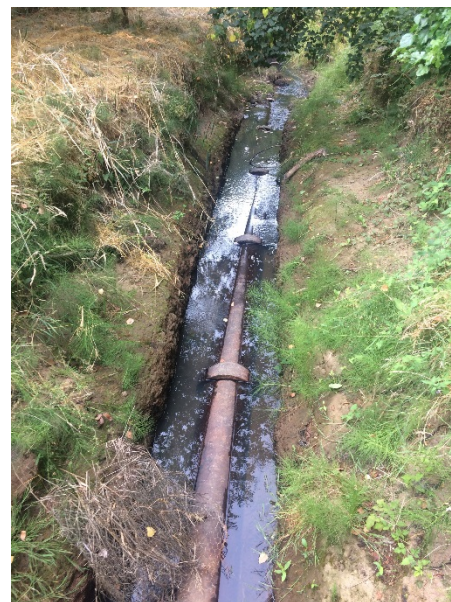
There is a sanitary sewer pipe exposed in Hess Creek near Hess Creek Court. The facility ID is wwgm1046. GIS data states the pipe is a 12-inch, concrete pipe, installed in 1973, and is approximately 265 feet from MH to MH. The exposed pipe was first documented on August 8th, 2017 by City maintenance department and Keller Associates staff as they walked the Hess Creek trunk line alignment to determine where the best possible access points for smoke testing would be. See photo of the exposed pipe. During smoke testing the week of August 21st, the smoker was placed on the upstream MH. No smoke was visible from the exposed pipe.

Exposed Hess Creek Pipeline

Night-time monitoring was performed from 1 – 5 am on the morning of September 6th. The manhole downstream (DS) of the exposed section is H105004. The manhole upstream (US) of the exposed pipe is H105005. Within the measurement tolerances of night-time monitoring, the approximate depth and velocity of flow was approximately equal in the US and DS manhole's. There was not significantly more I/I flowing through the DS manhole compared to the US manhole. There is some build-up of solids in MH H105005 (US of the exposed pipe).

Overall, the monitoring and testing indicates that the exposed pipe is not an excessive source of I/I to the Hess Creek trunk line. It is recommended that the pipe be monitored, but no immediate rehabilitation or replacement is required.

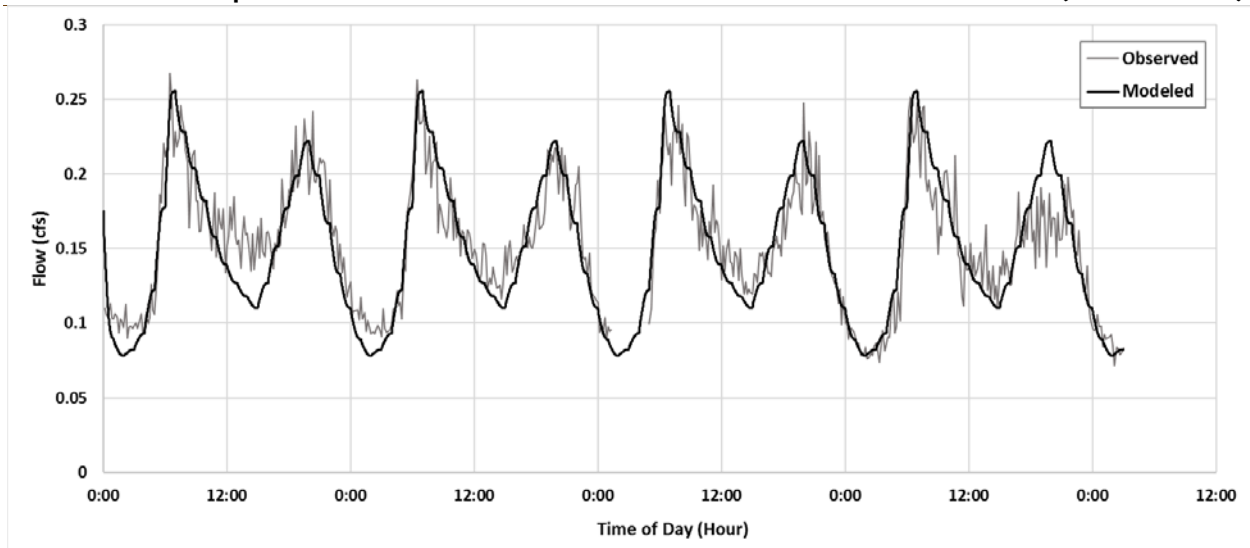
The model was calibrated at the flow monitoring locations within the collection system and total modeled influent flow at the Wastewater Treatment Plant (WWTP) was compared to the targeted design average daily flow. Furthermore, WWTP inflow data, downstream of the influent lift station, was available for calibration comparison. Appendix D contains a summary of the data and analysis used for modeling purposes. An example of DWF calibration results are shown below in Chart 4-1.

Chart 4-1: Sample DWF Calibration Site 16 – Modeled vs. Observed Flows (WWGM1810)

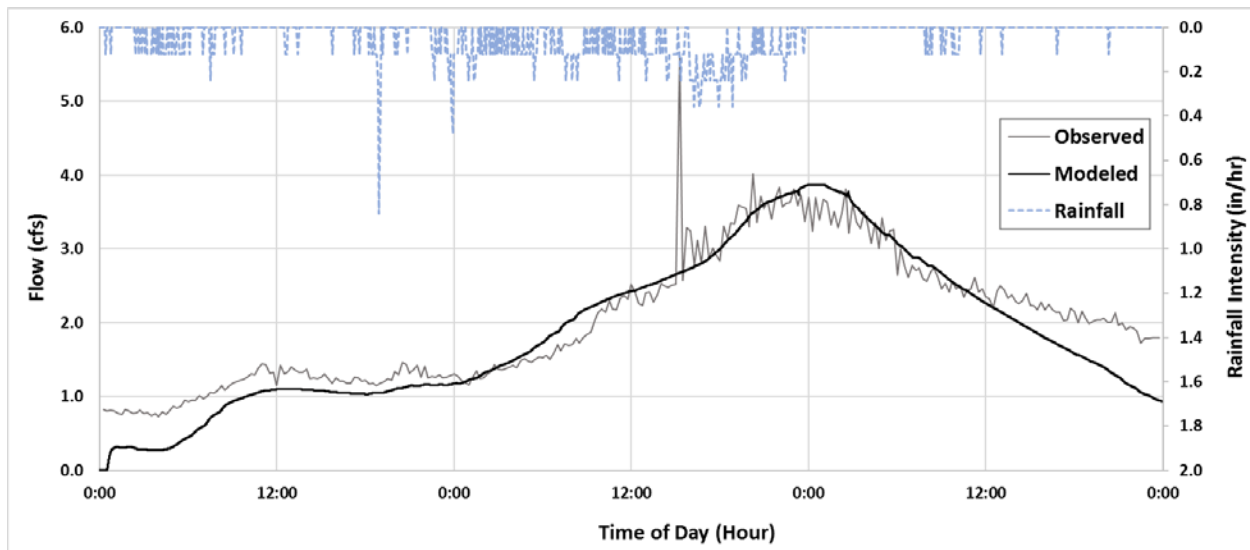
The RTK method was used for rainfall-derived infiltration and inflow (RDII) prediction. Rainfall data for a 72-hour period with the highest cumulative (3.34 in) and highest intensity (0.84 in/hr) rainfall during the period of flow monitoring was utilized to calibrate wet weather flows. The storm event rainfall was entered into InfoSWMM. RTK parameters were then adjusted to calibrate the model with flow monitoring data. Again, total modeled influent flows at the WWTP were compared to the targeted design average daily flow and influent flow data in addition to calibrating the model at various locations within the collection system and at the WWTP influent lift station. Example calibration is shown in Chart 4-2.

Chart 4-2: Sample WWF Calibration Site 12 – Modeled vs. Observed Flows (WWGM1794)

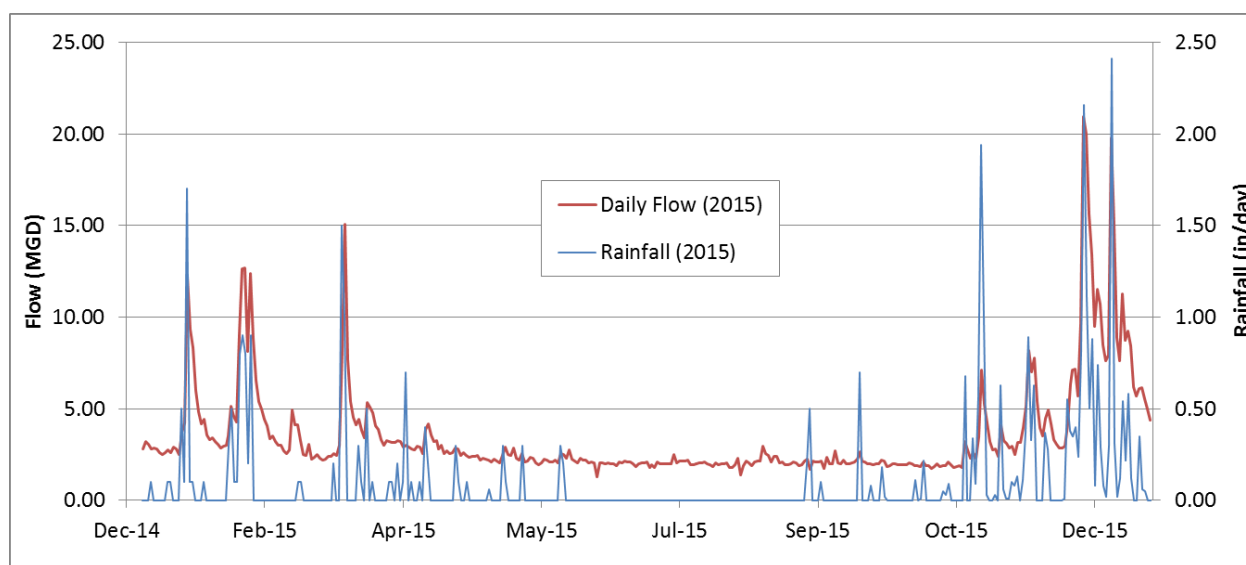
Visual evidence of I/I influence in the system can be seen in Chart 7-1, which shows the 2015 daily flows and precipitation recordings at the treatment plant site. The rapid response between precipitation events and increased flows suggests that a significant component of peak flow is from storm water inflow. The sustained increase in flow over several days following a large storm event suggests that groundwater is also infiltrating into the City’s wastewater collection system. Flows for 2015 are representative of previous years.

Chart 7-1: 2015 Daily Flow and Precipitation

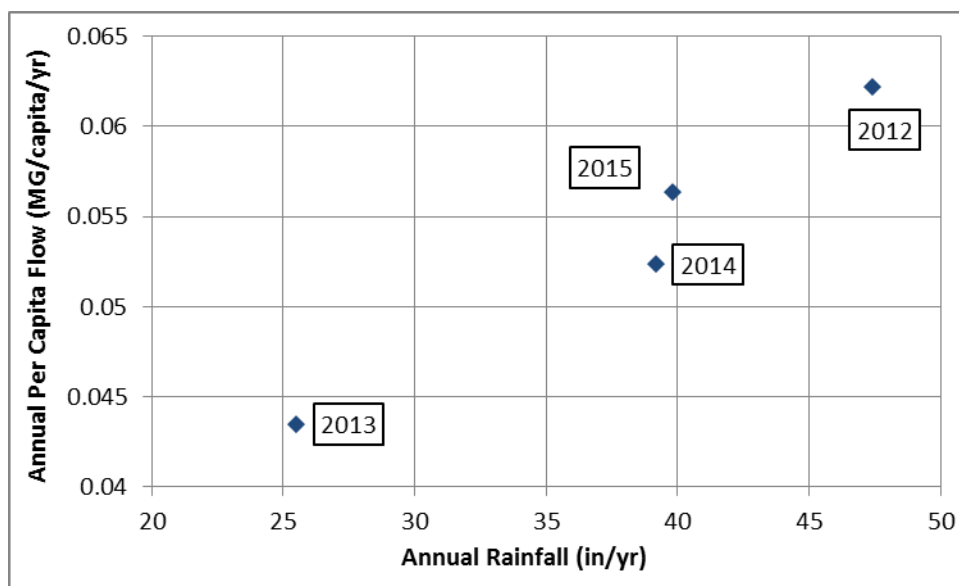
Evidence of I/I influence can also be seen by comparing annual rainfall against annual per capita flow. Chart 7-2 below shows a positive linear relationship between rainfall and normalized flow over the range of rainfall observed for 2012–2015.

Chart 7-2: Annual Rainfall vs. Per Capita Flow

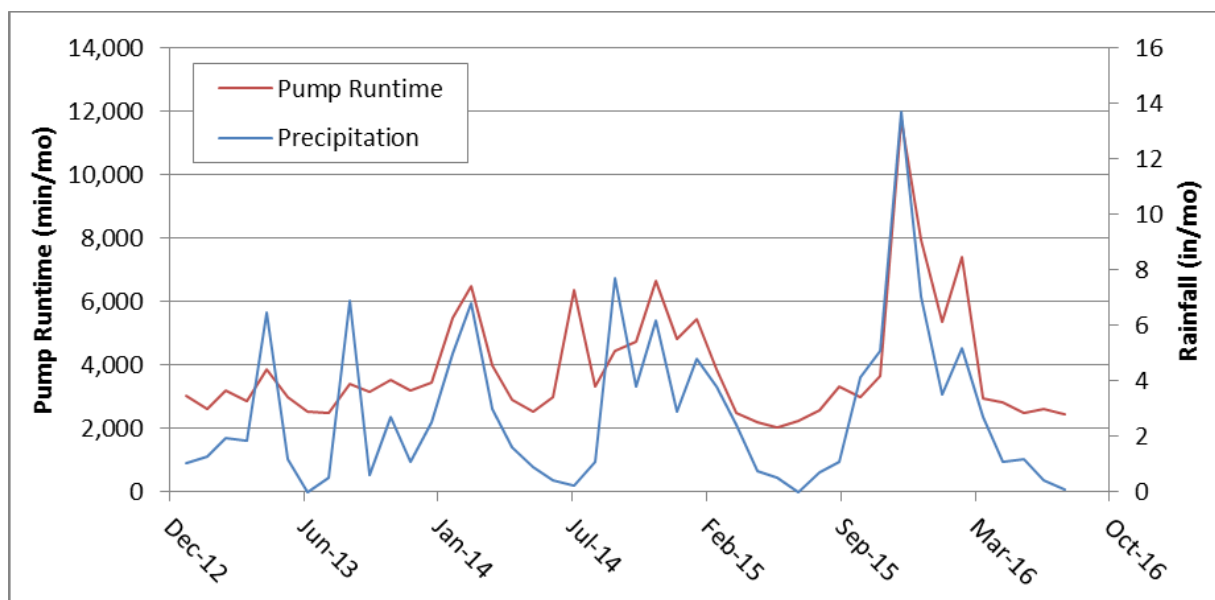
The daily run times for all eight public lift stations were analyzed. Chart 7-3 shows the results for the Andrew Lift Station (see Appendix G for all lift station run time graphs). When daily run times are compared with rainfall events, a close correlation between high rainfall months and monthly increase in run times is evident. This correlation indicates that I/I is the likely cause of increase in flow.

Chart 7-3: Andrew Lift Station Runtimes & Precipitation vs. Time

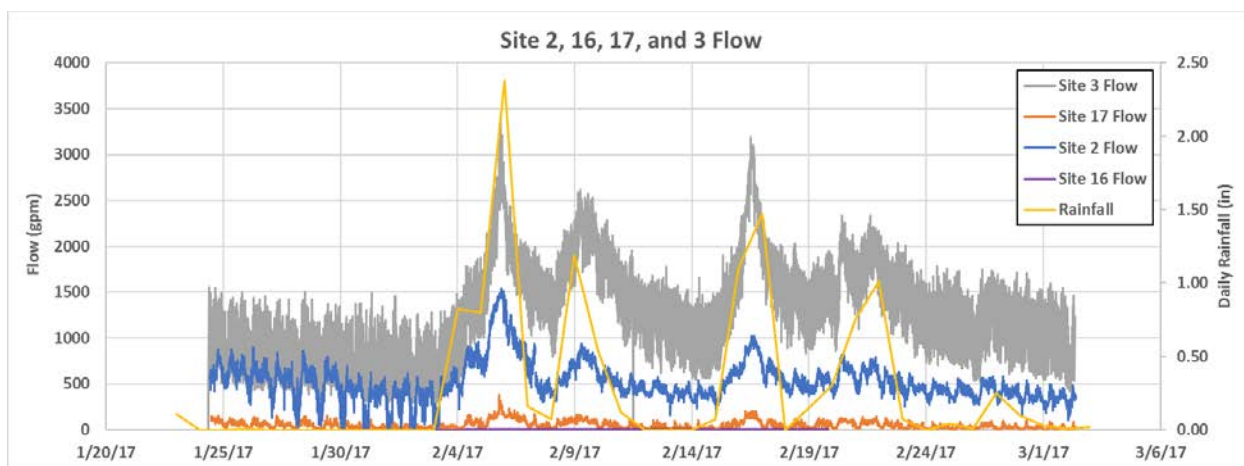
Chart 7-4 illustrates the flow and precipitation data for Basins 2, 3, 16, and 17. Site 16 flow is significantly lower than flow at the other sites and thus appears to be near zero on the chart because of the axis scale. The pattern of flow in Basin 16 shows similar responses to rainfall as the other three basins. Appendix G shows flow and precipitation data over time for all of the flow monitoring sites. Flow monitoring basins 2, 12, 13, 14, 16, and 17 are sub-basins of another basin, as indicated by Chart 7-5.

Chart 7-4: Flow Monitoring Basins with Sub-basins

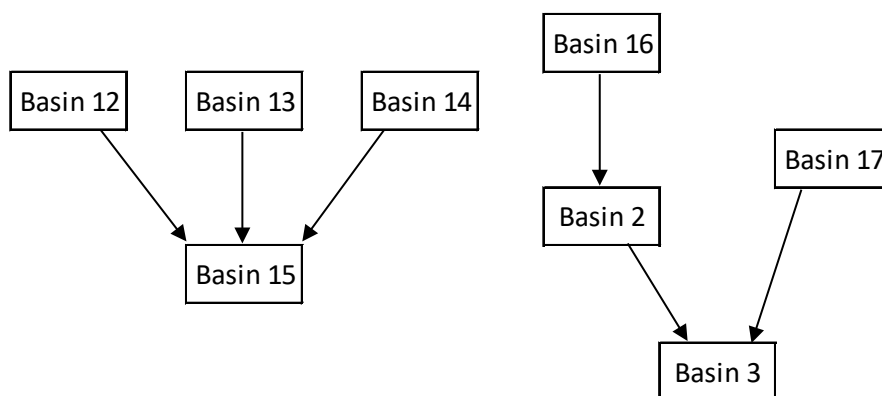
Chart 7-5: Flow Monitoring Basins with Sub-basins

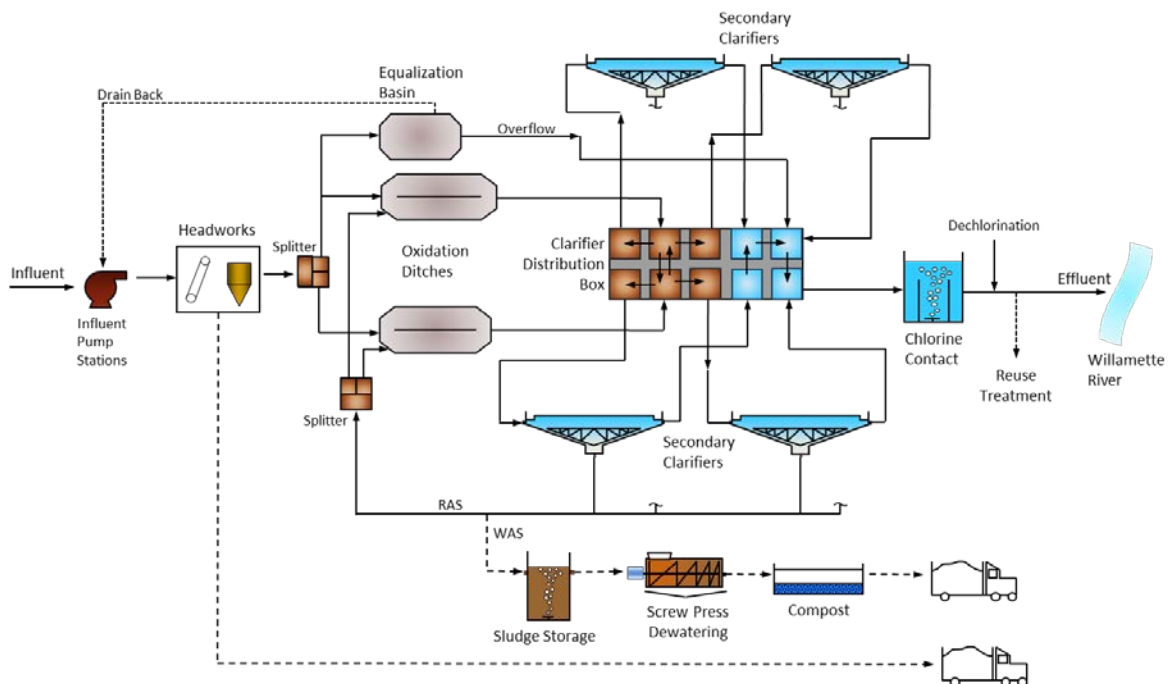
The Newberg WWTP consists of raw influent pumping; Headworks facility with influent flow measurement, screening, and grit removal; activated sludge oxidation ditches; equalization basin; secondary clarifiers; hypochlorite disinfection; dechlorination; membrane reuse; effluent outfall; sludge storage; solids dewatering; and biosolids composting. A simplified schematic of the treatment process is provided in Figure 9-2. Class A reuse water is sold to the Chehalem Glenn Golf Course for irrigation and Class A composted biosolids are sold to the community. The plant also accepts septage from local septic pumpers and RVs on a daily basis. For NPDES permit compliance, composite influent samples are taken at the Headworks facility downstream of screening, and effluent sampling is downstream of dechlorination.

Figure 9-2: Process Flow Schematic

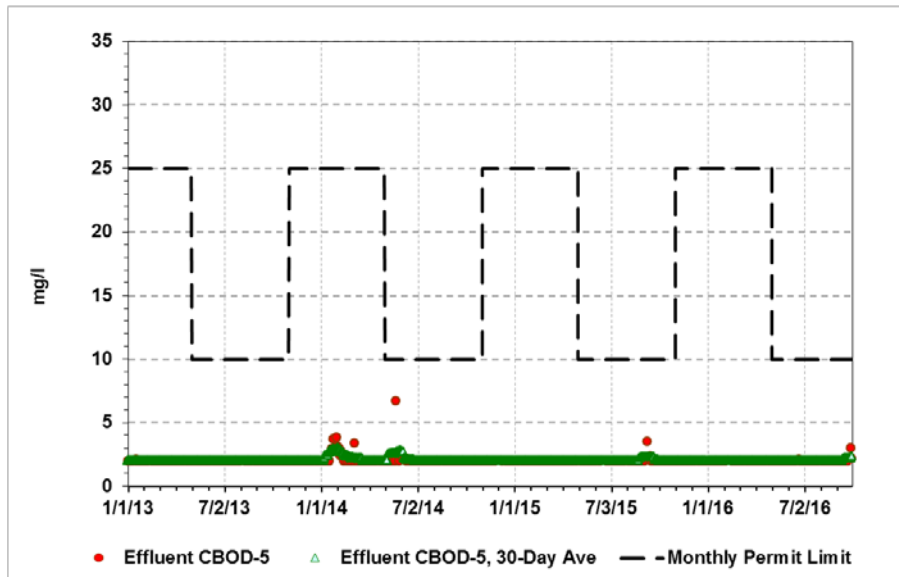
Historical trends of effluent cBOD and TSS concentrations are shown in Figure 9-3 and Figure 9-4, respectively. The figures show daily average and moving 30-day average concentrations for the past three years in relation to the current monthly average effluent permit requirements. The National Pollution Discharge Elimination System (NPDES) permit limits include average monthly and weekly concentrations, average monthly and weekly mass loadings, and a daily maximum mass loading. However, the daily mass loading is suspended when the daily influent flow exceeds 8-mgd. More details on the NPDES permit limits are discussed in Section 2. The plant has historically operated consistently with little risk of exceeding permit limits.

Figure 9-3: Historical Effluent cBOD

Note: Laboratory detection limit is 2.0 mg/L cBOD.

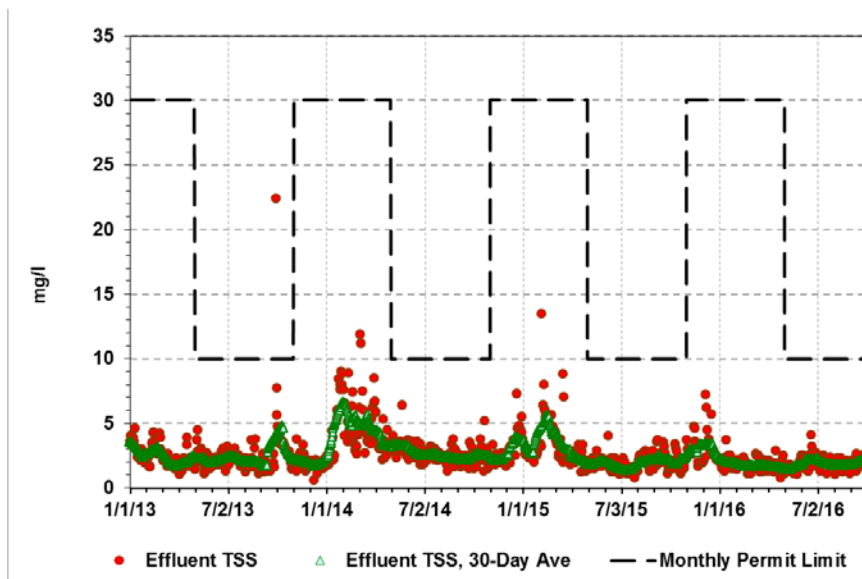
In general, the effluent TSS trend line (Figure 9-4) matches the shape of the influent flow. During peak flow events the hydraulic loading rate of the secondary clarifiers increases, effectively reducing settling time and TSS removal. This can lead to spikes in the effluent TSS. The daily effluent TSS result shown in Figure 9-4 in excess of the monthly permit limit occurred when the daily influent flow exceeded 8-mgd, suspending the daily maximum mass loading requirement. There is little concern of exceeding the

permit limit given the short duration of the events and their occurrence during the winter, rainy season, as discussed above.

Figure 9-4: Historical Effluent TSS

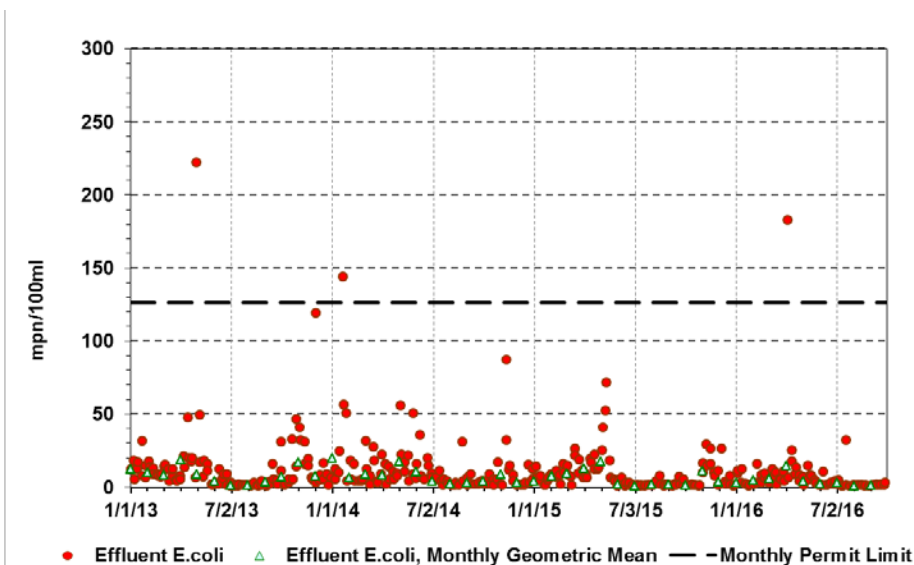
Figure 9-5: Historical Effluent E. coli

Note: No single sample shall exceed 406 organisms per 100-mL.
mpn = most probable number

Additional year-round permit requirements include effluent E. coli bacteria (Figure 9-5), pH (Figure 9-6), cBOD and TSS removal efficiency (Figure 9-7), and total residual chlorine (Figure 9-8). The figures show historical compliance with the year-round limitations.

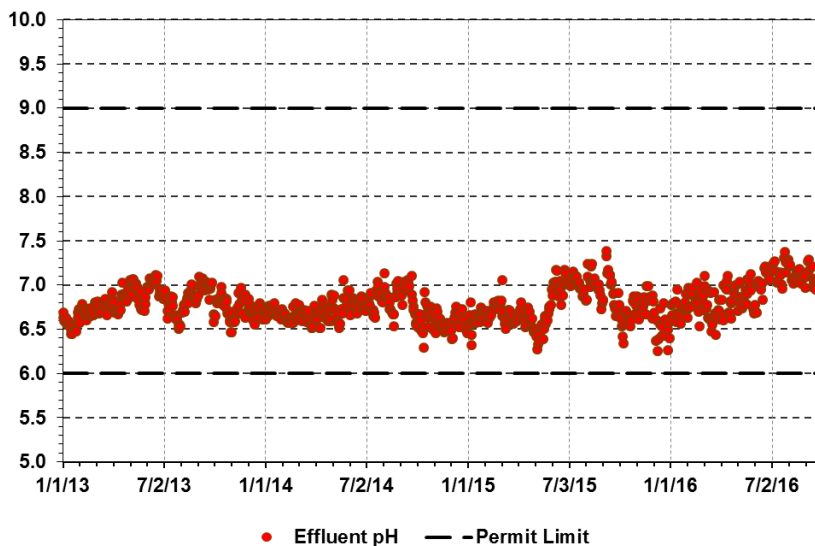
Figure 9-6: Historical Effluent pH
