REQUEST: A Resolution recommending City Council amend the 2018 Wastewater Master Plan incorporating the 2021 Riverfront Addendum into the Newberg Comprehensive Plan

Wastewater Master Plan

May 2018

*Technical Update May 2021
Addendum - Riverfront
Master Plan (Appendix K)*

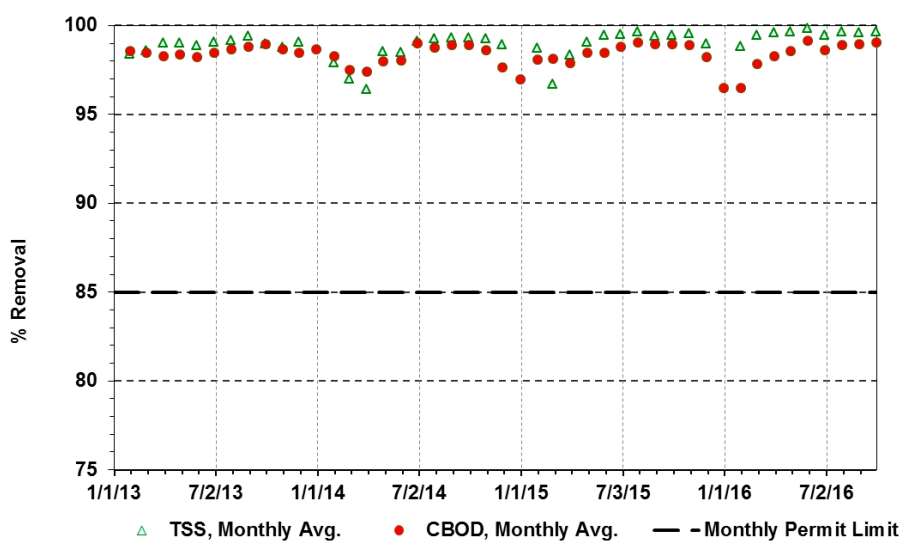
Figure 9-7: Historical Monthly Average cBOD and TSS Removal Efficiency

Additional year-round permit requirements include effluent E. coli bacteria (Figure 9-5), pH (Figure 9-6), cBOD and TSS removal efficiency (Figure 9-7), and total residual chlorine (Figure 9-8). The figures show historical compliance with the year-round limitations.

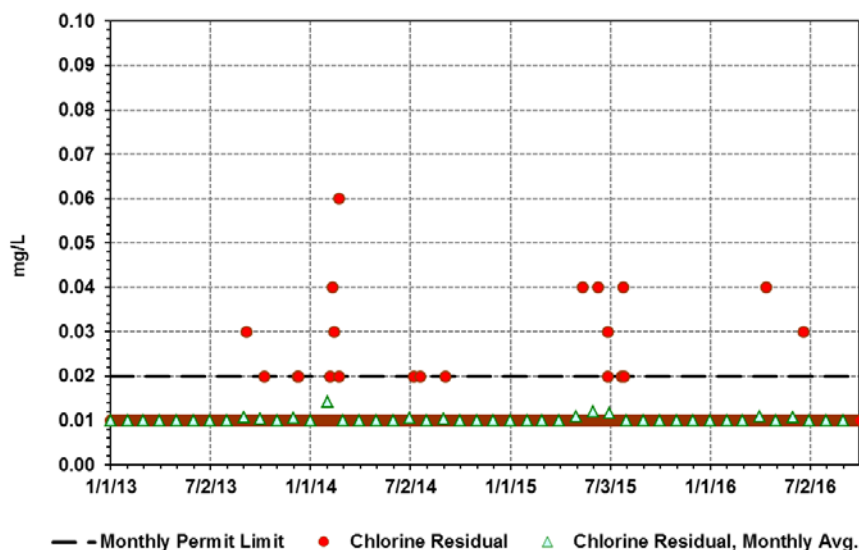
Figure 9-8: Historical Effluent Total Residual Chlorine

Note: Per the NPDES permit, daily maximum concentrations below 0.10-mg/L are considered in compliance with the limitation.

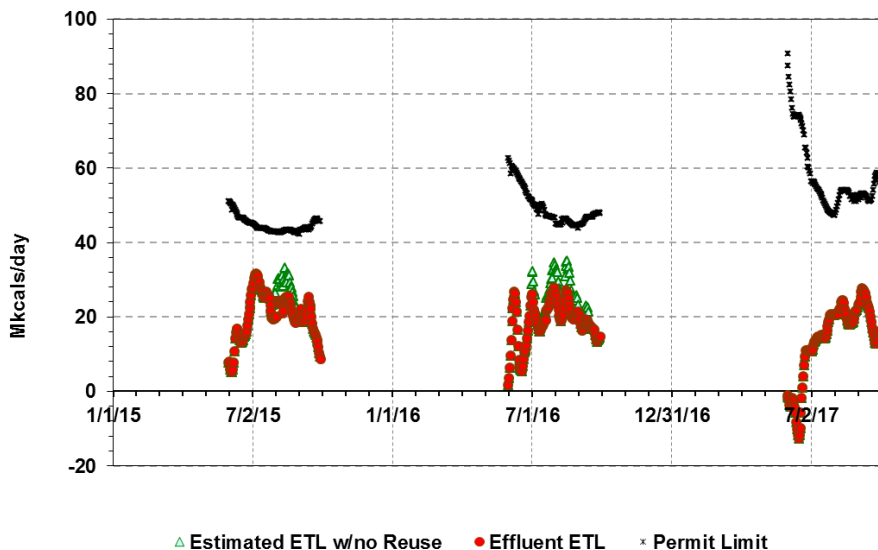
Figure 9-9 presents the excess thermal load (ETL) conditions. The 2009 NPDES permit modification added seasonal ETL limitations, June 1 through September 30, to protect the salmon and steelhead migration corridor in the Willamette River. Equations listed in the permit modification are used to determine the daily ETL limit, based on ambient river temperature, and the discharged effluent ETL, based on effluent flow and temperature. The plant has been in compliance since the addition of the ETL requirement.

The impact of the reuse system on ETL was also reviewed. During summer months the plant produces reuse water that is sold to the nearby golf course. This reduces discharge flow and effluent ETL to the Willamette River. Figure 9-9 includes a theoretical effluent ETL assuming no reuse water was produced and all effluent was discharged to the Willamette River. The result does show an increase in discharge ETL; however the impact does not trigger concern for compliance. In the future if ETL limits become more stringent the reuse system could be used to mitigate compliance concerns.

Figure 9-9: Historical Effluent ETL

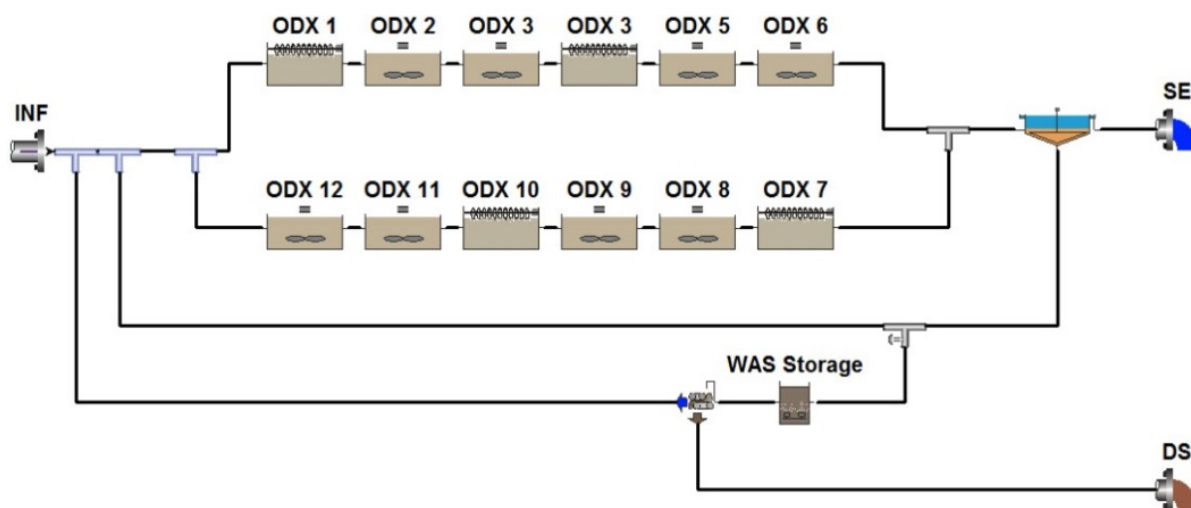
The oxidation ditch capacity was evaluated using BioWin 5.2 wastewater modeling software. Figure 9-10 shows the BioWin model schematic of the plant secondary treatment process. A wastewater influent characterization was developed using fractions typical to municipal wastewater with known rain inflow and infiltration (I&I). The I&I provides shorter collection system retention time and aerobic conditions which reduce the influent soluble BOD and COD fractions to the treatment plant. The influent characterization fractions are provided in Table 9-15 and the resulting influent wastewater composition for the Maximum Month Wet Weather (MMWW) flow condition is shown in Table 9-16. The influent wastewater composition is relatively dilute as a result of the I&I. This influent condition can create a concern for the NPDES permit requirement of 85 percent removal of BOD and TSS, specifically in BOD removal only mode. That is due to the shorter SRT which can limit floc formation and result in higher effluent TSS.

Figure 9-10: BioWin Model Schematic

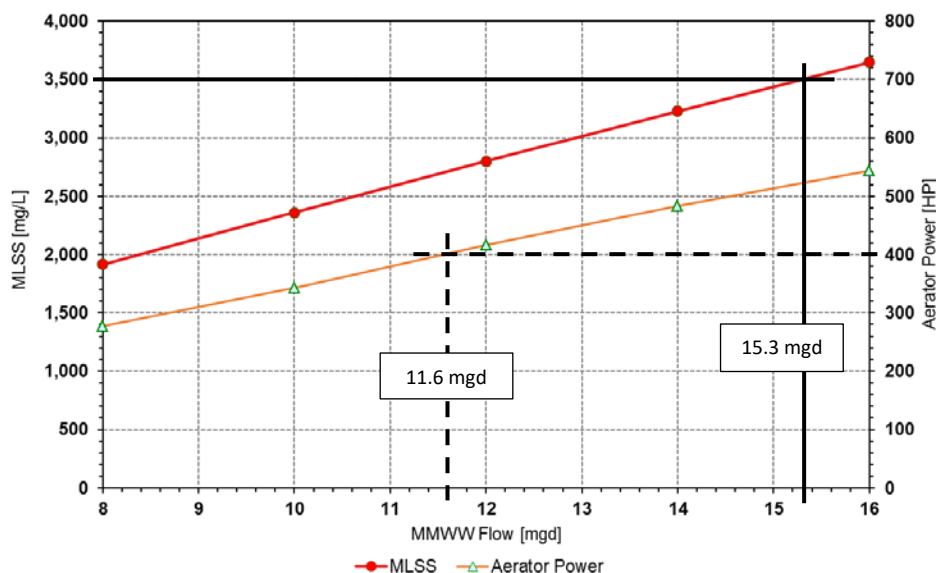
Figure 9-11: Nitrification Capacity vs. MLSS and Peak Aerator Power

Note: The black solid and dashed lines represent the design parameter per Table 9-14 (horizontal) and the resulting MMWW flow capacity (vertical).

The design influent composition was used in model simulations over a range of flows. Two capacity charts were generated for the two oxidation ditch operational modes, nitrification and BOD removal only, to show (1) the relationship between flow and MLSS, and flow and peak aerator power (Figure 9-11 and Figure 9-13, respectively) and (2) the relationship between flow and clarifier hydraulic and solids loading rates (Figure 9-12 and Figure 9-14, respectively). Figure 9-15 shows the relationship between peak capacity and chlorine contact hydraulic retention time. Process design parameters from Table 9-14 were added to the figures to determine a capacity for the corresponding parameter. A summary of the process capacity analysis is listed in Table 9-17.

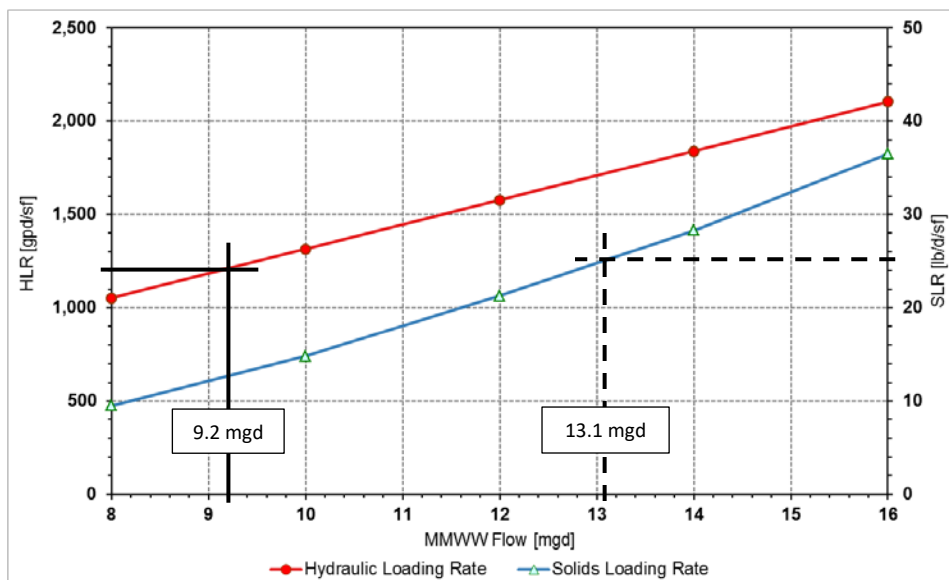
Figure 9-12: Nitrification Capacity vs. Clarifier Hydraulic and Solids Loading Rates

For BOD removal only operational mode, the capacity governing parameter for the secondary clarifiers is the peak hydraulic loading of 1,200-gpd/ft² based on industry standards. Using a ratio between peak and MMWW flow, the maximum design capacity based on MMWW flow is 9.1-mgd (Figure 9-12 and Figure 9-14). While the hydraulic analysis shows that the clarifiers can pass more flow, in order to show higher operational flows an increase in the peak hydraulic loading rate would need to be verified. This can be done through clarifier capacity re-rating and approval from DEQ. The historical flow data suggest that peak events which would exceed the current peak hydraulic loading are infrequent (less than three times per year) and of short duration (less than 24-hours per event).

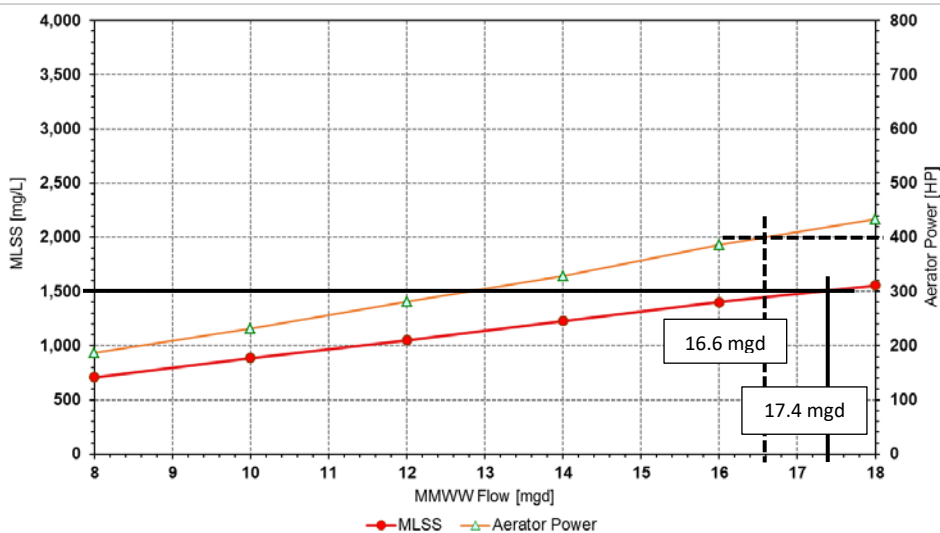
Figure 9-13: BOD Removal Only Capacity vs. MLSS and Peak Aerator Power

Note: The black solid and dashed lines represent the design parameter per Table 9-14 (horizontal) and the resulting MMWW flow capacity (vertical).

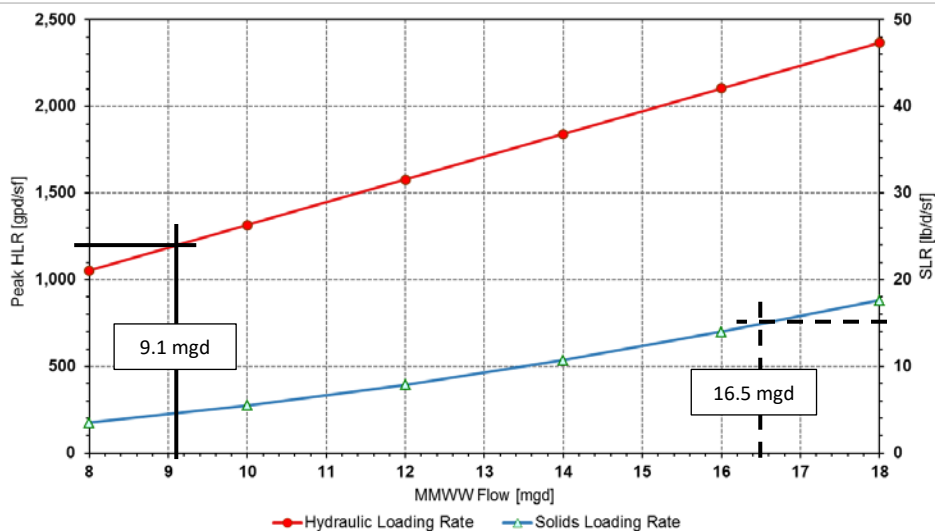
Figure 9-14: BOD Removal Only Capacity vs. Clarifier Hydraulic and Solids Loading Rates

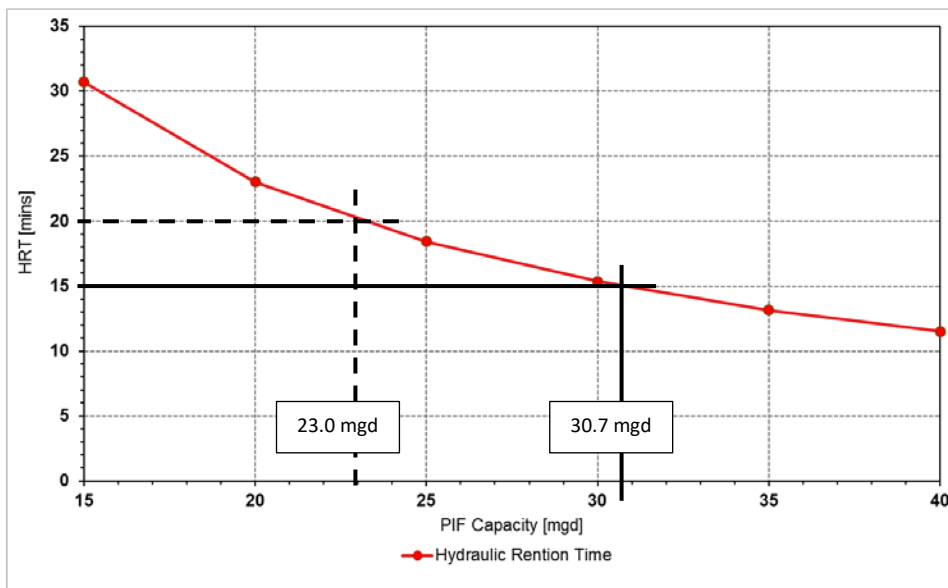
Figure 9-15: Capacity vs. Chlorine Contact Hydraulic Retention Time

Note: The black solid lines represent the design parameter per Table 9-14 (horizontal) and the resulting PIF flow capacity (vertical).

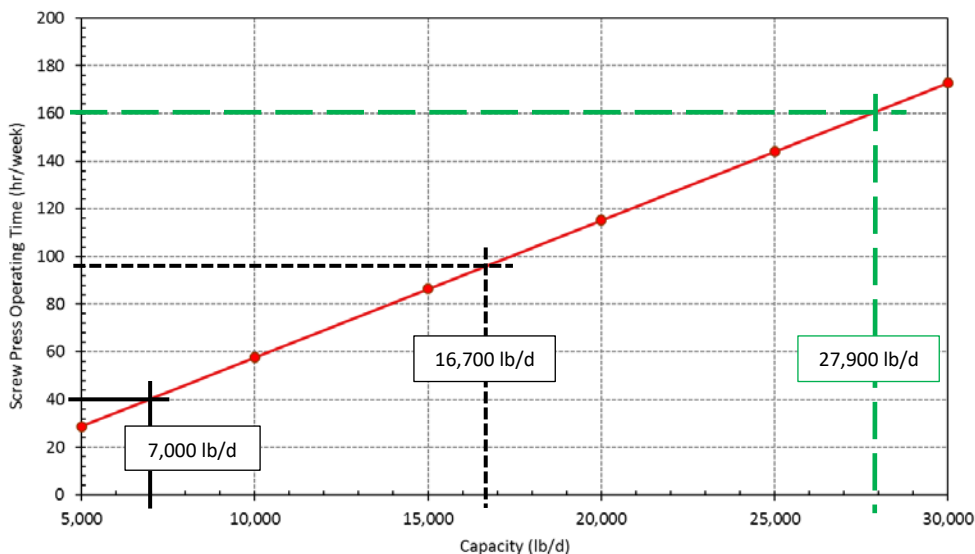
Figure 9-16 shows the relationship between the sludge dewatering solids loading capacity and the screw press operating time. The capacity was reviewed under three different operating scenarios. The more screw press operating hours per week, the more solids dewatered.

Figure 9-16: Capacity vs. Screw Press Dewatering Operating Time

Note: Assumes 1.5% TS sludge feed and two screw presses operating at 90% capacity. The horizontal lines represent the weekly operating durations, solid black line: 40-hrs (8-hrs/day with a 5-day week), dashed black line: 96-hrs (24-hrs/day with a 4-day week), and dashed green line: 161-hrs (23-hrs/day with a 7-day week). The vertical lines are the resulting capacity.

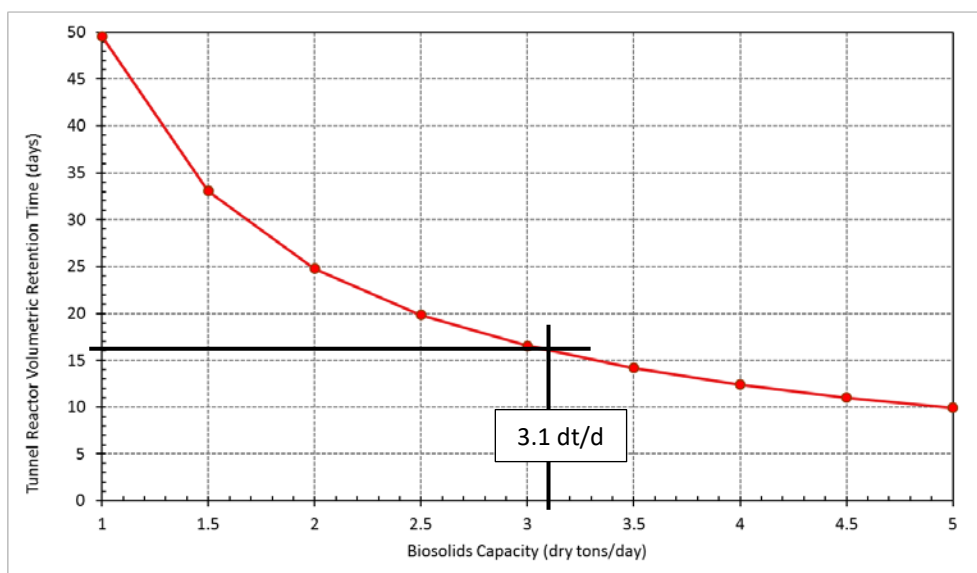
Figure 9-17: Capacity vs. Compost Reactor Tunnel Volumetric Retention Time

Note: The black lines represent the design parameter (horizontal) and the resulting capacity (vertical).

The capacity of the compost system is analyzed based on the volumetric retention time within the tunnel reactors. To meet EPA's 40 CFR 503 rules for Class A biosolids the biosolids must meet Process to Further Reduce Pathogen (PFRP) and Vector Attraction Reduction (VAR) stabilization requirements. PFRP requires biosolids be a minimum temperature of 55°C for 3 consecutive days and for VAR a minimum of 40°C for 14 consecutive days. For capacity analysis, a retention time of 16 days is used to assure compliance with all EPA's 40 CFR 503 requirements. Additional assumptions for the compost analysis are listed in Table 9-20. The relationship between solids loading capacity and the tunnel reactor volumetric retention time is in Figure 9-17.

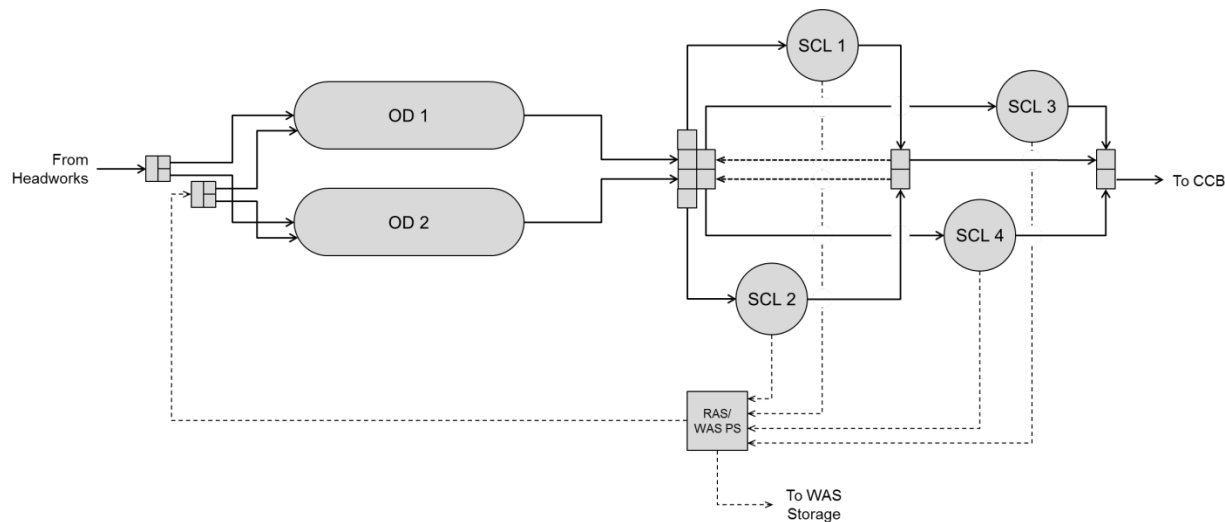
Figure 10-1: Schematic of Existing Secondary Treatment

Note: OD = oxidation ditch, SCL = secondary clarifier, CCB = chlorine contact basin, PS = pump station

Figure 10-1 shows a schematic layout of the existing secondary treatment process for reference. All alternatives are designed for full nitrification and are assumed to have the same oxygen demand and air demand.

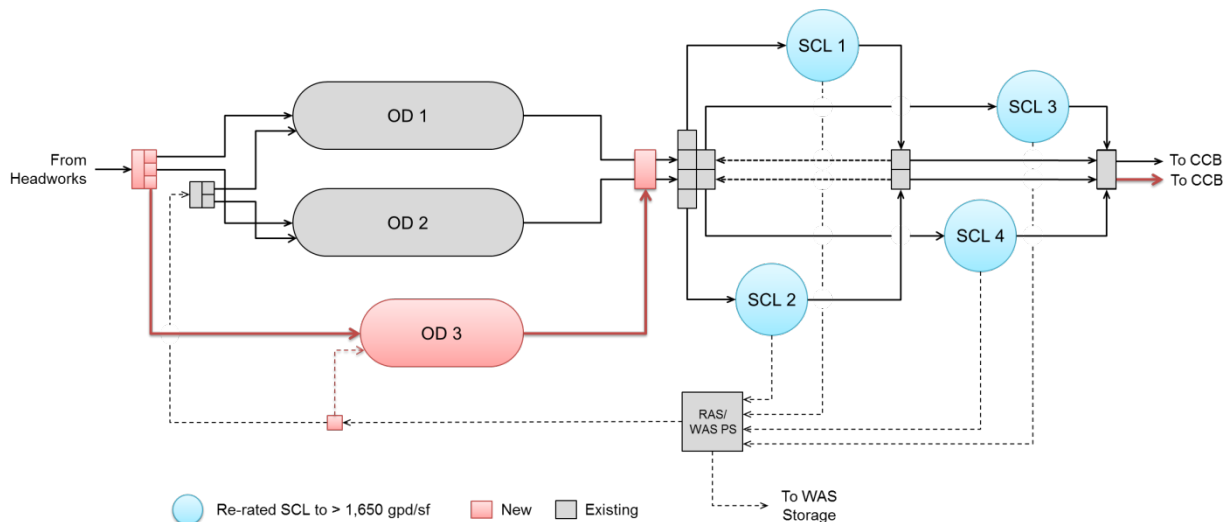
Figure 10-2: Schematic of Oxidation Ditch Alternative 1A

Note: OD = oxidation ditch, SCL = secondary clarifier, CCB = chlorine contact basin, PS = pump station

- 1A - Re-rate the existing secondary clarifiers to 1,650-gpd/sf (Figure 10-2)
- 1B - Re-rate the existing secondary clarifiers to 1,300-gpd/sf and add one secondary clarifier (Figure 10-3)
- 1C - Add two secondary clarifiers (Figure 10-4)

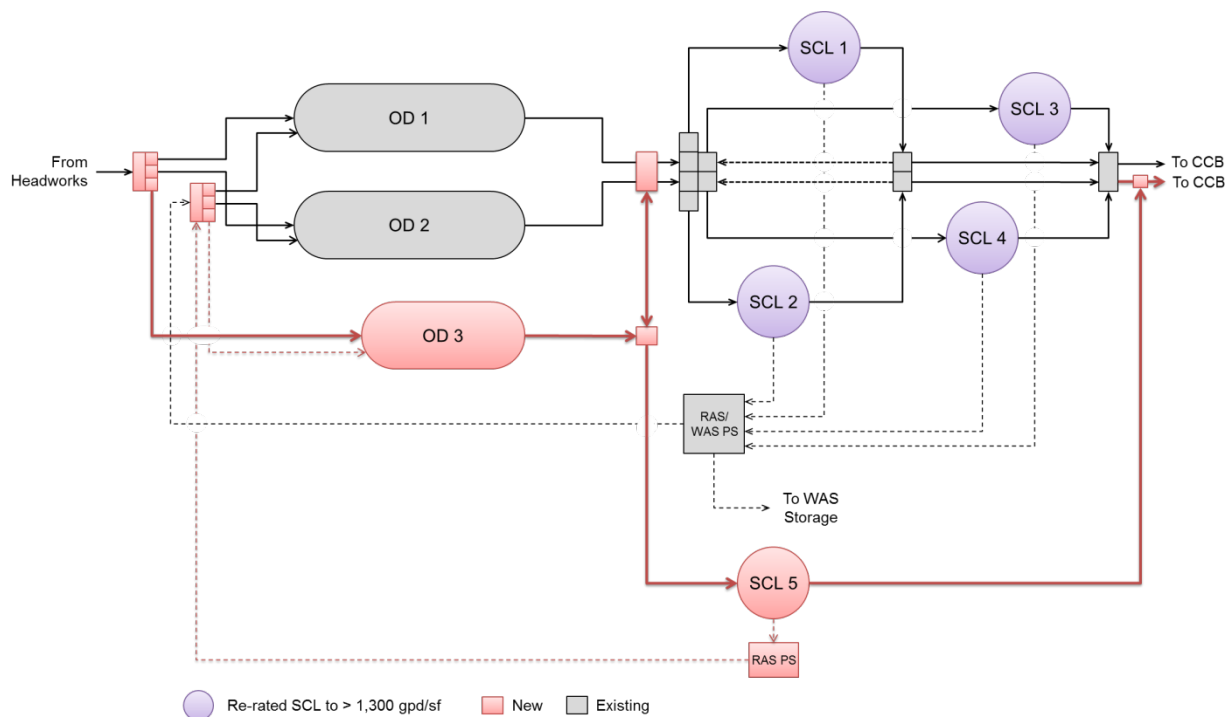
Figure 10-3: Schematic of Oxidation Ditch Alternative 1B

Note: OD = oxidation ditch, SCL = secondary clarifier, CCB = chlorine contact basin, PS = pump station

The new secondary clarifier will also require a new RAS pump station. Since the new clarifier may receive an uneven amount of ML, the RAS from both the new and existing RAS pump stations will need to be combined in a new junction box before it can be split evenly between the three oxidation ditches (Figure 10-3). Since the process operates a single sludge system, the new pump station does not need to include additional WAS pumps. All WAS can be wasted from the existing RAS/WAS pump station located in the Secondary Building. Secondary effluent from the new secondary clarifier would connect to a new parallel SE pipe between the CDB and CCB.

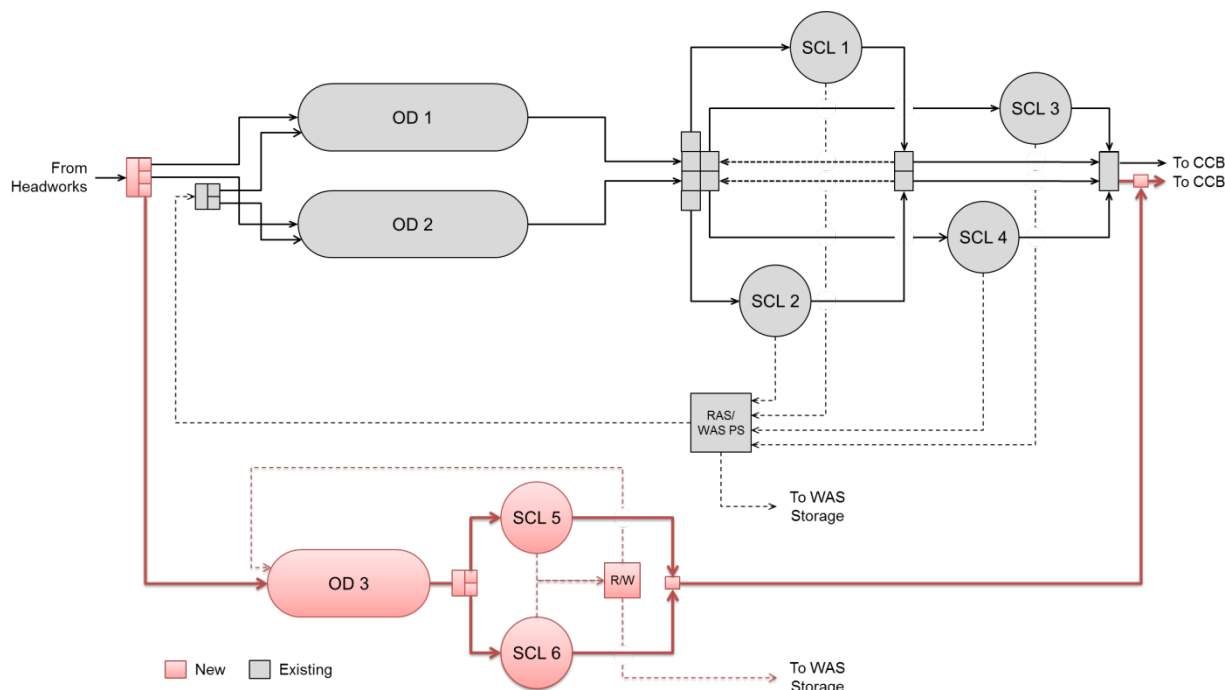
Figure 10-4: Schematic of Oxidation Ditch Alternative 1C

Note: OD = oxidation ditch, SCL = secondary clarifier, CCB = chlorine contact basin, PS = pump station, R/W = RAS/WAS PS

Alternative 1C adds one new oxidation ditch, two new secondary clarifiers, and a RAS/WAS pump station; effectively creating a parallel secondary treatment plant that operates independently from the existing (Figure 10-4). The biggest advantage of this alternative is that it leaves most of the existing secondary treatment process unmodified. RDS split box modification and CDB hydraulic improvements are required. This simplifies construction sequencing and adds flexibility as to the location of the new oxidation ditch and secondary clarifiers on the plant site.

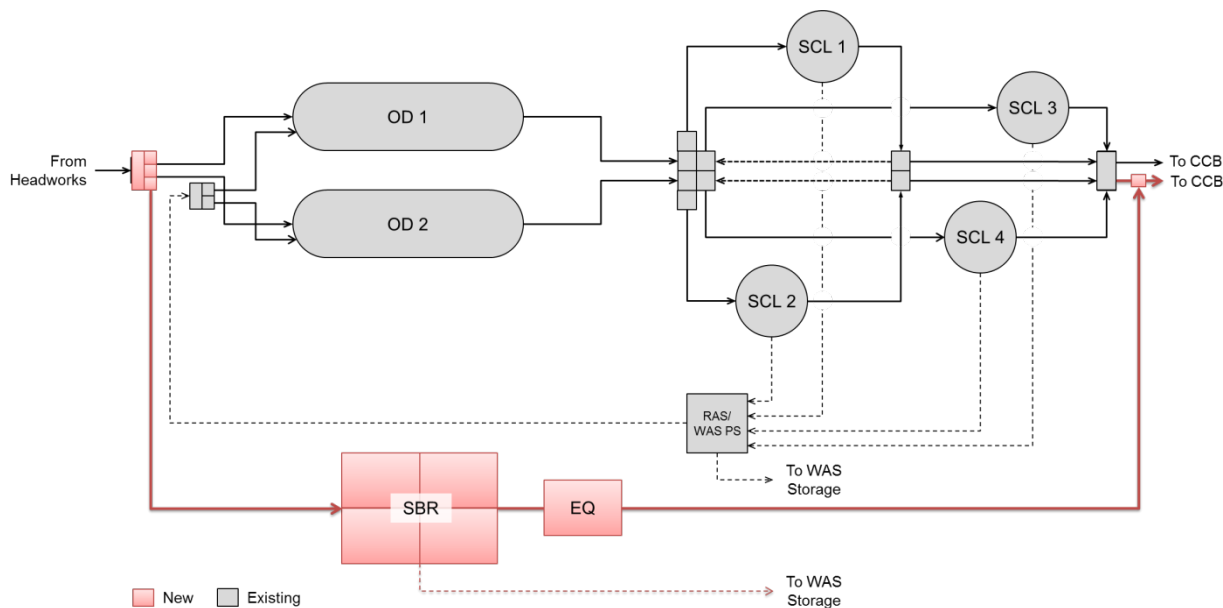
Figure 10-5: Schematic of SBR Alternative 2

Note: OD = oxidation ditch, SCL = secondary clarifier, CCB = chlorine contact basin, PS = pump station, EQ = effluent equalization

Sequencing batch reactors (SBR) combine activated sludge and clarification into a single structure. In this alternative a SBR would operate in parallel and independent from the existing oxidation ditches. Modifications to the RDS flow split are required for adding the new treatment train. A flow control valve from the Headworks could also be used to regulate flow to the SBR. For comparison of alternatives, expansion of the RDS box will be used. The equalized SBR effluent would combine with the secondary clarifier effluent in or upstream of the CCBs. A schematic of the SBR alternative is in Figure 10-5.

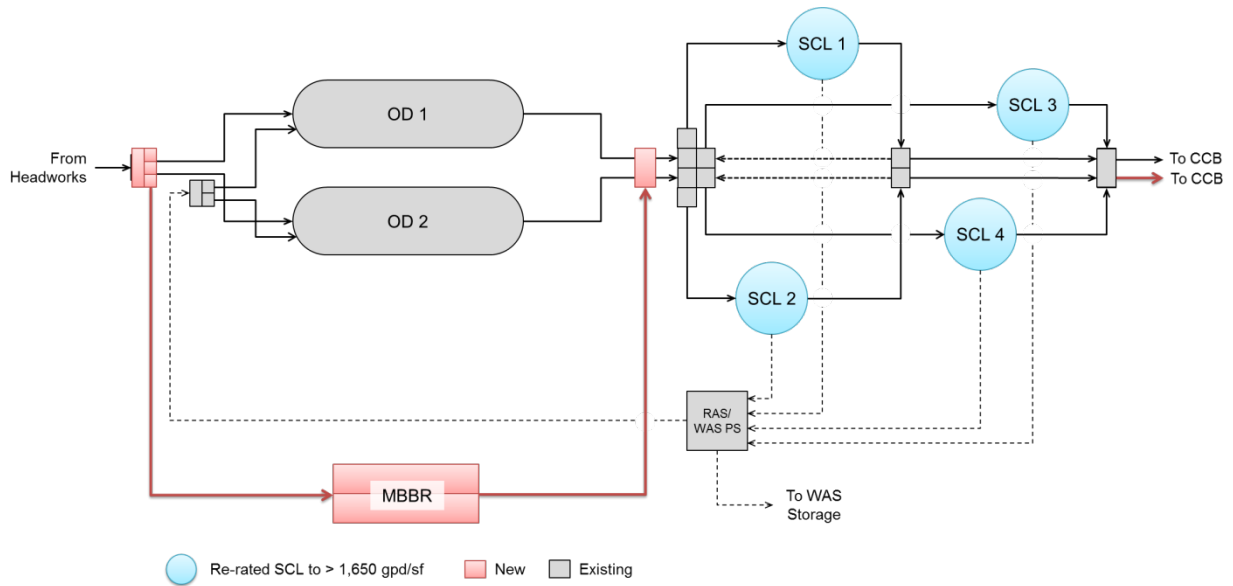
Figure 10-10: Schematic of MBBR Alternative 3A

Note: OD = oxidation ditch, SCL = secondary clarifier, CCB = chlorine contact basin, PS = pump station, R/W = RAS/WAS PS

Alternative 3A (Figure 10-10) relies on re-rating the existing secondary clarifiers to a maximum hydraulic loading rate of 1,650-gpd/sf (similar to Alternative 1A). Alternative 3B (Figure 10-11) considers diverting MBBR effluent in excess of the re-rated 1,300-gpd/sf existing secondary clarifiers capacity to another solids retention unit process. Options for another solids retention process include a disc or cloth filter, plate settler, or the rehabilitating the existing equalization basin as a settling basin.

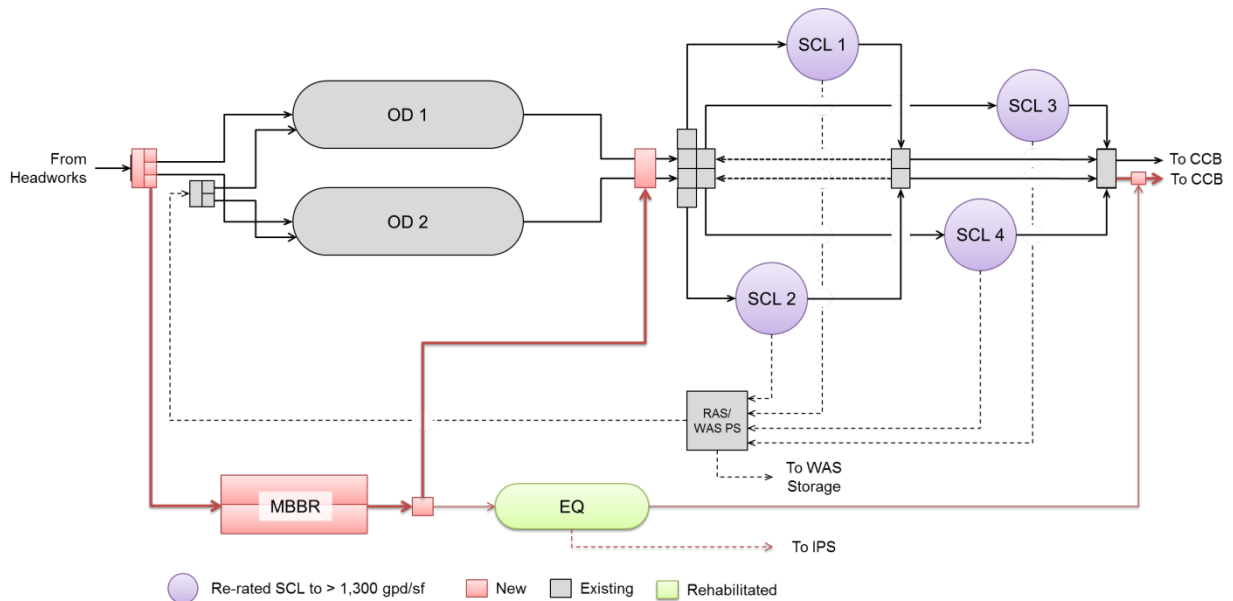
Figure 10-11: Schematic of MBBR Alternative 3B

Note: OD = oxidation ditch, SCL = secondary clarifier, CCB = chlorine contact basin, PS = pump station, R/W = RAS/WAS PS, EQ = equalization basin

The required reactor volume of the MBBR is 0.5-MG. Alternative 3B is selected for further comparison with the use of existing equalization basin for storage or settling at peak flows. The equalization basin requires structural rehabilitation in order to be used as part of the treatment process. It has a volume of 1.0-MG; thus, cumulative peak flows

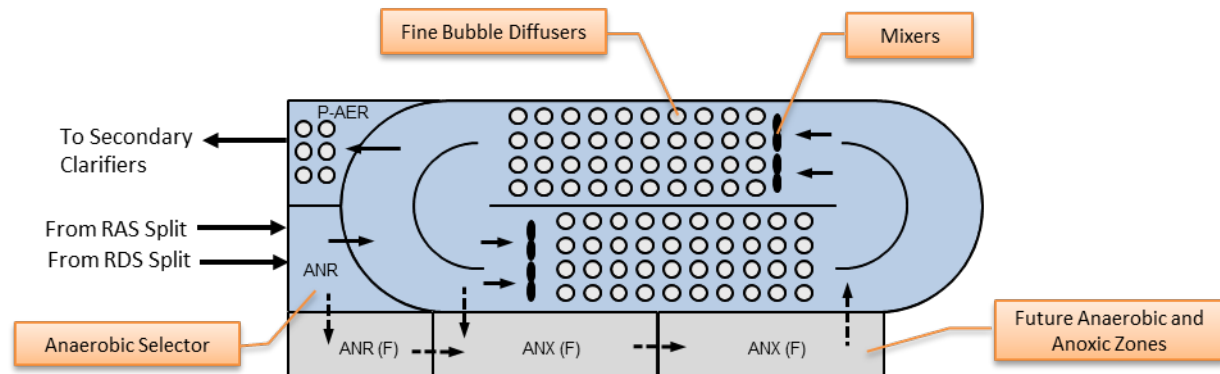
Figure 11-1: Proposed Oxidation Ditch Expansion Layout

Note: Figure not to scale. ANR = anaerobic zone, (F) = future, ANX = anoxic zone, P-AER = post-aeration zone.

It is assumed that the new oxidation ditch will have a total volume of 2.0 MG with a side water depth of 20 ft, width of 60 ft and length of 235 ft. The new oxidation ditch will have a racetrack layout with straight vertical wall construction. RDS flow to the oxidation ditches will be controlled at the new influent split box to equally split the flow between the three treatment trains. RDS and RAS will initially pass through an anaerobic zone before entering the oxidation ditch racetrack. Upon exiting the racetrack, the mixed liquor is aerated in the post aeration zone to oxidize residual ammonia and raise the dissolved oxygen (DO) during air off cycles. The anaerobic and post-aerobic zones are optional, however for this evaluation it is assumed they will be included as it provides flexibility for operating in simultaneous nitrification and denitrification (SNDN). A schematic layout of the proposed oxidation ditch expansion is provided in Figure 11-1.

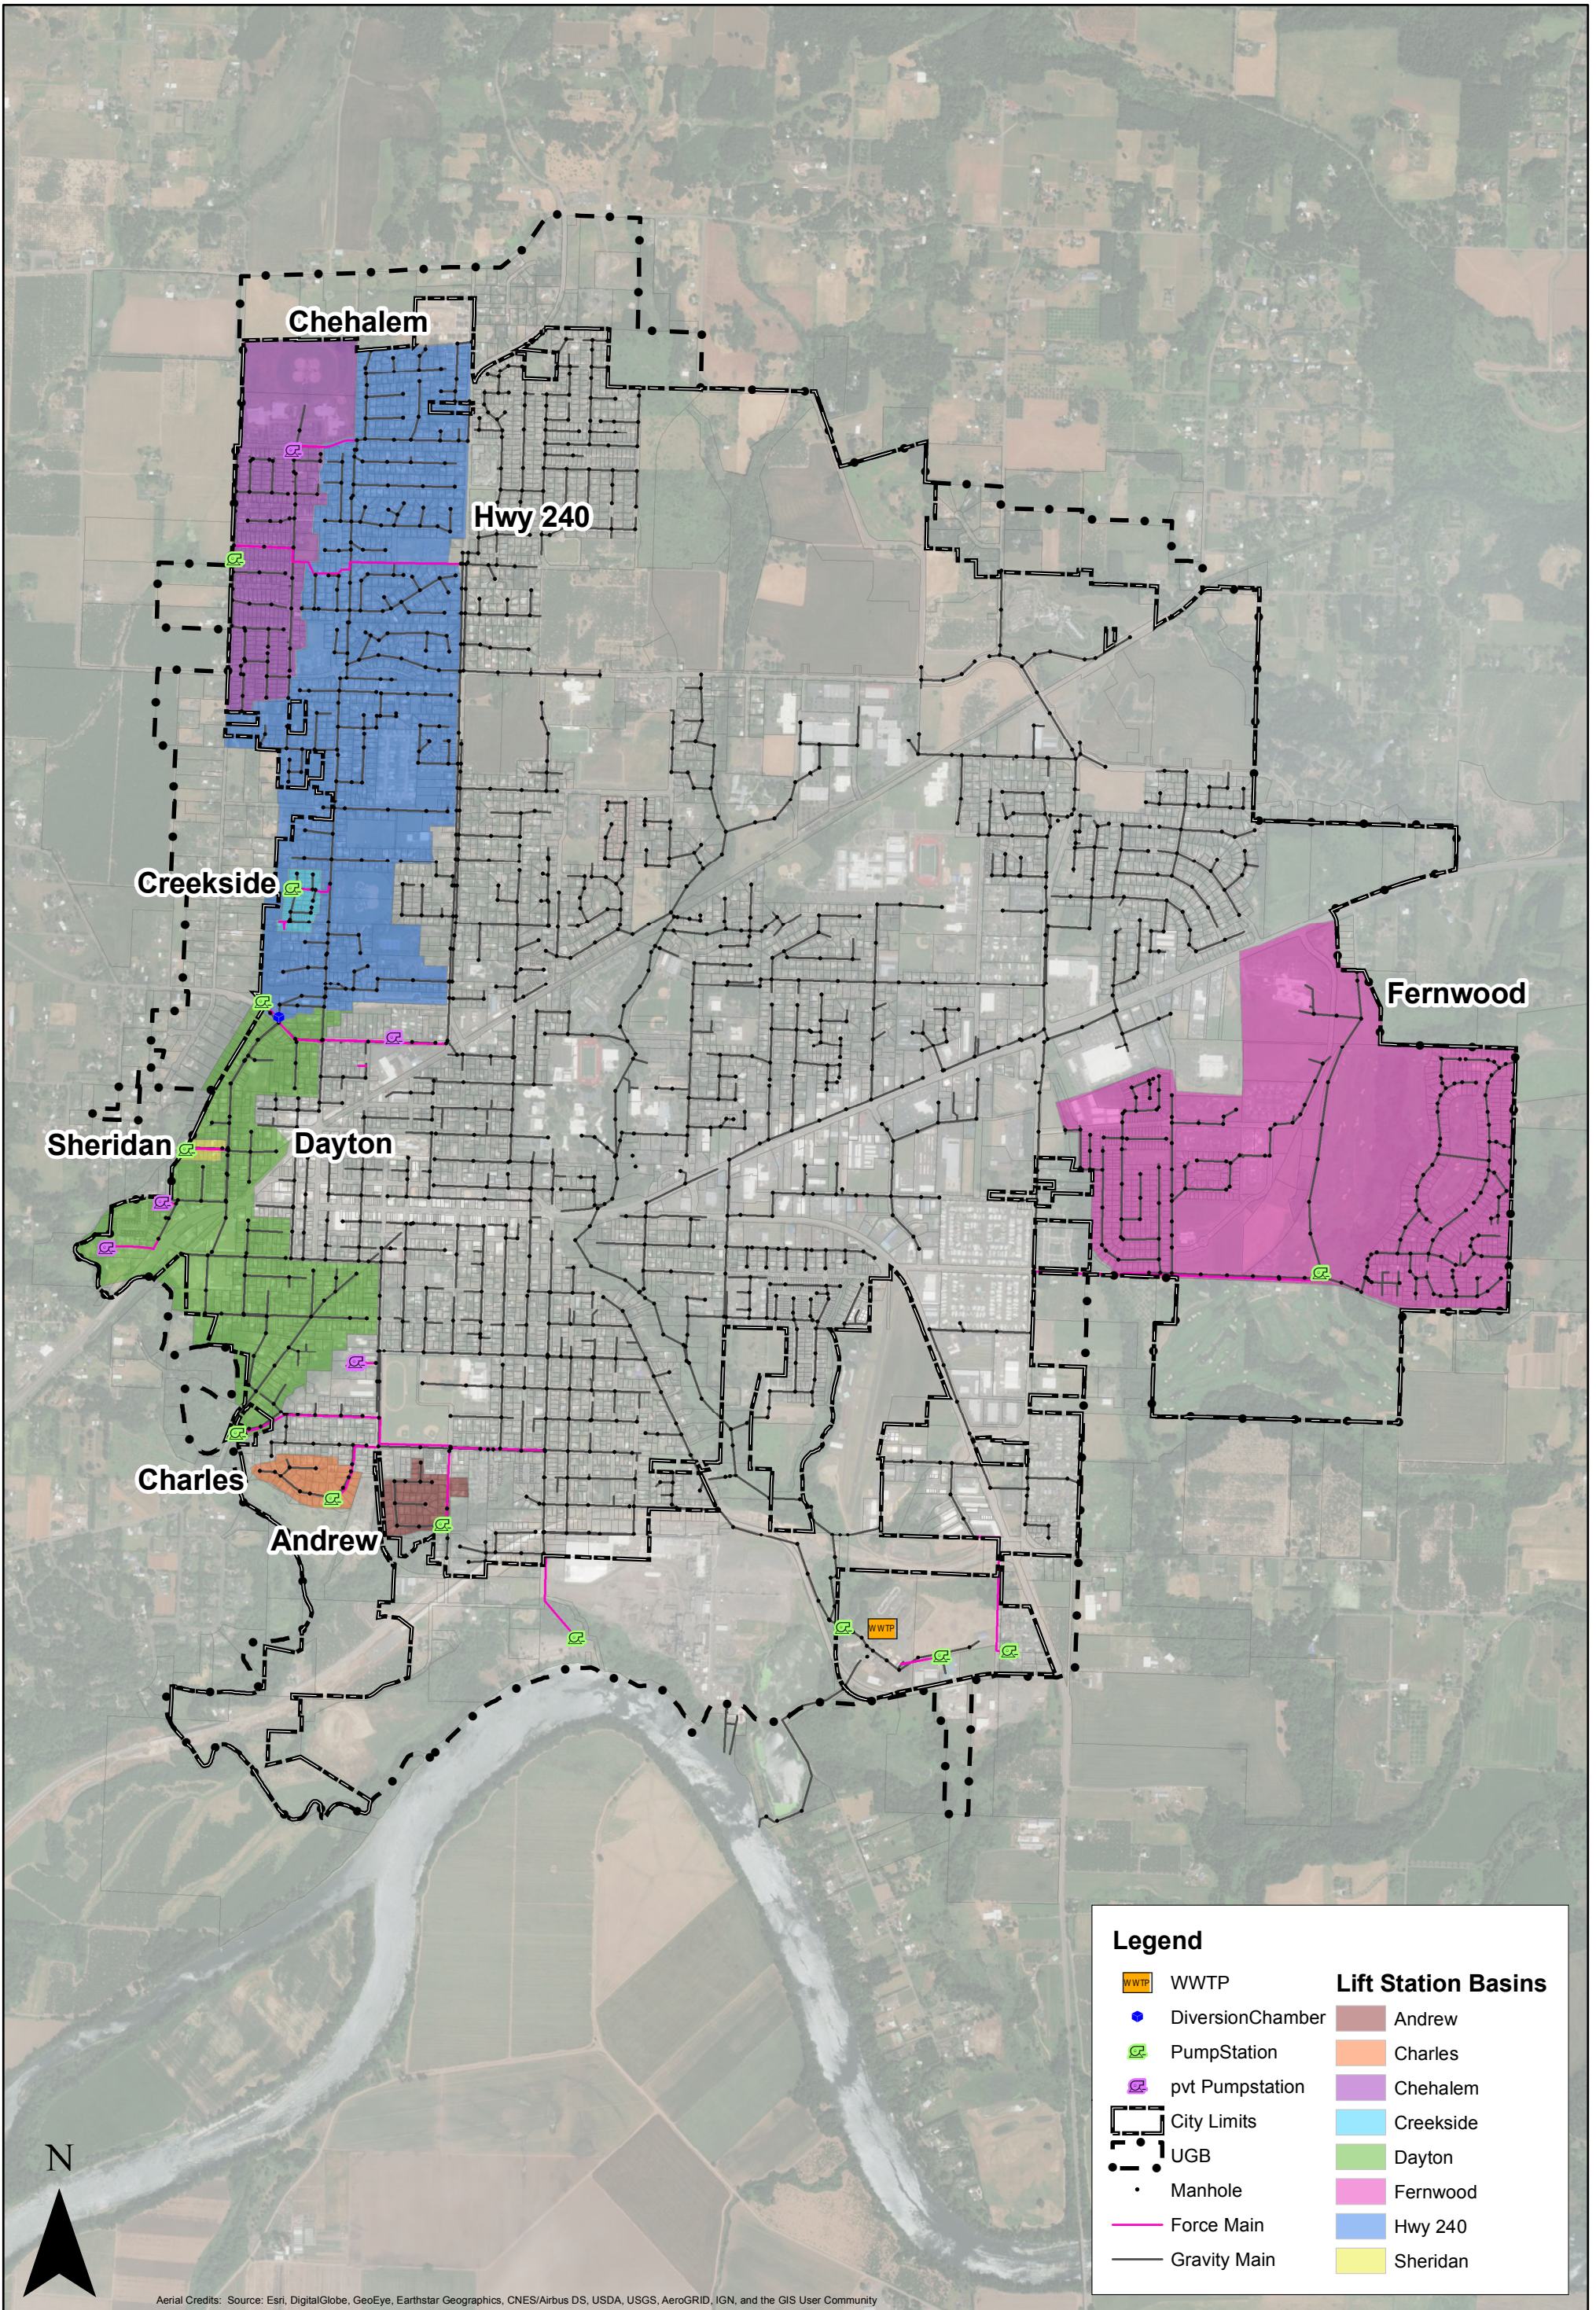
Lift Station Basins

Each of the eight City-owned lift stations (Andrew, Charles, Chehalem, Creekside, Dayton, Fernwood, Highway 240, and Sheridan) were visited to complete pump flow tests and facilities evaluations. City staff provided lift station history and anecdotal performance records. The lift stations and their service areas are shown in Figure 7 (Appendix A).

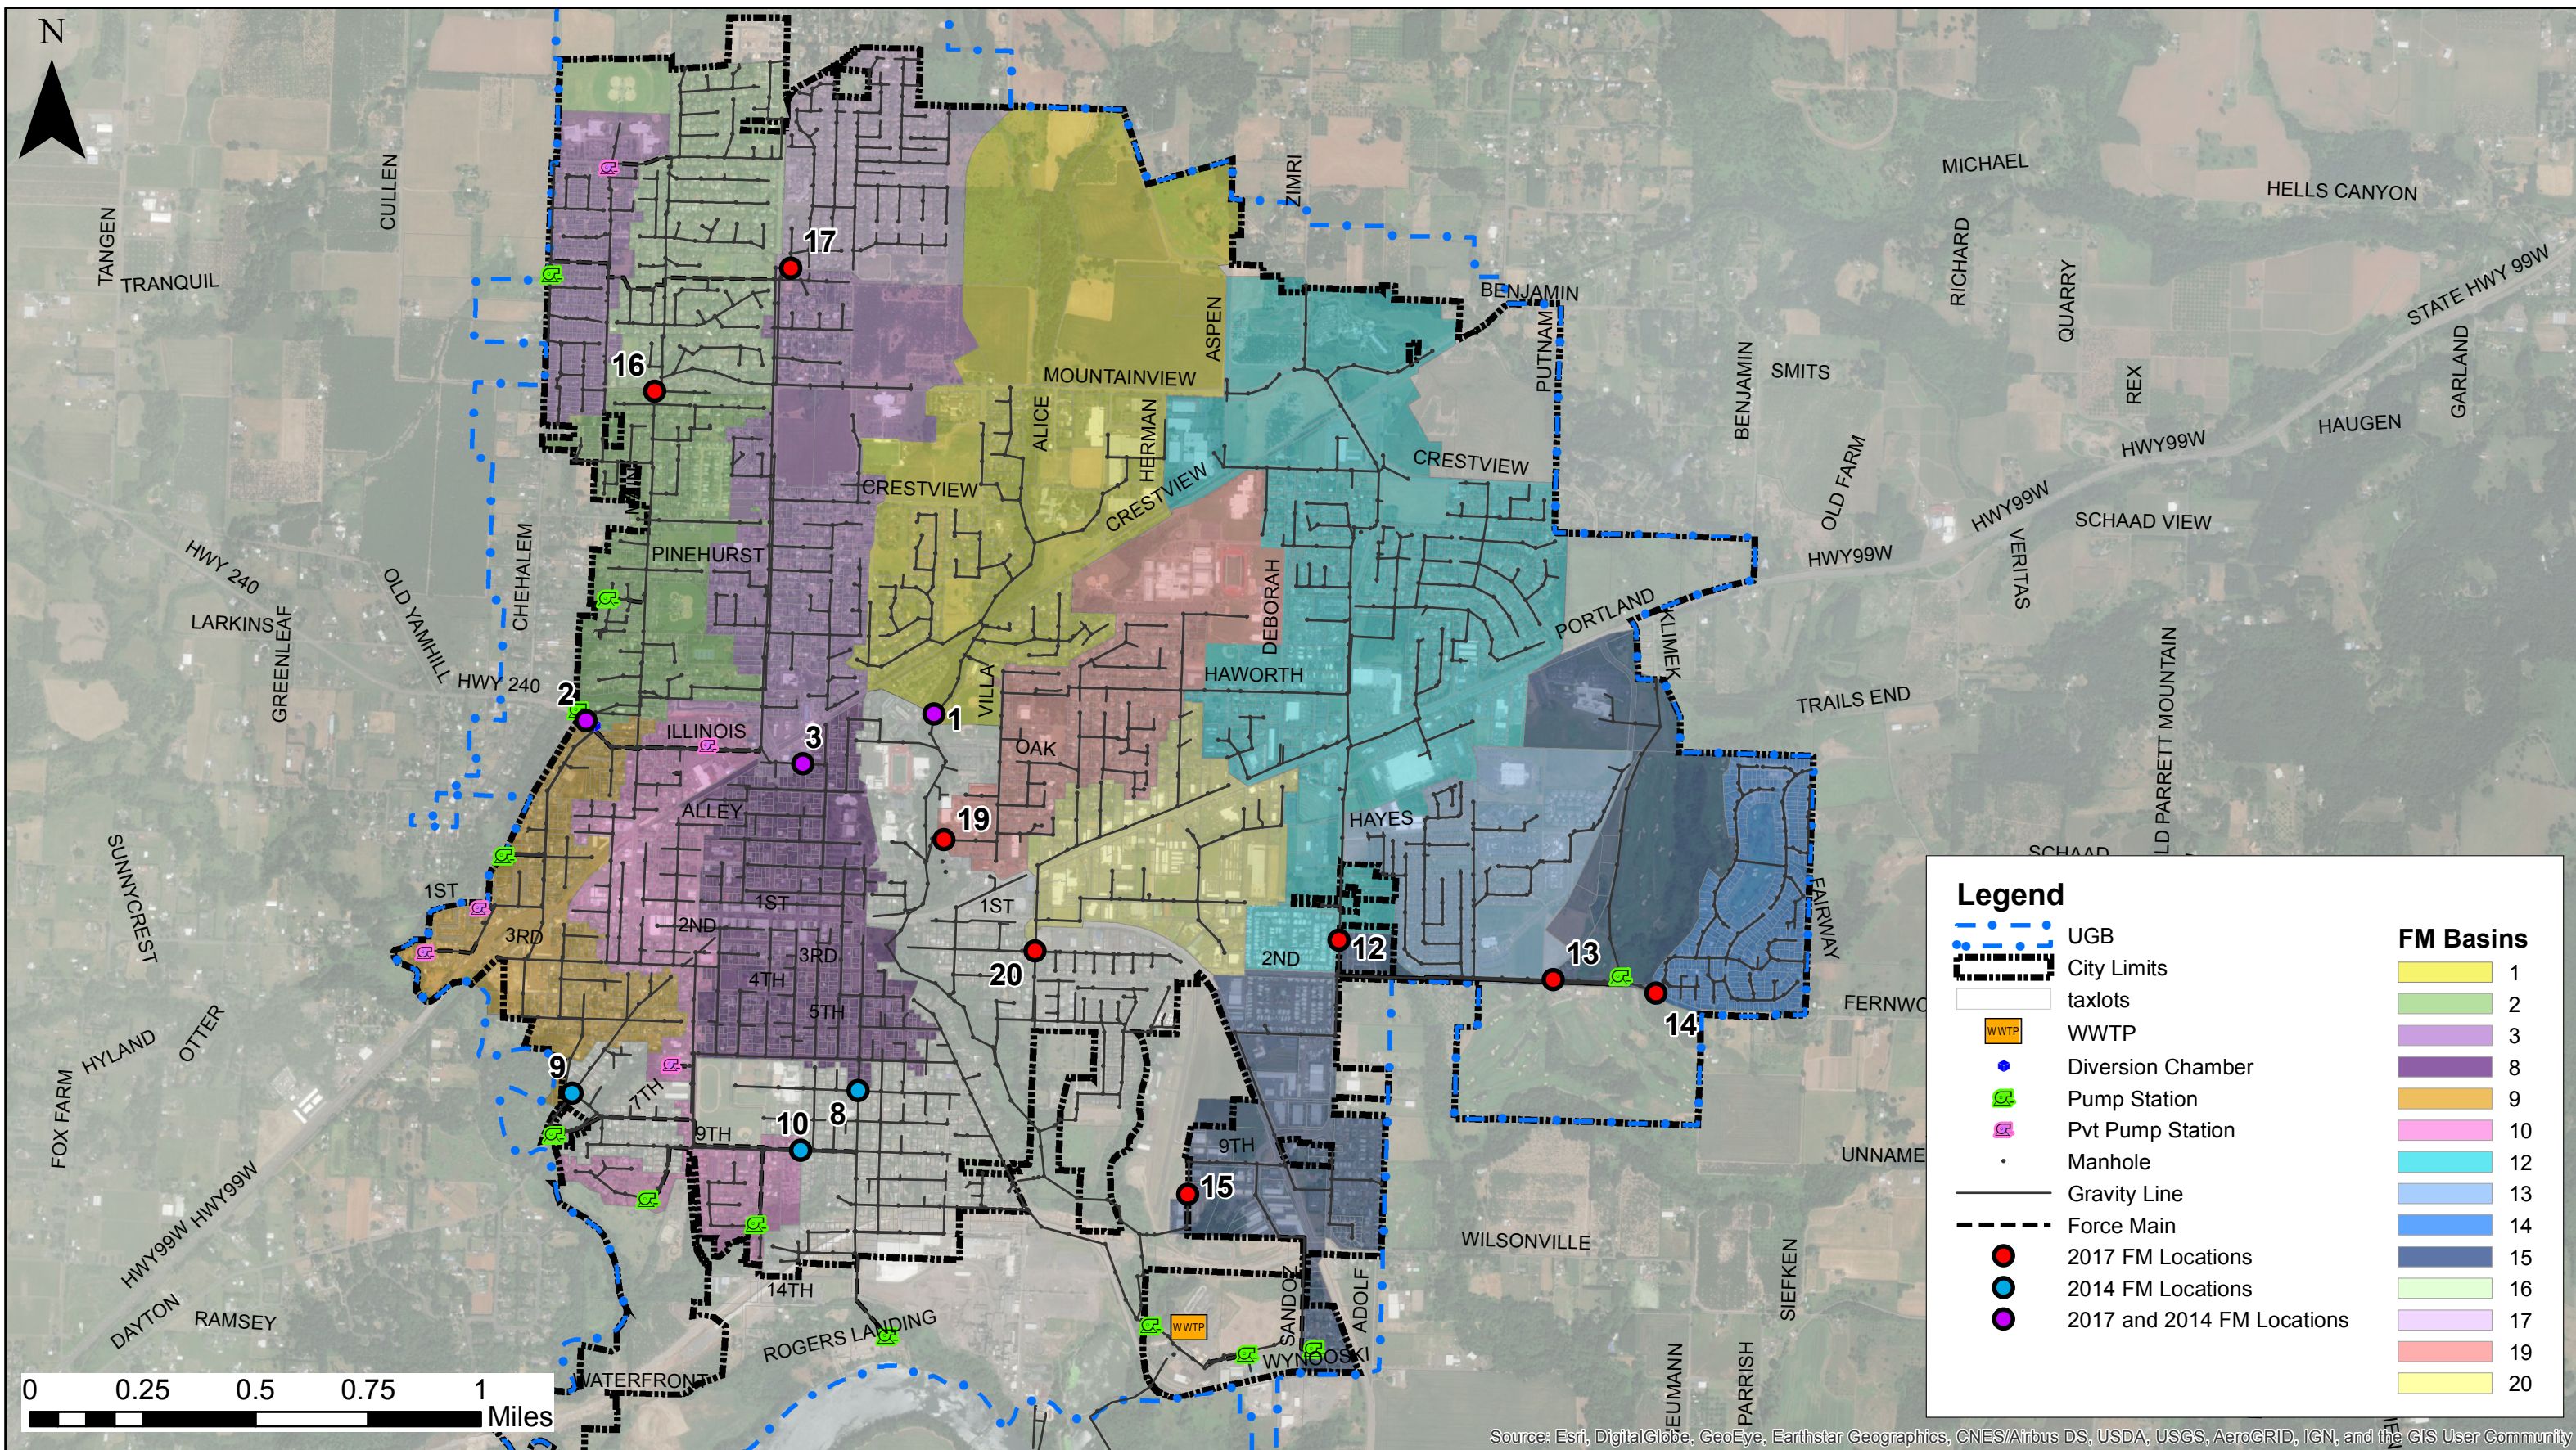
Flow Monitoring Locations

Continuous flow monitoring was completed for five weeks during January-March 2017 to better characterize the nature and distribution of I/I in the system. Eleven flow monitors were placed throughout the system (See Figure 9 (Appendix A) based on staff recommendations, the pump run time analysis, previous I/I study data collected, and land use considerations. Eight flow monitors from Keller and three City-owned flow monitors were used to collect level, velocity, and flow data at 10- to 15-minute intervals. Rainfall data was collected at the WWTP weather station in 5-minute intervals.
