REQUEST: A Resolution recommending City Council amend the 2018 Wastewater Master Plan incorporating the 2021 Riverfront Addendum into the Newberg Comprehensive Plan

Wastewater Master Plan

May 2018

*Technical Update May 2021
Addendum - Riverfront
Master Plan (Appendix K)*

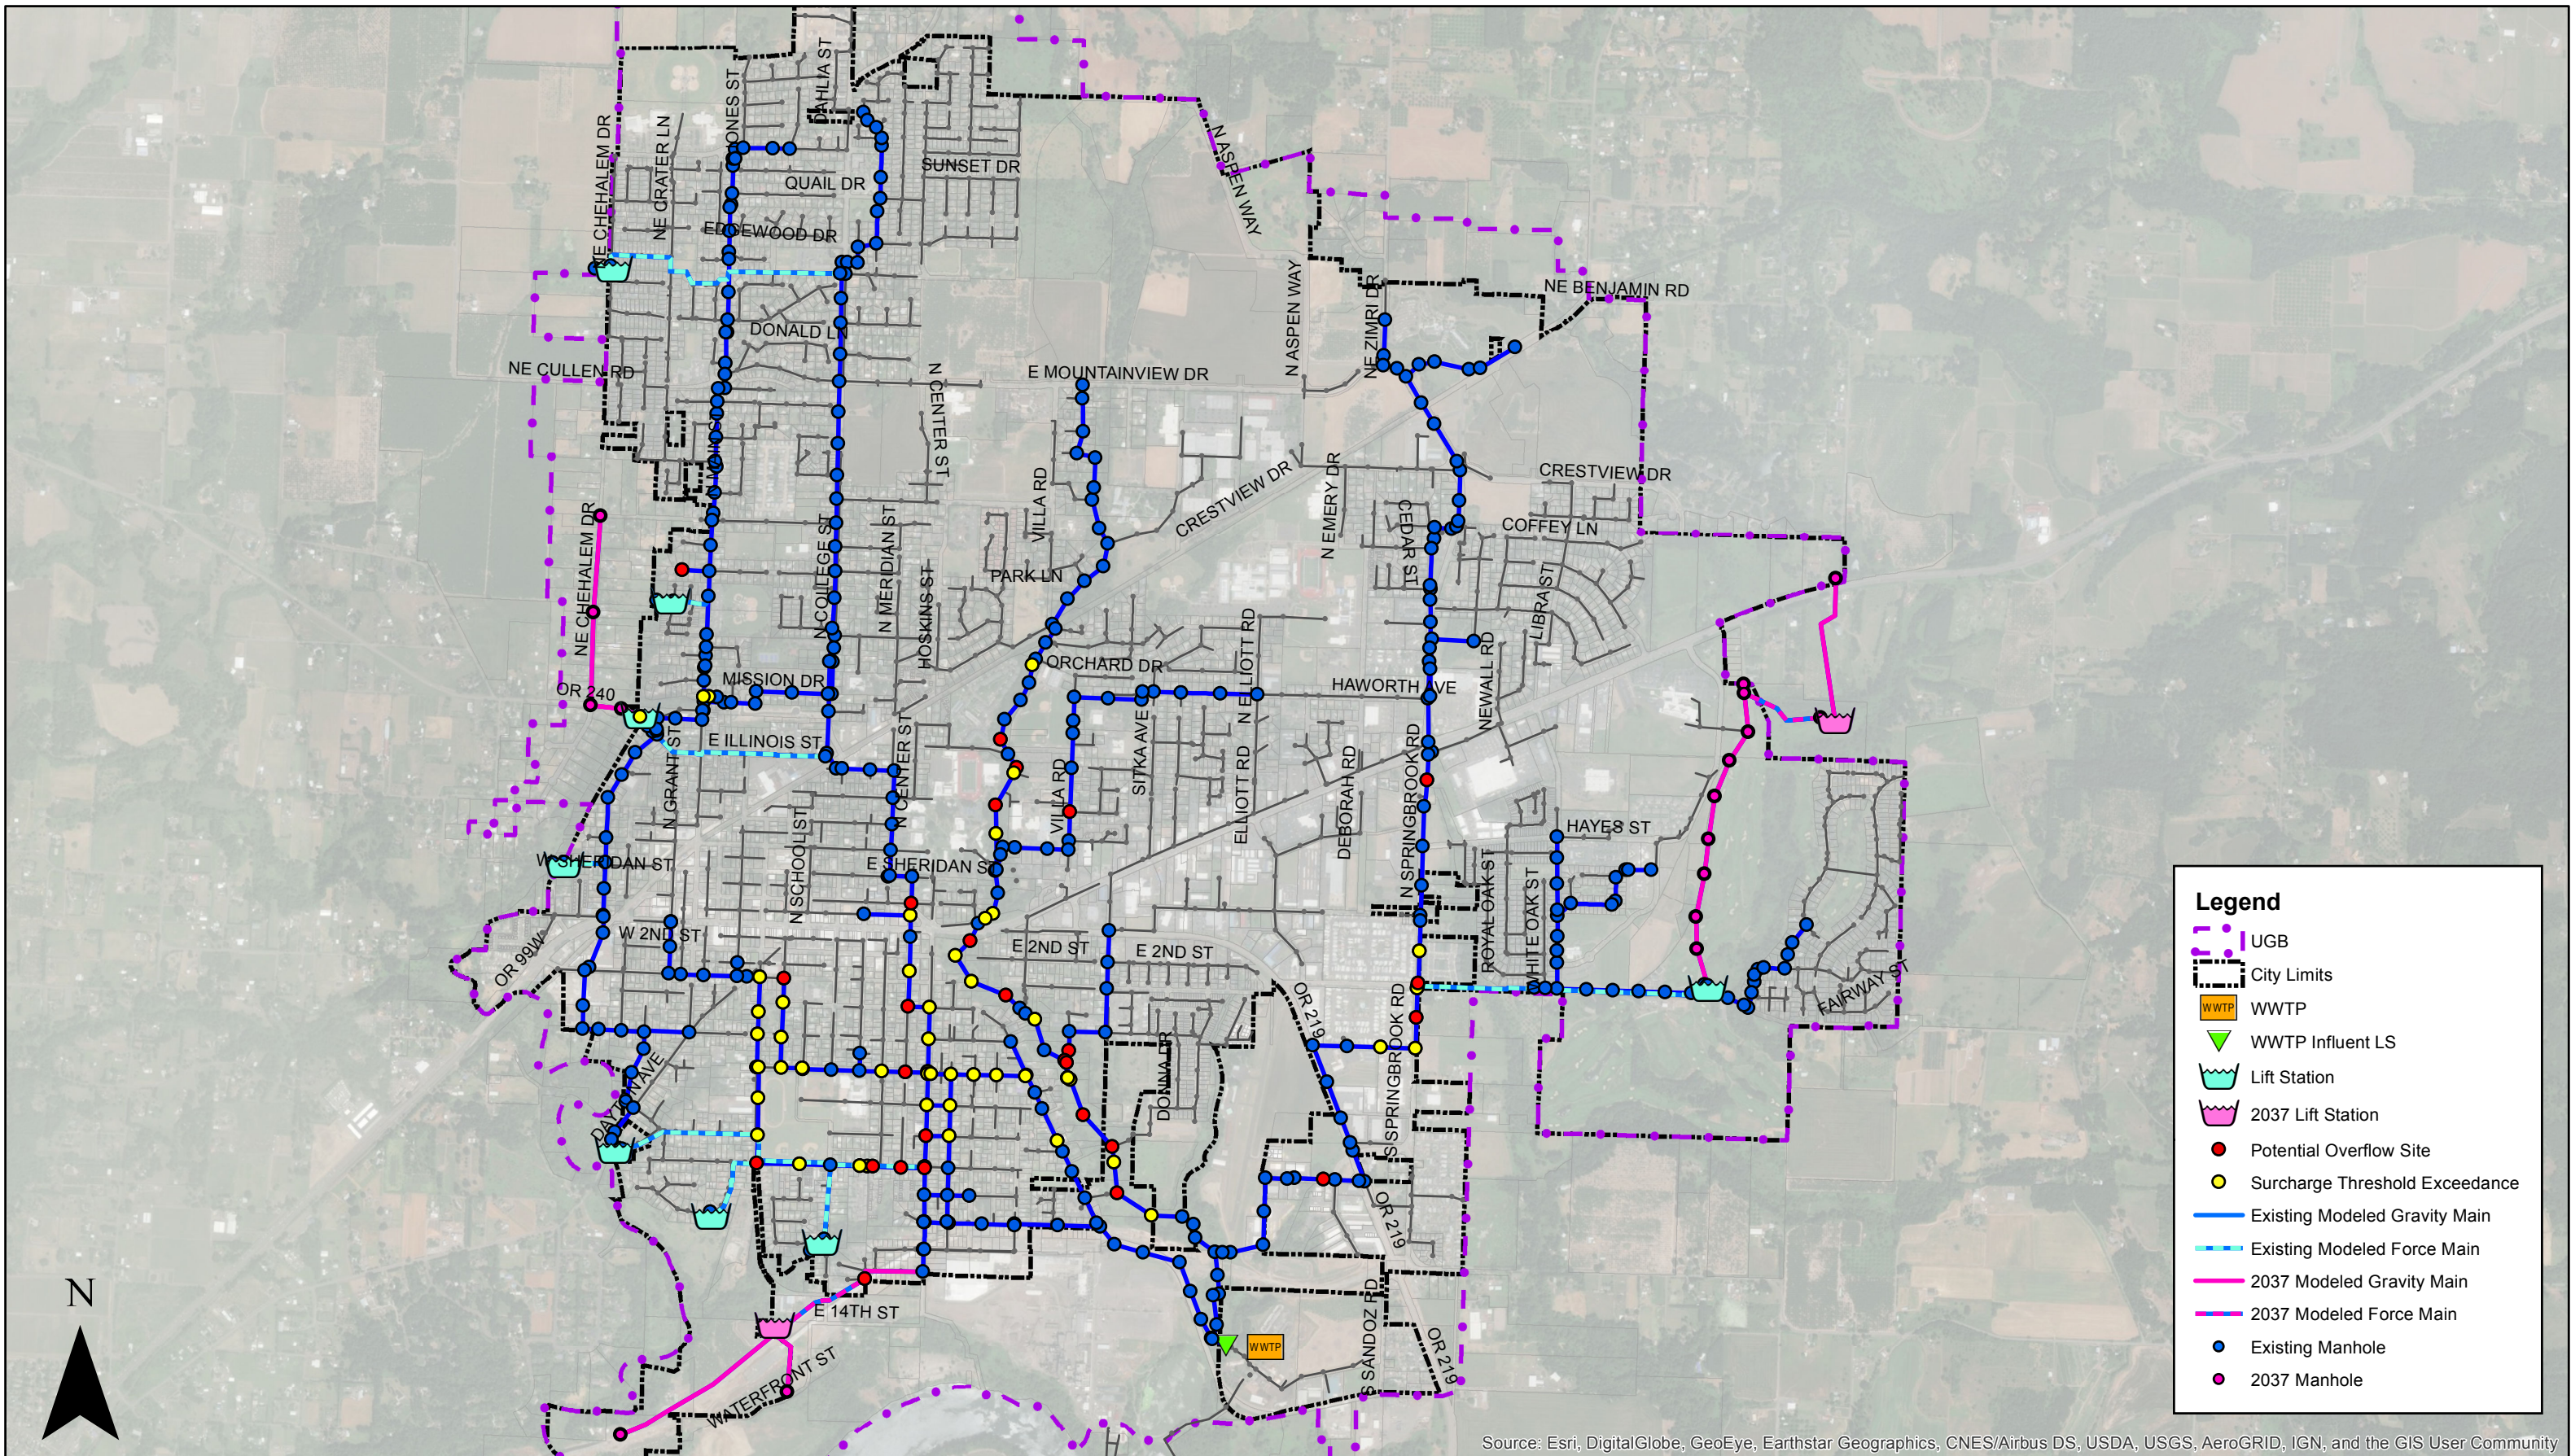
20-Year System Evaluation - Peak Flows (PIF5)

Problem Areas

- A - Pinehurst Ct, topographic low point
- B - N. Main St, downstream bottleneck
- C - HWY240 LS, undersized pumps
- D - Excess flows from HWY240
- E - S. River St, undersized
- F - Wynooski St, downstream bottleneck
- G - Villa Rd, downstream bottleneck
- H - Hess Creek, undersized and limited or no access to line
- I - S. Springbrook Rd, undersized and topographic low point
- J - Fernwood/Springbrook Rd, undersized

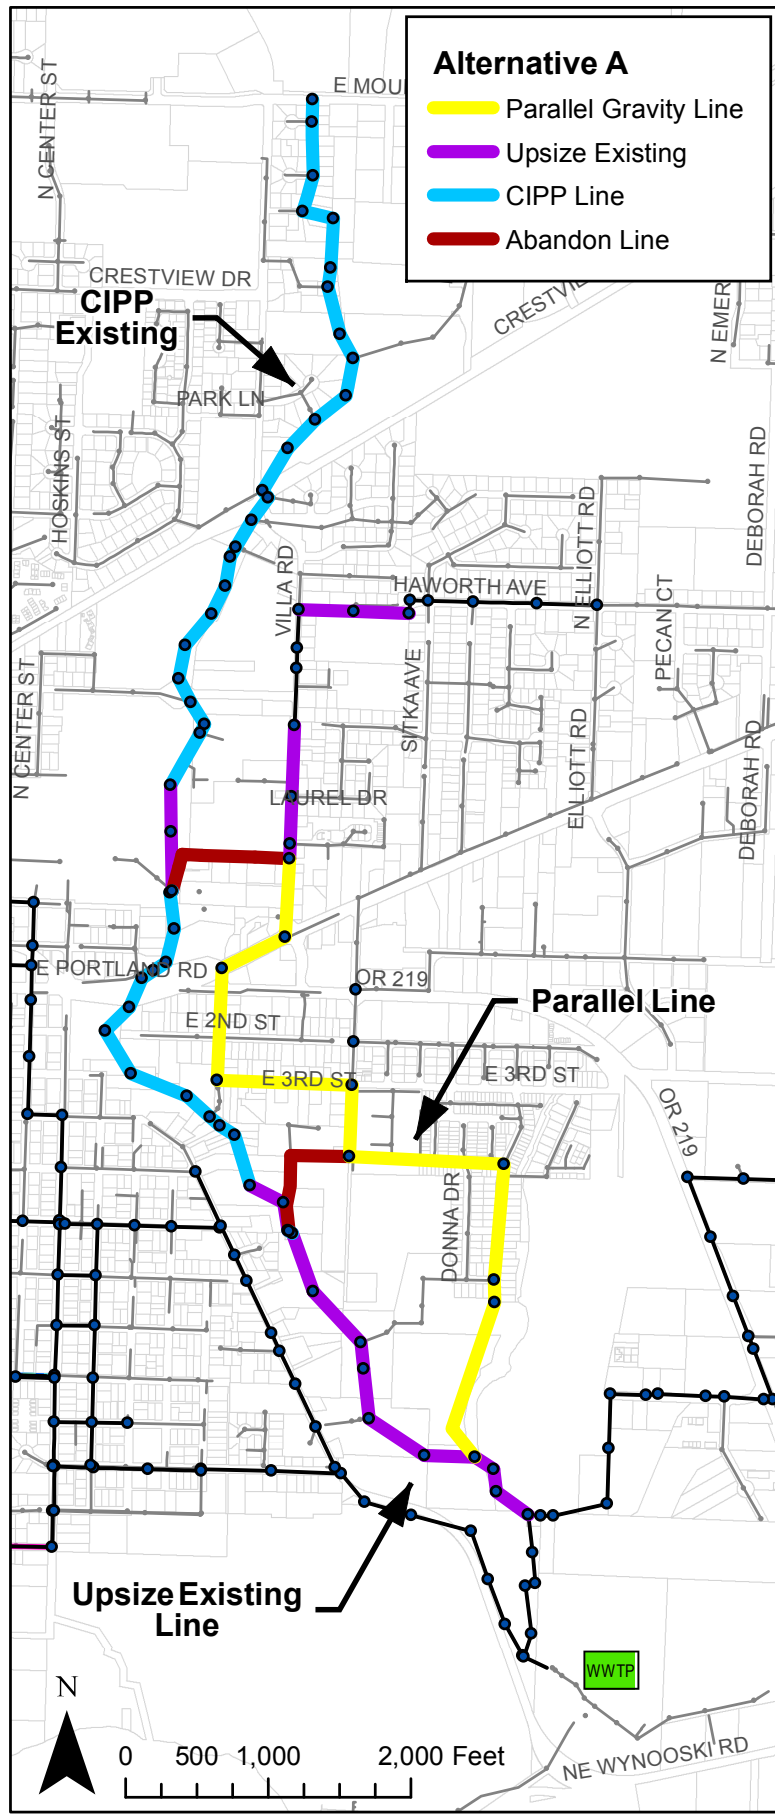
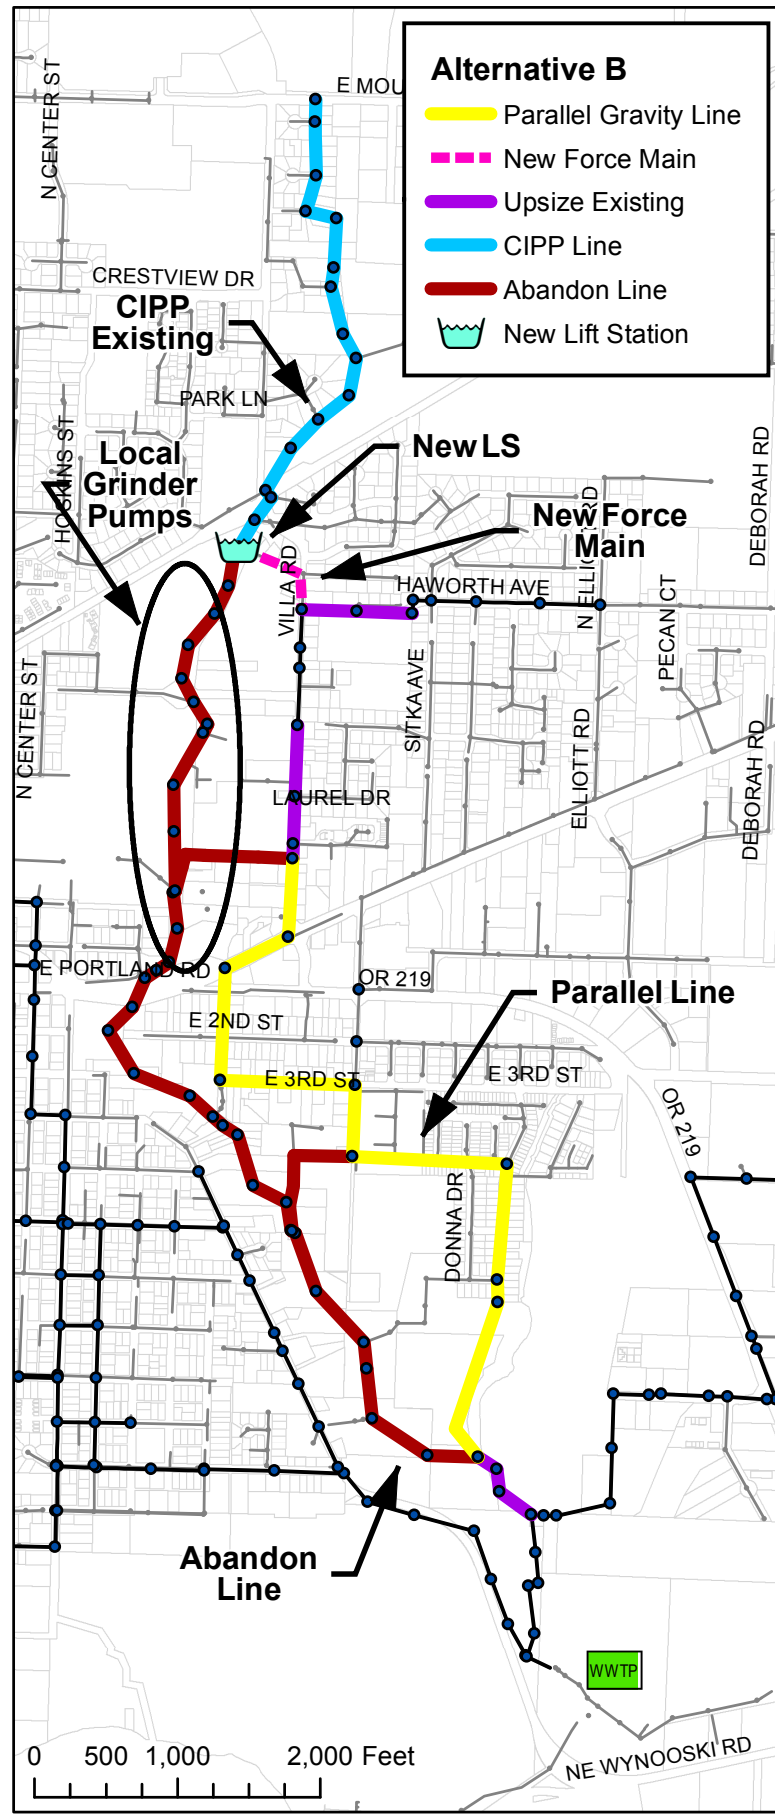
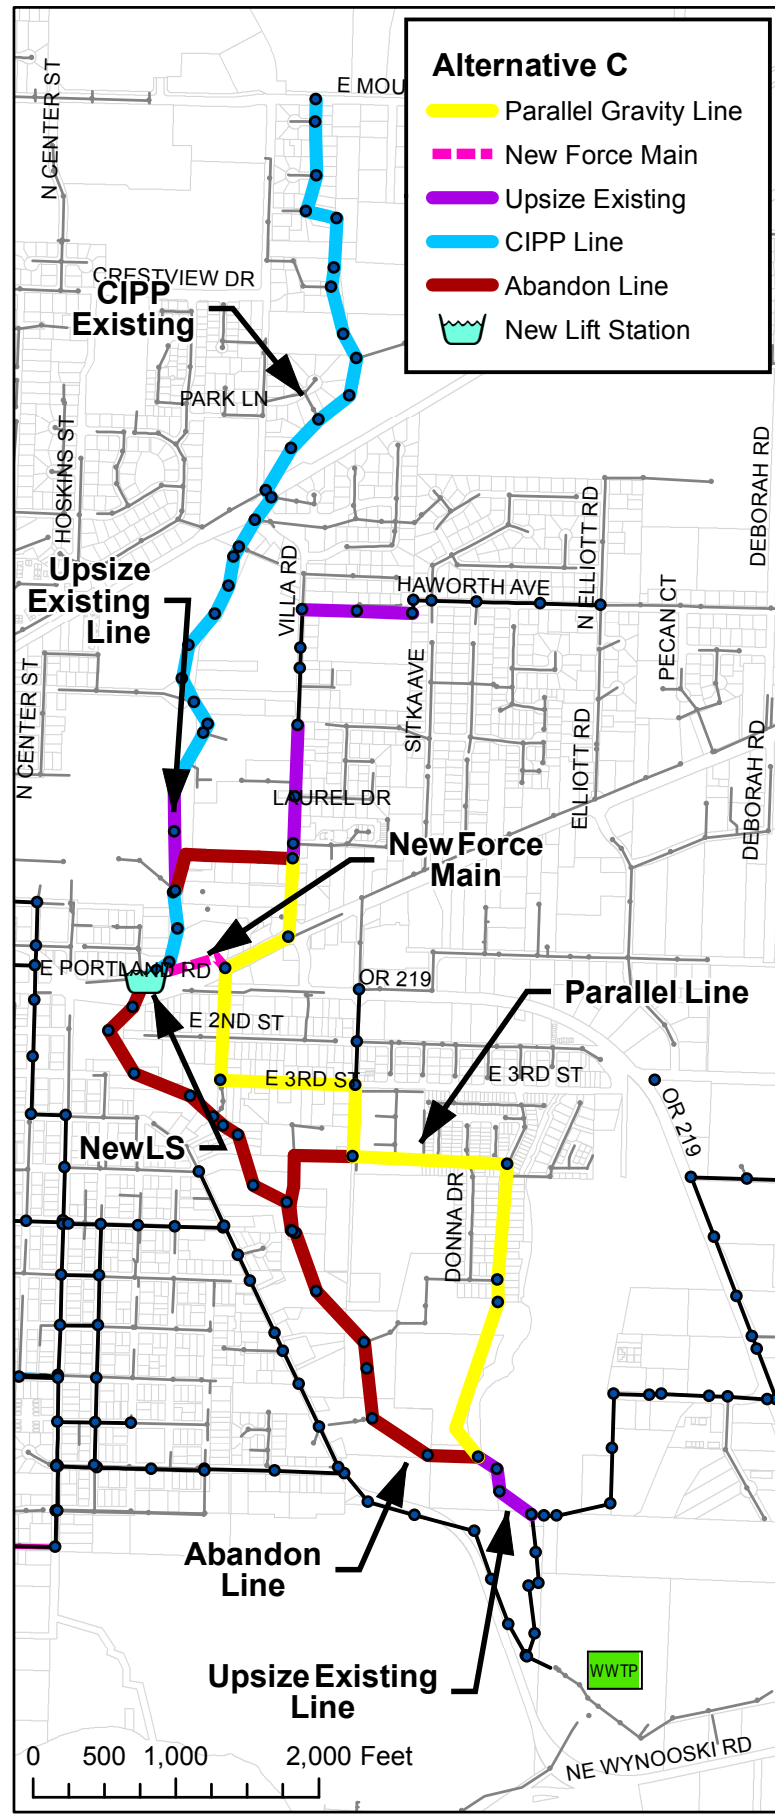
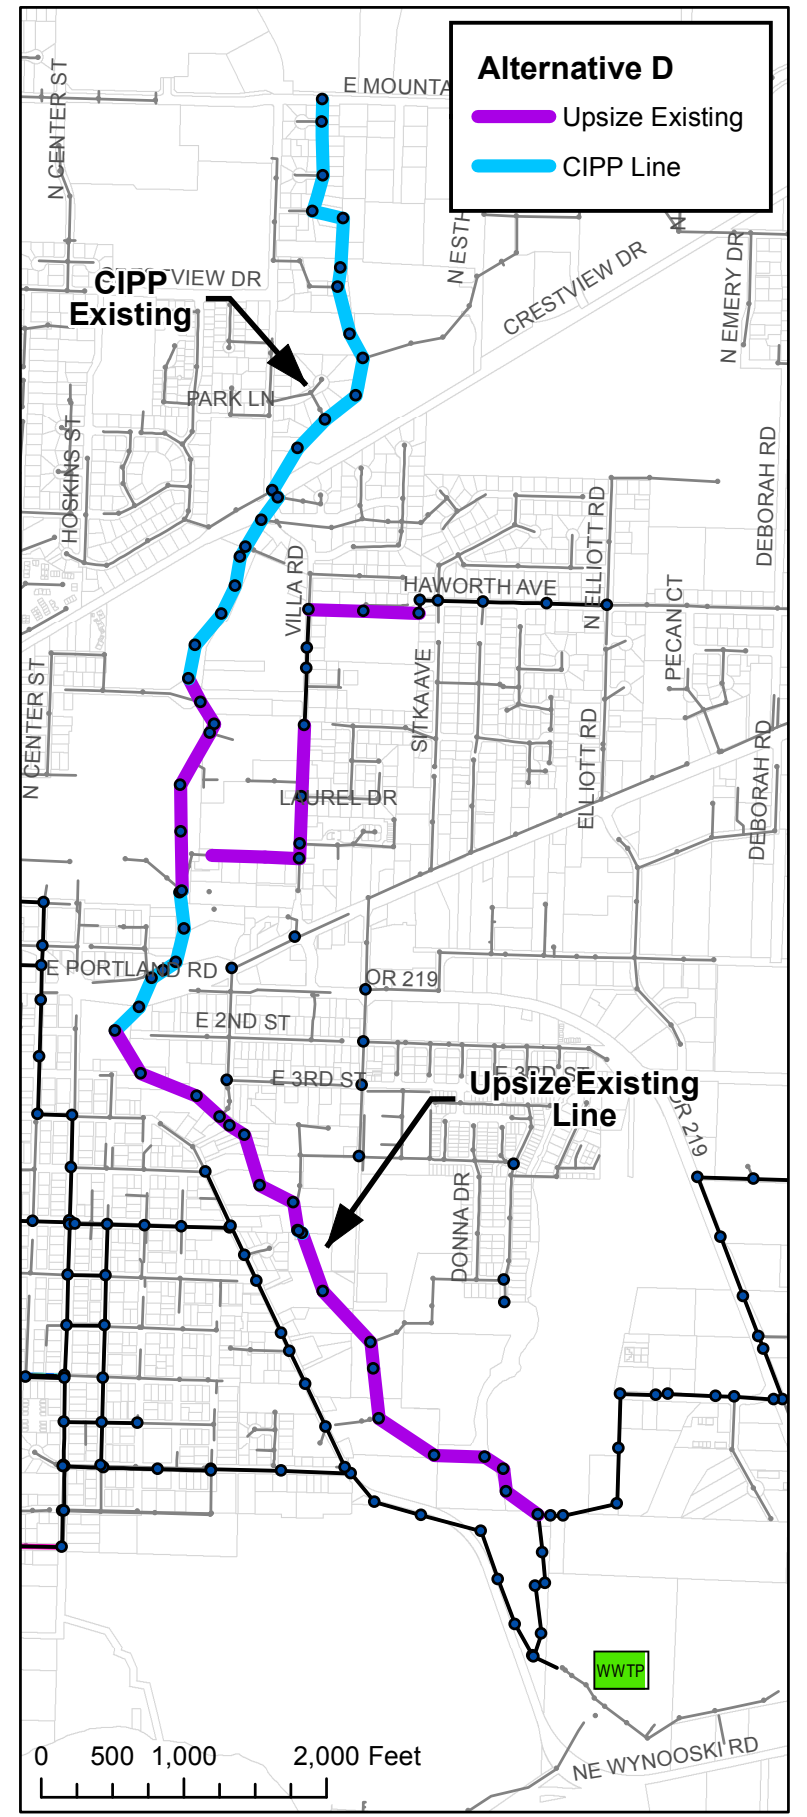
Hess Creek Alternatives

City staff have observed evidence of overflows along the Hess Creek trunk line and on Villa Road. The trunk line in Hess Creek is limited in capacity and also presents numerous maintenance problems and costs. Maintenance access varies along the pipeline from completely inaccessible along the lower and upper portions to fairly good in the vicinity of George Fox University. Figure 16 (Appendix A) illustrates the four alternatives summarized below that have been explored to rehabilitate and/or replace sections of the Hess Creek trunk line. Alternatives to address the deficiencies for the Villa Road pipeline are also included in the combined alternatives described below.

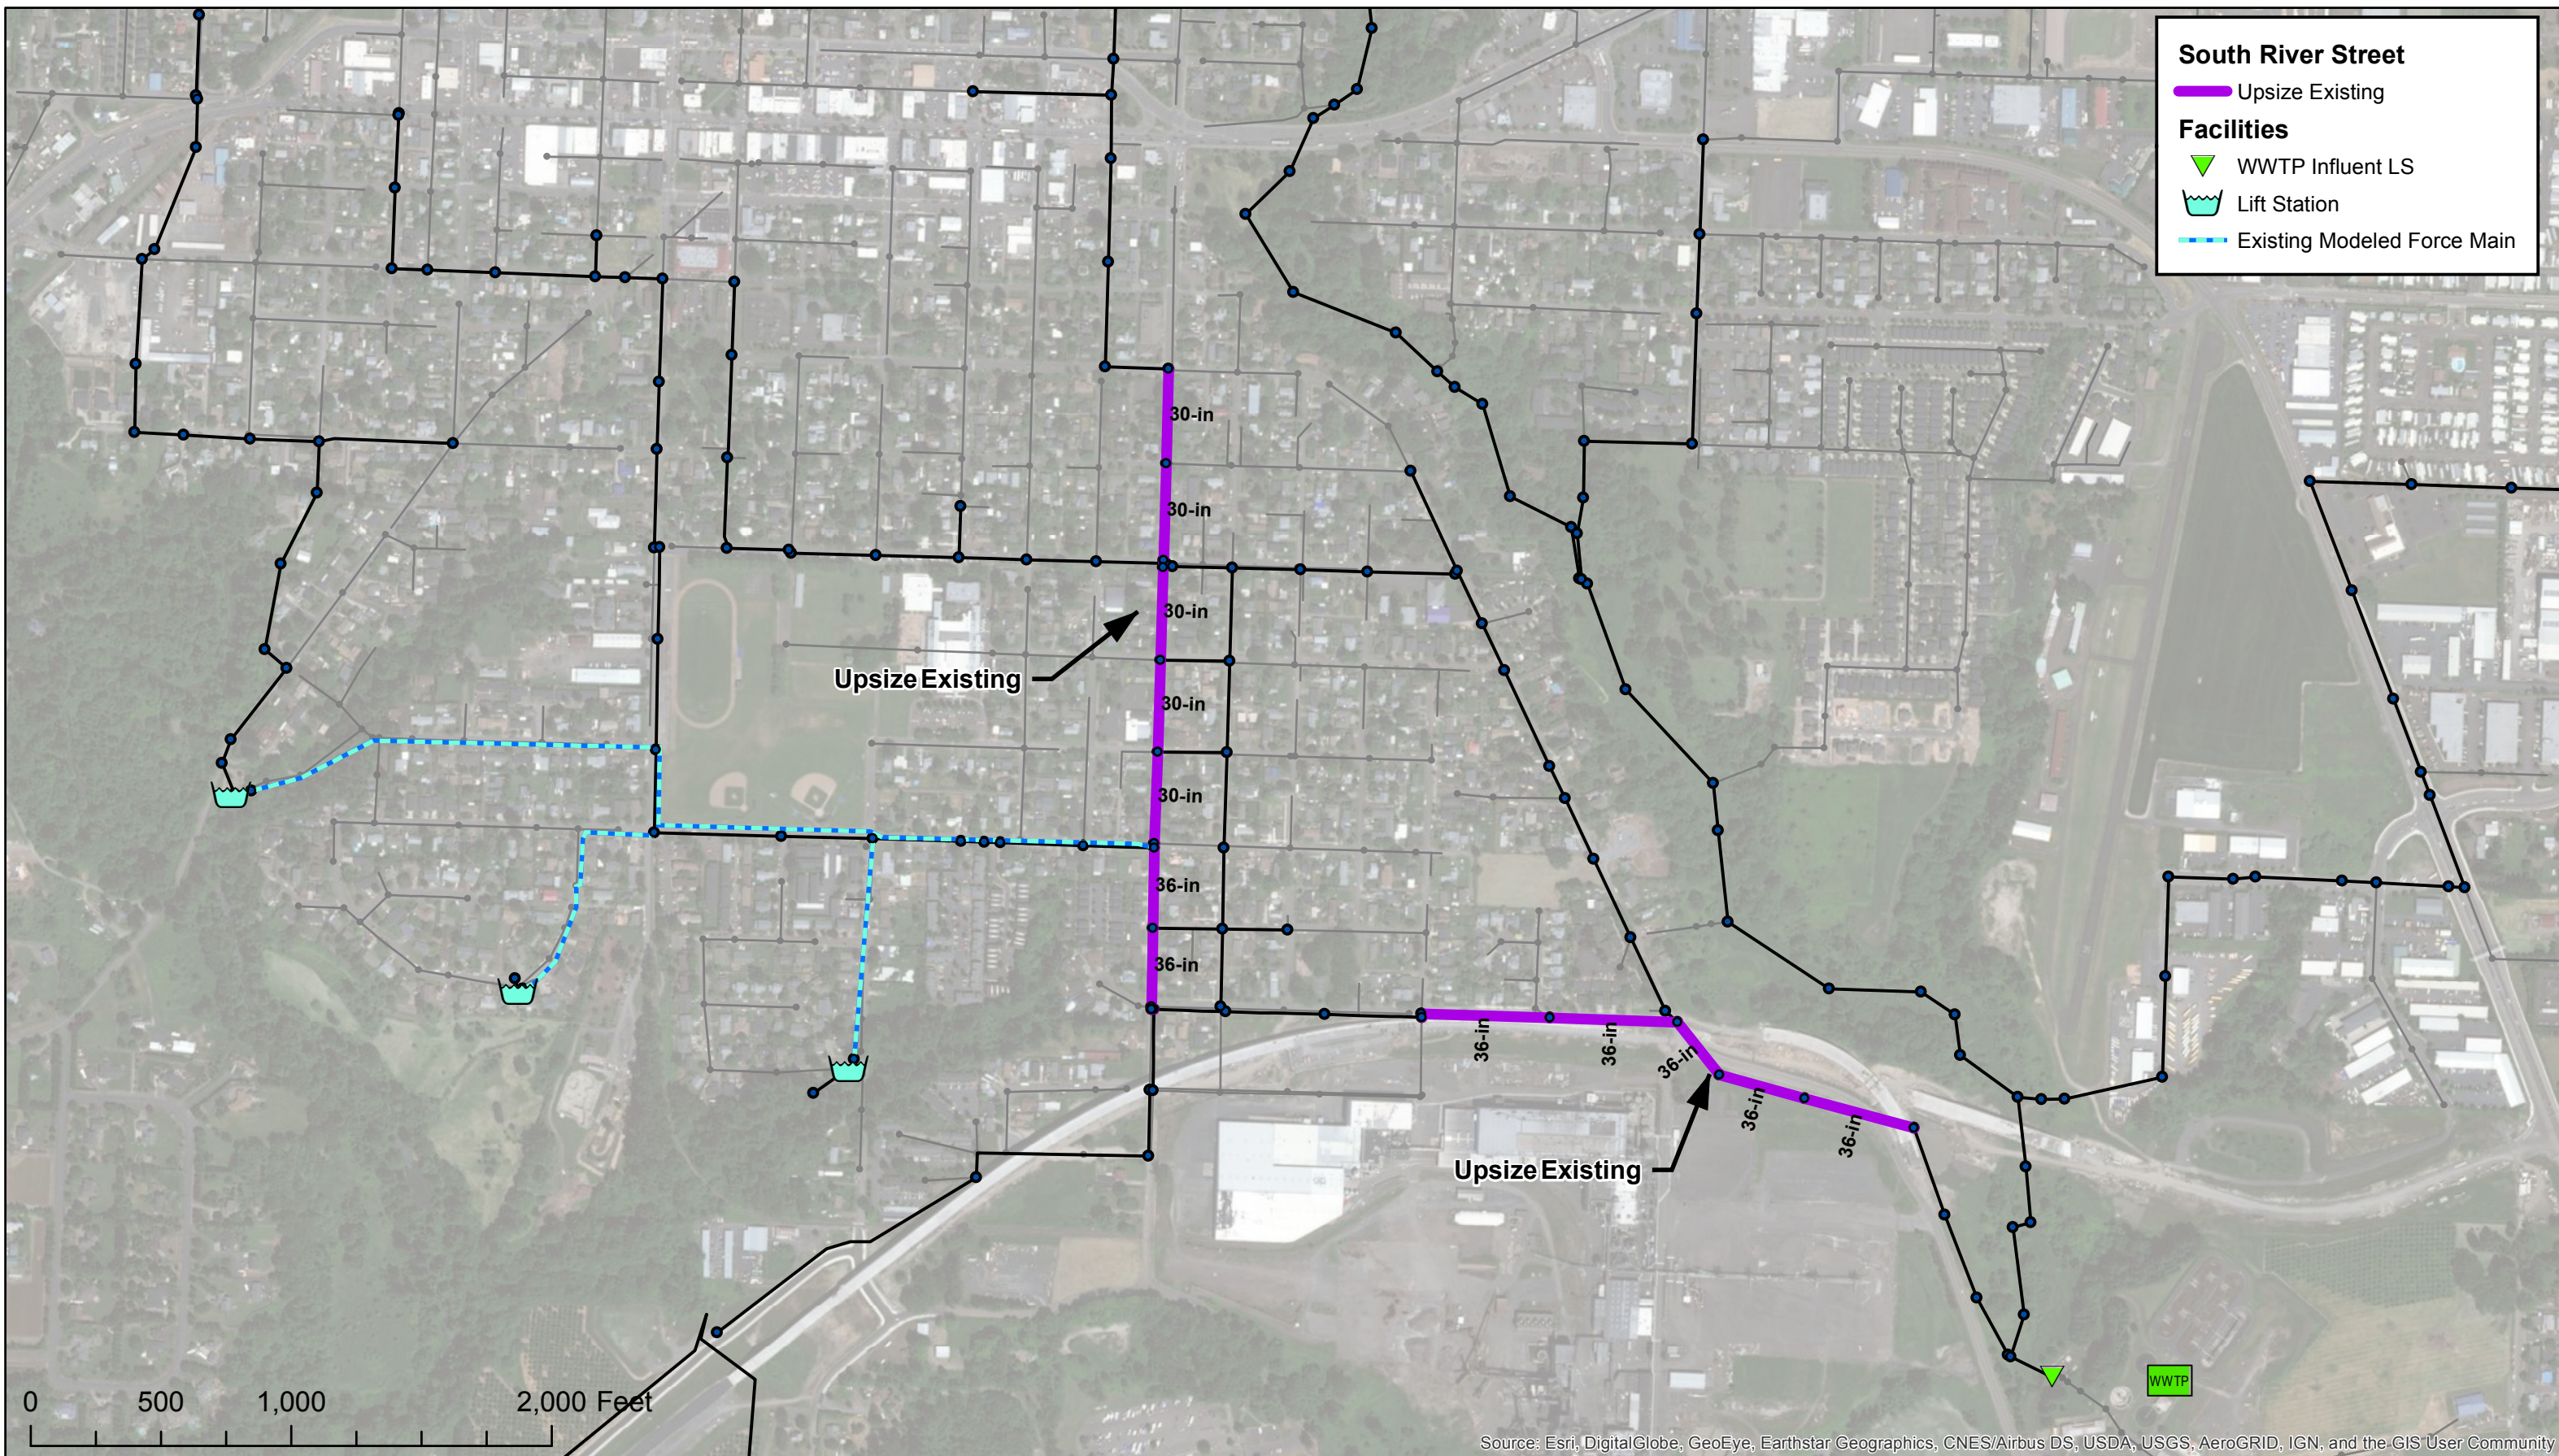
Figure 17

South River Street Improvements

Capacity deficiencies along the South River Street trunk line cause capacity issues upstream along South Blaine, Howard, and Chehalem Streets; and East 6th and 9th Streets. To alleviate these capacity issues, approximately 1,900 linear feet would be upsized from 21-inch to 30-inch diameter along South River Street between East 4th and 9th Streets. In addition, approximately 3,200 linear feet of 36-inch diameter pipeline would replace existing 30-inch diameter pipeline along South River Street south of East 9th Street, and along East 11th Street and Wynooski Street. (Figure 18). This new 36-inch diameter pipeline on East 11th Street and Wynooski Street would result in smaller diameter downstream pipelines. There are three 30-inch diameter segments (approximately 800 feet total) and one 24-inch diameter segment (approximately 300 feet) downstream of the improvements. The 24-inch diameter segment has a significantly higher slope than the other segments, which prevents it from being capacity limiting. During preliminary design it should be determined if the downstream pipeline should be replaced to match the upstream pipeline size. The cost estimate for these improvements is summarized in Table 6-6.

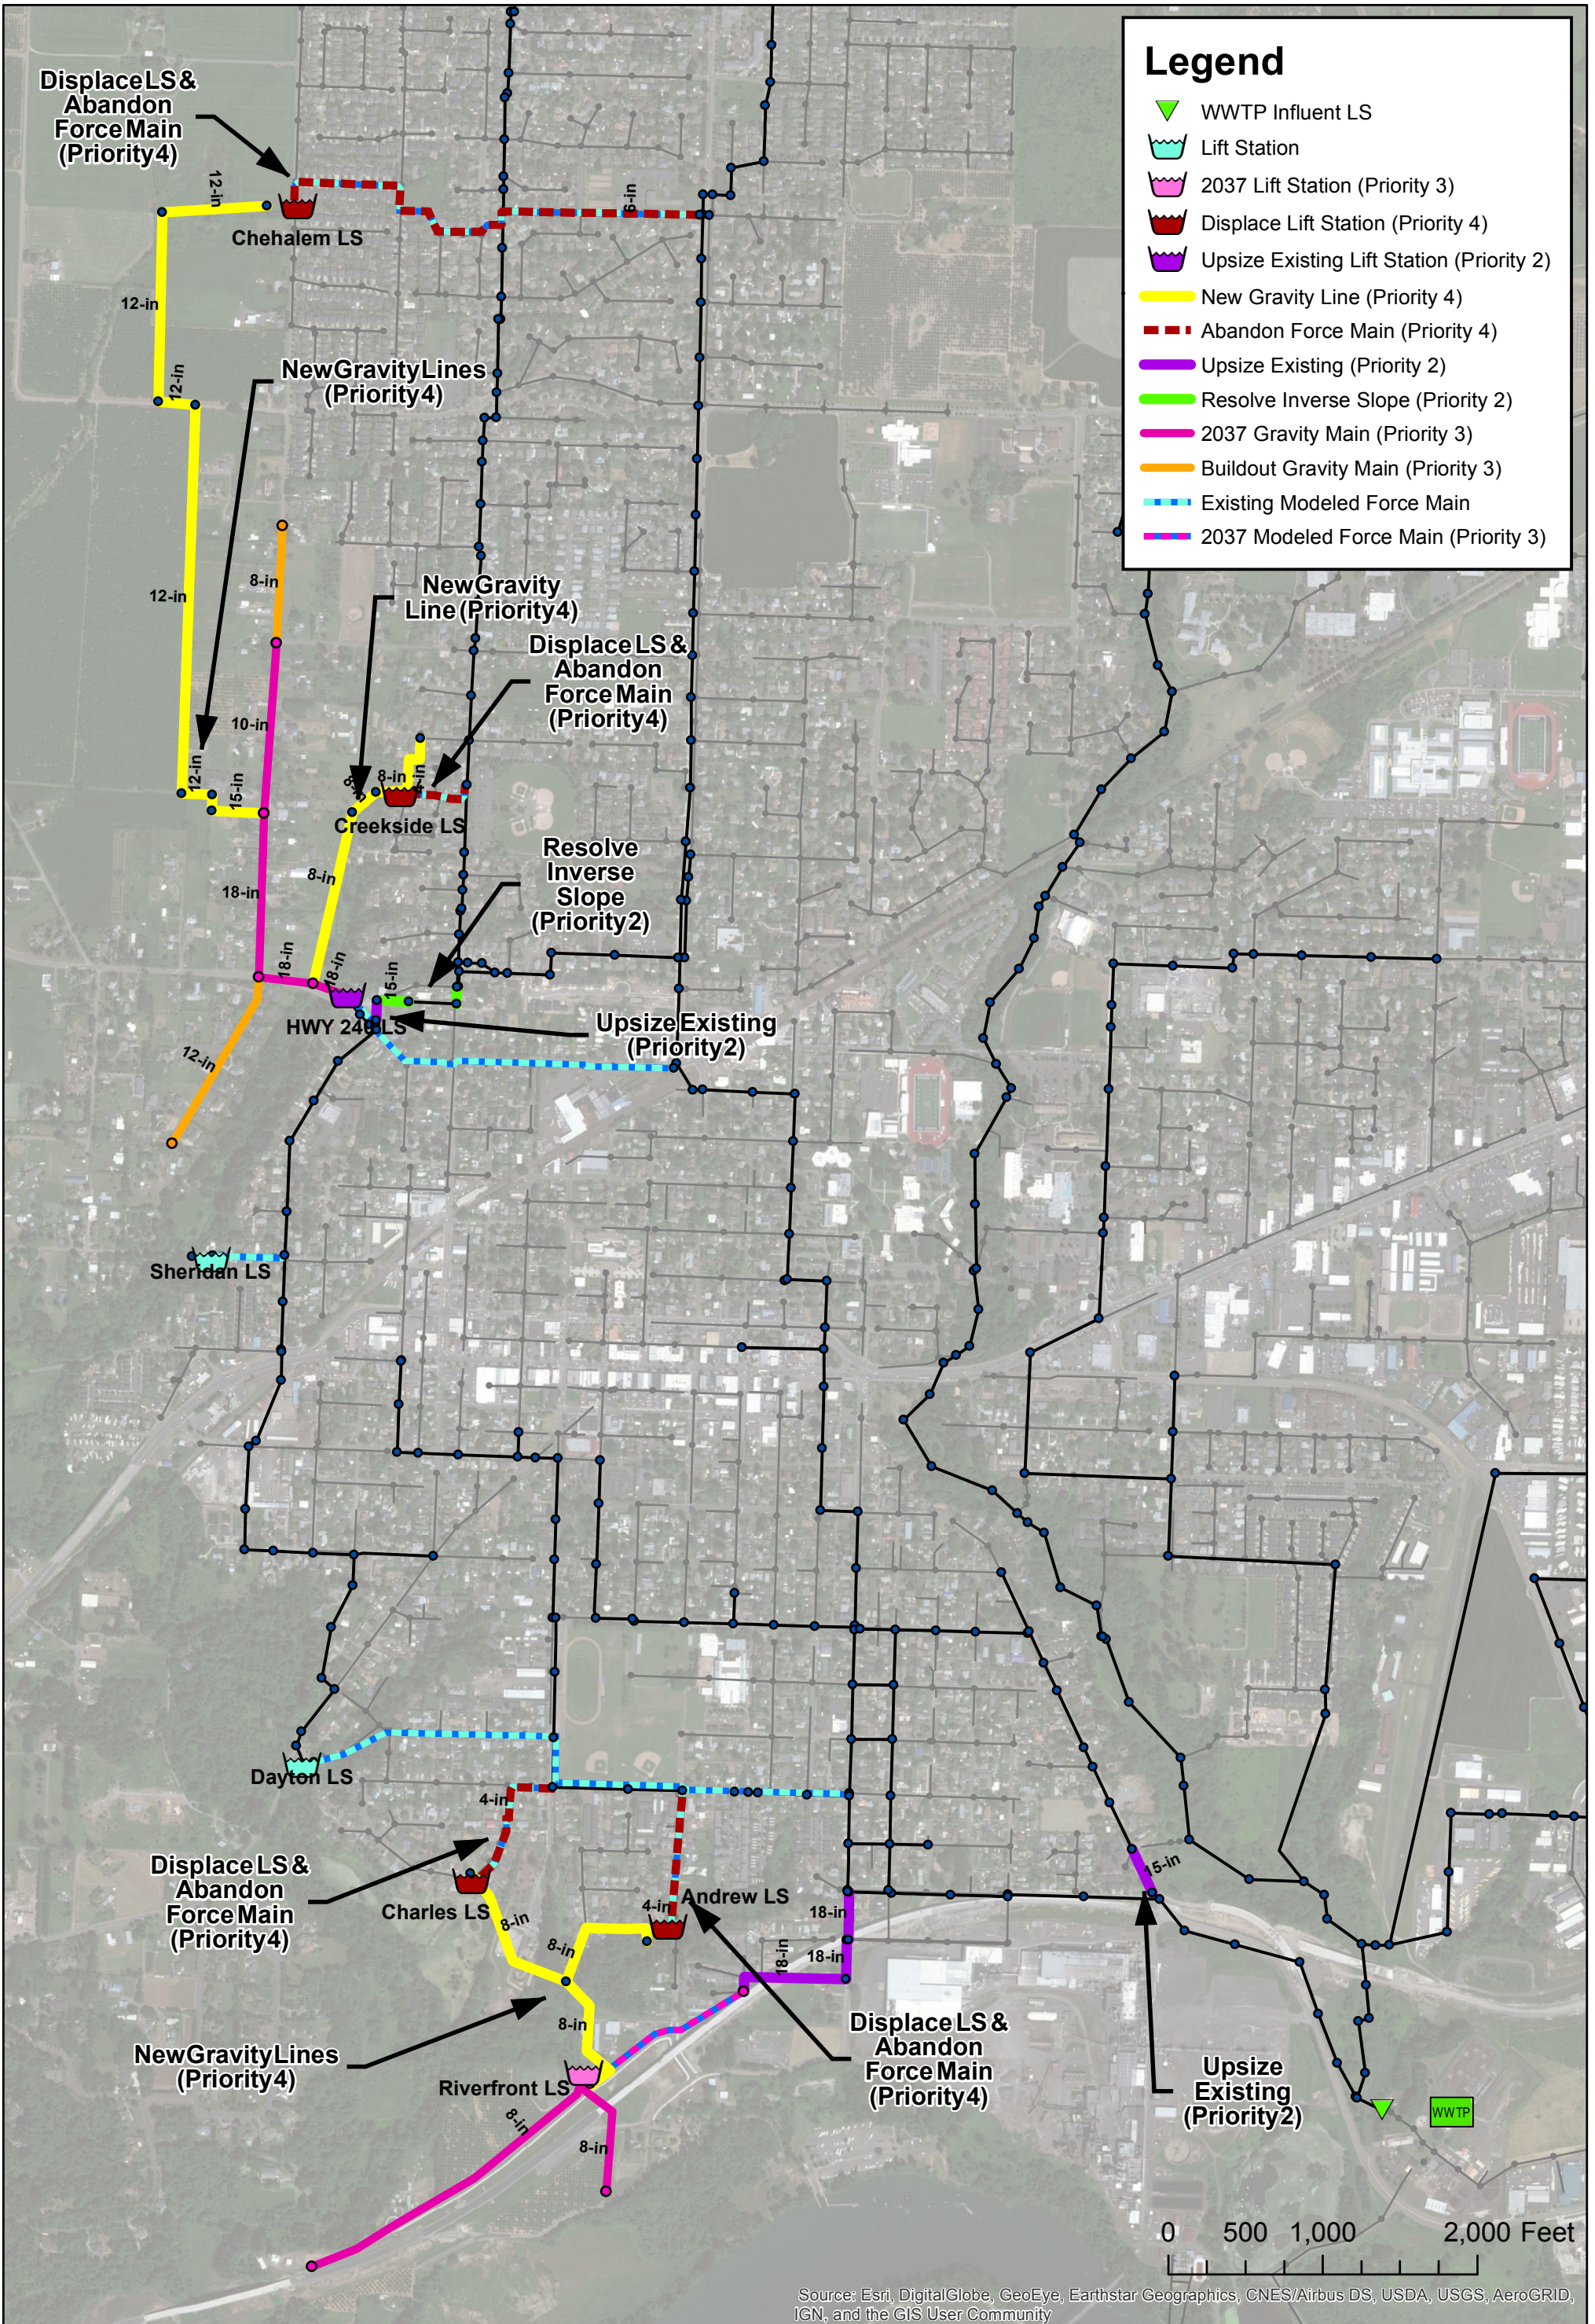
Figure 18

Additional Improvements & Lift Station Consolidation

It is recommended the pipeline segment on Wyooski Street north of East 11th Street be upsized from 10-inch to 15-inch diameter pipeline to alleviate surcharging along Wyooski Street (Figure 19). There is a short segment of 10-inch diameter pipeline downstream of this segment that has a steep slope that prevents it from causing capacity deficiencies. During preliminary design it can be determine if this segment should be replaced to match the upstream pipeline size. Cost estimates for both North Main Street and Wyooski Street Improvements are summarized in Table 6-8.

In addition to serving future development, this infrastructure could allow for the displacement of Chehalem and Creekside Lift Stations. Additional gravity pipelines with approximate alignments shown in Figure 19 could transport Chehalem and Creekside Lift Station flows to the HWY 240 Lift Station. This infrastructure is recommended to decrease the capital cost and O&M required to continue operation of the two lift stations. The vertical alignment of Phase 1 improvements would need to be lower in general to facilitate the displacement of Chehalem and Creekside Lift Stations. Phase 3 in Table 6-10 summarizes the cost estimate for these changes.

Future infrastructure in the Riverfront area will be necessary to service developments predicted in the next 20 years. Approximate regional lift station, force main, and gravity main locations are shown in Figure 19. See lift station displacement considerations below that impact the vertical alignment of the lift station. The force main discharge near East 12th Street will require upsize of the downstream pipeline. Cost estimates for the recommended infrastructure and improvements are in summarized as Phase 1 in Table 6-11.

In addition to serving future development, this infrastructure could allow for the displacement of Andrew and Charles Lift Stations. Additional gravity pipelines with approximate alignments shown in Figure 19 could transport Andrew and Charles Lift Station flows to the new, regional Riverfront Lift Station. This infrastructure is recommended to decrease the capital cost and O&M required to continue operation of the two existing lift stations. The vertical alignment of Phase 1 improvements should consider the displacement of Andrew and Charles Lift Stations during design phase. The estimated cost of displacement and new gravity pipelines for Andrew and Charles Lift Stations is summarized in Phase 2 in Table 6-11.

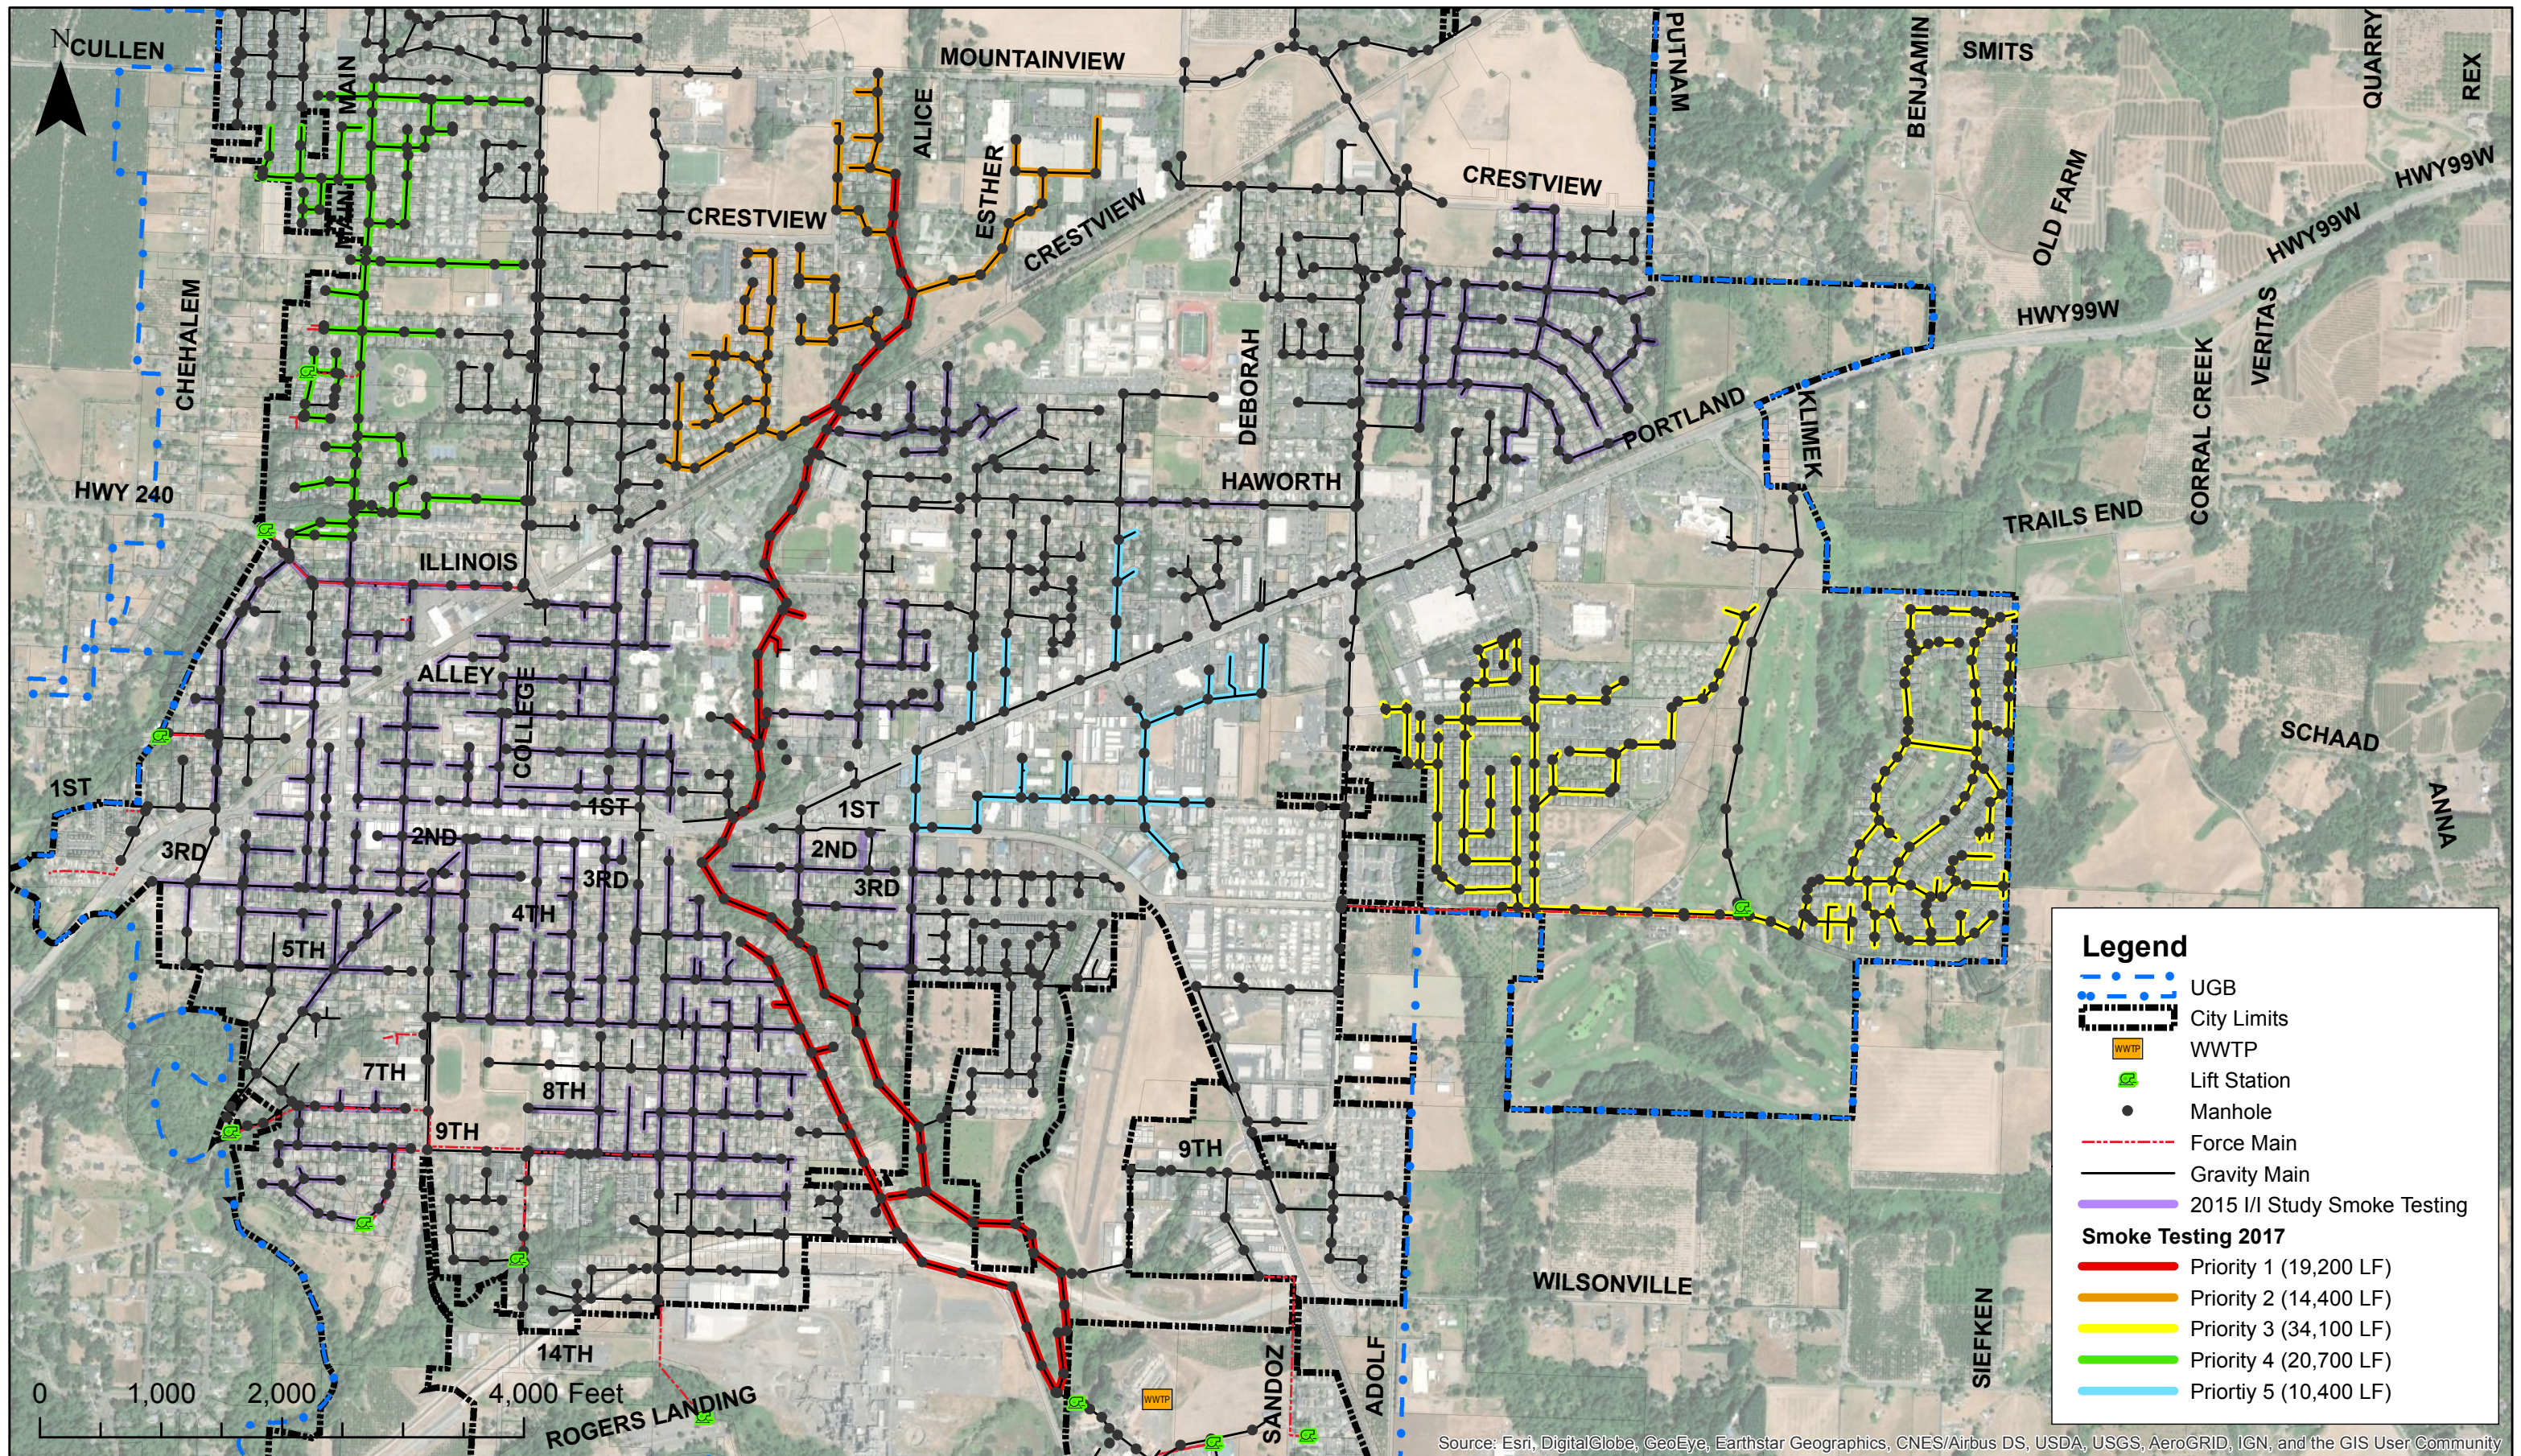
2017 Smoke Testing Priorities

Based on available pump run and flow analysis, pipe age and material, previous experience from the 2015 I/I Study, and input from City staff, areas of the system were prioritized for smoke testing. Figure 25 in Appendix A shows the areas included in smoke testing for the 2015 I/I Study and prioritized areas for smoke testing for this master plan. The length of pipe smoke tested for the 2015 I/I Study totaled 110,000 linear feet. For this master plan, we prioritized 98,800 linear feet for smoke testing and completed nearly all of that linear footage as shown in Figure 26 in Appendix A. Due to the results of the pump run analysis, priority area 3 (Fernwood) was included in the targeted smoke testing areas. Priority areas 1 and 2 were targeted to investigate the Hess Creek trunk line. Priority 4 was targeted as a residential area. Priority 5 was targeted as a commercial/industrial area.
