REQUEST: A Resolution recommending City Council amend the 2018 Wastewater Master Plan incorporating the 2021 Riverfront Addendum into the Newberg Comprehensive Plan

Wastewater Master Plan

May 2018

*Technical Update May 2021
Addendum - Riverfront
Master Plan (Appendix K)*

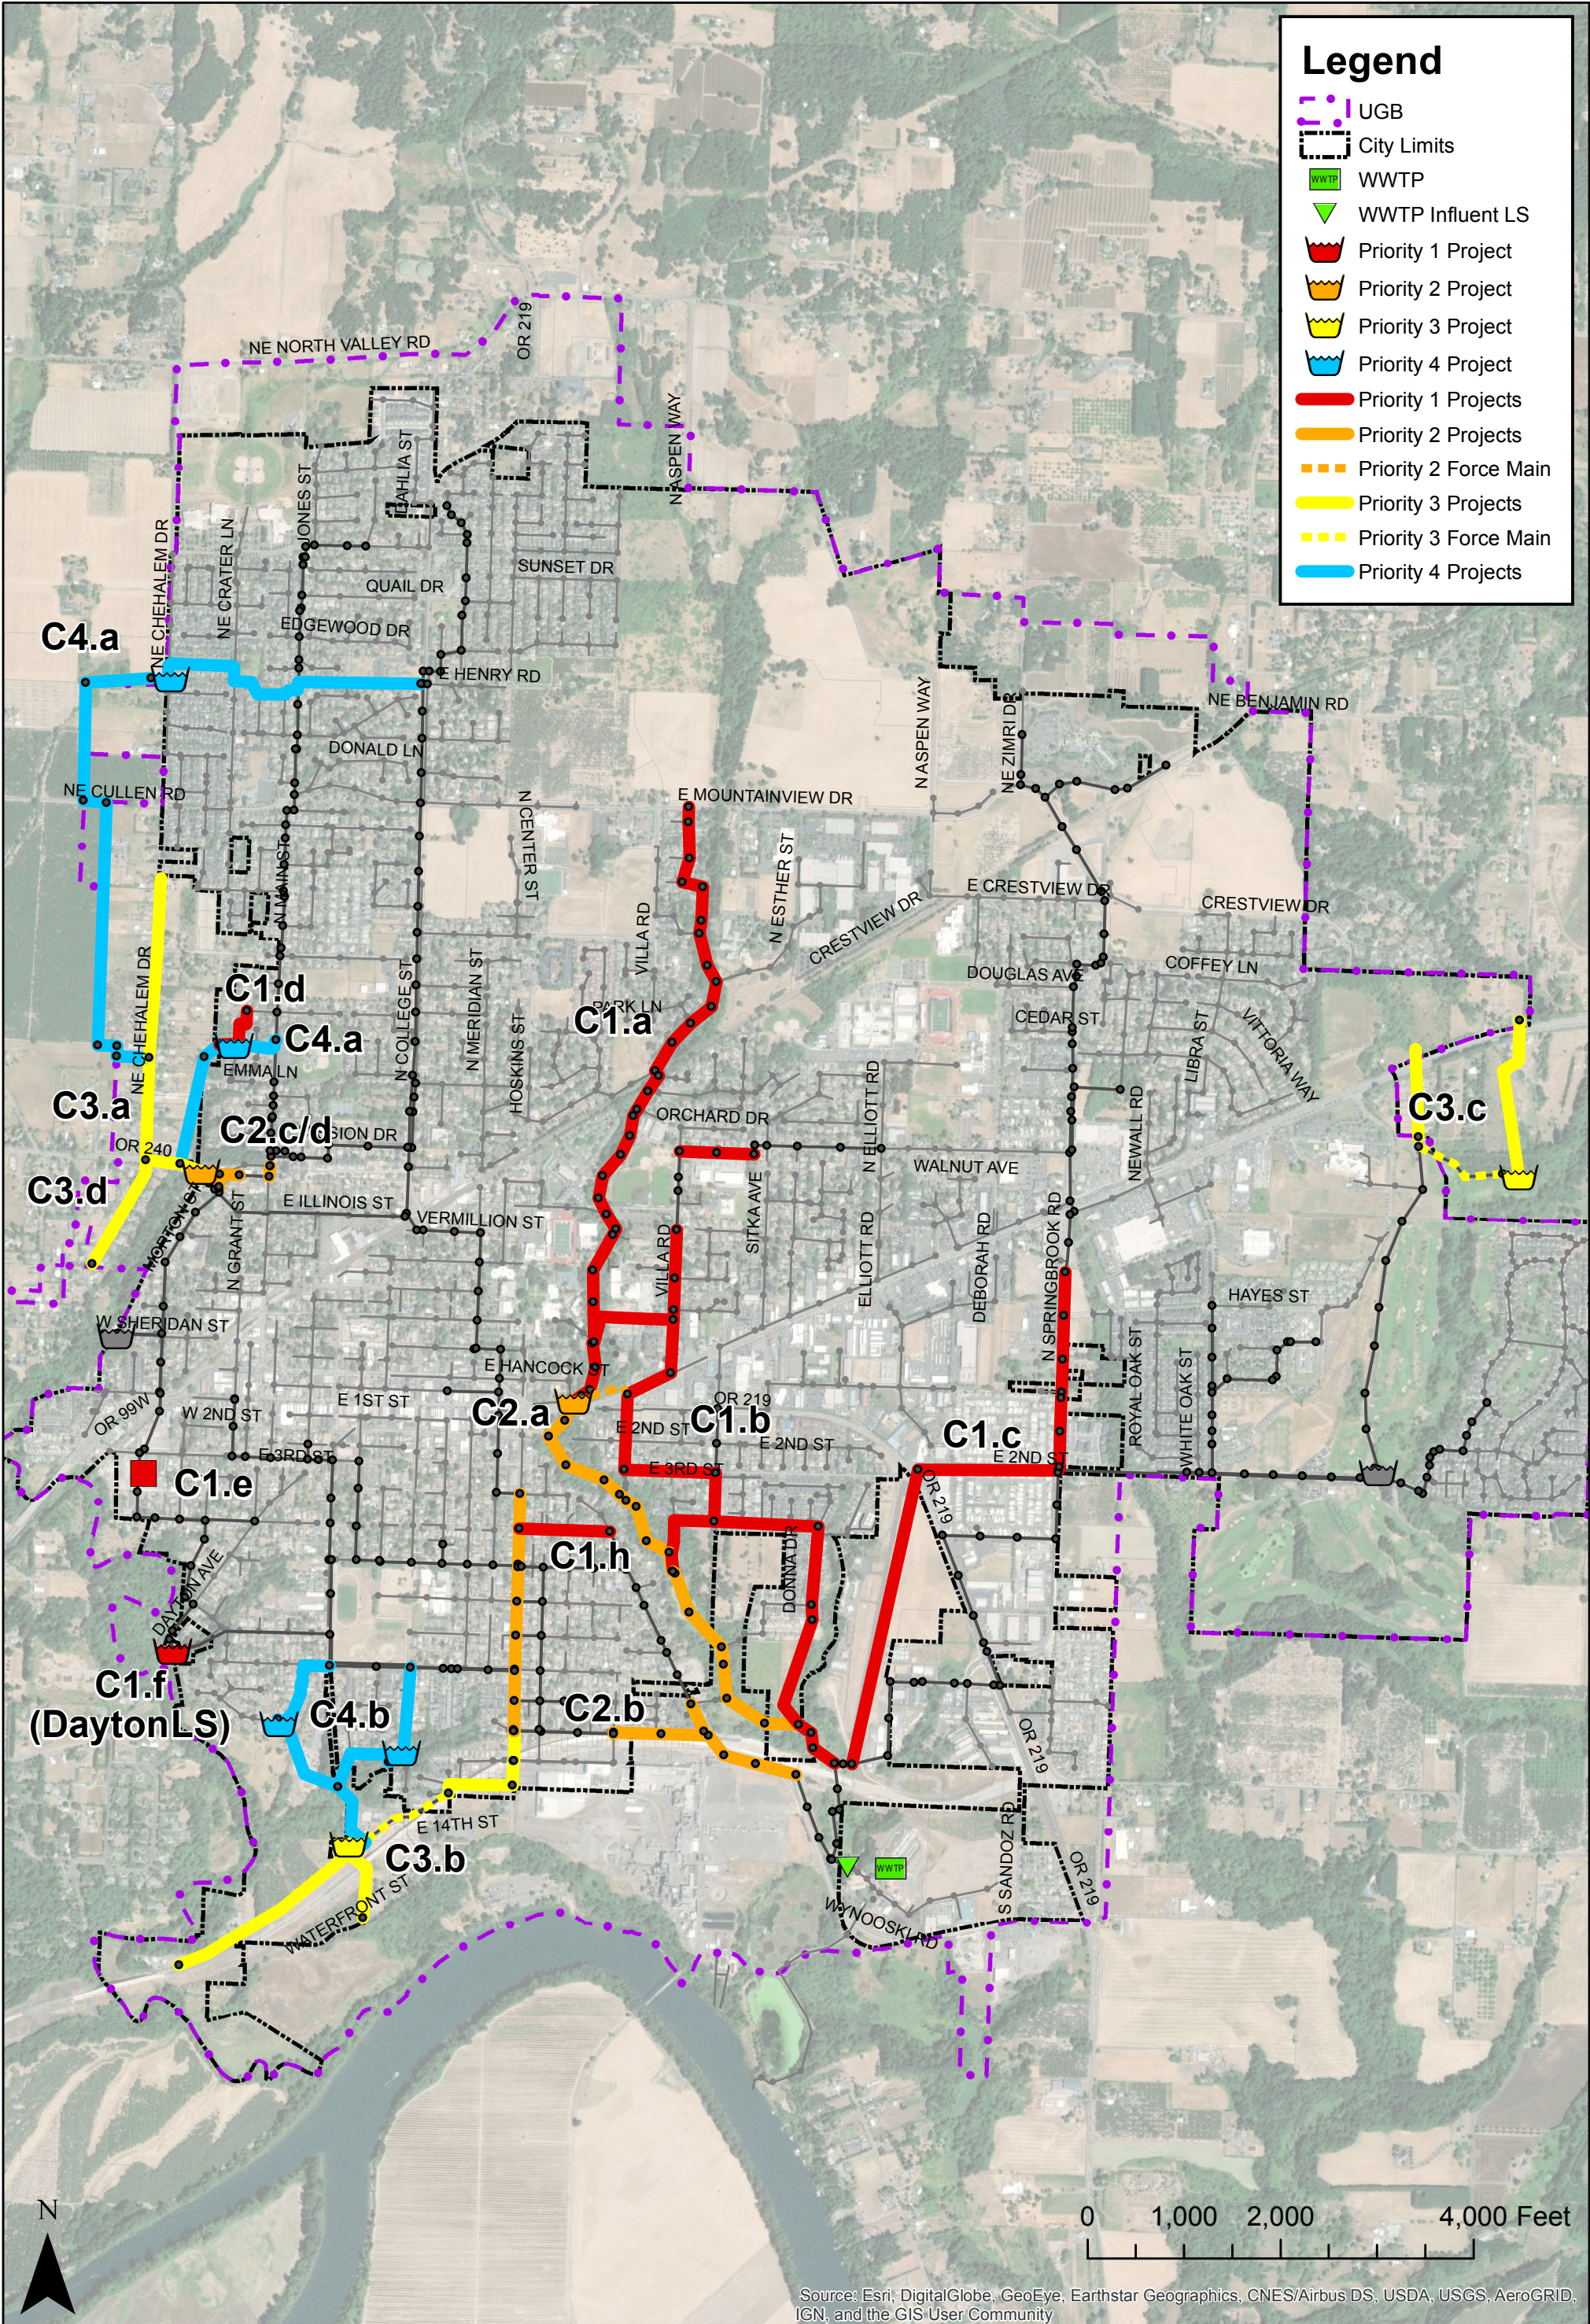
Figure 28

Note: See Appendix K, Addendum Riverfront Master Plan (Adopted 5/3/21)

Collection System CIP

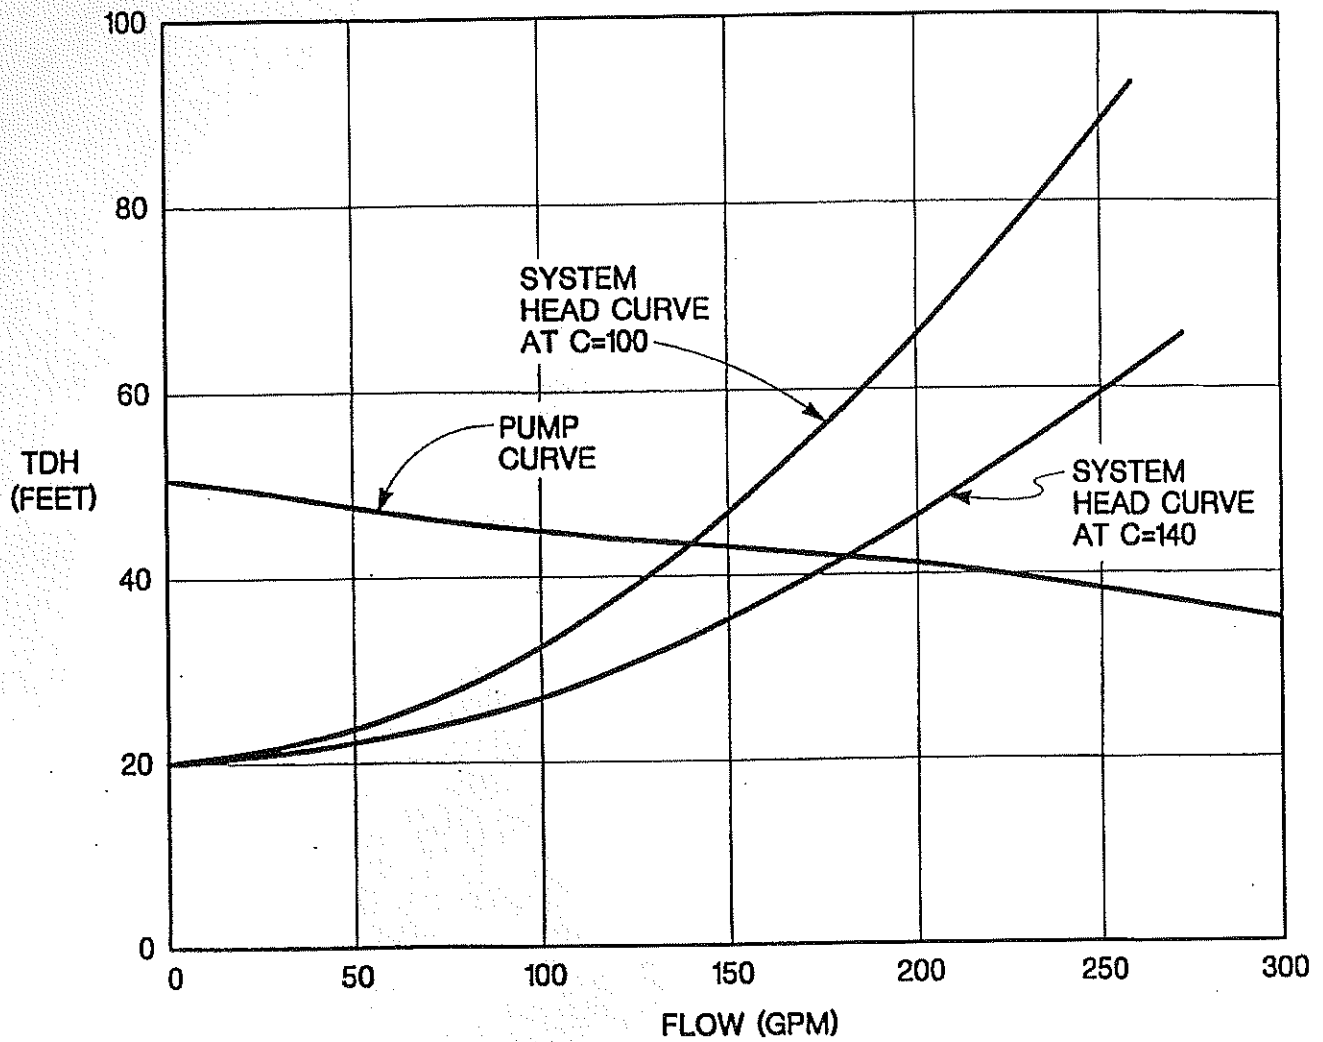
**CITY OF NEWBERG
 ANDREW STREET PUMP
 STATION SYSTEM CURVES**

PERFORMANCE CURVE			PRODUCT CP3127.090		TYPE MT	
DATE 2000-05-19		PROJECT Charles & Andrew Street Pump Sta			CURVE NO 63-434-00-2240		ISSUE 3	
POWER FACTOR	1/1-LOAD	3/4-LOAD	1/2-LOAD	RATED POWER	7.5	Hp	---	
	0.88	0.85	0.77	STARTING CURRENT ...	52	A	---	
EFFICIENCY	83.5 %	84.5 %	83.5 %	RATED CURRENT ...	9.6	A	MOTOR #	STATOR
MOTOR DATA	---	---	---	RATED SPEED	1740	rpm	21-10-4AL	12YSER
COMMENTS	INLET/OUTLET		IMP. THROUGHLET	TOT. MOM. OF	0.082	kgm ²	FREQ.	PHASES
	- /100 mm			INERTIA ...	---	---	60 Hz	3
		80 mm		NO. OF	1		VOLTAGE	POLES
				BLADES			230 V	4
							GEARTYPE	RATIO
							---	---

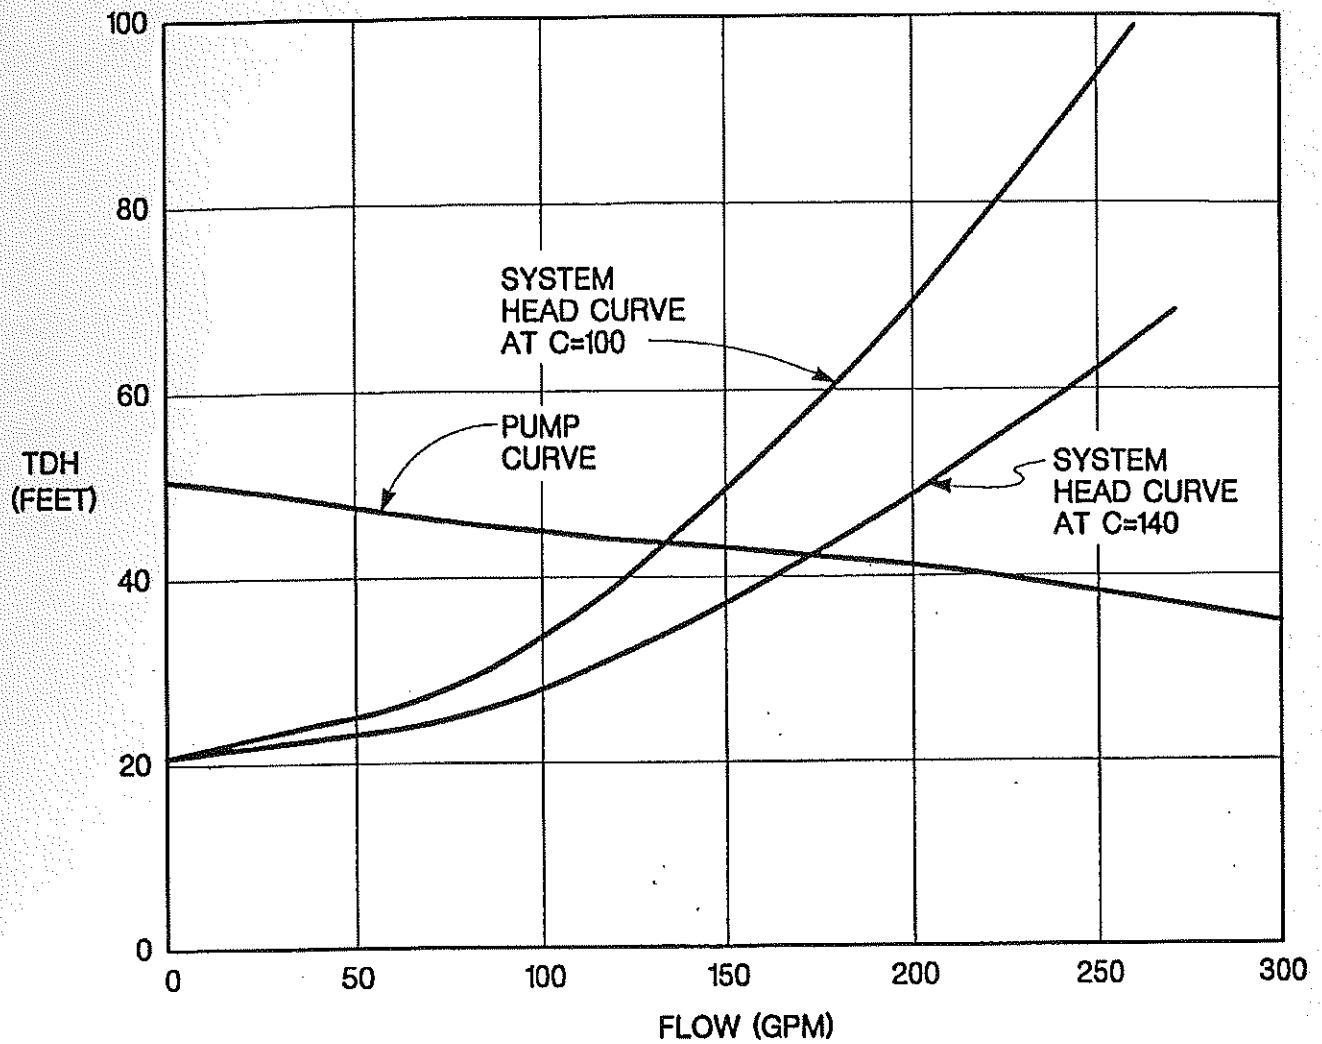
CITY OF NEWBERG
CHARLES STREET PUMP
STATION SYSTEM CURVES

PERFORMANCE CURVE		PRODUCT	CP3127.090	TYPE	MT
DATE	2000-05-19	PROJECT	Charles & Andrew Street Pump Sta	CURVE NO	63-434-00-2240	ISSUE	3
POWER FACTOR	0.88	1/1-LOAD	0.85	3/4-LOAD	0.77	1/2-LOAD	
EFFICIENCY	83.5 %		84.5 %		83.5 %		
MOTOR DATA	---			RATED POWER	7.5	Hp	
COMMENTS	INLET/OUTLET			STARTING CURRENT ...	52	A	MOTOR #
	- /100 mm			RATED CURRENT ...	9.6	A	21-10-4AL
	IMP. THROUGHLET			RATED SPEED	1740	rpm	STATOR
	80 mm			TOT.MOM.OF INERTIA ...	0.082	kgm2	12YSER
			NO. OF BLADES	1		REV	10
						FREQ.	60 Hz
						PHASES	3
						VOLTAGE	230 V
						POLES	4
						GEARTYPE	---
						RATIO	---

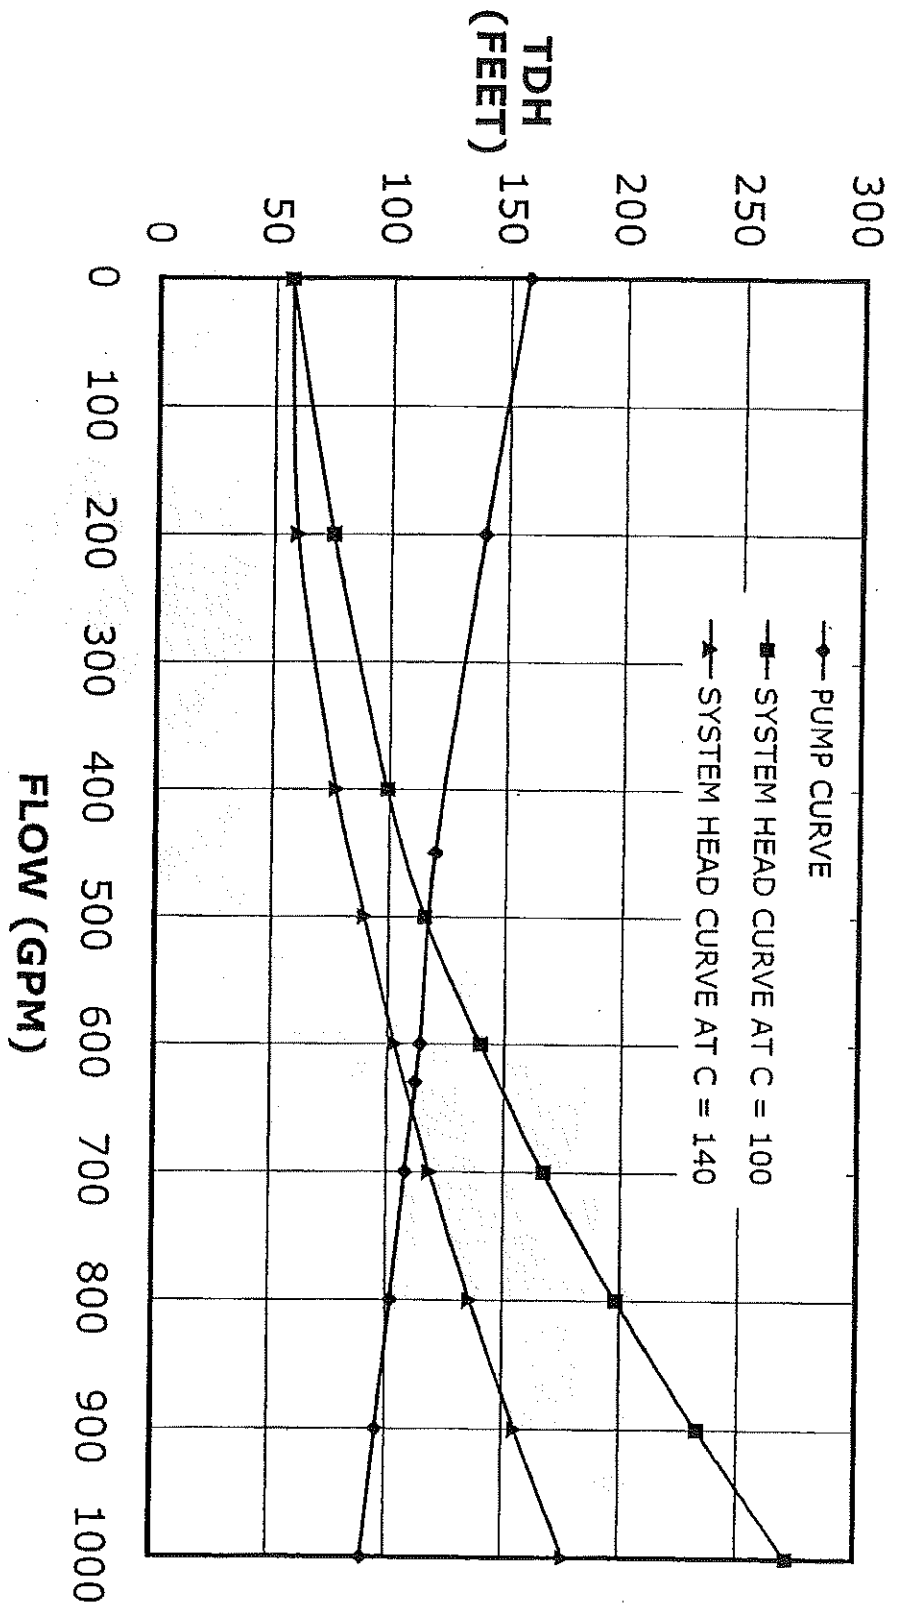
CITY OF NEWBERG CHEHALEM DRIVE PUMP STATION SYSTEM CURVES

FLYGT		PERFORMANCE CURVE			PRODUCT NP3171.090	TYPE HT
DATE 2003-09-03	PROJECT Newberg, Chehalem Dr. SPS			CURVE NO 63-453-00-6050	ISSUE 2	
POWER FACTOR	1/1-LOAD 0.83	3/4-LOAD 0.77	1/2-LOAD 0.66	RATED POWER 30 hp	IMPELLER DIAMETER 286 mm	
EFFICIENCY	89.5 %	90.5 %	90.0 %	STARTING CURRENT ... 257 A	MOTOR # 25-17-4AA	STATOR REV 07YSER
MOTOR DATA	---			RATED CURRENT ... 38 A	REV 10	
COMMENTS	INLET/OUTLET - /100 mm			RATED SPEED 1760 rpm	FREQ. 60 Hz	PHASES 3
	IMP. THROUGHLET ---			TOT.MOM.OF INERTIA ... 0.16 kgm2	VOLTAGE 460 V	POLES 4
	---			NO. OF BLADES 2	GEARTYPE ---	RATIO ---

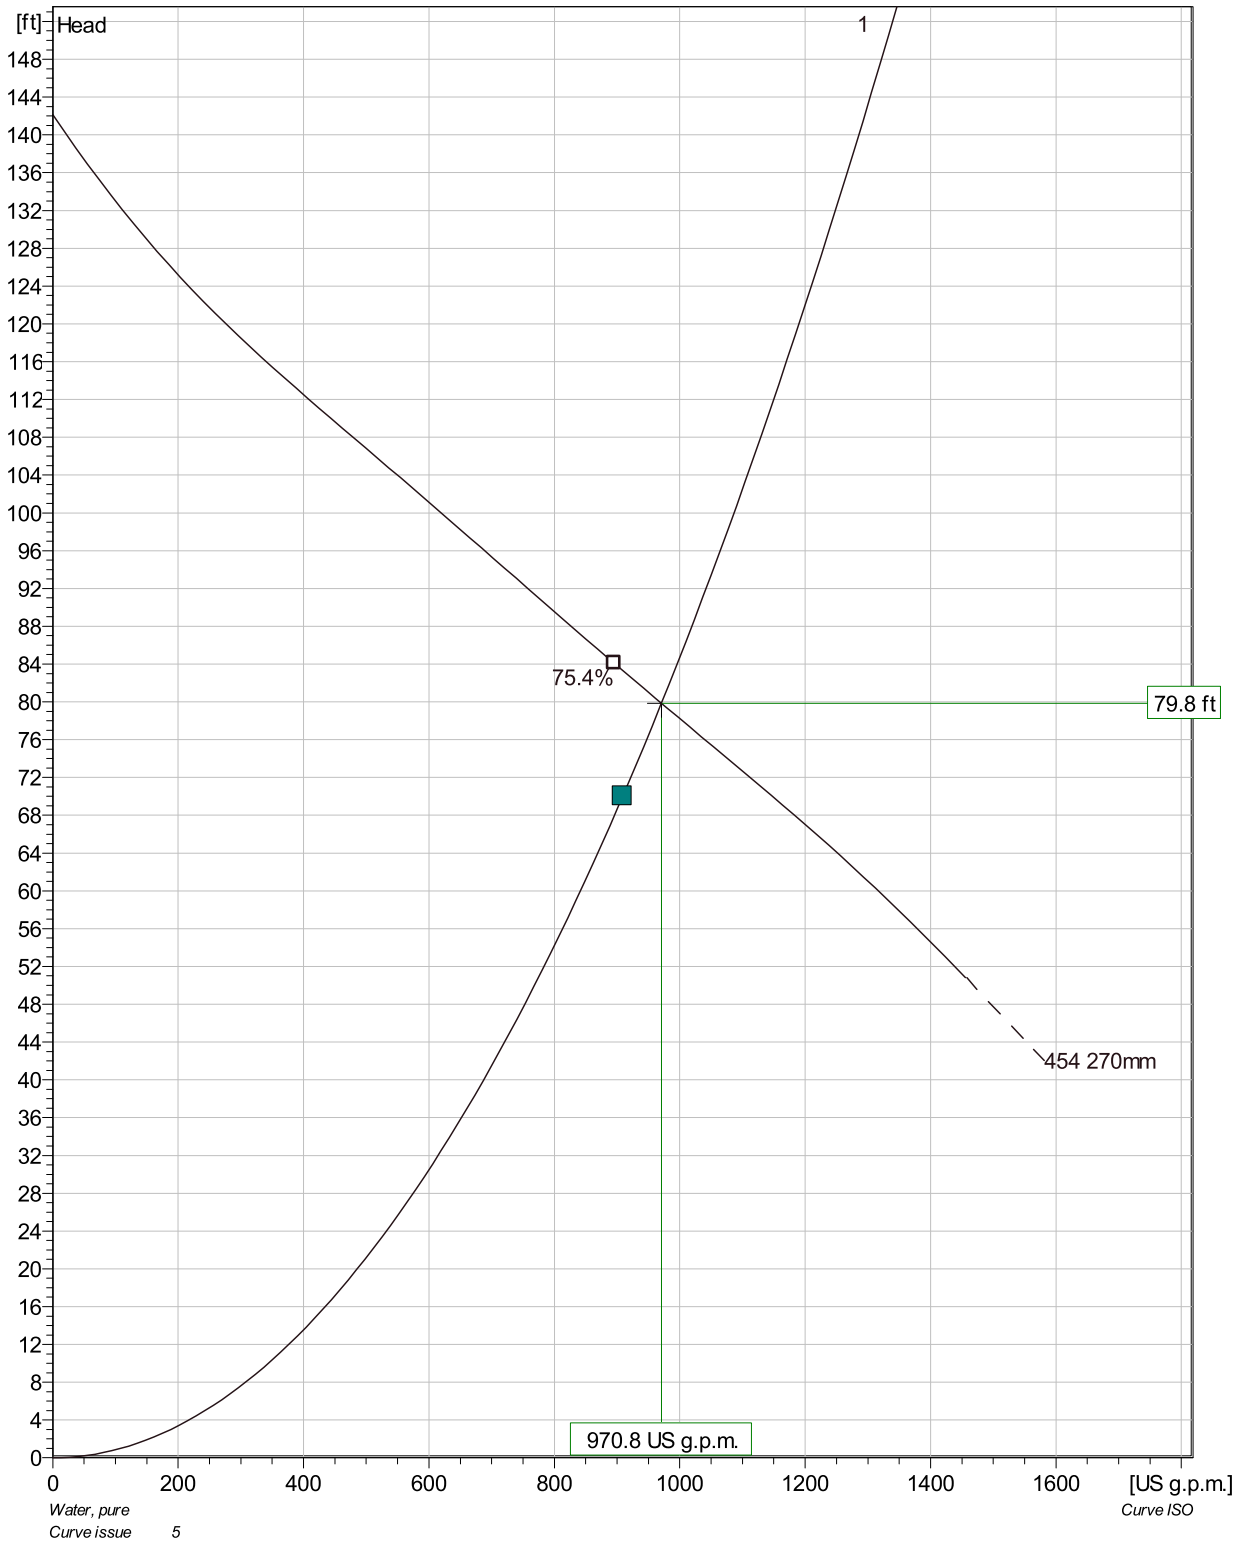
NP 3171 HT 3~ 454 Duty Analysis

Pumps running /System	Individual pump			Total					
	Flow	Head	Shaft power	Flow	Head	Shaft power	Pump eff.	Specific energy	NPSHre
1	971 US g.p.m.	79.8 ft	26.1 hp	971 US g.p.m.	79.8 ft	26.1 hp	75.2 %	372 kWh/US MG	18.2 ft

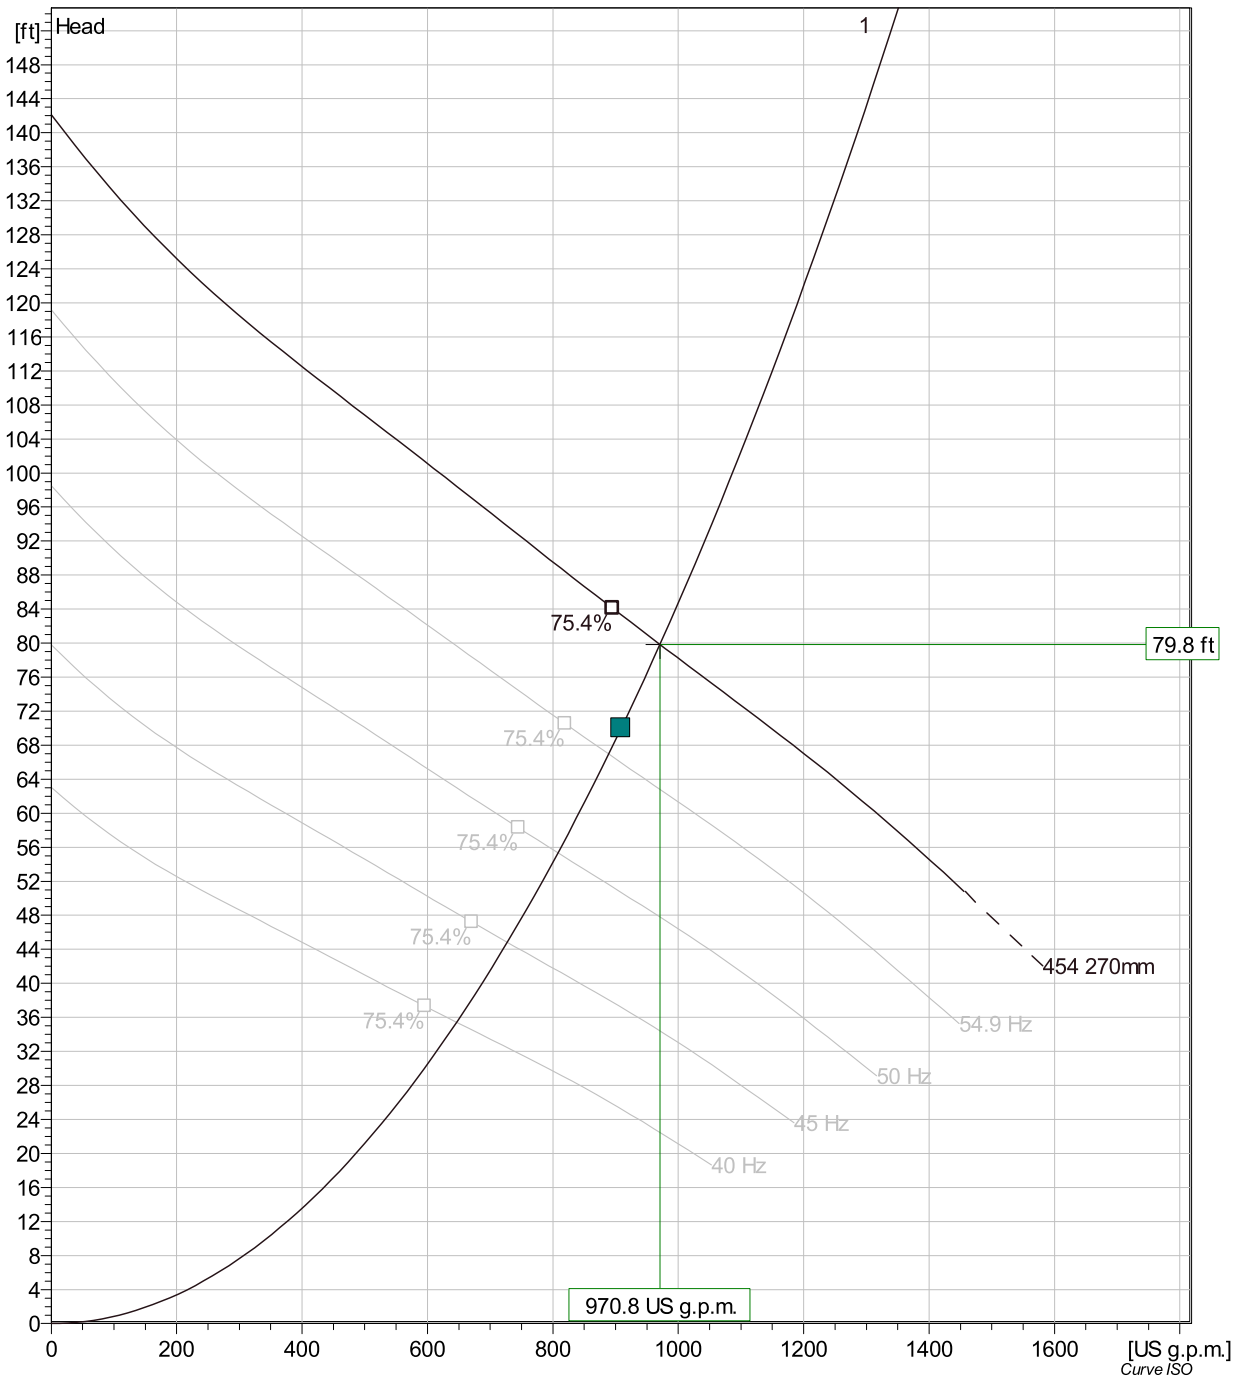
NP 3171 HT 3~ 454 VFD Analysis

Pumps running /System	Frequency	Flow	Head	Shaft power	Flow	Head	Shaft power	Hyd eff.	Specific energy	NPSHre
1	60 Hz	971 US g.p.m.	79.8 ft	26.1 hp	971 US g.p.m.	79.8 ft	26.1 hp	75.2 %	372 kWh/US MG	18.2 ft
1	54.9 Hz	889 US g.p.m.	67 ft	20 hp	889 US g.p.m.	67 ft	20 hp	75.2 %	309 kWh/US MG	15.8 ft
1	50 Hz	808 US g.p.m.	55.3 ft	15.1 hp	808 US g.p.m.	55.3 ft	15.1 hp	75.2 %	256 kWh/US MG	13.5 ft
1	45 Hz	727 US g.p.m.	44.8 ft	11 hp	727 US g.p.m.	44.8 ft	11 hp	75.2 %	209 kWh/US MG	11.4 ft
1	40 Hz	647 US g.p.m.	35.4 ft	7.71 hp	647 US g.p.m.	35.4 ft	7.71 hp	75.2 %	168 kWh/US MG	9.48 ft

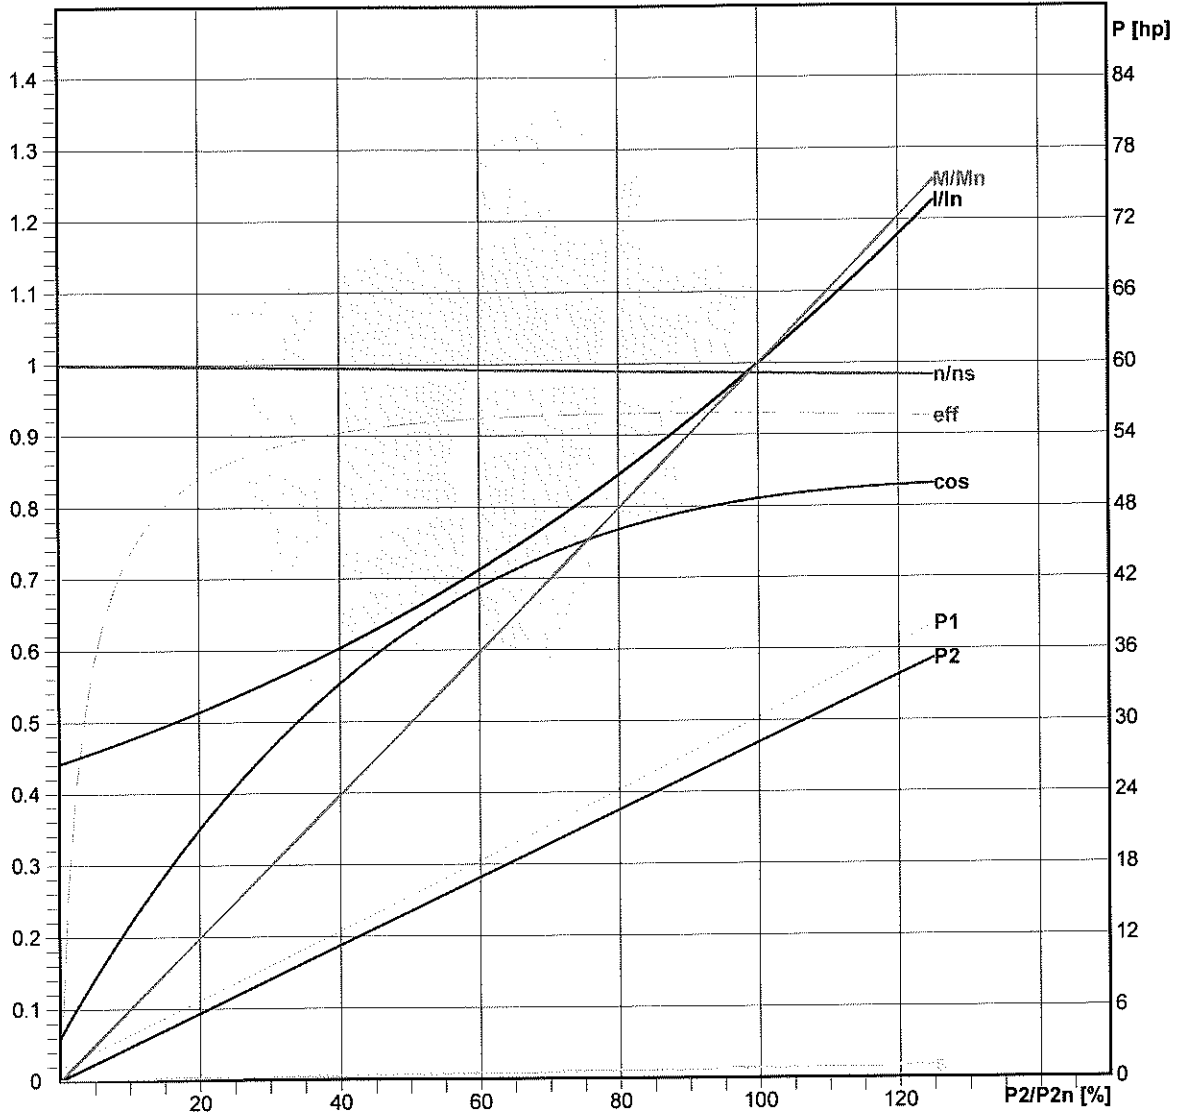
Loading	No load	25 %	50 %	75 %	100 %	125 %
P1 [hp]	0.9888	8.141	15.36	22.73	30.28	38.06
P2 [hp]	0	7.04	14.08	21.12	28.16	35.2
I [A]	15.43	18.67	22.89	28.29	34.96	42.87
eff [%]	0	86.48	91.69	92.91	93	92.48
cos	0.05999	0.4081	0.6279	0.7521	0.8107	0.831
n [rpm]	1199	1196	1192	1188	1184	1179
M [lbf ft]	0	30.92	62.04	93.38	124.9	156.8
s [%]	0.08333	0.3333	0.6667	1	1.333	1.75

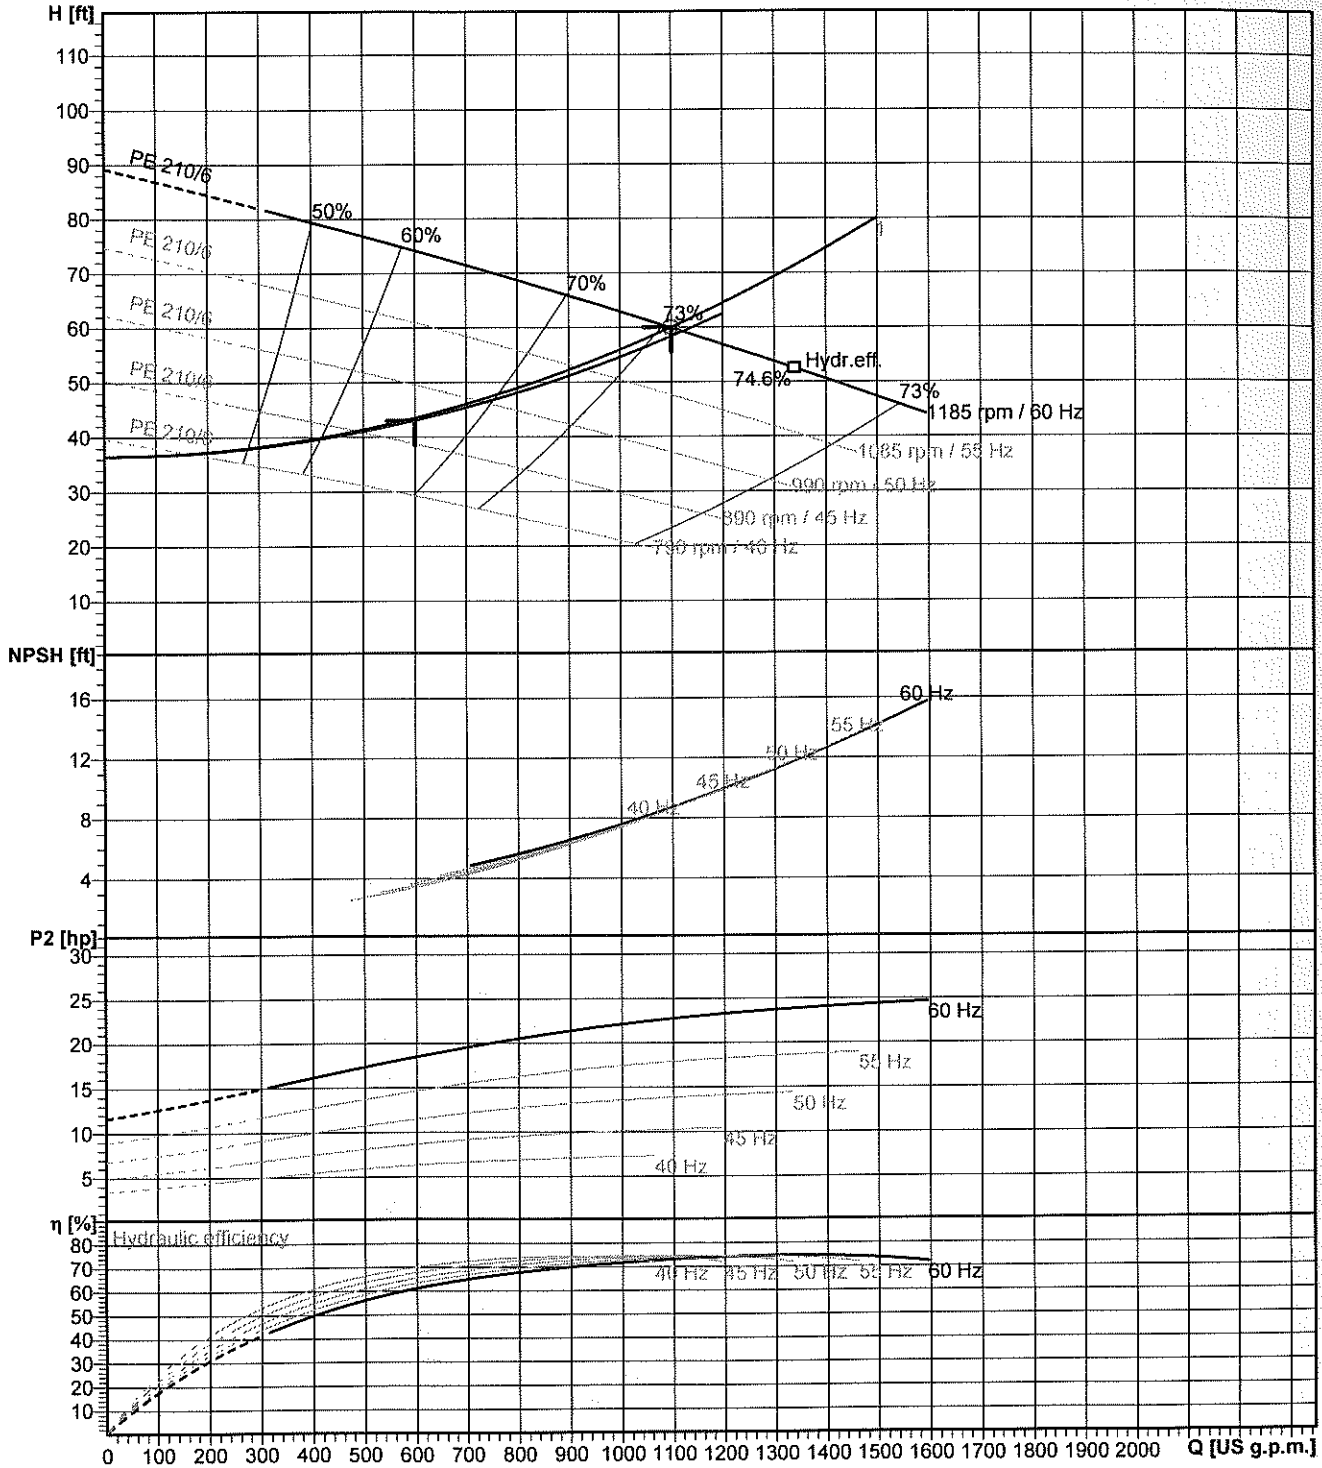
Density 62.43 lb/ft ³	Viscosity 0.0000169 ft ² /s	Testnorm Hydraulic Institute	Discharge Rated speed 1185 rpm
Flow 1099 US g.p.m.	Head 60 ft	Rated power 22.7 hp	Hydraulic efficiency 73.2 %

Impeller size 14.4. 10.2 inch	N° of vanes 2	Impeller 2-vane channel impeller	Solid size 3 1/8 x 3 7/8"	Revision 2009-11-10
----------------------------------	------------------	-------------------------------------	------------------------------	------------------------

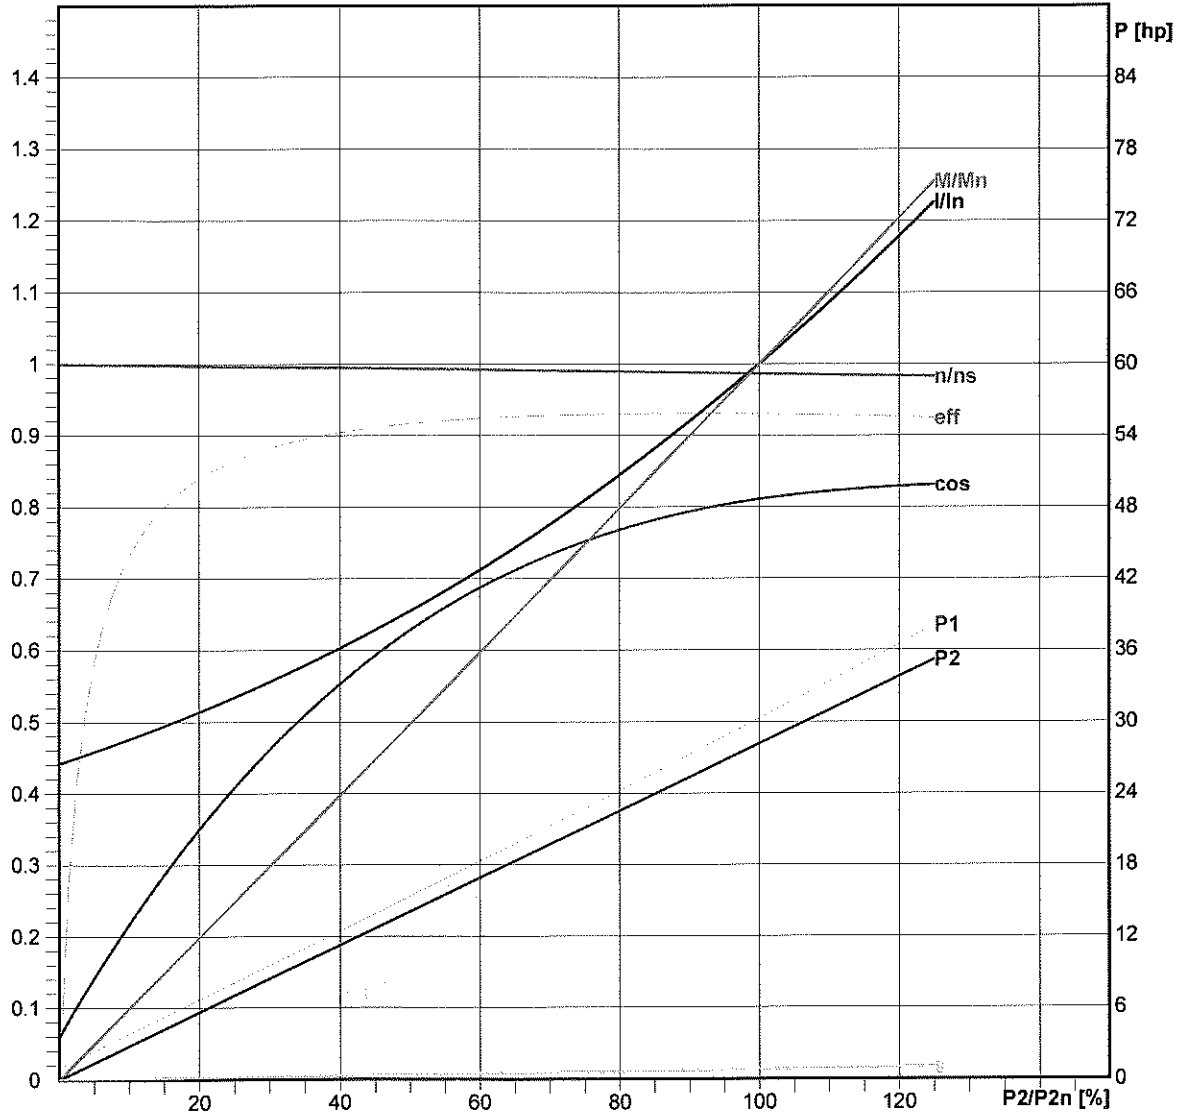
Loading	No load	25 %	50 %	75 %	100 %	125 %
P1 [hp]	0.9888	8.141	15.36	22.73	30.28	38.06
P2 [hp]	0	7.04	14.08	21.12	28.16	35.2
I [A]	15.43	18.67	22.89	28.29	34.96	42.87
eff [%]	0	86.48	91.69	92.91	93	92.48
cos	0.05999	0.4081	0.6279	0.7521	0.8107	0.831
n [rpm]	1199	1196	1192	1188	1184	1179
M [lbf ft]	0	30.92	62.04	93.38	124.9	156.8
s [%]	0.08333	0.3333	0.6667	1	1.333	1.75

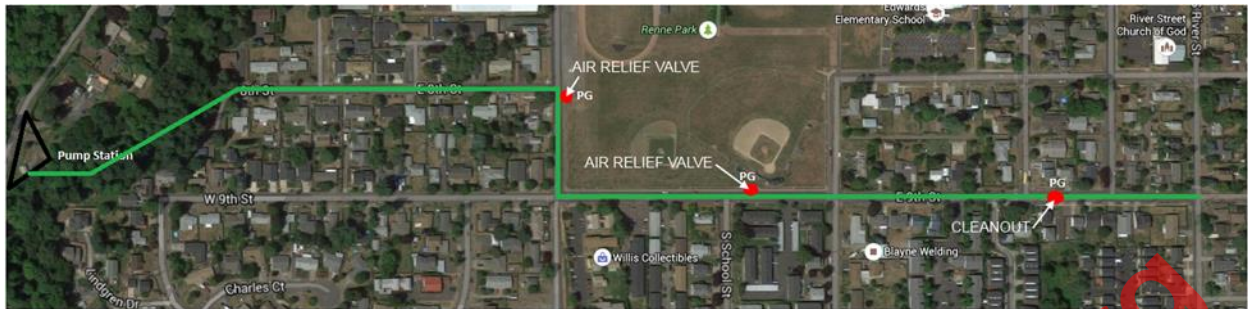
Figure 1
Force Main Alignment and Pressure Gauge Locations

The Station discharge is pumped through an approximately 4,000-foot-long, 12-inch-diameter force main that discharges into a receiving manhole, located near the intersection of East 9th Street and South River Street. The force main rises from an elevation of approximately 105 feet at the Station, to approximately 162 feet at the receiving manhole, and is equipped with two sewage air relief valves and one cleanout along the alignment, as shown in **Figure 1**. Pressure gauges are also installed along the force main at the air relief valve and cleanout locations. The force main materials consist of both ductile iron and SDR 26 PVC pipe. The majority of the force main, which originally served the 8th Street Lift Station, was upgraded in 1985. Approximately 650 feet of ductile iron force main was constructed as part of the Station upgrade in 1993.

According to City records, it appears that the air relief valves were last serviced or replaced in March, 2012. During the condition assessment and performance testing performed on July 23, 2015, City staff observed a minor amount of air and wastewater purging from the second air relief valve along the force main, suggesting it is operating as intended. No such observation was made at the first air relief valve and its condition is unclear.

The pressure gauges installed at the air relief valves, both with a 0 to 30 psi range, appear to be in good condition. The pressure gauge located at the cleanout manhole appears significantly older and is installed with a 0 to 60 psi range. In general, it is recommended that pressure gauges be installed so that the normal operating pressure falls within 25 to 75 percent of the gauge range. Since normal operating pressure at this location is around 4 psi, the installed gauge greatly exceeds this standard recommendation and compromises the accuracy of pressure readings taken at this point. It is recommended that this gauge be replaced with a 0 to 10 or 0 to 15 psi range gauge.

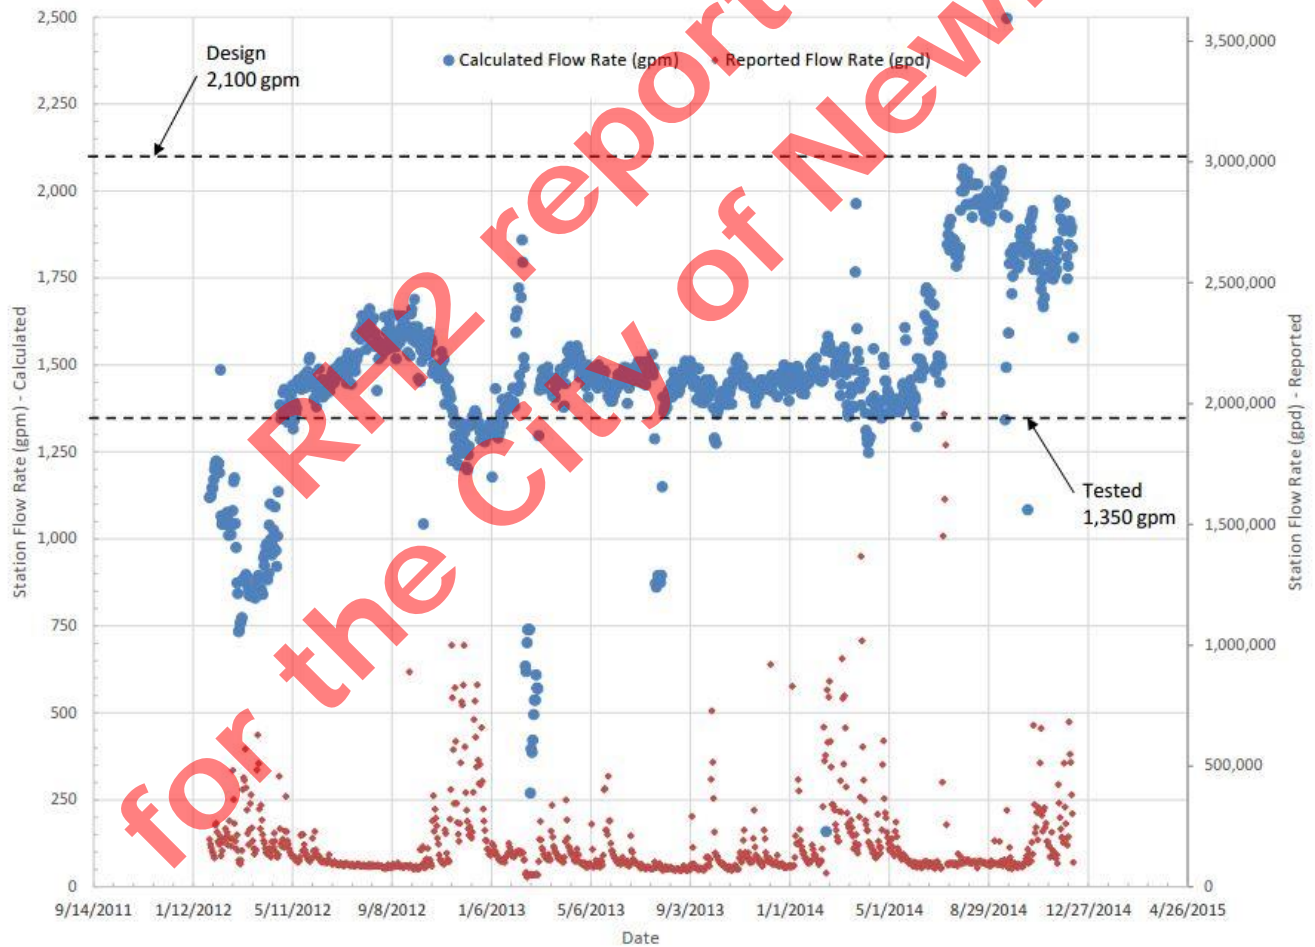
Figure 2
Historical Flow Rate (2012 to 2014)

The City-provided SCADA data included the cycles per day for each pump, run time per day for each pump, and total daily flow for the Station. This data covered the 2012, 2013, and 2014 calendar years. RH2 analyzed the data provided to calculate the approximate instantaneous pump flow rates for each day as shown in **Figure 2**. The design and tested flow rate of 2,100 gpm and 1,350 gpm, respectively, are also shown for reference.

As can be seen in **Figure 2**, the calculated flow rates vary considerably throughout the 3-year period encompassed by the data. This high variability in flow rates is likely do to inaccurate daily flow volumes

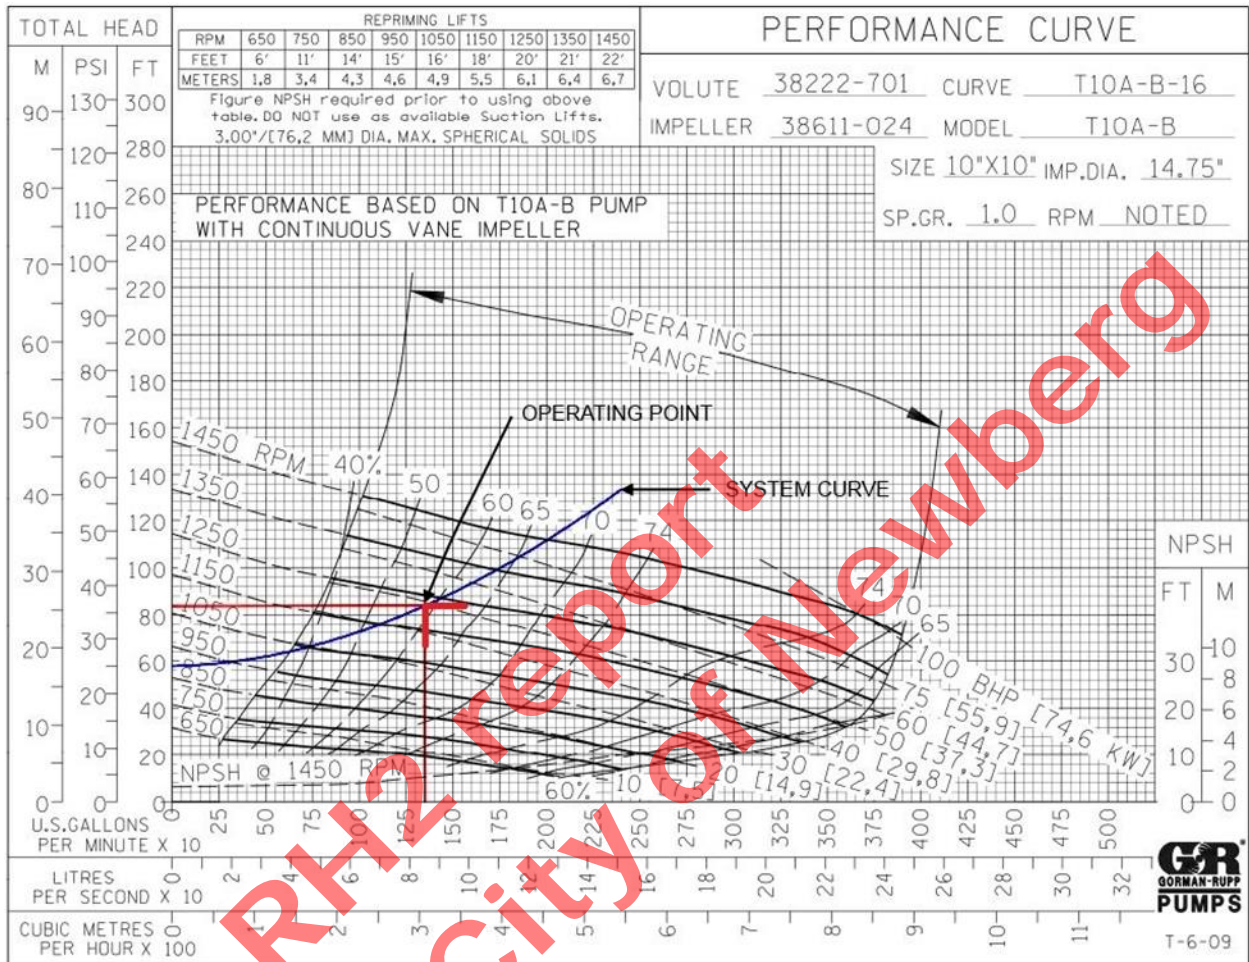
Figure 3
System and Pump Curves

The measured pressure values were then compared to calculated pressure values based on the system head curve for new pipe conditions. The system head curve was then revised and validated to account for age and condition of the pipe by adjusting the roughness coefficient to match calculated pressures in the force main to measured field conditions. The calculated pressures differ from measured values by approximately 2 to 3 psi. This indicates that the system is experiencing a minor increase in headloss over original (new) conditions. The calculations for the system head curve are attached to this report. The system head curve, based on performance testing, was overlaid on the pump curve provided by the manufacturer, which can be seen in **Figure 3**.

The operating point of 1,350 gpm at a TDH of 84 feet obtained from the performance testing is also indicated in **Figure 3**. According to as-constructed records, the pumps are expected to be operating at a speed of 1,315 rotations per minute (rpm). However as shown in **Figure 3**, the system curve and performance testing data would suggest that the pumps are operating on the curve for a speed of approximately 1,250 rpm. A decrease in pumping capacity would typically indicate that the pumps are experiencing an increase in head in the system. However, this does not appear to be the case here as the pumps are operating at a lower head and lower capacity than originally designed. Although this may suggest that the pumps are operating at a lower speed than originally designed, the operating speeds of the pumps were field verified using a tachometer by City staff.
