REQUEST: A Resolution recommending City Council amend the 2018 Wastewater Master Plan incorporating the 2021 Riverfront Addendum into the Newberg Comprehensive Plan

Wastewater Master Plan

May 2018

*Technical Update May 2021
Addendum - Riverfront
Master Plan (Appendix K)*

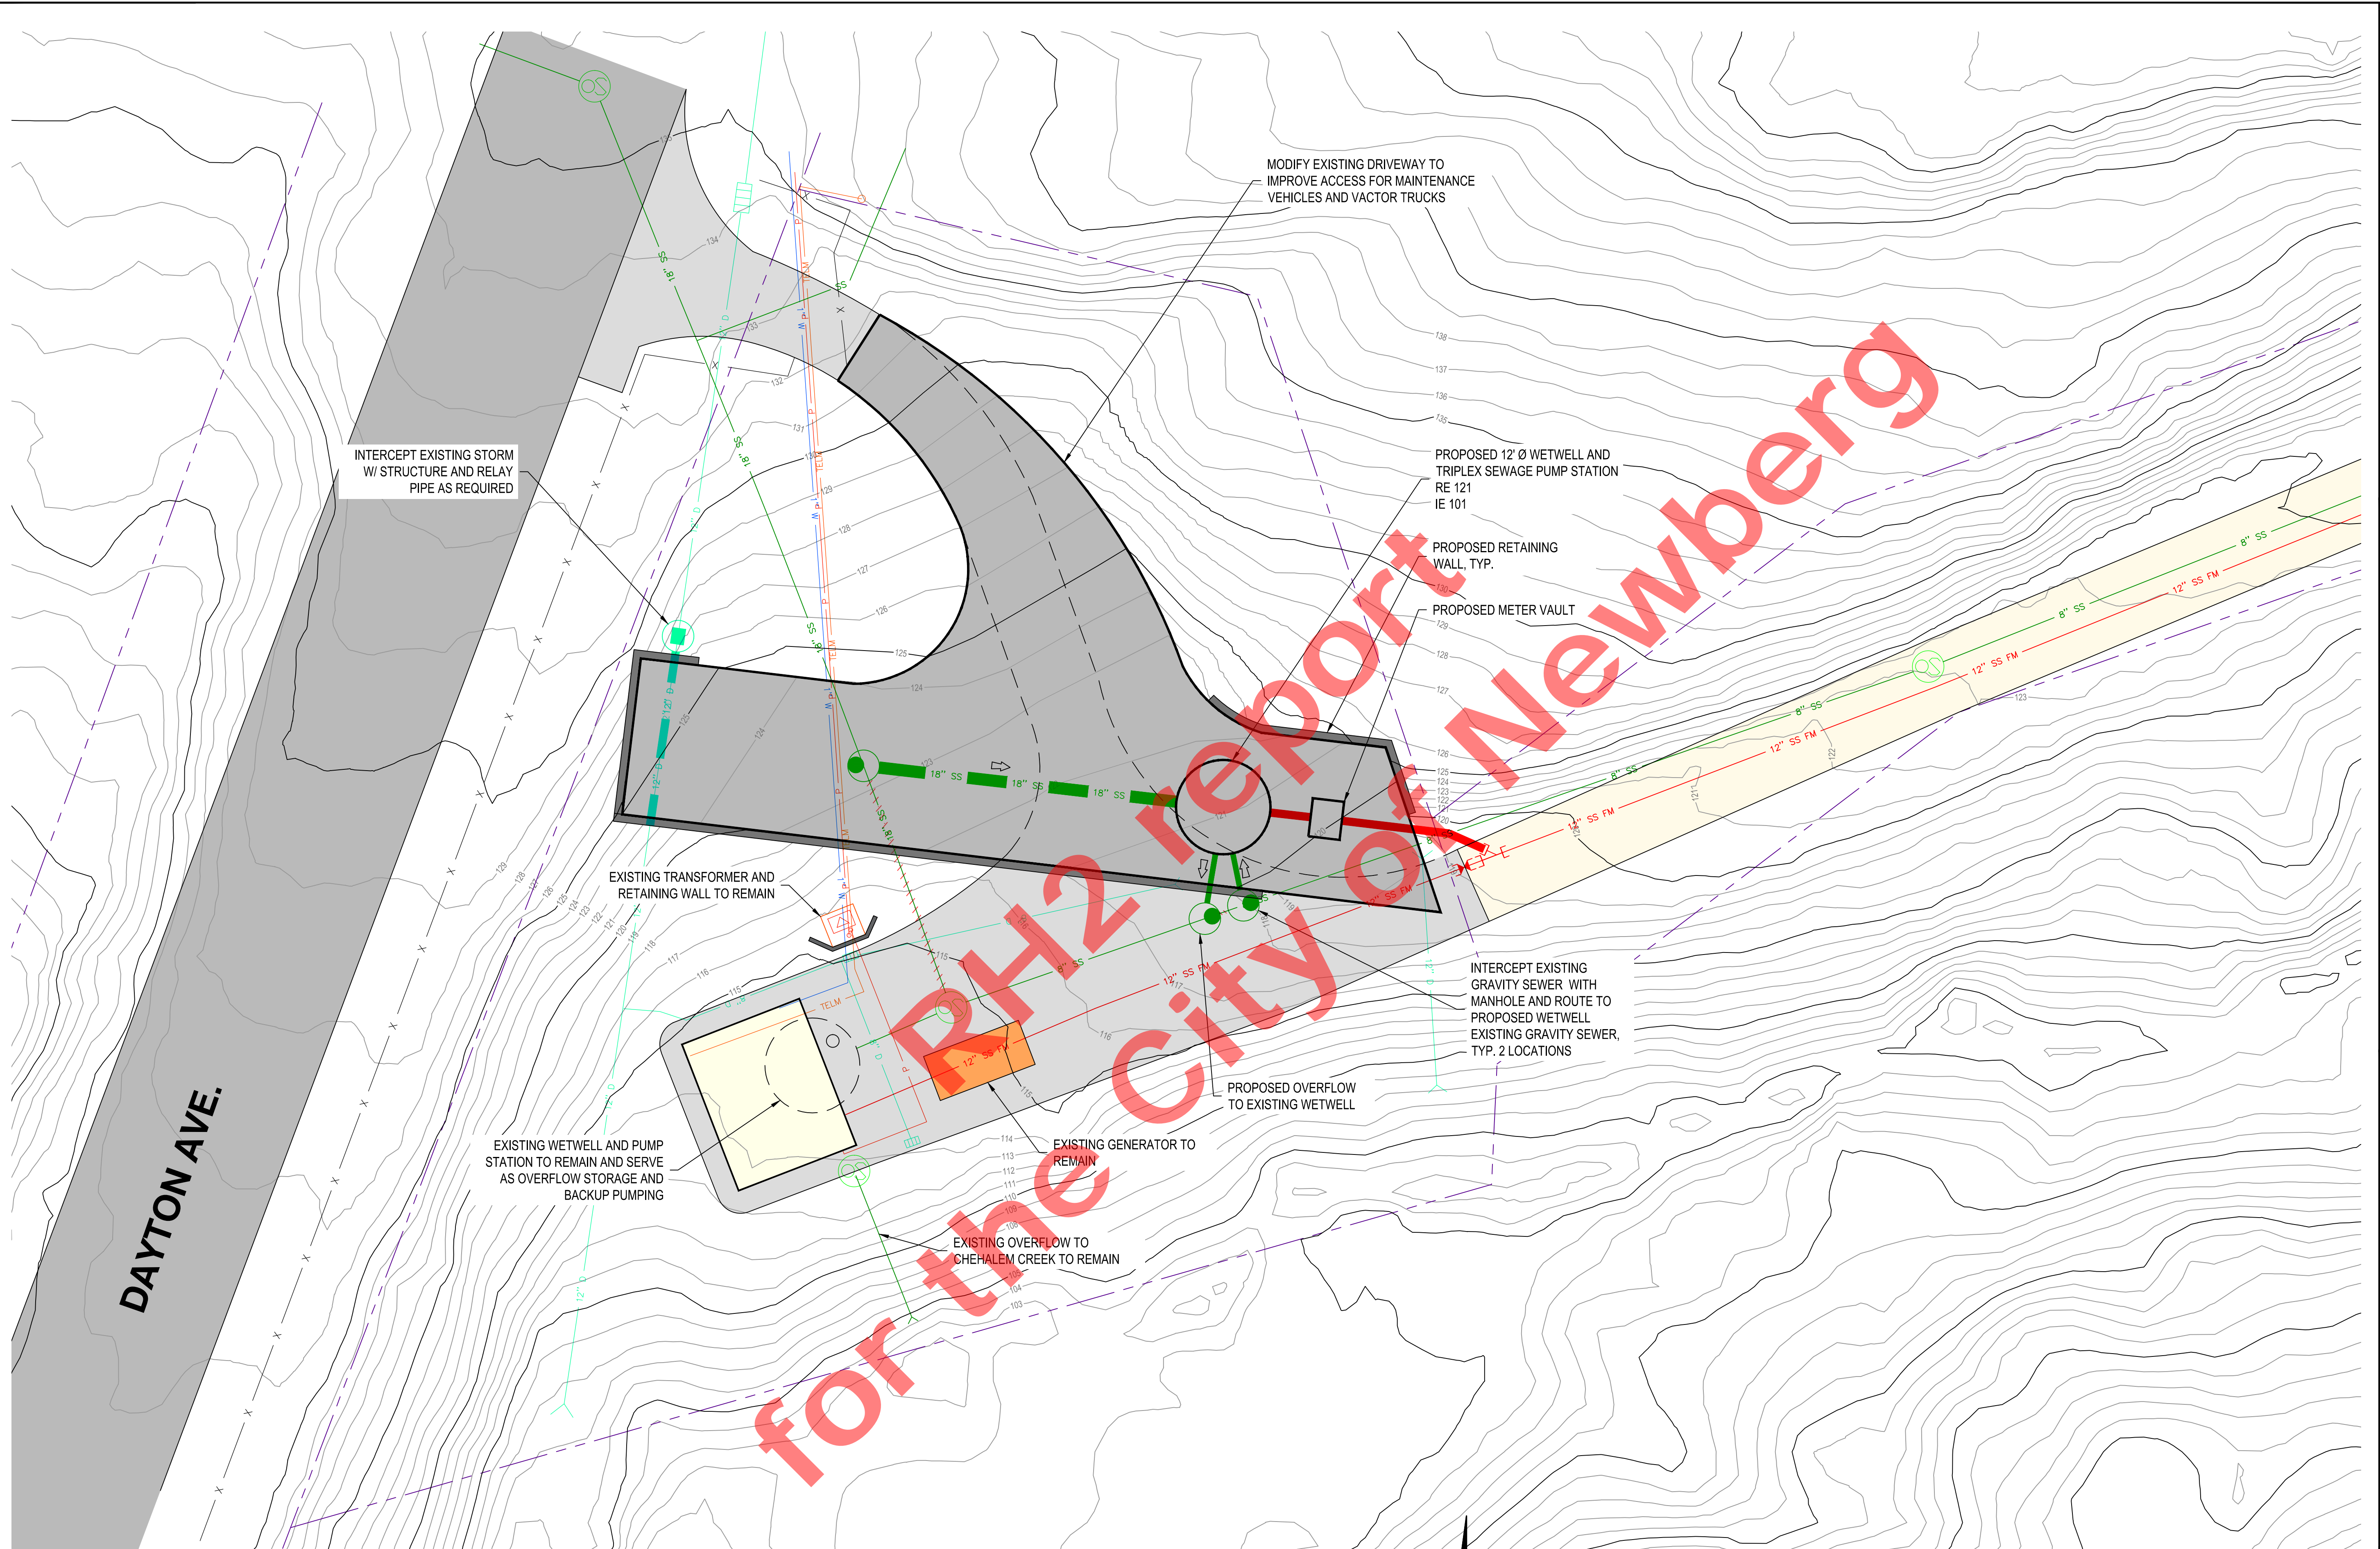
CONCEPTUAL SITE PLAN
1" = 10'

CITY OF NEWBERG
DAYTON AVENUE LIFT STATION
PRELIMINARY DESIGN
CONCEPTUAL SITE PLAN

Summary of Deficiencies and Recommended Actions			
Lift Station Deficiencies	Priority Level	Recommended Action	
		Short-term Improvements	Long-term Improvements
The 3-way plug valve located at the pump discharge is broken. This results in the inability to isolate the pump station from the force main for routine maintenance and repairs.	1	Remove and replace existing 3-way plug valve with new full-port 3-way valve. Cut sheets for a replacement valve are included in the Attachments.	N/A
The Station has no means of isolation or bypass pumping for use in an emergency or during rehabilitation.	1	Provide bypass pumping port and isolation valve. See Preliminary Design Bypass Pumping Alternatives plan in the Attachments for details.	N/A
The Check Valves at Pump No. 1 and No. 2 are showing signs of leakage at the hinge pin.	1	Repair/replace check valve packing at the hinge pin.	N/A
The availability of spare parts for the pumps is limited.	2	N/A	Recommend eventual replacement of pumps with submersibles. See Conceptual Site Plan in the Attachments for details.

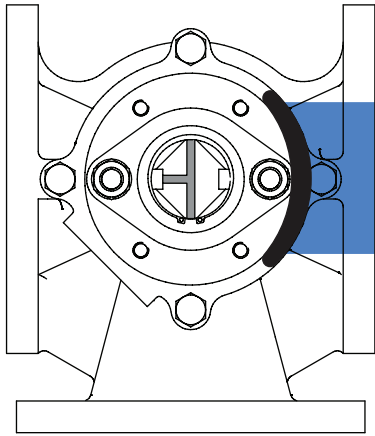
Valve in closed position*

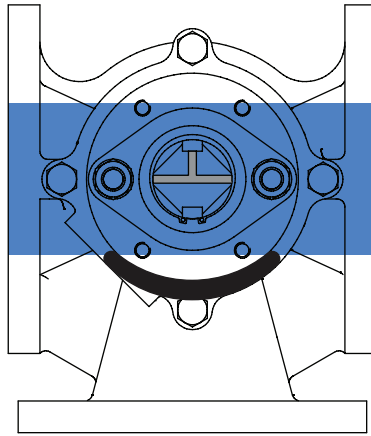
Flow straight through valve

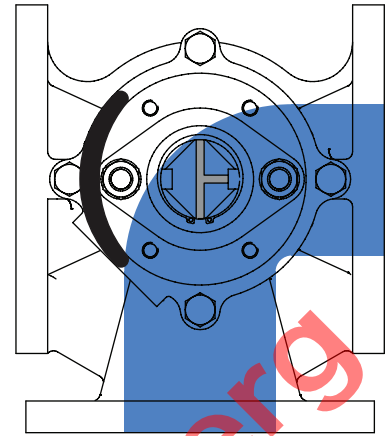
Flow through 90° to side port

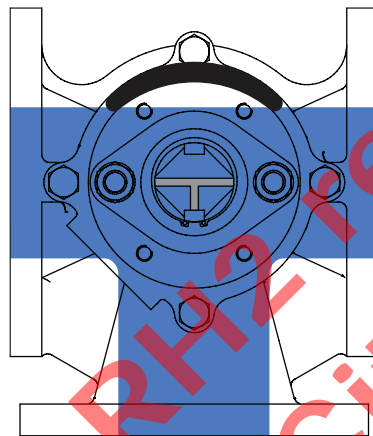
All 3 ports connected and open

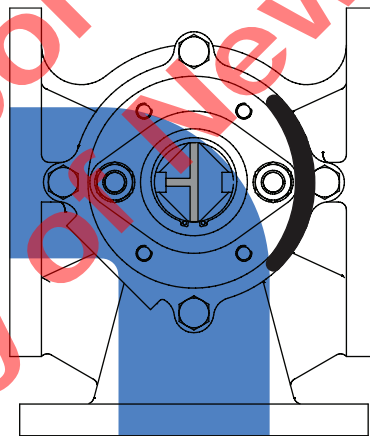
Flow through 90° to side port

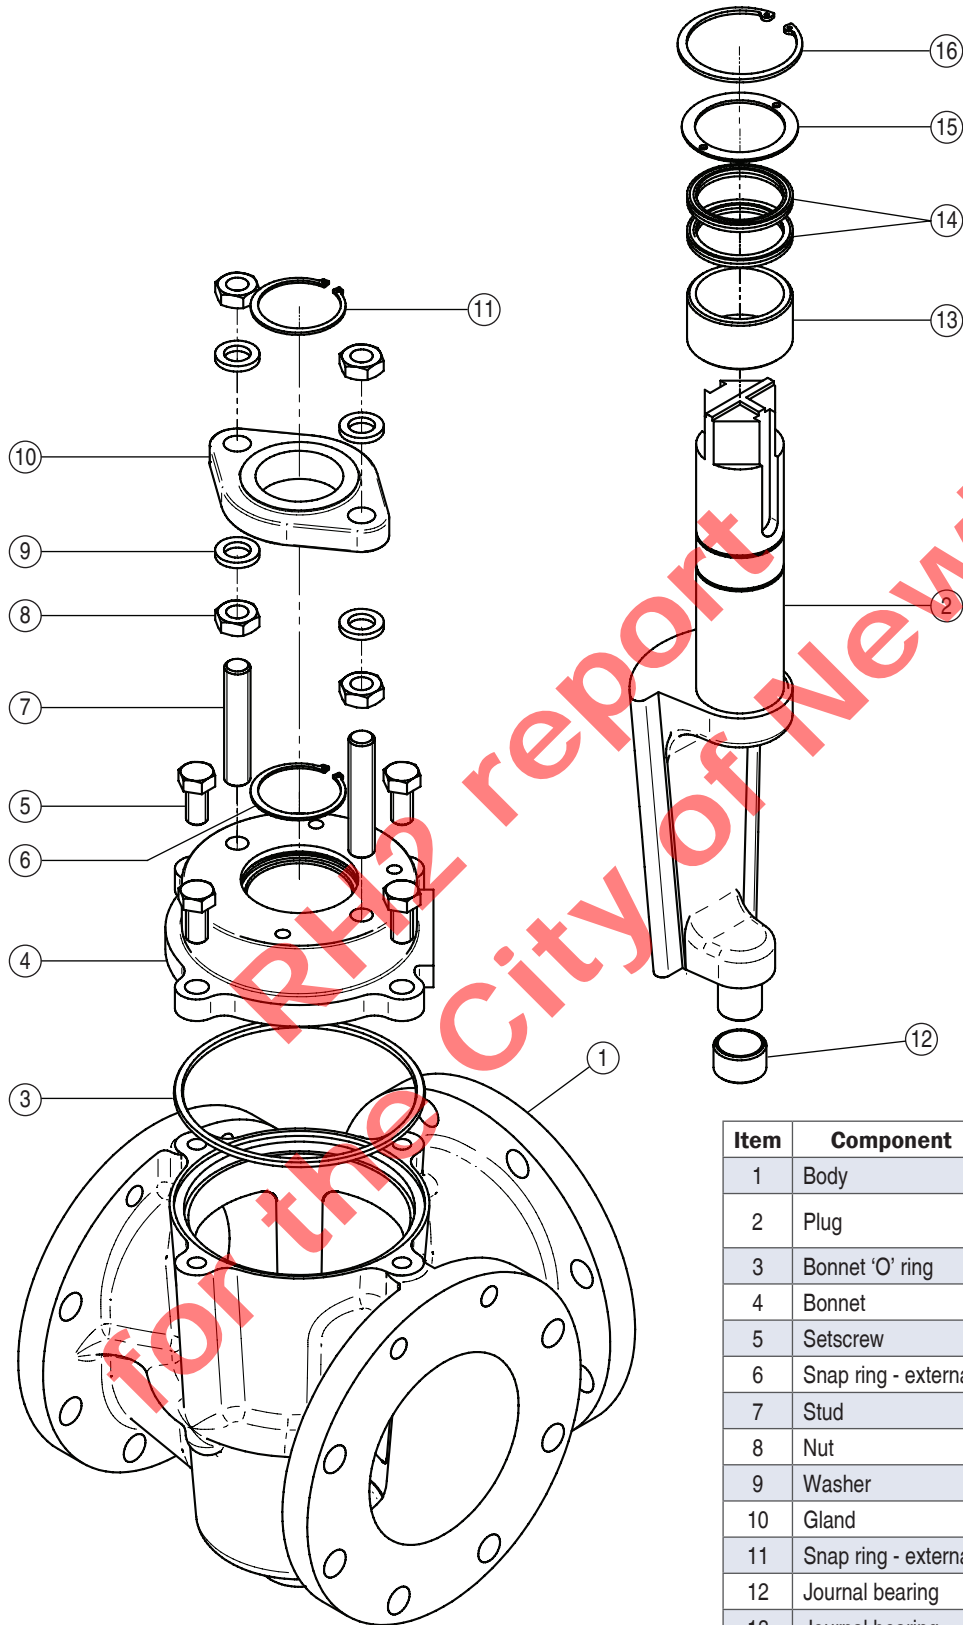
Standard Materials of Construction - 3" to 16"

Item	Component	Material
1	Body	Cast iron A126 Class B
2	Plug	Ductile iron ASTM A536 Rubber coated
3	Bonnet 'O' ring	Elastomer as specified
4	Bonnet	Cast iron A126 Class B
5	Setscrew	Steel - zinc plated
6	Snap ring - external	Steel
7	Stud	Steel - zinc plated
8	Nut	Steel - zinc plated
9	Washer	Steel - zinc plated
10	Gland	Ductile iron ASTM A536
11	Snap ring - external	Steel
12	Journal bearing	Stainless Steel
13	Journal bearing	Stainless Steel
14	'U' cup seal	Elastomer as specified
15	Seal retaining ring	Brass
16	Snap ring - internal	Steel

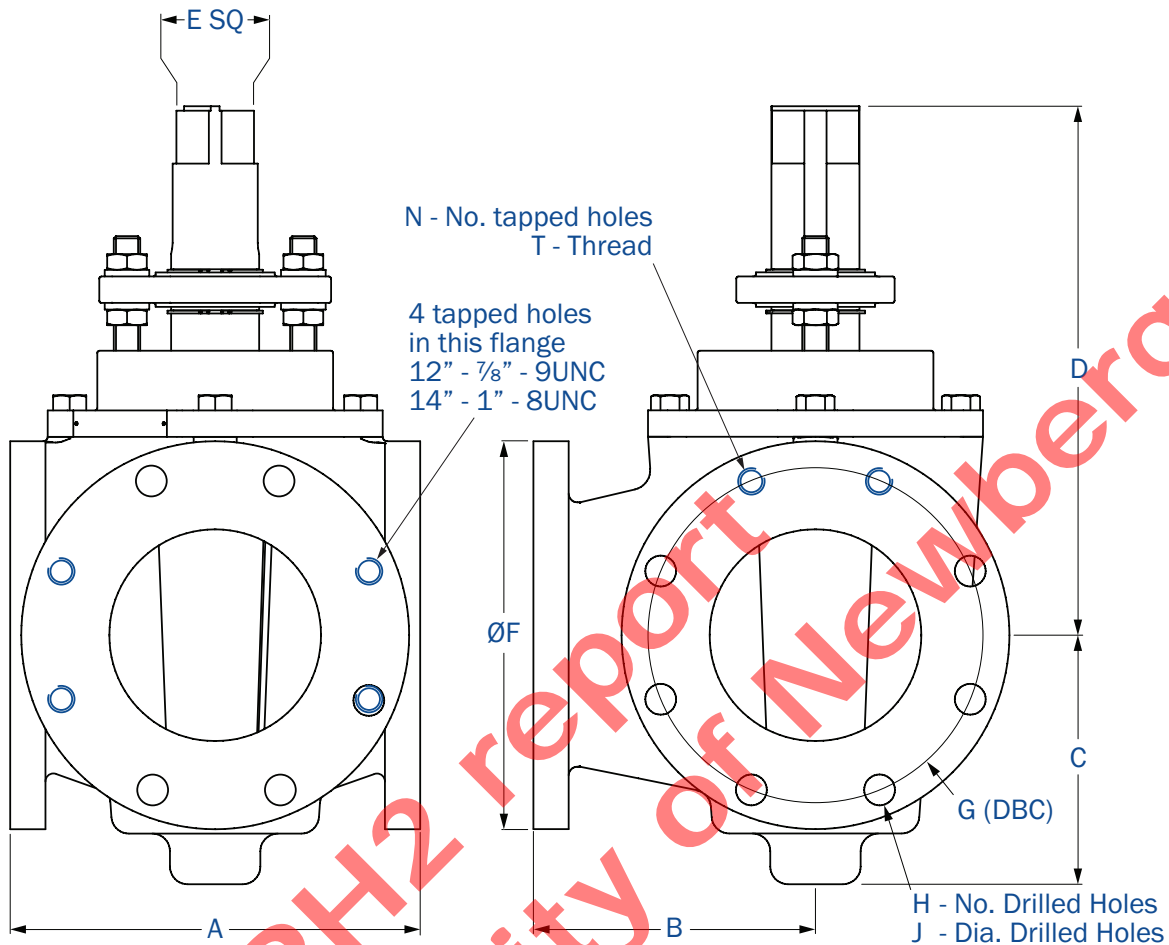
Flanged End - Fig. 604 - Class 125

Dimensions in	Nominal Valve Size							
	3"	4"	6"	8"	10"	12"	14"	16"
A	8	9.88	11.63	13.88	16.75	19	21	23.75
B	5.5	6.5	8	9	11	11.56	12.5	15.13
C	4.81	5.94	7.06	10.94	10.94	12.88	14.19	14.75
D	9.04	13.36	15.04	18.69	18.69	21.20	21.10	22.00
E	1*	2	2	2	2	2	2	2
F	7.50	9.00	11.00	13.50	16.00	19.00	21.00	23.50
G	6.00	7.50	9.50	11.75	14.25	17.00	18.75	21.25
H	4	6	6	4	12	12	10	16
J	0.75	0.75	0.88	0.88	1	1	1.13	1.13
N	-	2	2	4	-	-	2	-
T	-	5/8" - 11 UNC	3/4" - 10 UNC	3/4" - 10 UNC	-	-	1" - 8 UNC	-
Weight - lb	65	120	170	325	380	475	850	970

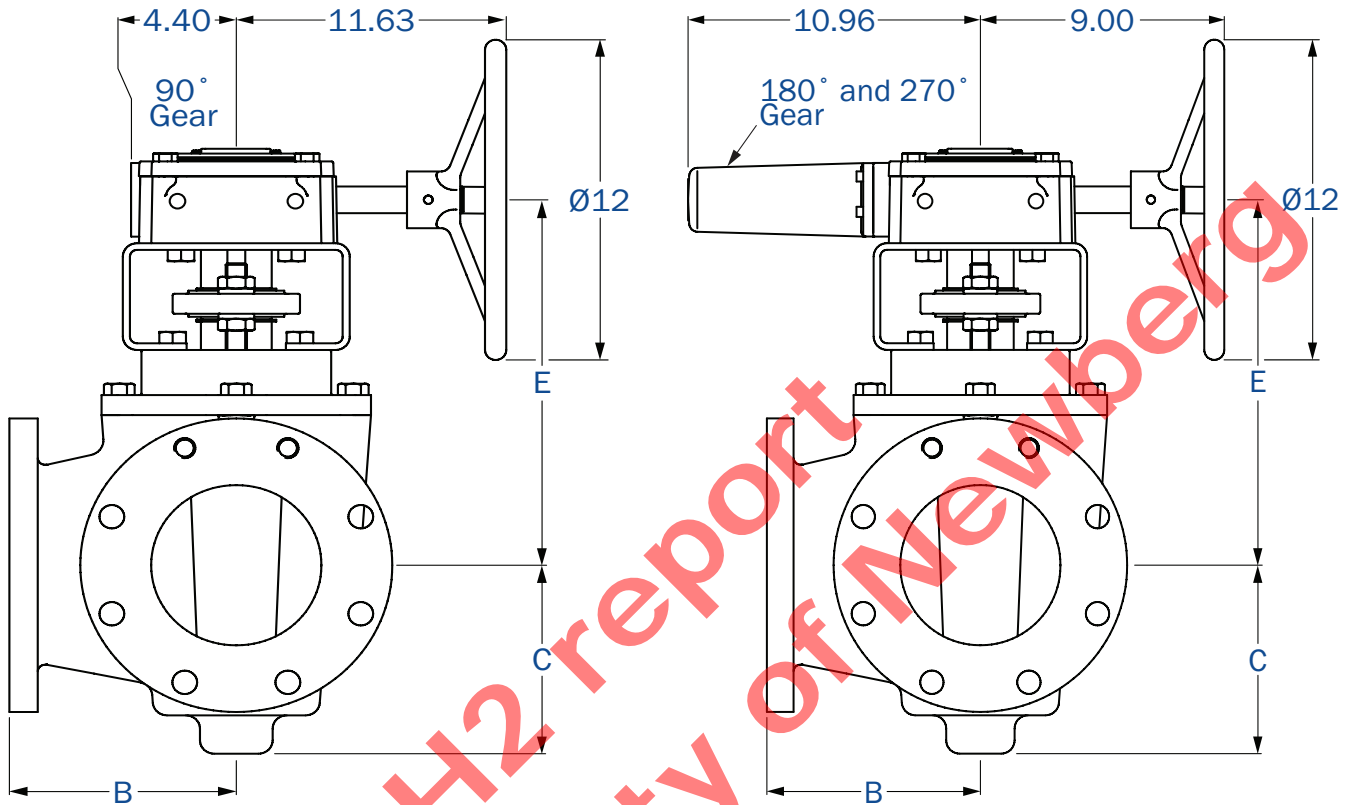
Flanged End - Fig. 604AGHW - Class 125

Dimensions in	Nominal Valve Size						
	4"	6"	8"	10"	12"	14"	16"
A*	9.88	11.63	13.88	16.75	19	21	23.75
B	6.50	8	9	11	11.56	12.50	15.13
C	5.94	7.06	10.94	10.94	12.88	14.19	14.75
E	12.94	14.06	17.75	17.75	19.50	20.38	21.06
Weight - lb	200	250	405	460	555	937	1053

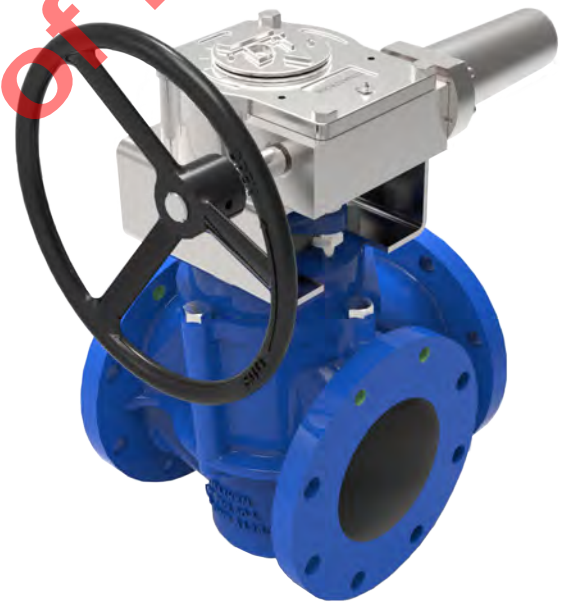
Shown with 180°/270° Gear

Where required, gear operators shall be of heavy duty construction with a ductile iron quadrant supported by upper and lower oil-impregnated bronze bearings. The worm gear and shaft shall be manufactured in hardened steel and run in high efficiency roller bearings. Gear operators shall require single handwheel operation only.

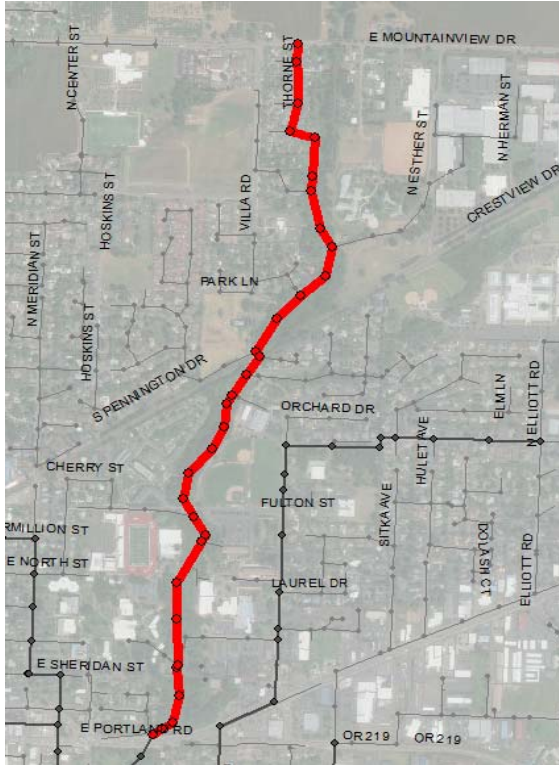
C1.a

Project Location: Upper Portion of Hess Creek Trunk Line

Objective: Cured-in-place pipe lining of the upper portion of Hess Creek trunk line to reduce I/I influence and extend the life of the pipe. Flow monitoring in the basin will also be completed to inform the design phase of Hess Creek Phase 2 Project.

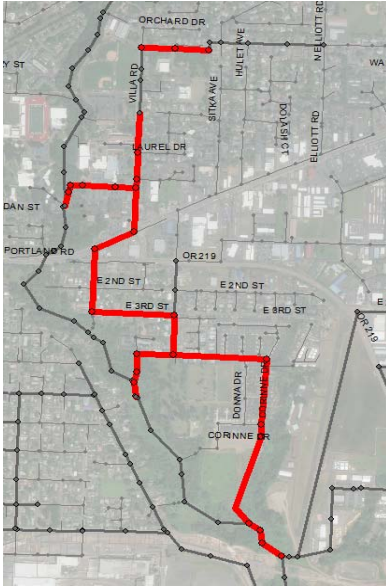
C1.b

Project Location: Parallel Line to Lower Portion of Hess Creek

Objective: Resolve undersized downstream pipeline along Villa Road. Construct gravity line parallel to Hess Creek canyon and reduce flow going to Hess Creek trunk line. The new lift station in Hess Creek Phase 3 will discharge to this gravity main.

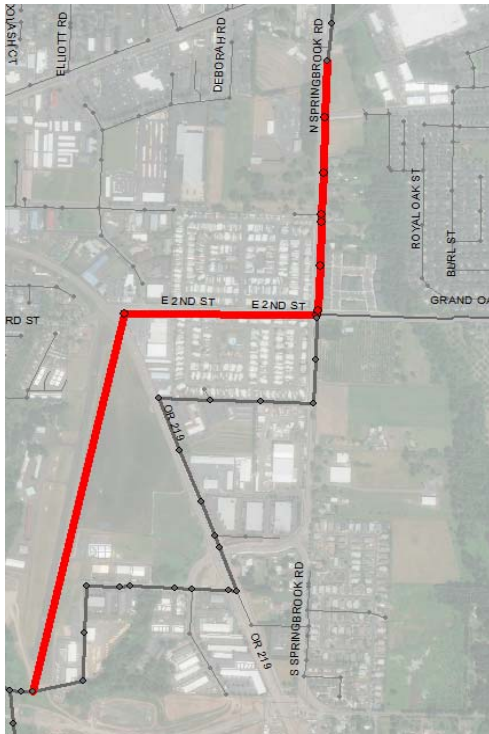
C1.c

Project Location: Springbrook Road south of Portland Road

Objective: Increase capacity of Springbrook Road pipeline north of Fernwood Road. Construct a parallel line south of Fernwood Road to alleviate surcharging and overflows.

Key Issues: Pipeline will need to be bored under HWY 219. Easement to be negotiated with Sportsman Airpark.

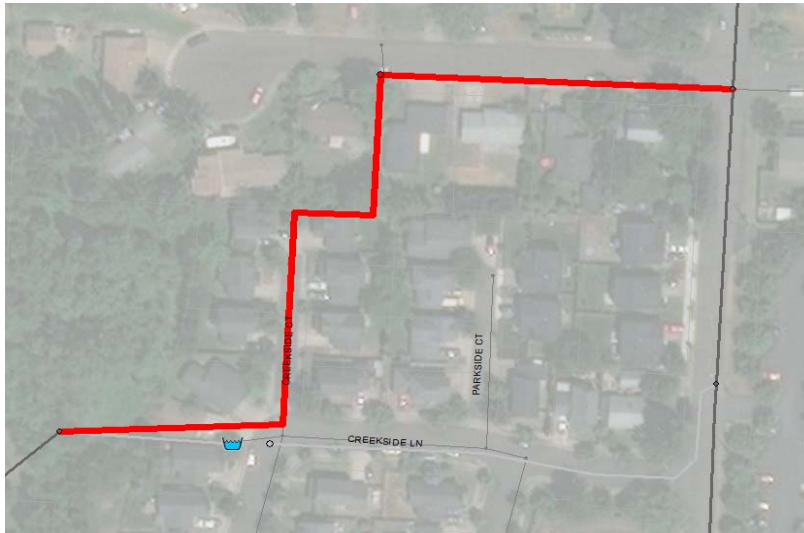
Objective: Eliminate overflows at Pinehurst Court. The grade of Pinehurst Court and shallow gravity main, produce a potential overflow site when the trunk line on North Main Street flow close to full. This project will re-direct flow from Pinehurst Court south to existing lines on Creekside Court and to the Creekside LS basin.

Key Issues: Easements will be needed to connect to Creekside court. There are local grinder pumps on Pinehurst that could potentially be removed if the vertical alignment allows; this should be evaluated during design.

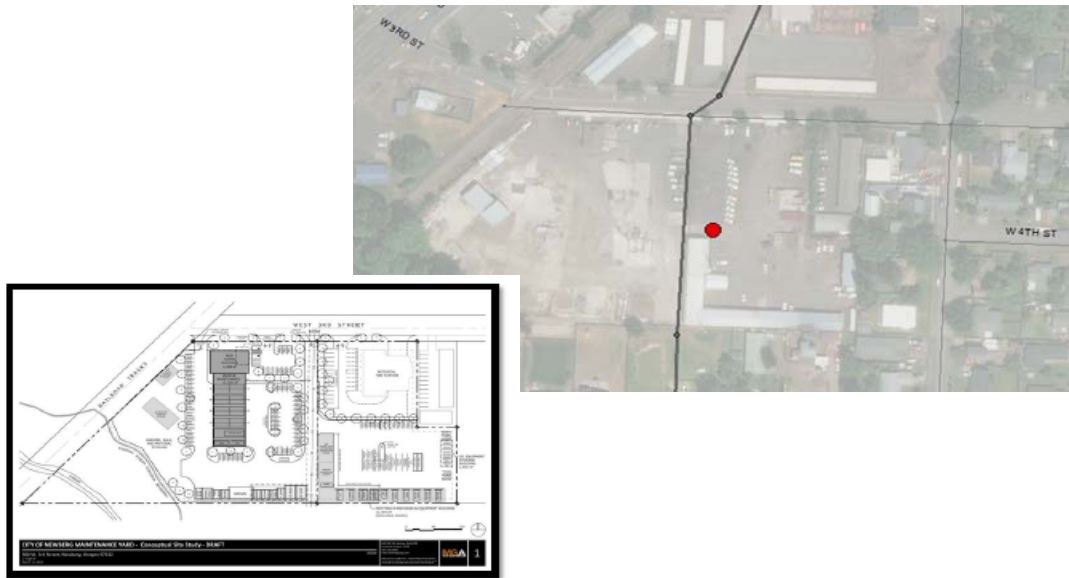
FIGURE 1 CONCEPTUAL PUBLIC WORKS MAINTENANCE YARD PLAN

Project Location: Maintenance Yard (SW 3rd Street)

Objective: A Master Plan was completed for the maintenance yard. This project is in the City's draft CIP 2017-2022. The project will include major site work, new fleet building, and eventually new administration building. The maintenance yard is utilized by a number of City divisions.

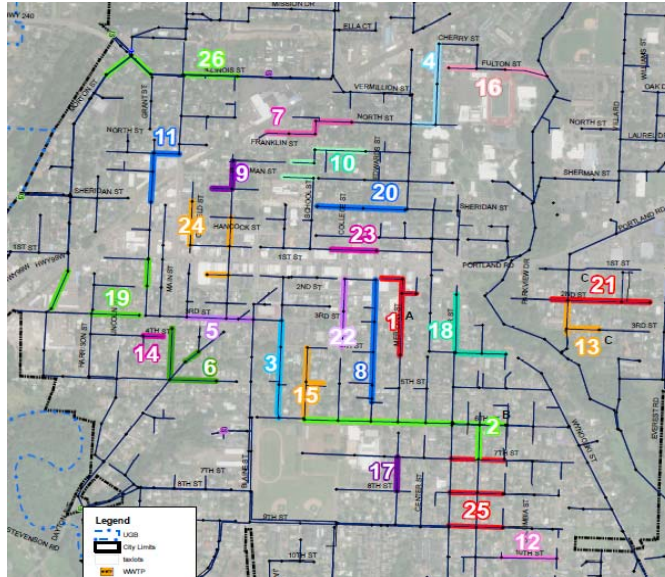
Objective: Reduce I/I in the system. Focus annual pipeline replacement in areas of high I/I. Potentially postpone larger capital improvements on trunk lines and at WWTP by reducing I/I influence and peak flows in the system.

Key Issues: I/I data should be updated periodically to provide current recommendations for reducing I/I in the system. Coordination with other utilities could provide cost-savings for the City.

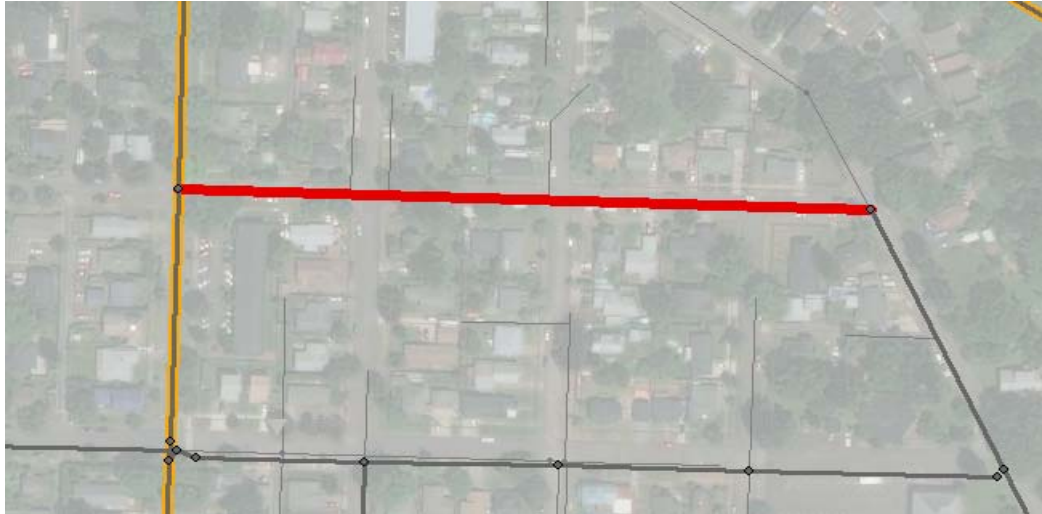
Objective: The existing gravity line in SW 5th Street from Chehalem to River is in need of rehabilitation. There are several parcels that need ccess to the public WW system. This project is in the City's draft CIP 2017-2022.

Key Issues: This project will be constructed in conjunction with the pavement rehabilitation project.

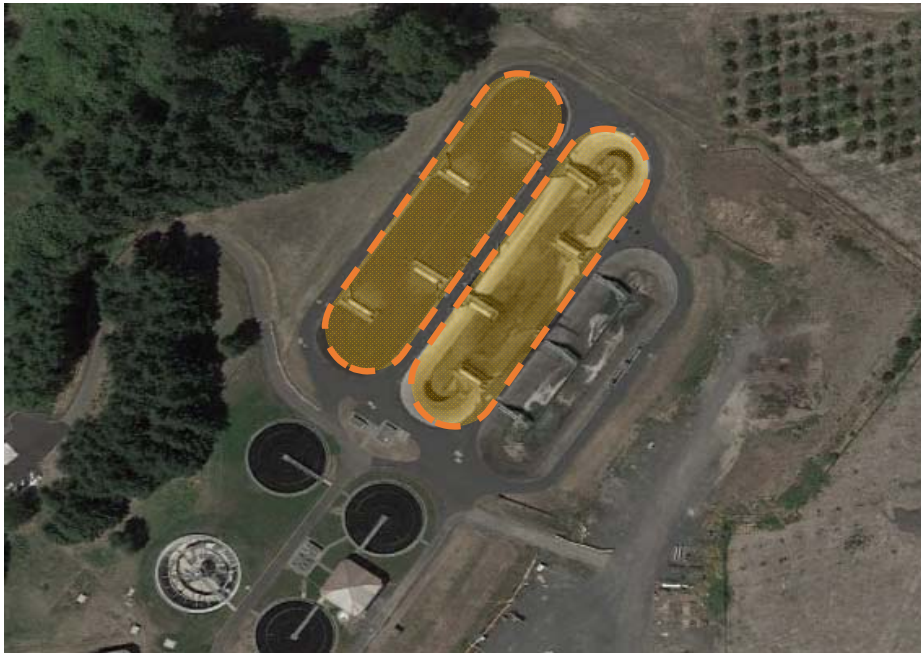
Oxidation Ditch Rotor Replacement
T1.a

Objective: There are a total of 8 brush rotor aerators in the 2 oxidation ditches. Rotor #8 was replaced in 2017. The remaining 7 need replacement since they have been in operation since the plant start up in 1987. The plan is to replace one rotor per year for the next 7 years. All the rotors are inspected annually and will be replaced based on the need determined by the inspections.

Project Location: Oxidation Ditches

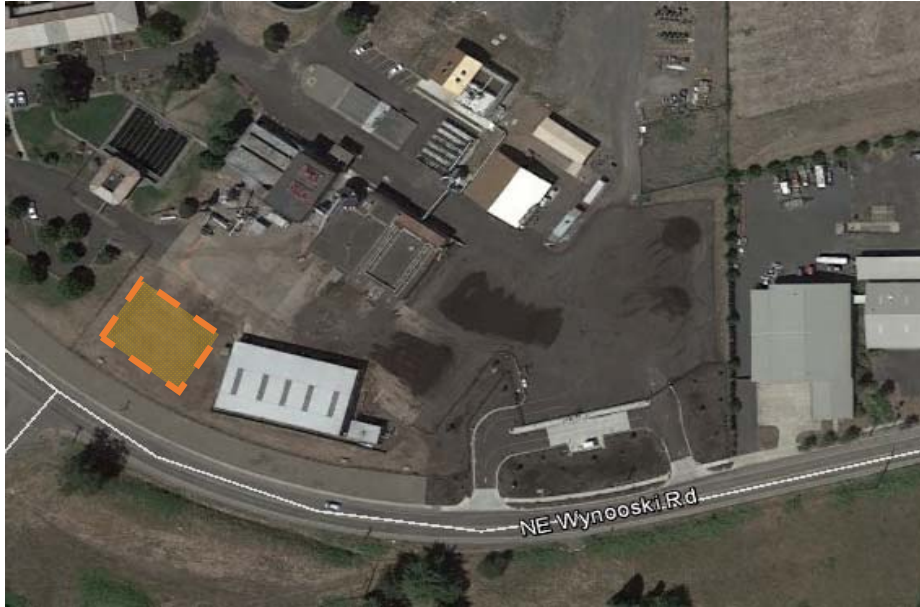
Objective: The current cure bay setup is configured to allow the use of two (2) of the bays as compost curing bays (equipped with blowers and temperature probes to cure compost). The sawdust that is used in the composting process must stay under cover in inclement weather otherwise it will become too wet and unusable. Adding bays will allow sufficient storage for sawdust and of the existing bays to be used for compost curing.

Project Location: Curing Bays

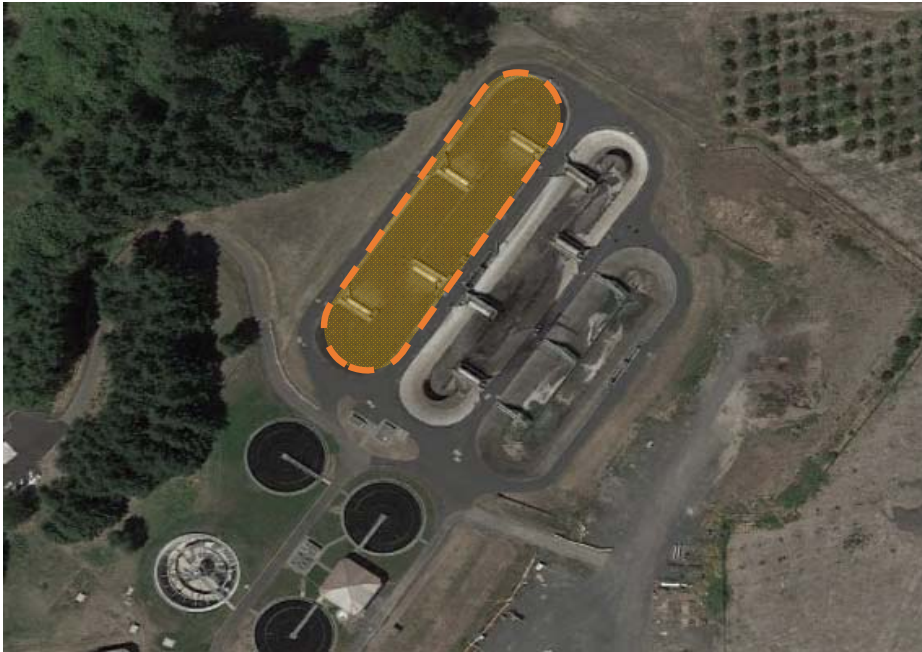
Objective: In order to extend the useful life of the oxidation ditches structural rehabilitation is required. Only one ditch can be taken offline at any time. The rehabilitation of Oxidation Ditch 2 occurred in the summer of 2017.

Project Location: Oxidation Ditch 1

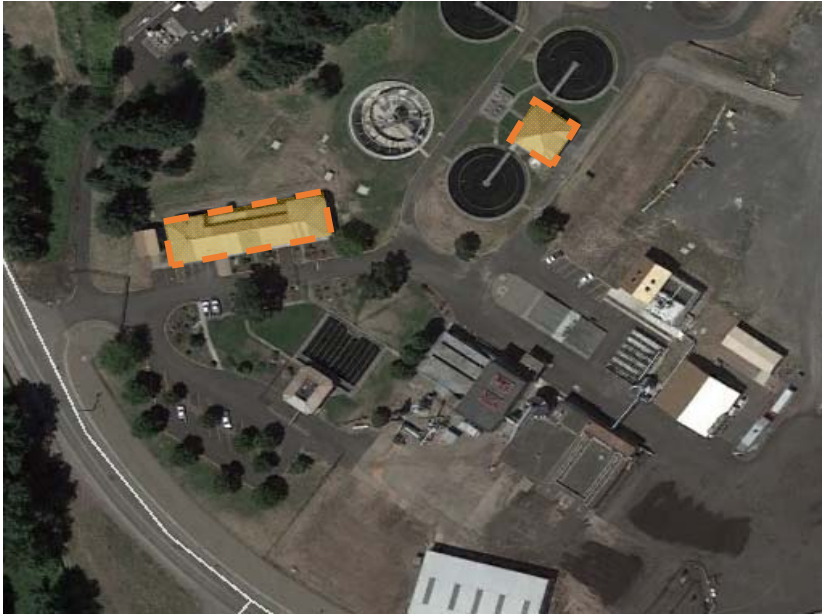
Roofing Replacement at the WWTP

Objective: The maintenance of roofs on the existing buildings at the plant had been deferred over the years. Many of the buildings require new gutters and soffits to collect and control water from the roofs. The remaining buildings include: Administration Building and Secondary Building.

Project Location: Admin. and Secondary Buildings

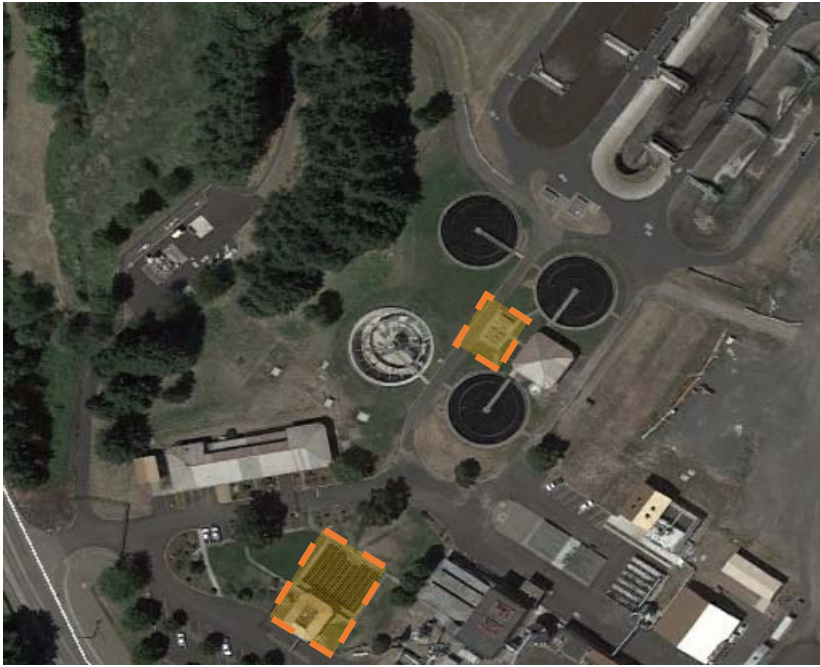
Objective: Hydraulic limitations between the Clarifier Distribution Box and the discharge to the Outfall are noticed at a peak flow conditions causing high water surface elevations in the oxidation ditches. The objective is to decrease headloss across these processes.

Project Location: Disinfection and Clarifier Distribution Box

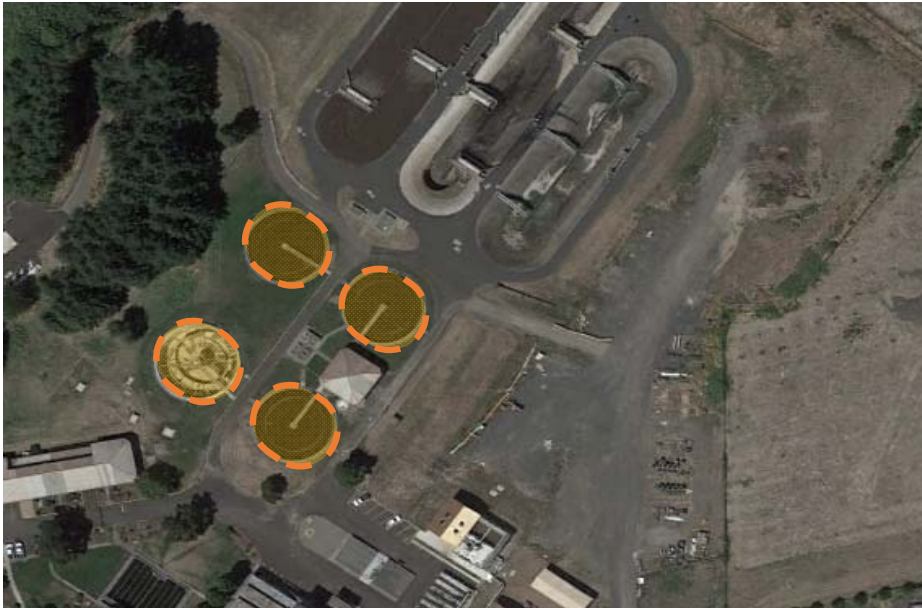
Objective: The existing secondary clarifiers are designed with a peak hydraulic loading rate of 1,200 gallons per day per square foot (gpd/sf) based on industry standards. With hydraulic improvements to the Clarifier Distribution Box, the clarifiers can pass more flow. To show higher operational flows the increased peak hydraulic loading rate would need to be verified through capacity re-rating and approval from DEQ. Historical data suggests that the current peak hydraulic loadings are infrequent (< 3 times/year) and of short duration (< 24 hours/event).

Project Location: Secondary Clarifiers

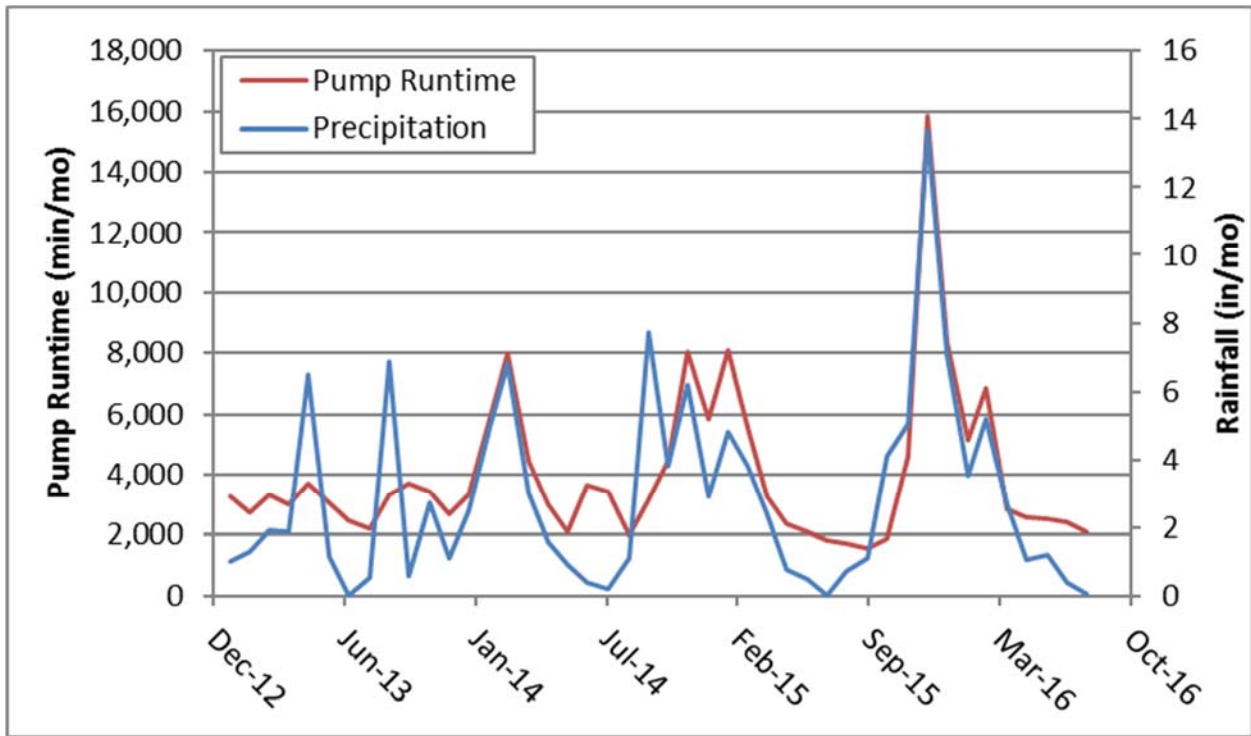
Chart E-1: Charles Lift Station Runtimes & Precipitation vs. Time

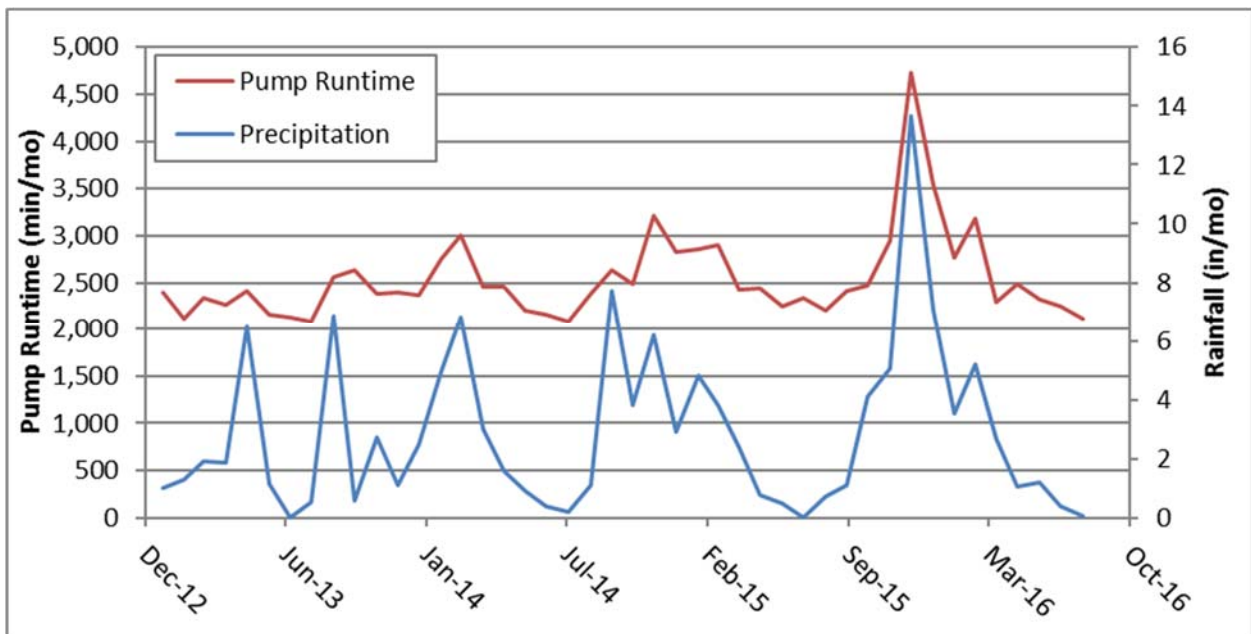
Chart E-2: Chehalem Lift Station Runtimes & Precipitation vs. Time

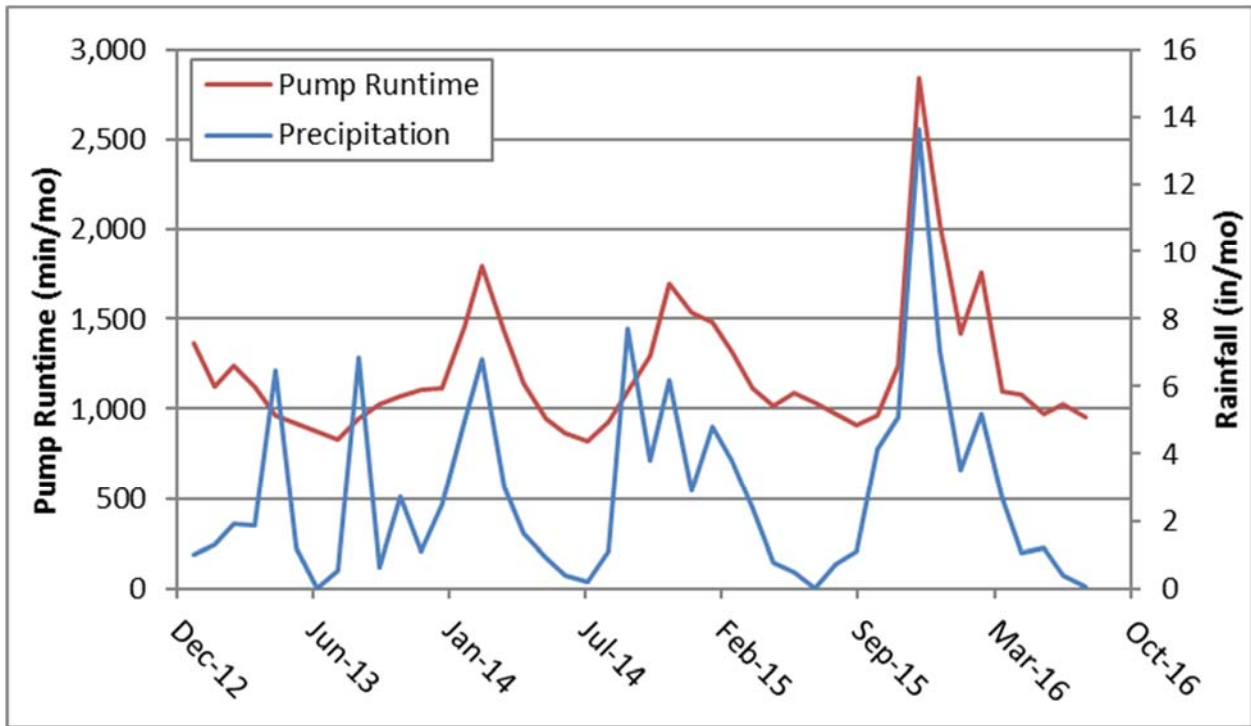
Chart E-3: Creekside Lift Station Runtimes & Precipitation vs. Time

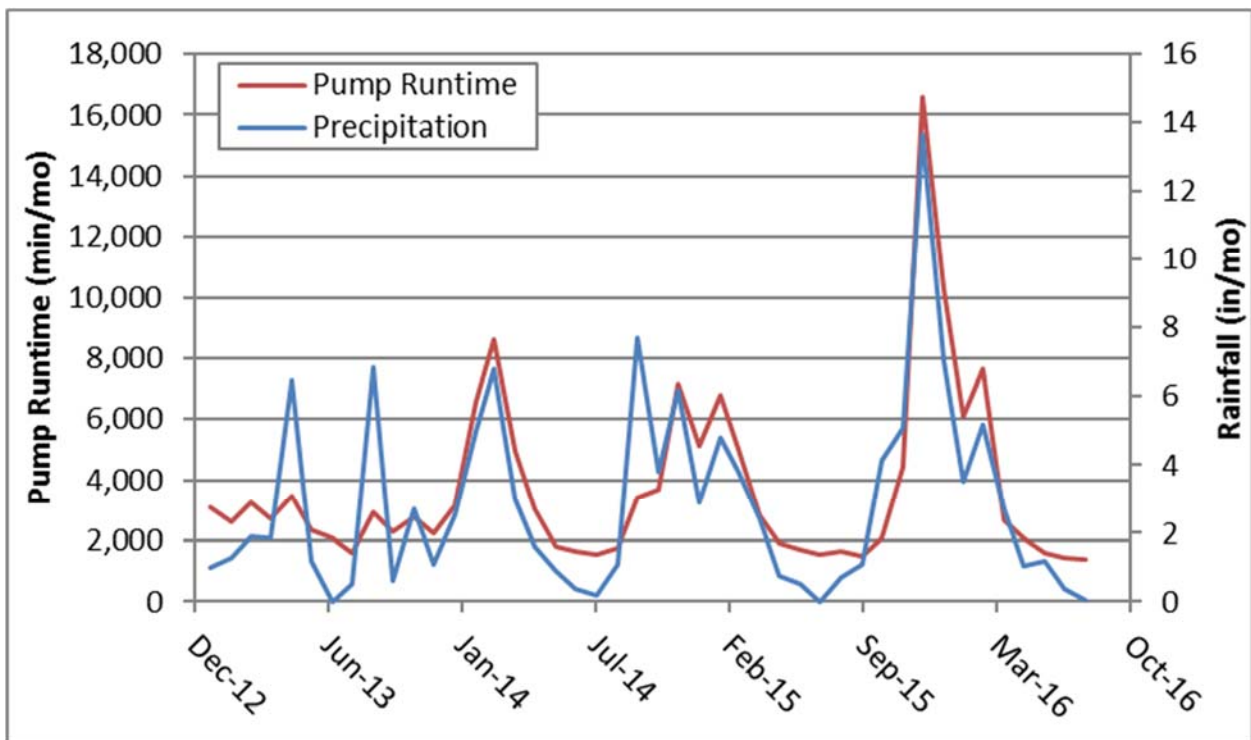
Chart E-4: Dayton Lift Station Runtimes & Precipitation vs. Time

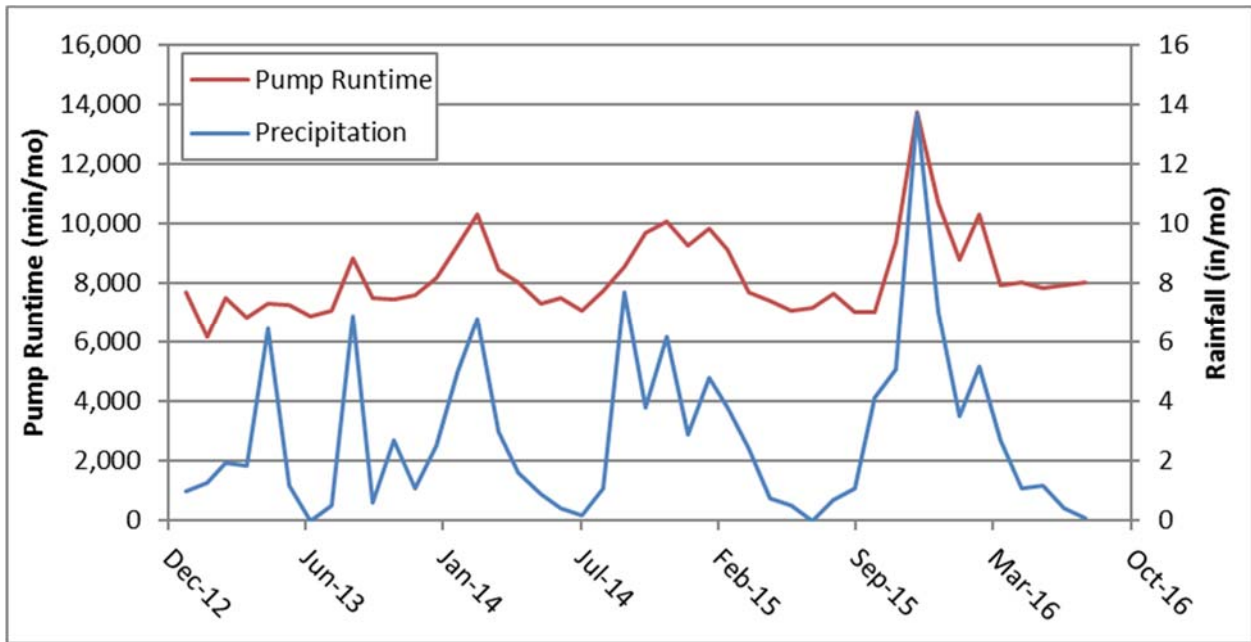
Chart E-5: Fernwood Lift Station Runtimes & Precipitation vs. Time

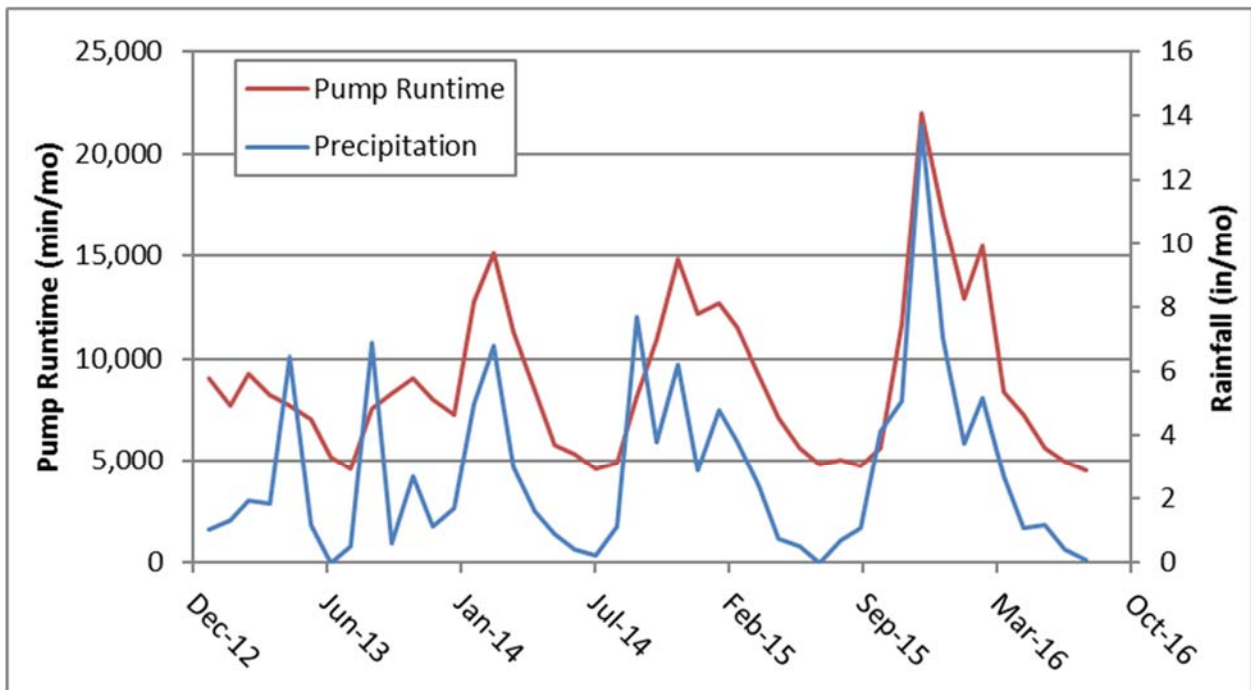
Chart E-6: HWY 240 Lift Station Runtimes & Precipitation vs. Time
