REQUEST: A Resolution recommending City Council amend the 2018 Wastewater Master Plan incorporating the 2021 Riverfront Addendum into the Newberg Comprehensive Plan

Wastewater Master Plan

May 2018

*Technical Update May 2021
Addendum - Riverfront
Master Plan (Appendix K)*

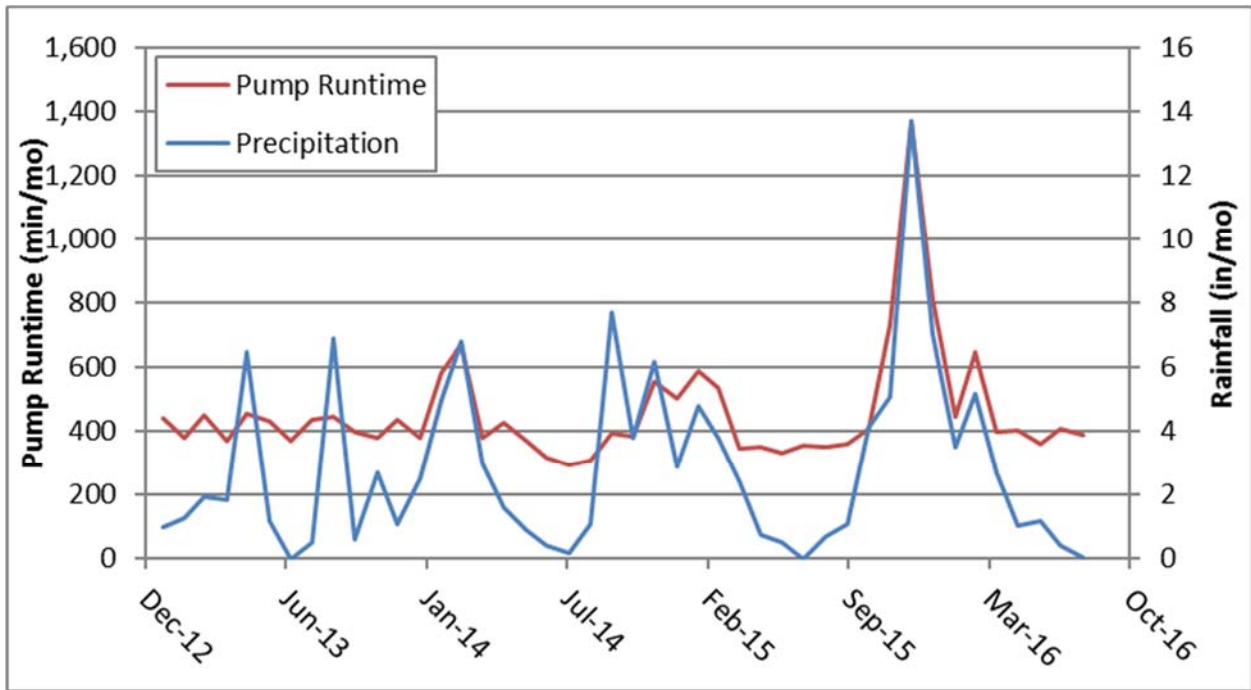
Chart E-7: Sheridan Lift Station Runtimes & Precipitation vs. Time

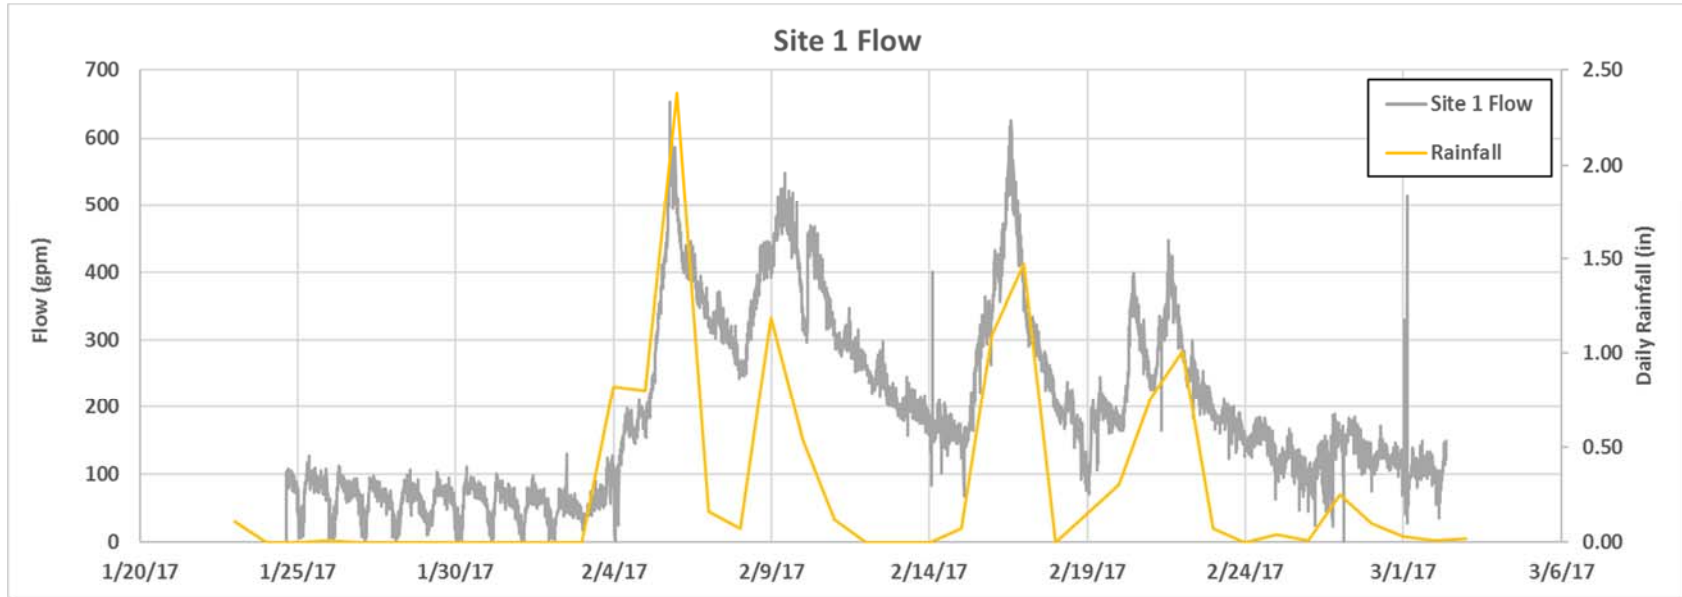
Chart E-8: Site 1 Flow vs. Precipitation

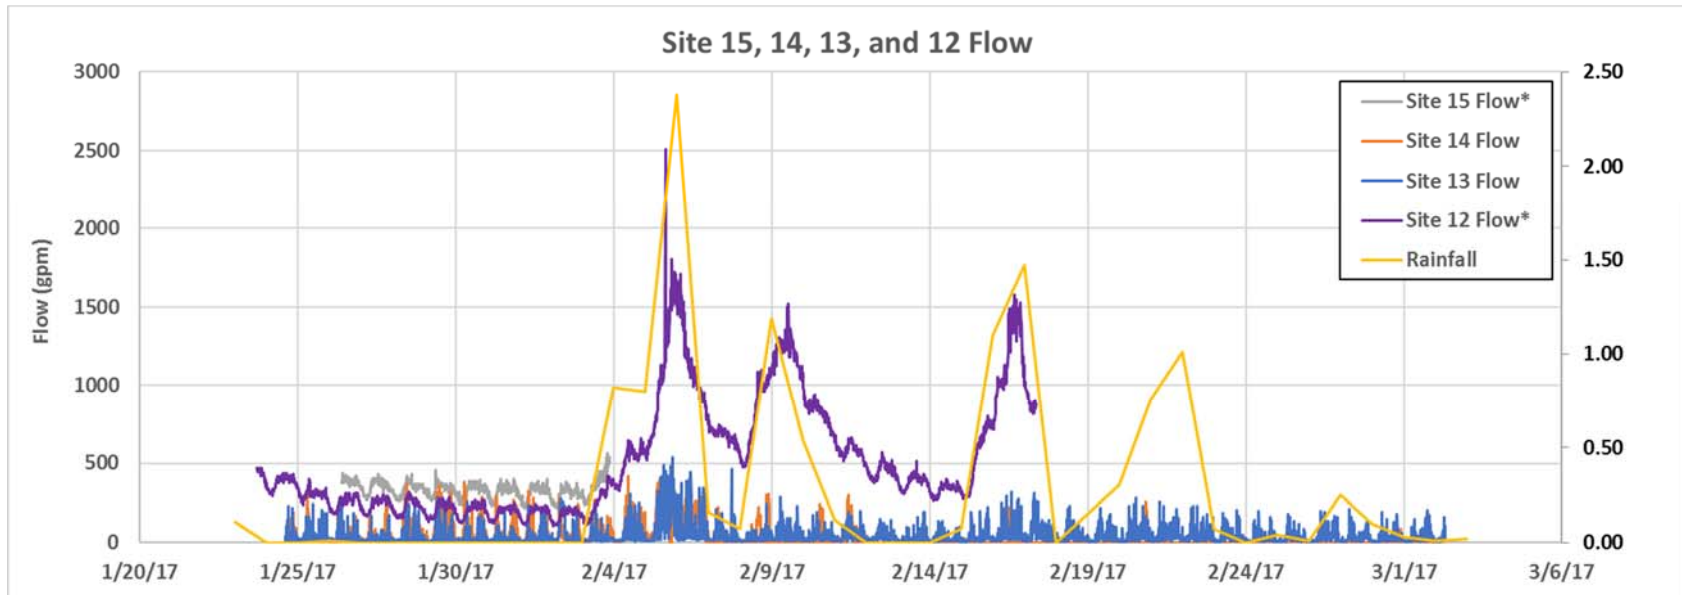
Chart E-9: Sites 15, 14, 13, and 12 Flow vs. Precipitation

*Flow meter was surcharged and clogged by rags during the monitoring period and had to be removed. Data later in monitoring period is inaccurate due to rags and was not included in analysis.

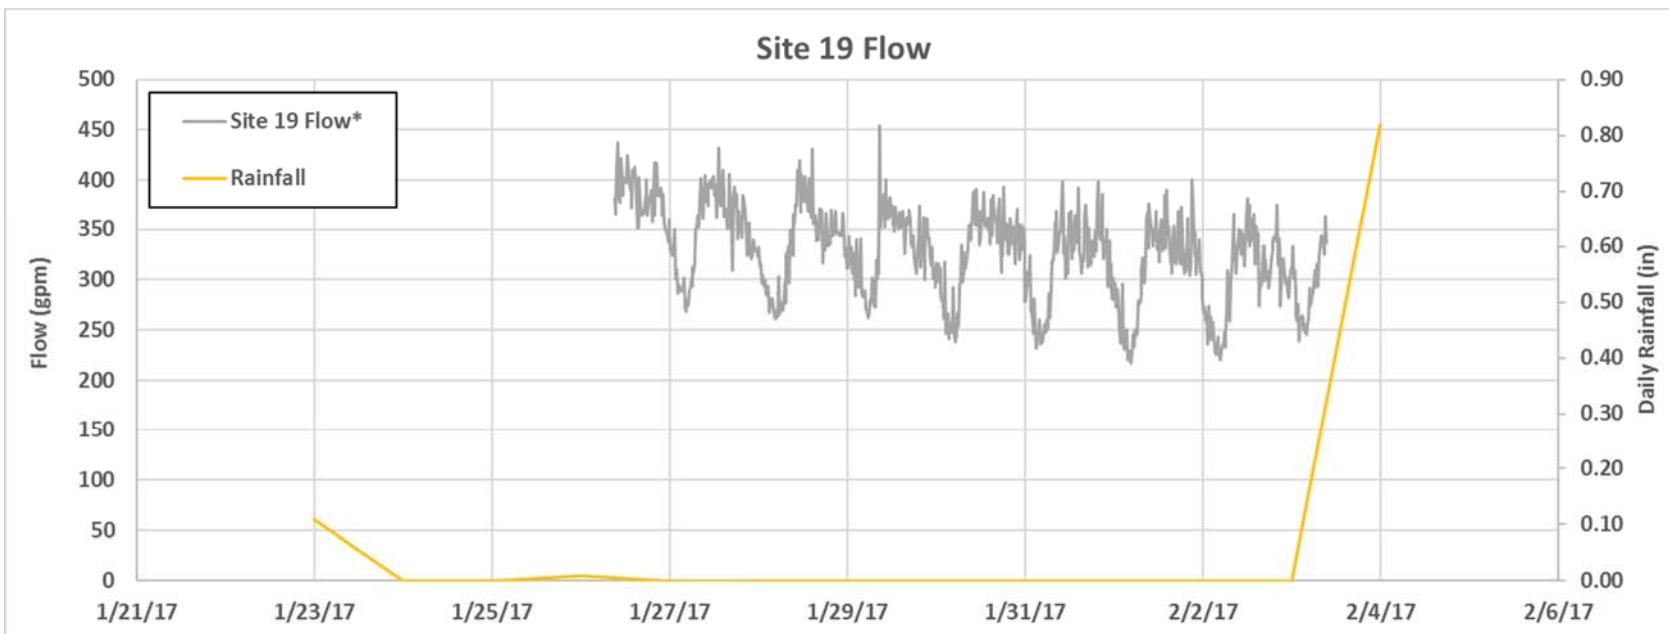
Chart E-10: Site 19 Flow vs. Precipitation

*Flow meter was surcharged and clogged by rags during the monitoring period and had to be removed. This pipe is known to the City to surcharge and cause backup problems.

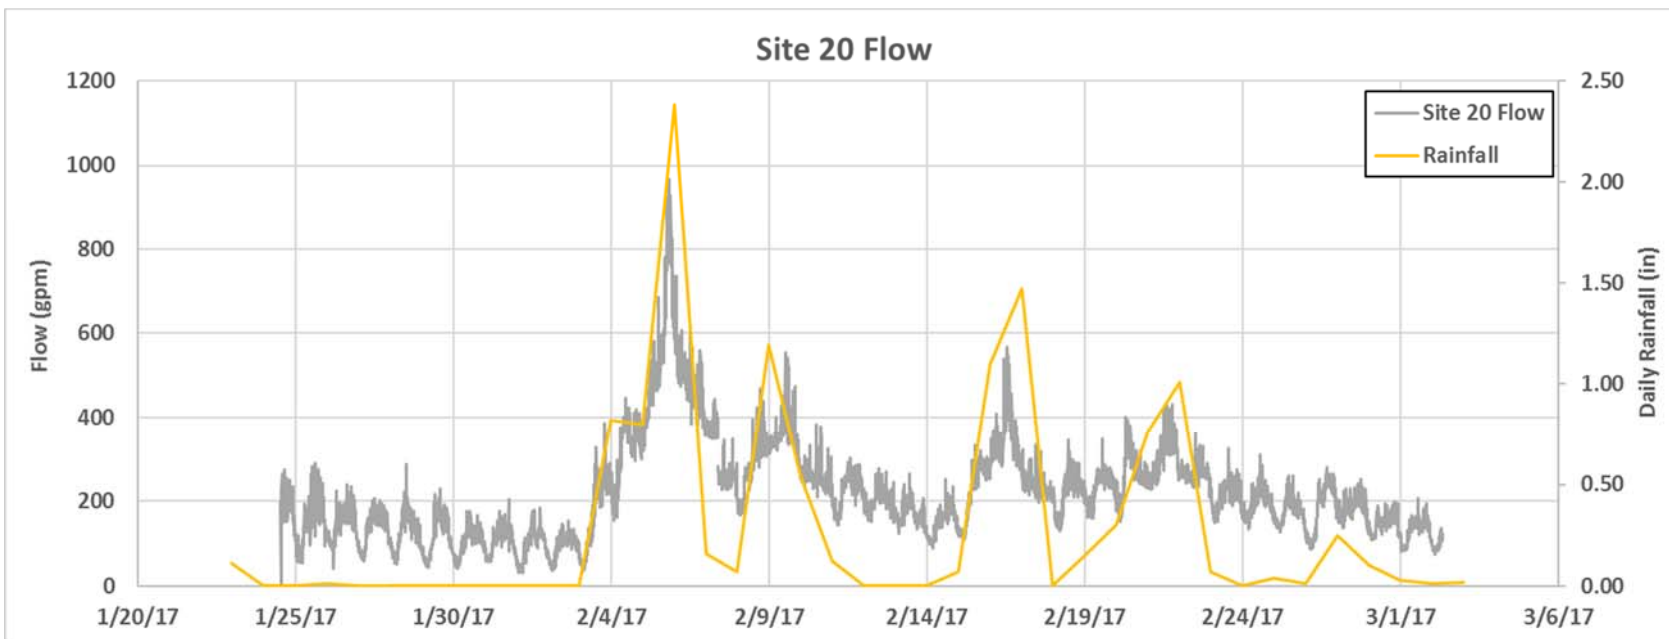
Chart E-11: Site 20 Flow vs. Precipitation

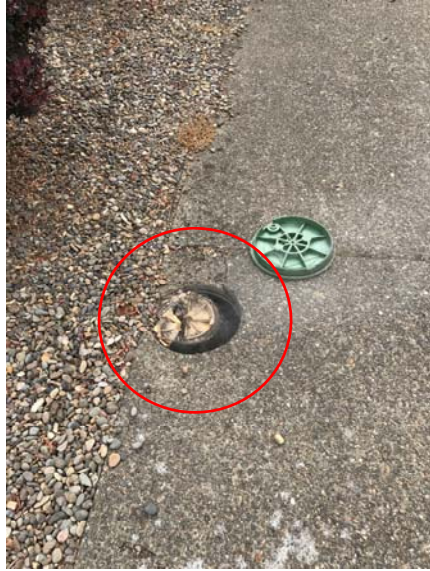
Address: 2200 Thorne St

Description: Broken lateral under yellow irrigation cap; open cleanout.

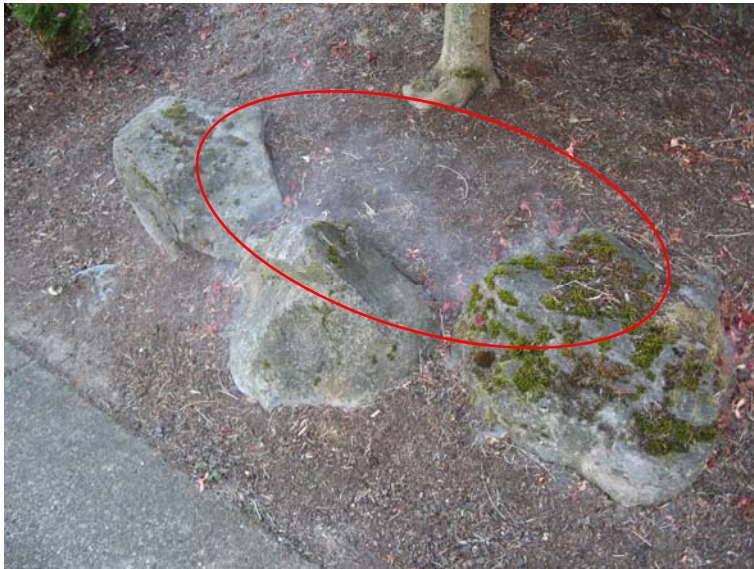
Picture ID #2

Address: 2219 Thorne St

Description: Broken lateral, bark in front yard smoking.

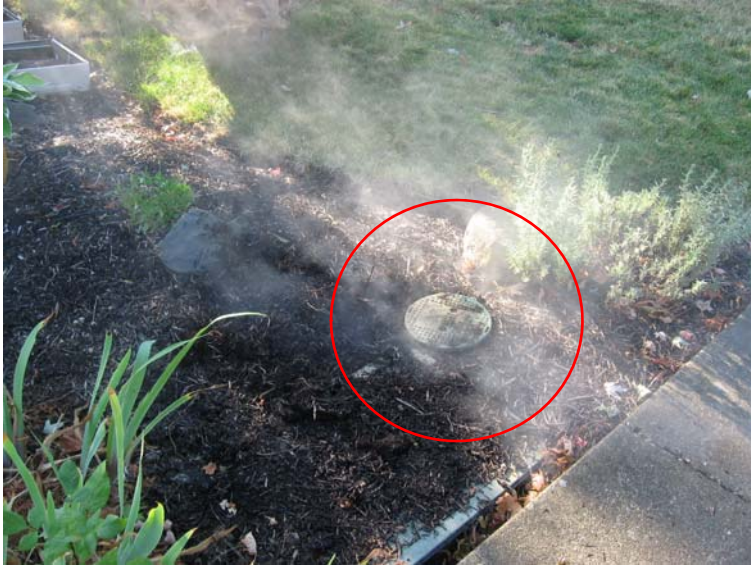
Address: 2210 Thorne St

Description: Open cleanout.

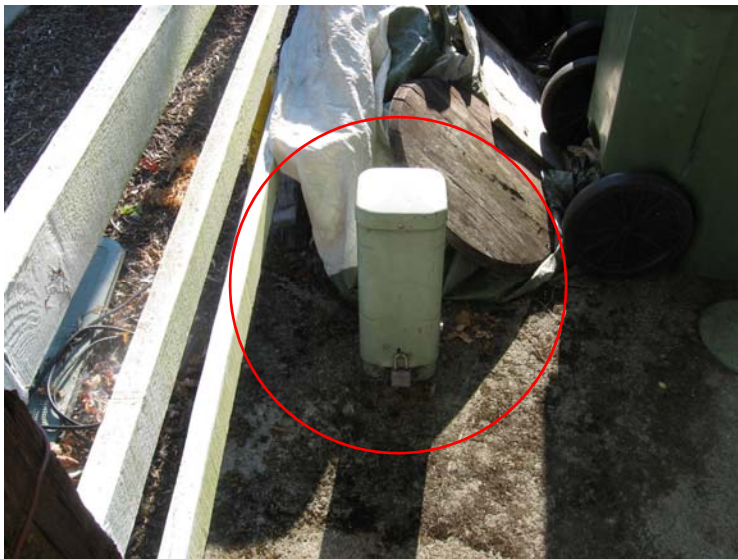
Picture ID #4

Address: 2220 Thorne St

Description: Open cleanout and phone pedestal smoking from inside.

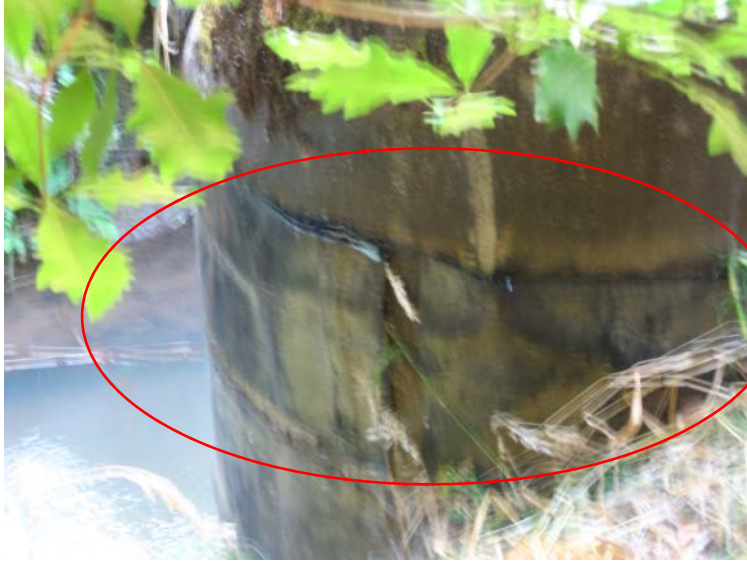
Picture ID #5

Address: MH H105004

Description: Manhole wrap is smoking.

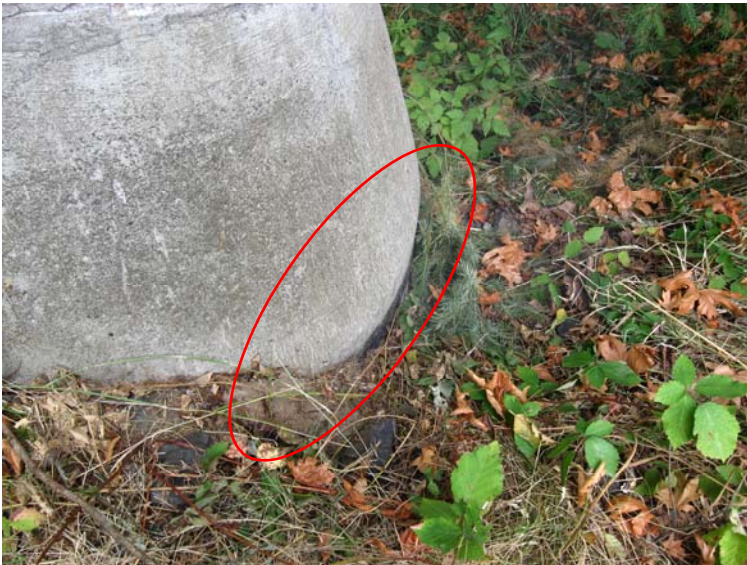
Picture ID #6

Address: MH H114005

Description: Manhole wrap is smoking.

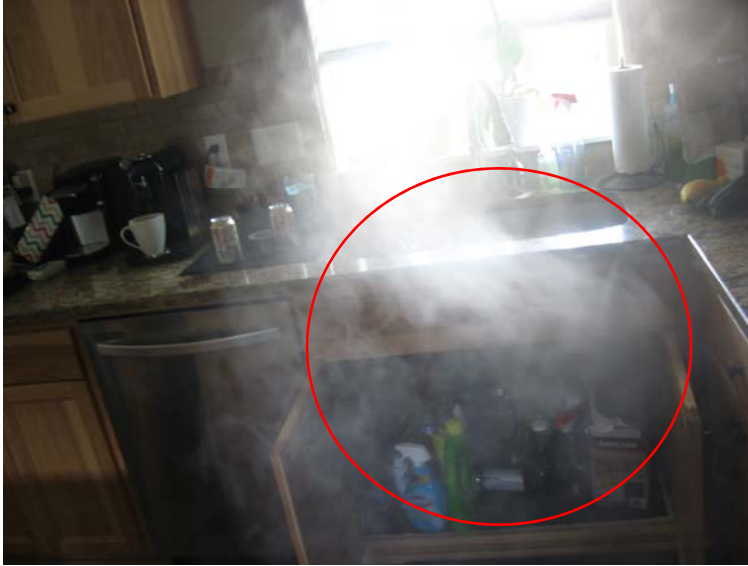
Address: 2340 Thorne St

Description: Smoke emitting from under sink.

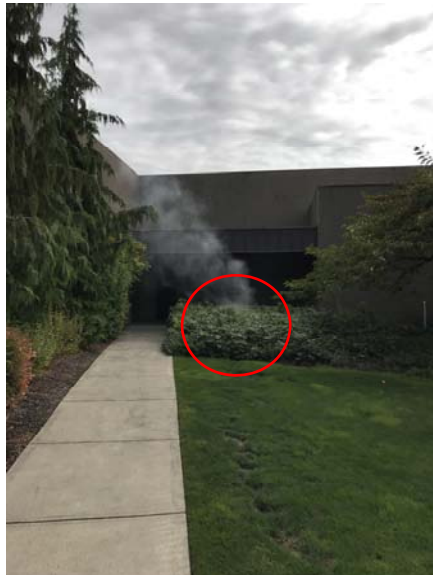
Picture ID #12

Address: Unmarked MH (east of MH H95012)

Description: MH rim and lid smoking excessively, storm covers.

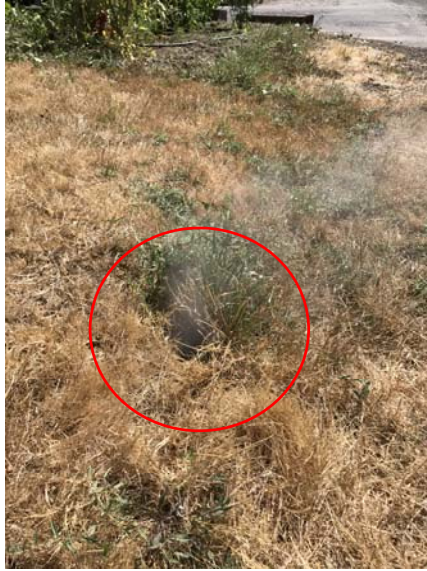
Picture ID #13

Address: 1104 S Pennington Dr

Description: Cleanout lid missing.

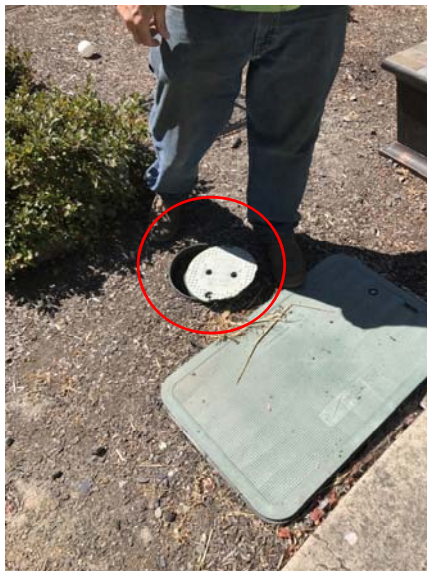
Picture ID #14

Address: 1000B Pennington Ct

Description: Smoking around cleanout.

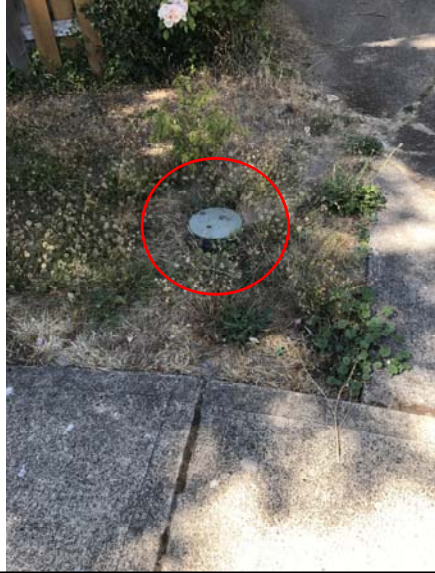
Picture ID #15

Address: 1011A Pennington Ct

Description: Broken cleanout and cap.

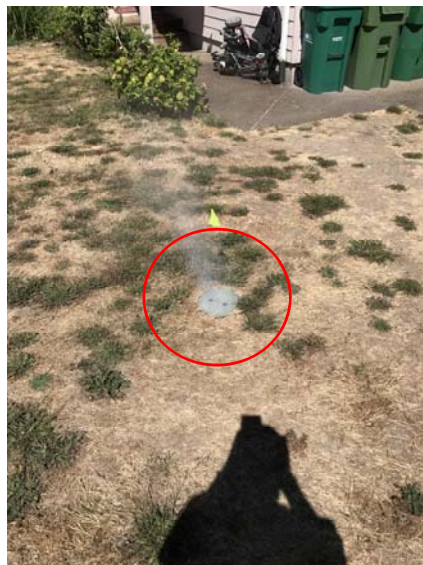
Picture ID #16

Address: 1021A Pennington Ct

Description: Broken cleanout and cap.

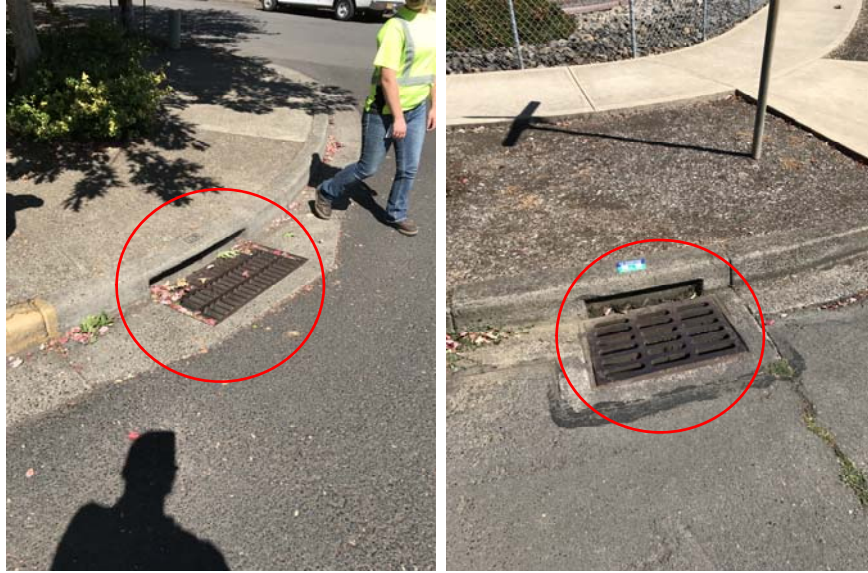
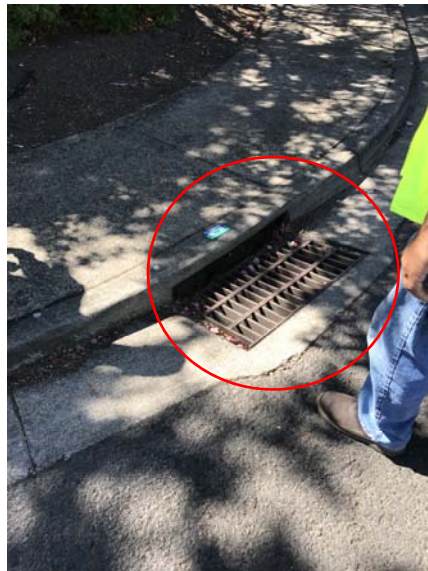
Picture ID #17

Address: Intersection of S Pennington Dr and Hoskins St

Description: All 4 catch basins smoking.

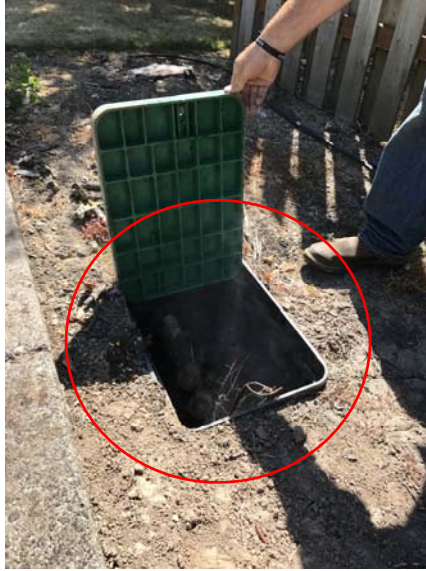
Picture ID #18

Address: 1020 Sierra Vista Dr

Description: Coming from inside irrigation control valve box and next to water meter box/sidewalk.

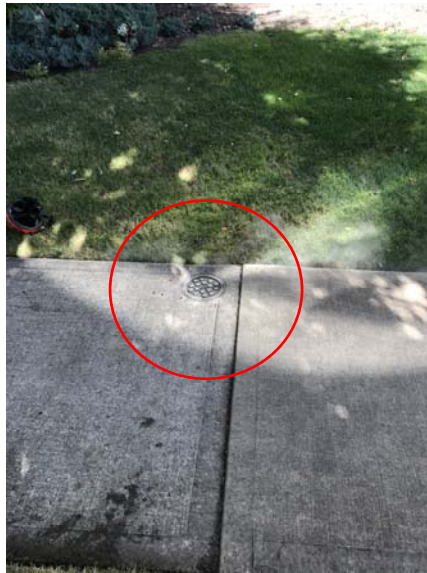
Picture ID #19

Address: 534 The Greens Ave

Description: Smoking along sidewalk edge with grass and in sidewalk joint.

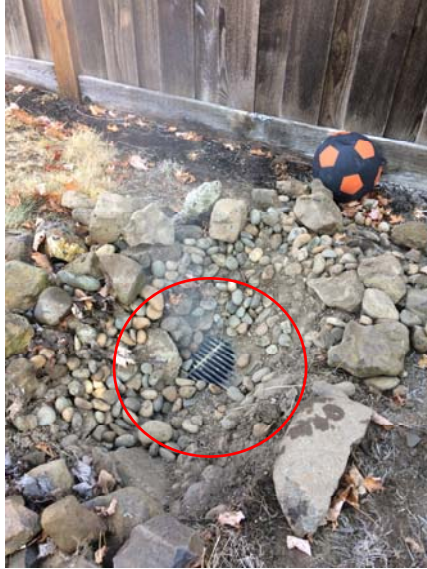
Picture ID #20

Address: 5270 Wedgewood Lp

Description: Area drain in backyard under rocks smoking excessively.

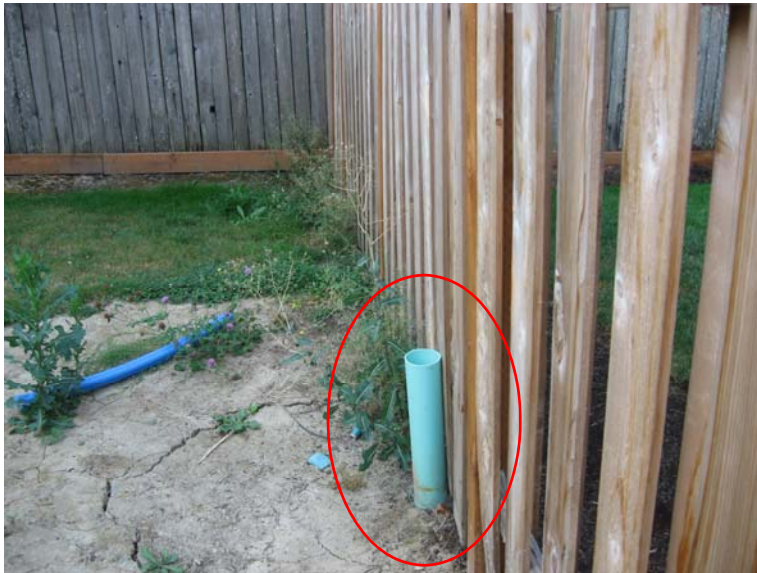
Picture ID #21

Address: 2215 Prospect Dr

Description: Open cleanout.

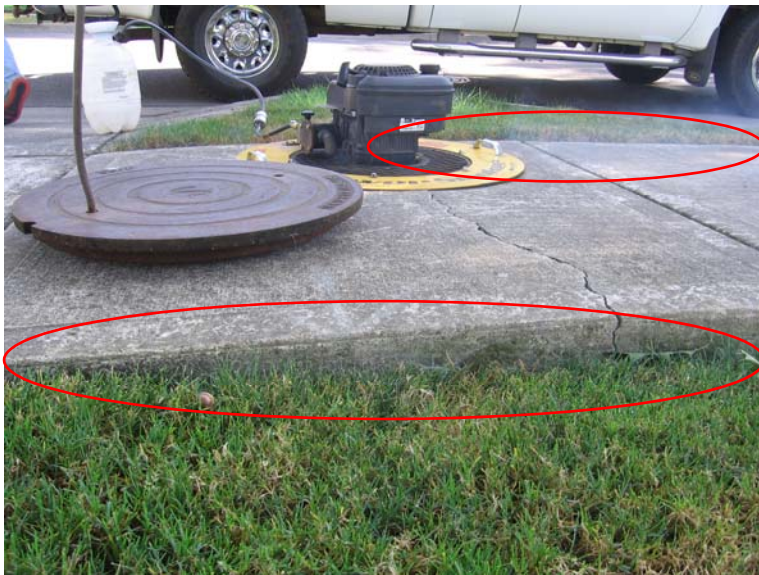
Address: 3891 Oak Meadows Lp

Description: Smoke on either side of sidewalk next to MH.

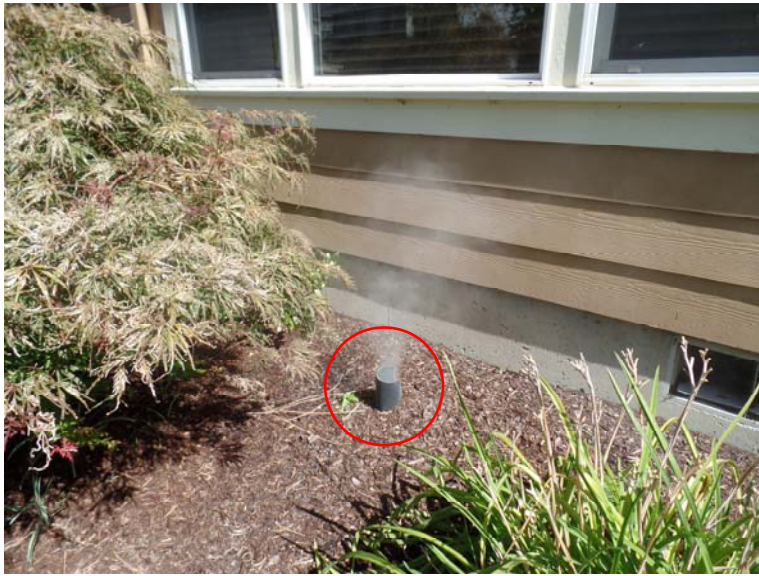
Picture ID #24

Address: 216 Acorn St

Description: Open cleanout.

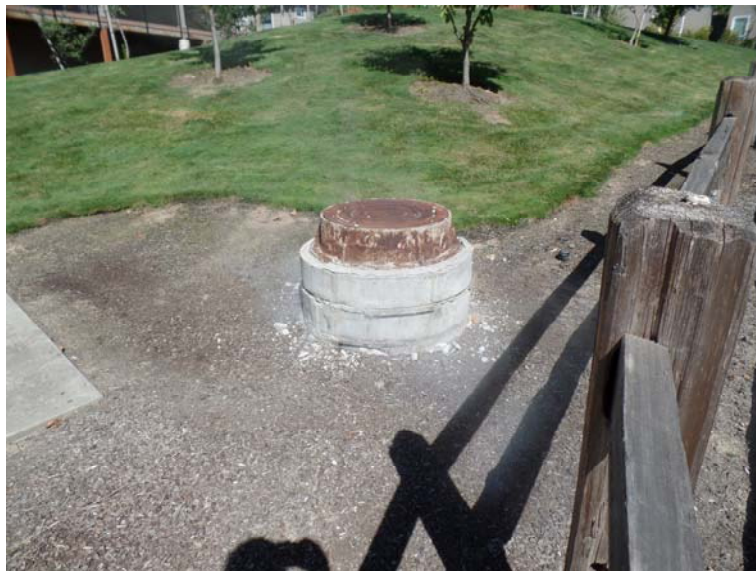
Picture ID #25

Address: North of MH I113155 (new MH)

Description: No grout, raised MH smoking excessively; on south side of new apartments.

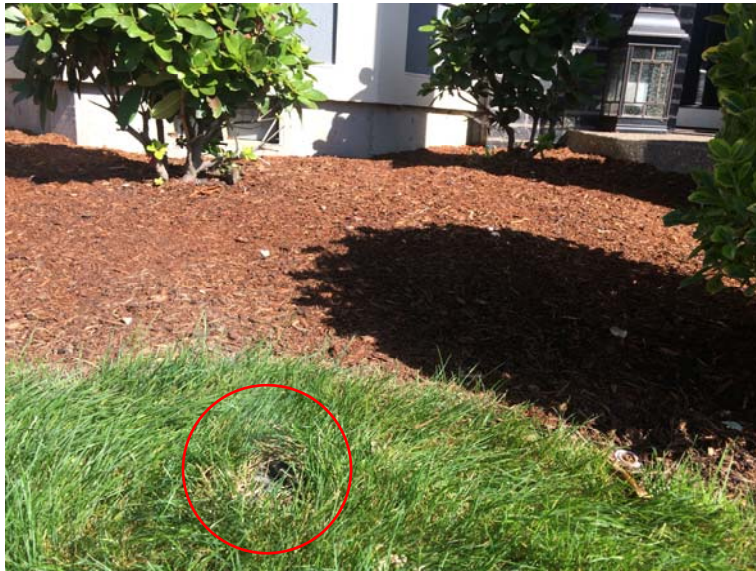
Picture ID #26

Address: 148 Argyle Ct

Description: Broken cleanout in front yard grass.

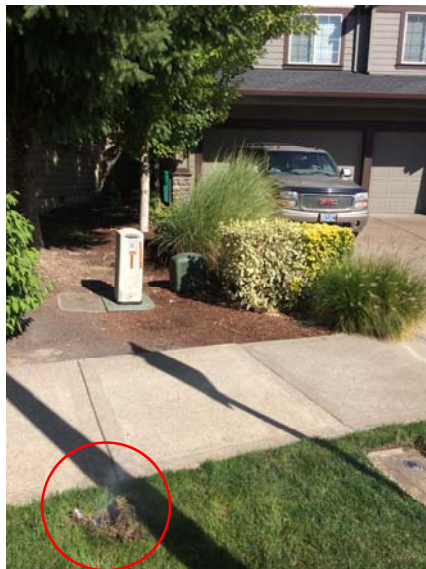
Picture ID #27

Address: 136 The Greens Ave

Description: Open cleanout between 136 and 148 The Greens Ave.

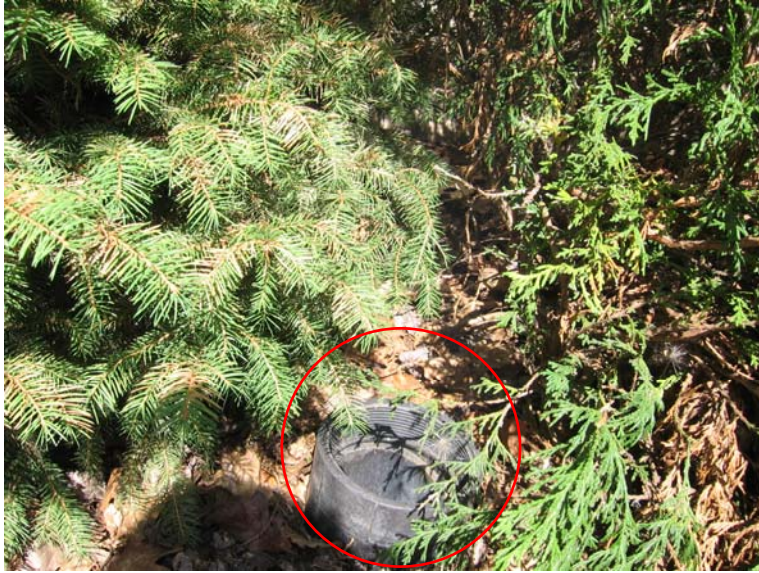
Picture ID #28

Address: 5217 Fairway St

Description: Open cleanout.

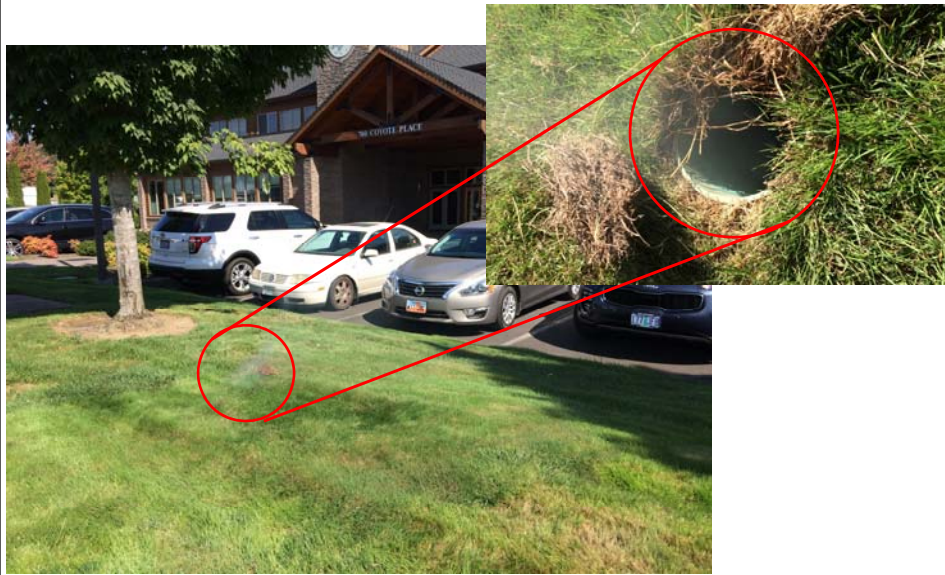
Picture ID #29

Address: 700 Deborah Rd

Description: Open cleanout in front median strip grass.

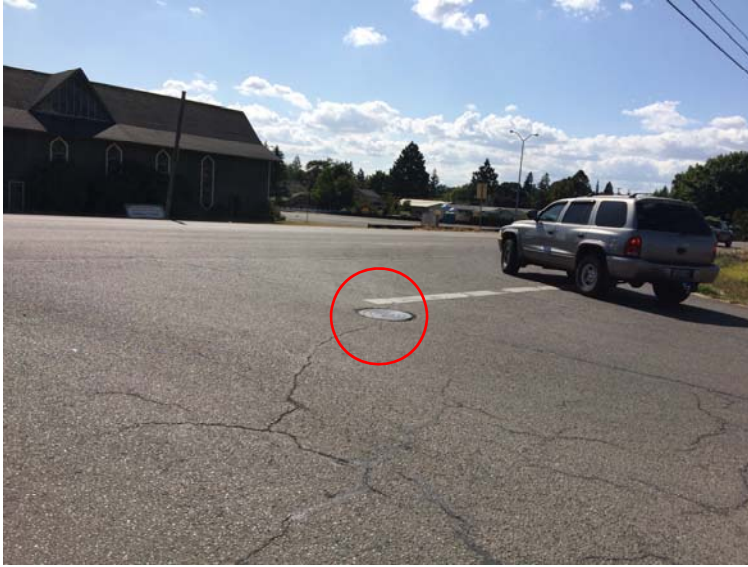
Picture ID #30

Address: MH H123039

Description: Smoking around rim.

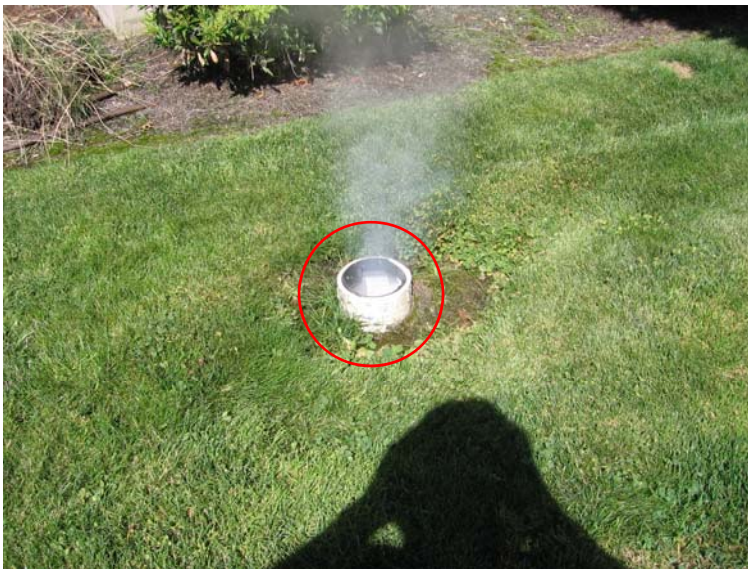
Picture ID #31

Address: 3411 Hayes St building 7

Description: Open cleanout.

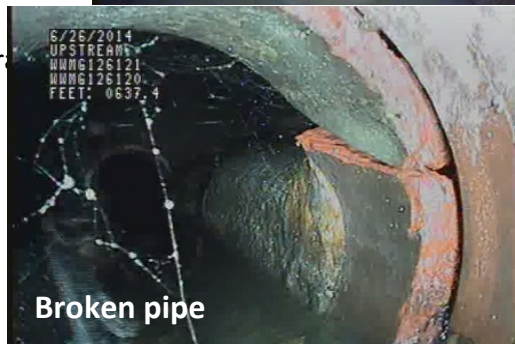
Broken pipe

- Line is crushed
- Broken pipe
- Multiple small holes; one with soil visible
- Grade 4 fractures
- Broken tap with offset joint
- Cracked taps
- Leaking around taps
- Scattered roots in joints and laterals

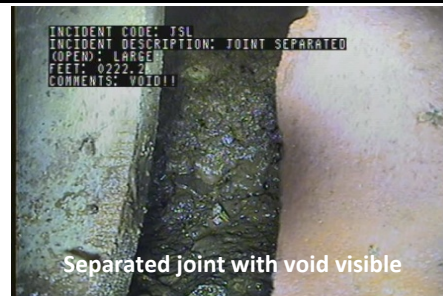
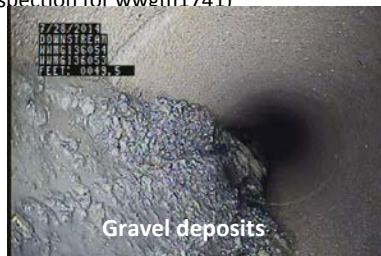
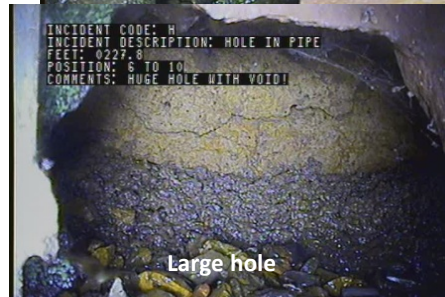
- Lots of lateral issues; majority of laterals are offset or broken and blocked with dirt; may want to investigate if blocked laterals are abandoned
- Segment wwgm1744 has two offset joints and a large hole, all with void visible
- Number of cracks and fractures throughout
- Roots scattered throughout
- Gravel deposits along entire wwgm1323 line

(*see inspection for wwgm1741)

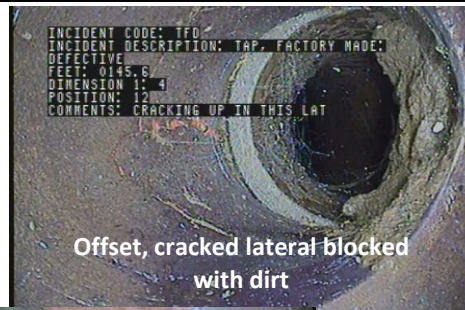
Offset, cracked lateral blocked with dirt

- Approximately 1003' of 1025' video inspected
- Large hole
- Crack that looks like small rips in wall
- Cracks throughout pipeline
- Number of laterals are blocked with dirt; may want to investigate if blocked laterals are abandoned
- Broken lateral cap
- Grout deposits; one joint impassable because of intruding grout or gasket
- Gravel deposits
- Large root ball

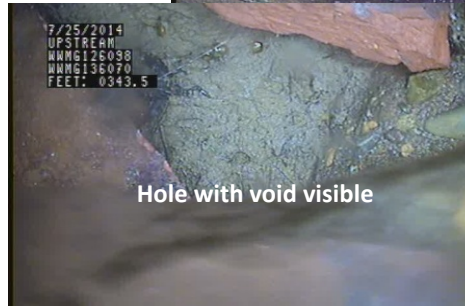
Hole with void visible

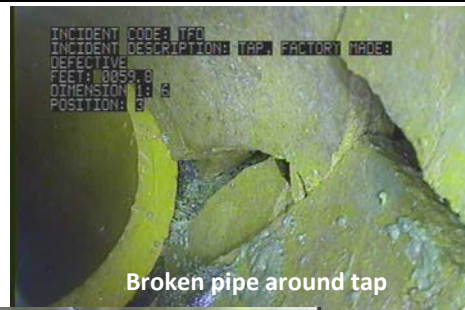
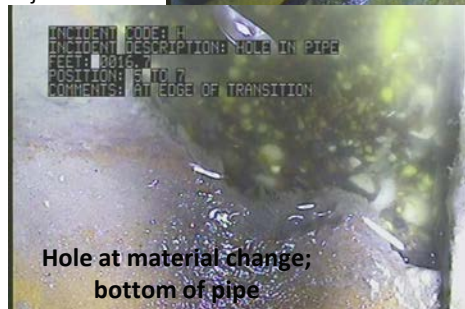
- Approximately 419' of 1087' video inspected
- Broken tee at tap with holes; camera cannot pass; pipe no longer round
- Hole at material transition
- Large root ball; camera cannot pass
- Intruding taps; some camera cannot pass
- Grout deposits
- Roots scattered in pipe segments; some in joints
- At least one separated lateral joint

(*reverse inspection performed)

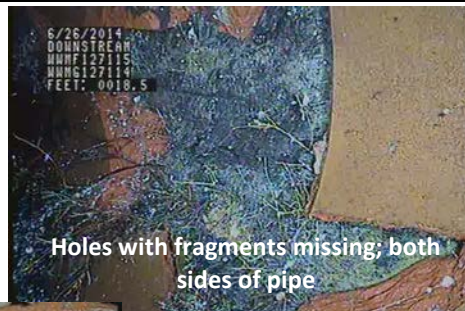
Holes with fragments missing; both sides of pipe

- Inspected by Pacific Int-R-Tek in 2014
- Large hole with fragments missing; soil visible
 - Heavy roots at large hole
 - Number of fractures throughout segment
 - Multiple cracks throughout segment
 - Fine roots in some joints
 - Leaking tap

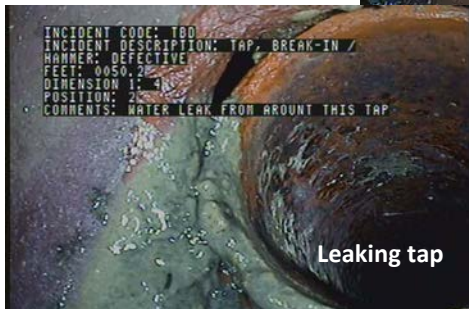
Leaking tap

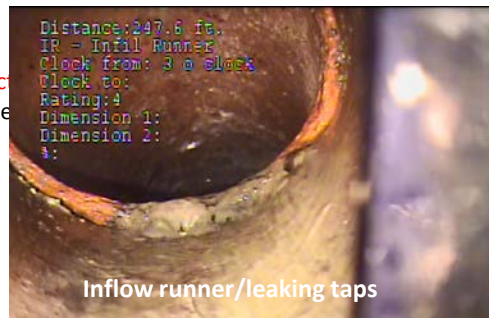
Inflow runner/leaking taps

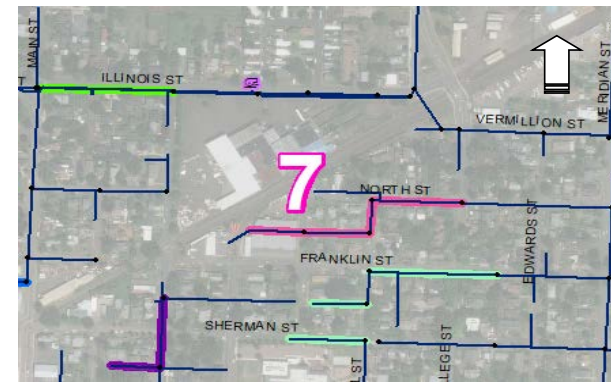
Project Location:

E North St from N College St to N School St
 South down N School road and west into alley

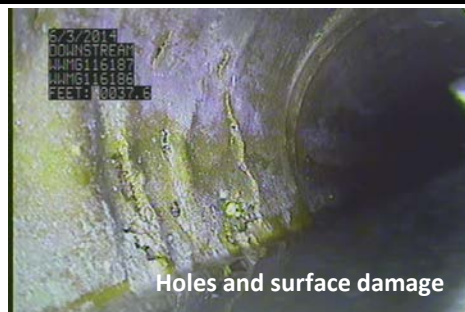
Holes and surface damage

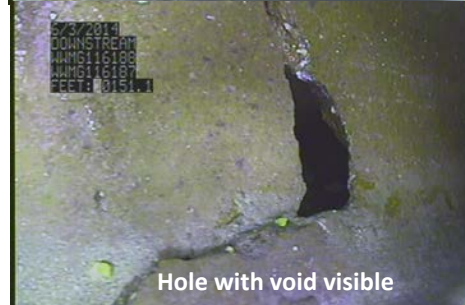
Hole with void visible

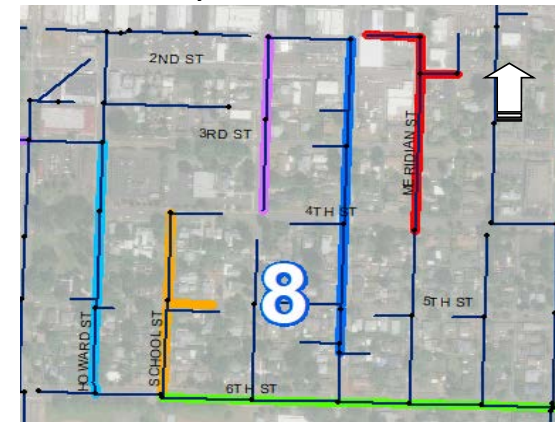
Project Location:

S Edward St from south of E 5th St to alley north of E 2nd St

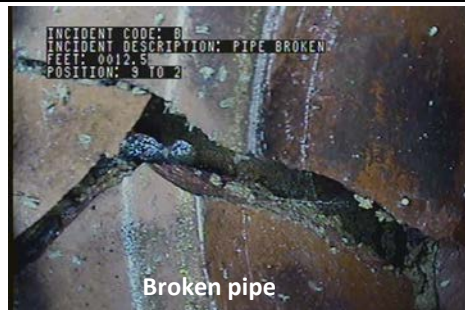
Broken pipe

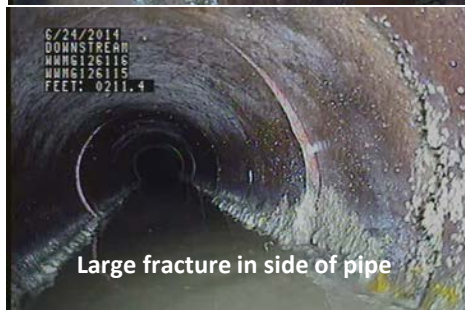
Large fracture in side of pipe

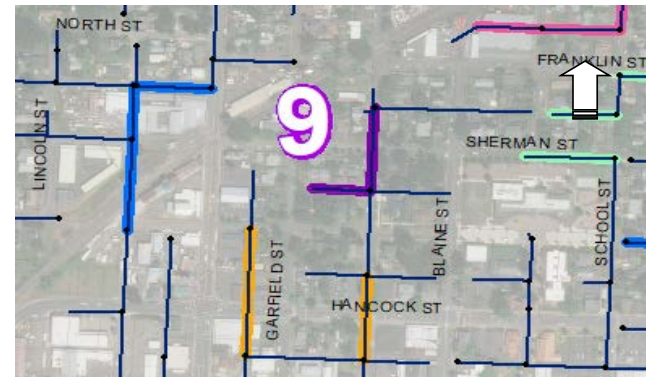
Project Location:

N Washington from alley north of E Sherman St
to alley south and along alley to west

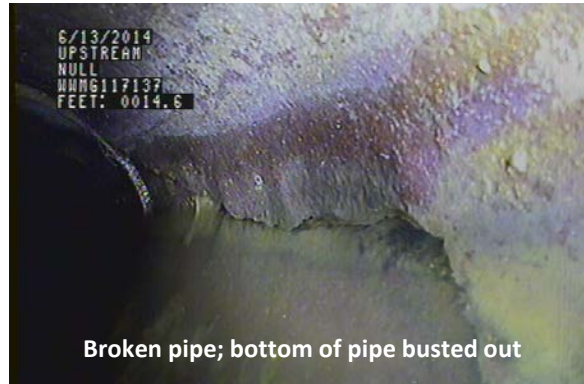
Broken pipe; bottom of pipe busted out

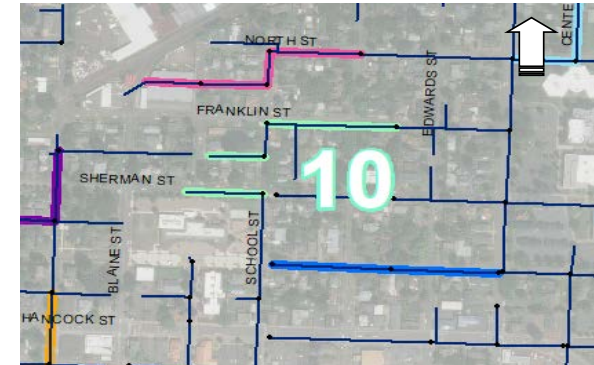
Project Location:

E Franklin St from N School St to east of N College St
E Sherman St from N School St to N Howard St
Alley north of E Sherman St from N Howard St to N School St

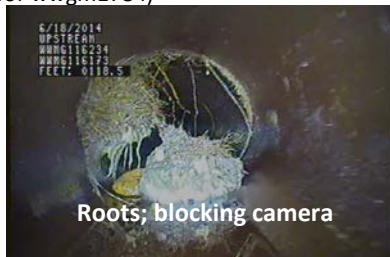
Roots; blocking camera

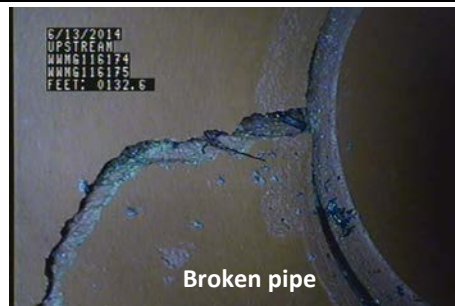
Broken pipe

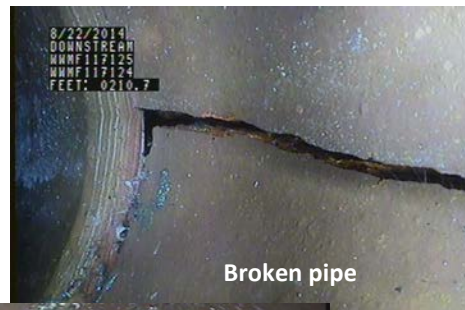
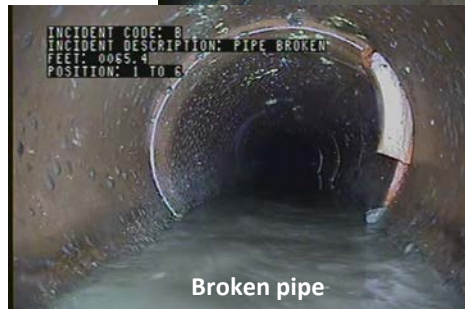
- Two breaks
- Some fractures and cracks
- Small hole
- Root ball camera cannot pass
- Intruding tap

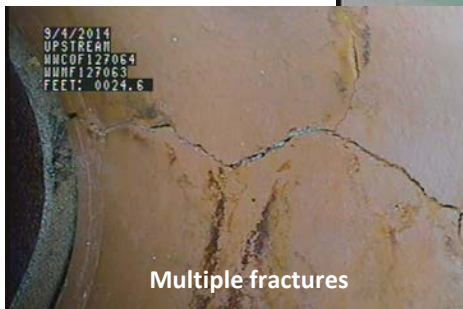
Multiple fractures

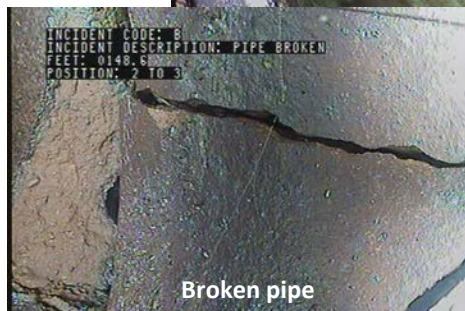
Broken pipe

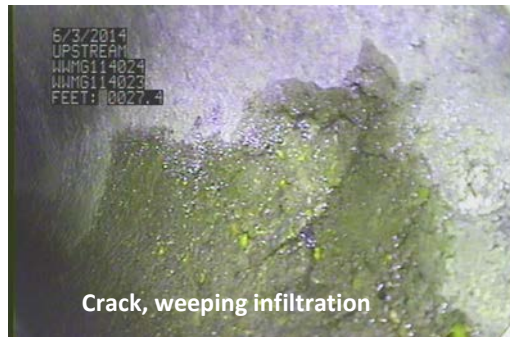
- Approximately 183' of 682' video inspected
- Cracks and infiltration stain from cracks
- Intruding tap camera cannot pass; only about one third of pipe length surveyed
- Root ball and root obstruction camera cannot pass

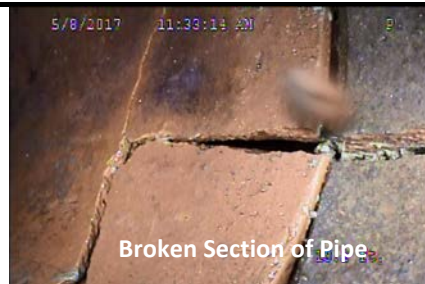
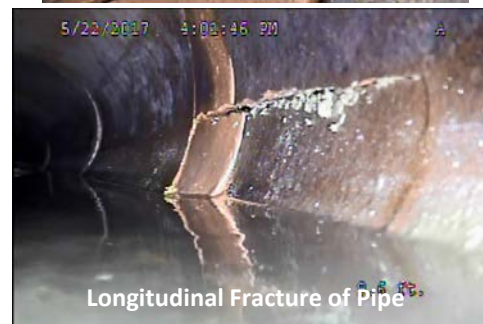
- Reverse inspections completed
- Multiple structural cracks and fractures along length of pipe

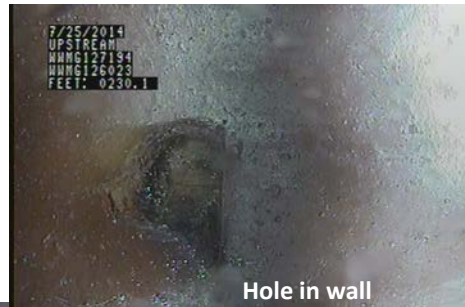
Hole in wall

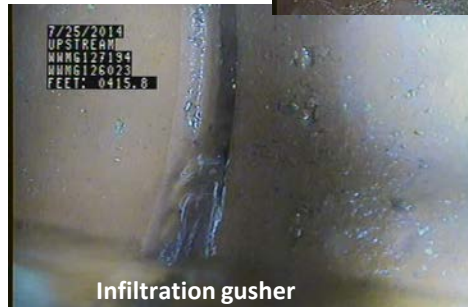
Infiltration gusher

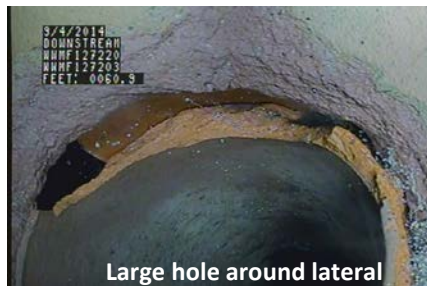
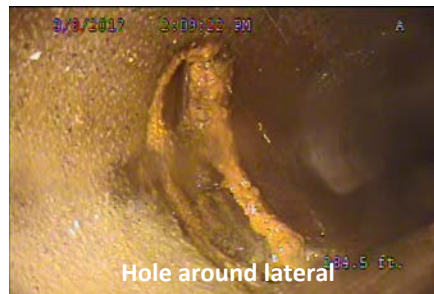
- One segment (wwgm1402) inspected by Pacific Int-R-Tek in 2014 and two by the City
- Approximately 1082' of 1166' video inspected
 - Broken with soil visible
 - Hole with void visible
 - Broken lateral pipe
 - Broken lateral connection
 - Infiltration gusher at tap (water entering pipe "under pressure")
 - Large hole around lateral
 - Couple of cracks; one with roots visible
 - Large chunk of asphalt in pipeline camera cannot pass

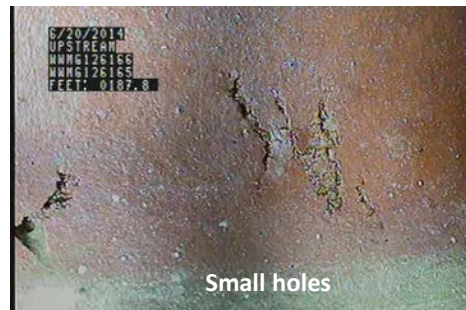
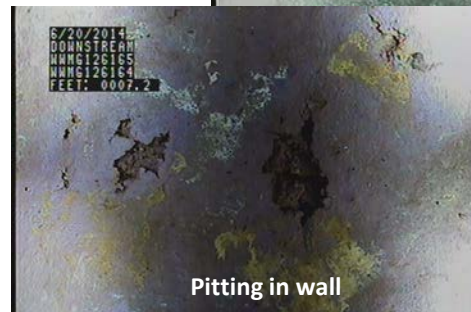
- Small holes in wall
- Couple of fractures; one grade 4
- Surface pitting at one location
- Crack
- Infiltration stain
- Large offset at lateral joint
- Encrustation in one location
- A few roots in pipeline and in laterals

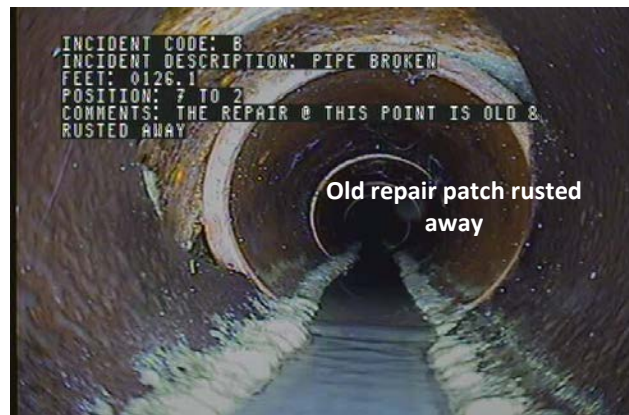
- Approximately 432' of 711' video inspected
- Broken; repair at this location is rusted away
- Minor cracks
- Intruding tap
- Fine roots in a joint

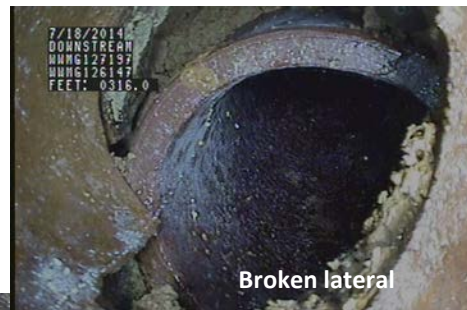
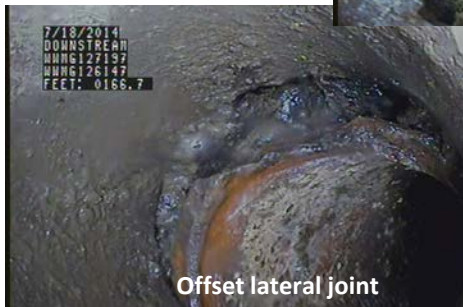
PACP Findings

Inspected by Pacific Int-R-Tek in 2014

- Approximately 419' of 643' video inspected
- Multiple sags in the line
- Two broken lateral pipes
- Small hole in lateral
- Open lateral joint with dirt and rock
- Separated joint
- Crack
- Intruding tap

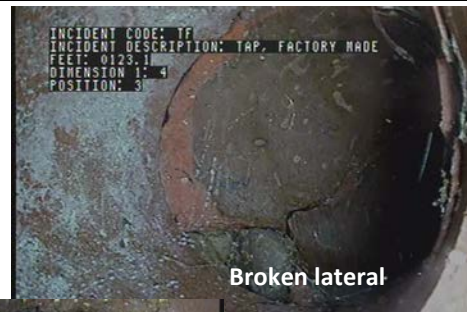
Broken lateral

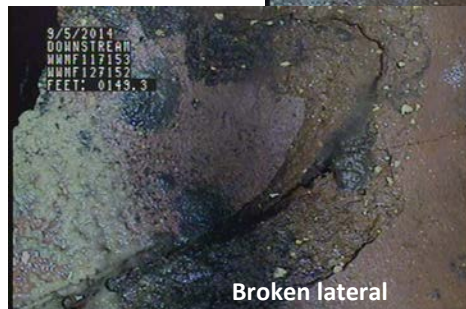
Broken lateral
