REQUEST: A Resolution recommending City Council amend the 2018 Wastewater Master Plan incorporating the 2021 Riverfront Addendum into the Newberg Comprehensive Plan

Wastewater Master Plan

May 2018

*Technical Update May 2021
Addendum - Riverfront
Master Plan (Appendix K)*

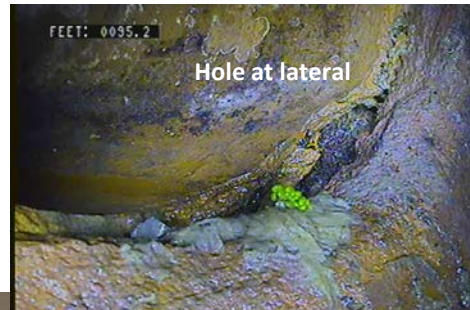
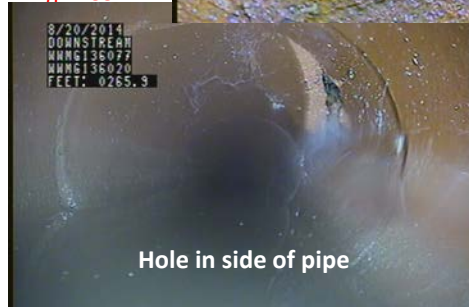
PACP Findings

Inspected by Pacific Int-R-Tek in 2014

- Broken
- Two grade 4 fractures
- A few other fractures and cracks
- Broken lateral cap
- Hole in lateral
- Intruding tap
- Grout stuck in the joints along wwgm1351
- Need to see CCTV inspection video for wwgm1352

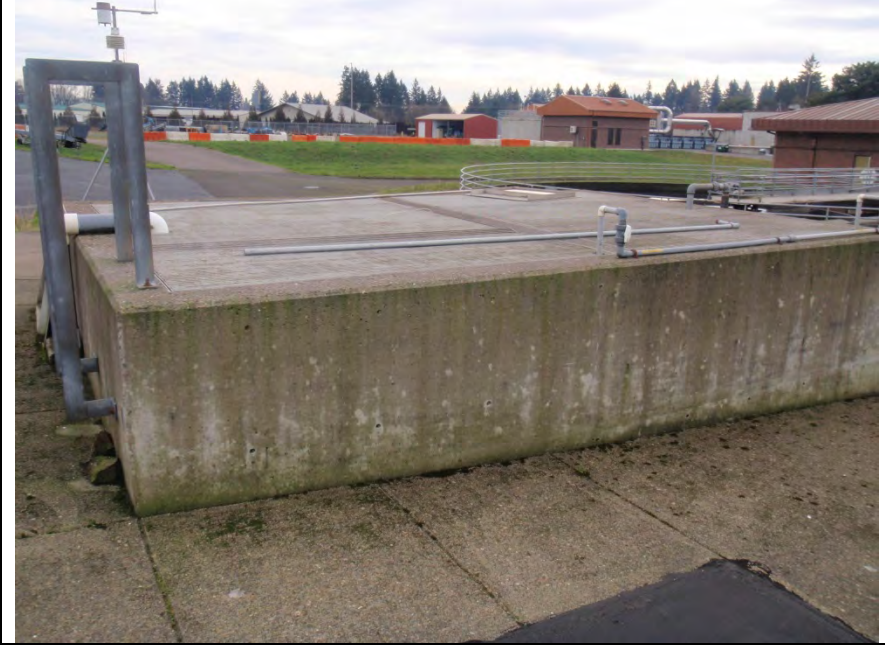
Passive system that under normal operating conditions splits raw, degrittied, sewage (RDS) from the Headwork to Oxidation Ditches 1 and 2. During high flow conditions, an overflow weir within the box sends flow to the Equalization basin.

Photo 1 – RDS Distribution Box (northwest side)

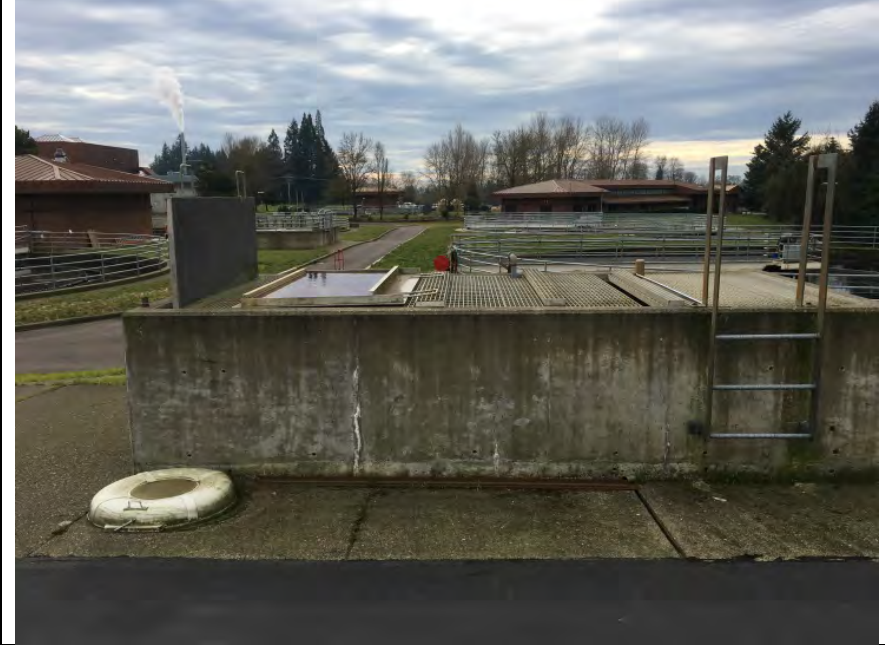
Photo 2 – RDS Distribution Box (northeast side)

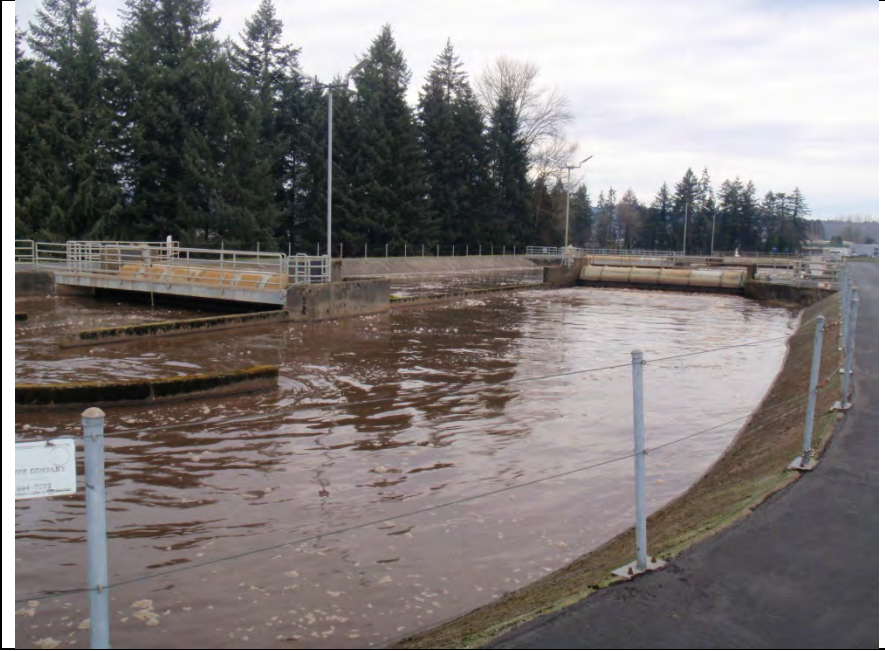
Photo 1 – Oxidation Ditch 1

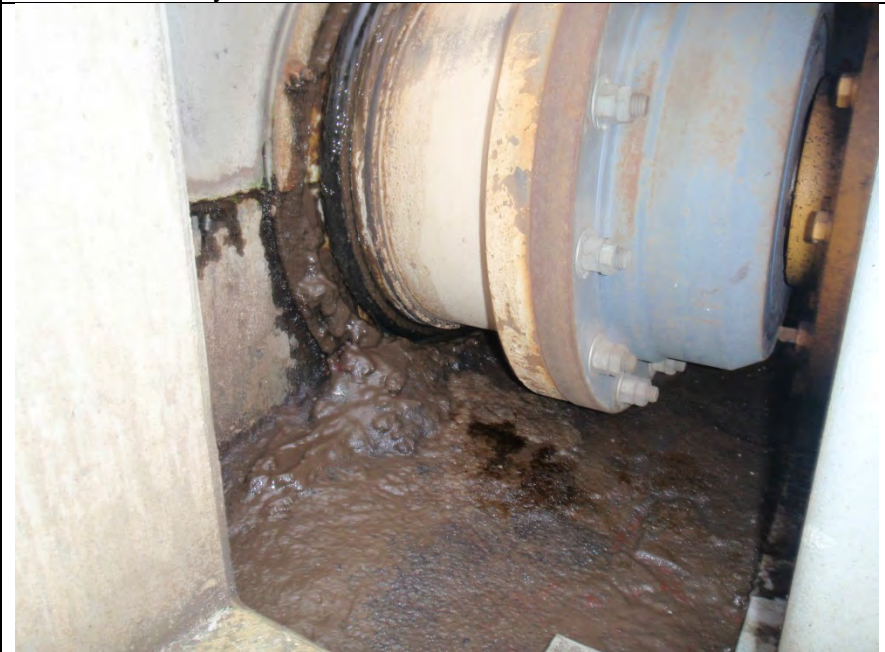
Rotor seals are in need of replacement.
Rotor seals are in stock and will be replaced as the corresponding rotor assemblies are replaced in the next 2 to 5 years.

Photo 2 – Leaky Rotor Seal

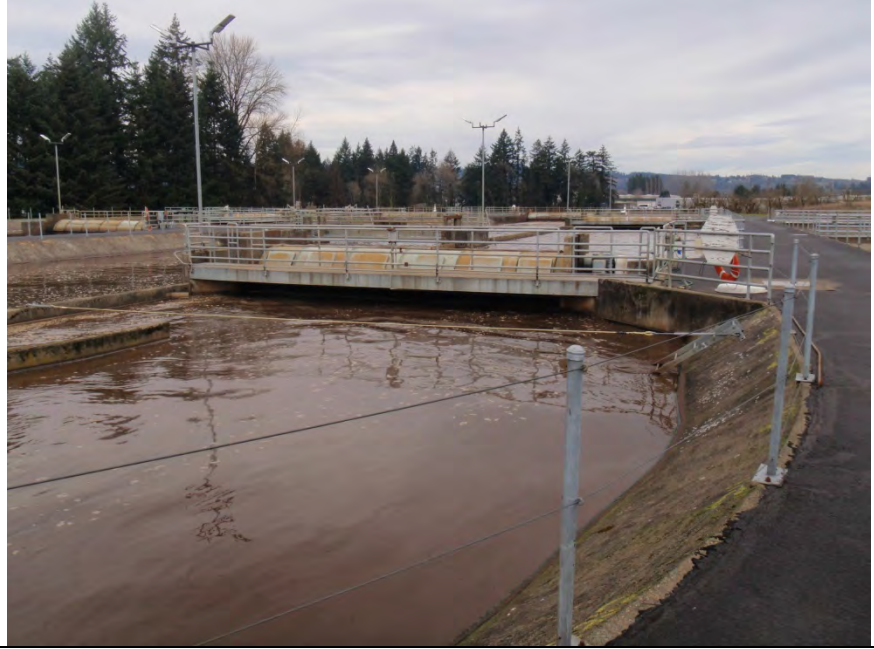
Photo 1 – Oxidation Ditch 2

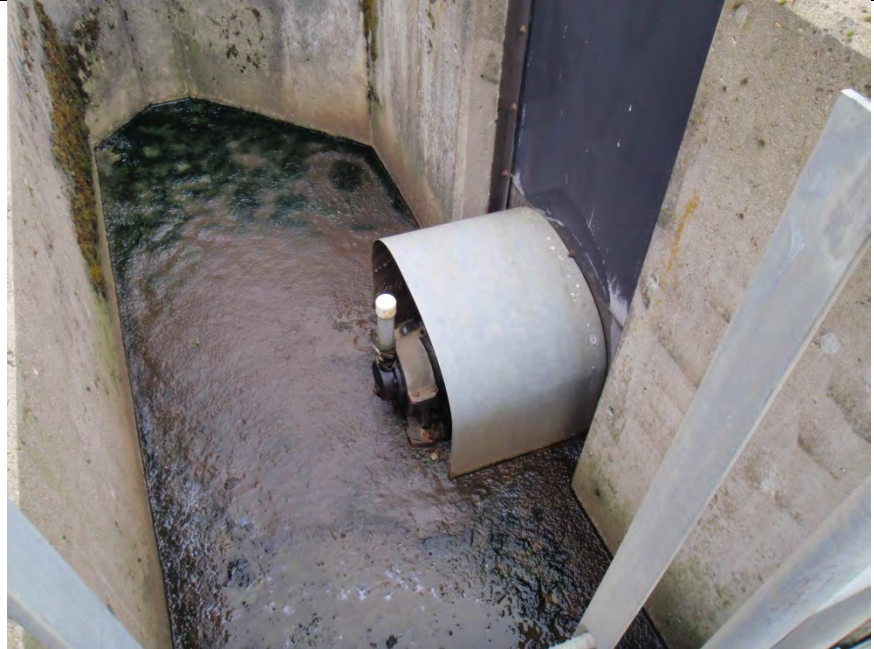
Rotor seals are in need of replacement.

Rotor seals were replaced in October 2017 with no improvement with seal leaking. Rotor seals will again be replaced as the corresponding rotor assemblies are replaced in the next 2 to 5 years.

Photo 2 – Leaky Rotor Seal

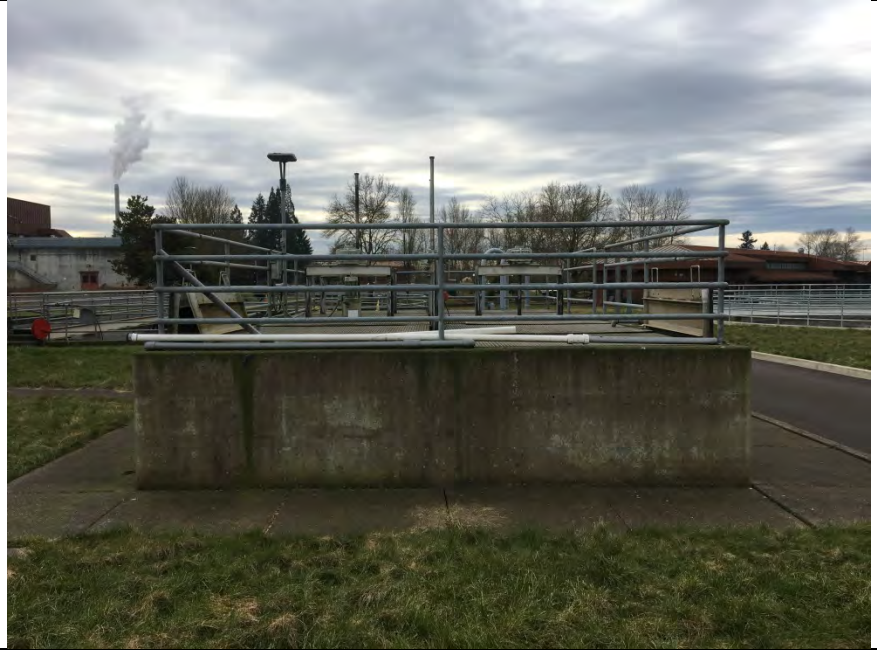
Photo 1 – Clarifier Distribution Box

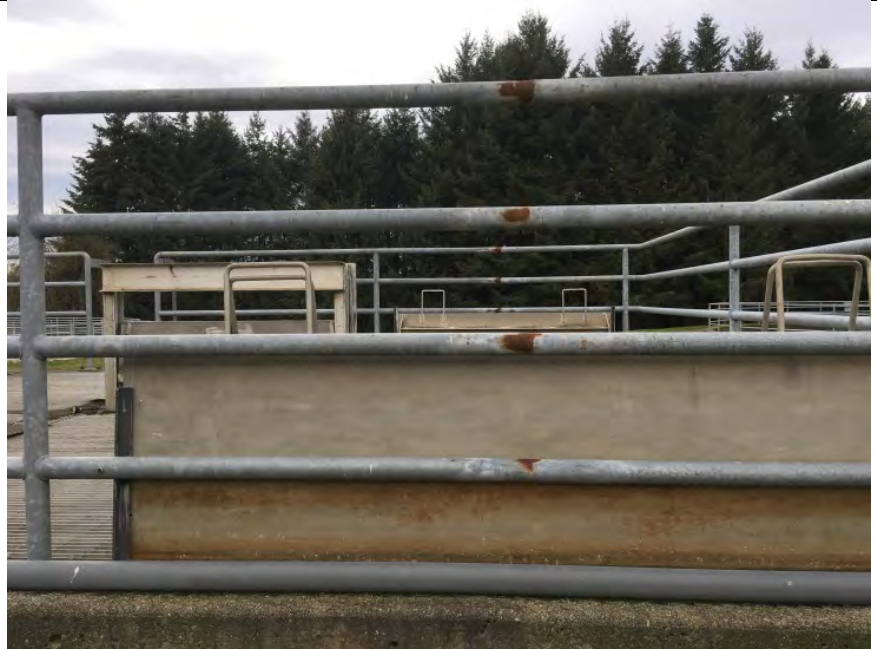
SYSTEM ASSETS	CR	COMMENTS		
Civil and Site	2	Differential settlement and some high spots in sidewalk.		
Architectural	2	Handrail has localized corrosion due to lack of galvanizing at field welded joints.		
Structural	3	Rating primarily based on age. No major structural deficiencies identified		
Power Distribution	N/A	N/A		
Electrical	N/A	N/A		
Instrumentation/ Analyzers	N/A	N/A		
Process or Mechanical Equipment	2	Per discussion with operations staff, the isolation gate into the last segment is not functional.		
Pumping Systems	N/A	N/A		
Piping and Valves	1	Sodium hypochlorite piping for disinfection is new. Old air, soda ash, polymer piping on/to the structure are not used.		
HVAC	N/A	N/A		
Odor Control	N/A	N/A		
Other	N/A	N/A		
Overall Facility Rating	2.0	System asset criteria weighted equally		
CONDITION RATING LEGEND	0	Unknown	Original Useful Life (OUL)	
	1	New or Excellent Condition	100% OUL	Normal Preventive Maintenance

Photo 2 – Handrail Corrosion

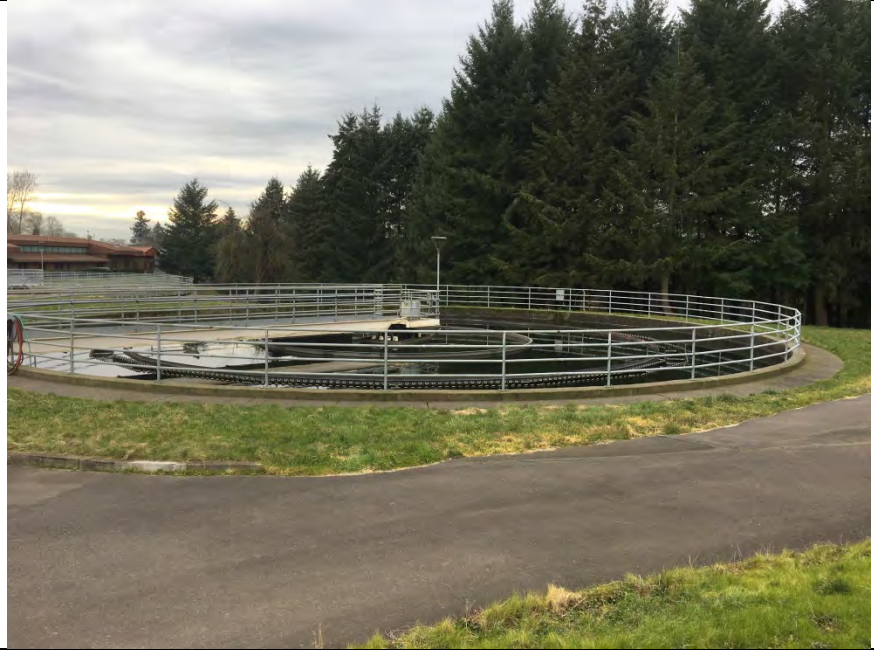
Photo 1 – Secondary Clarifier 1

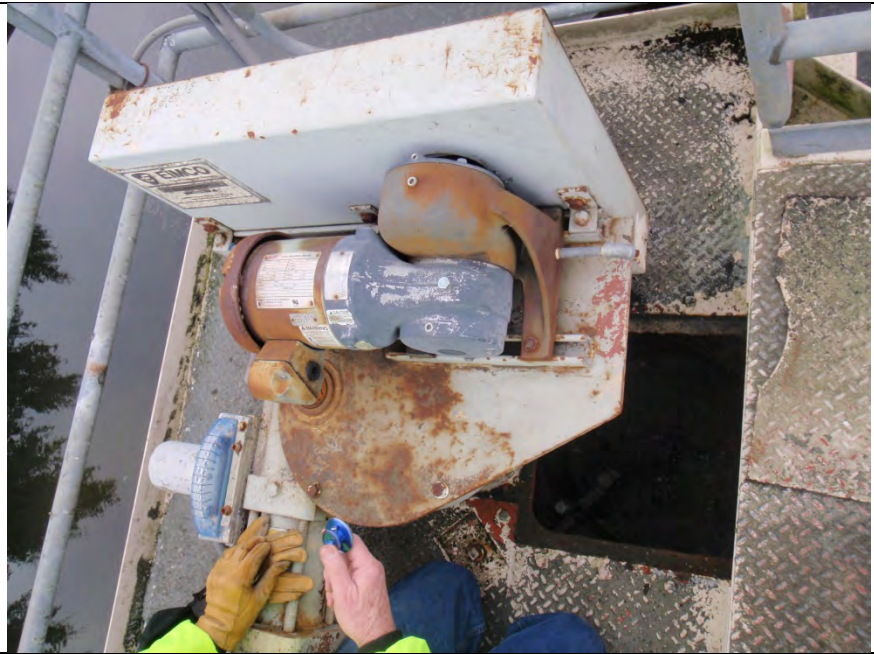
Photo 2 – Gear Box

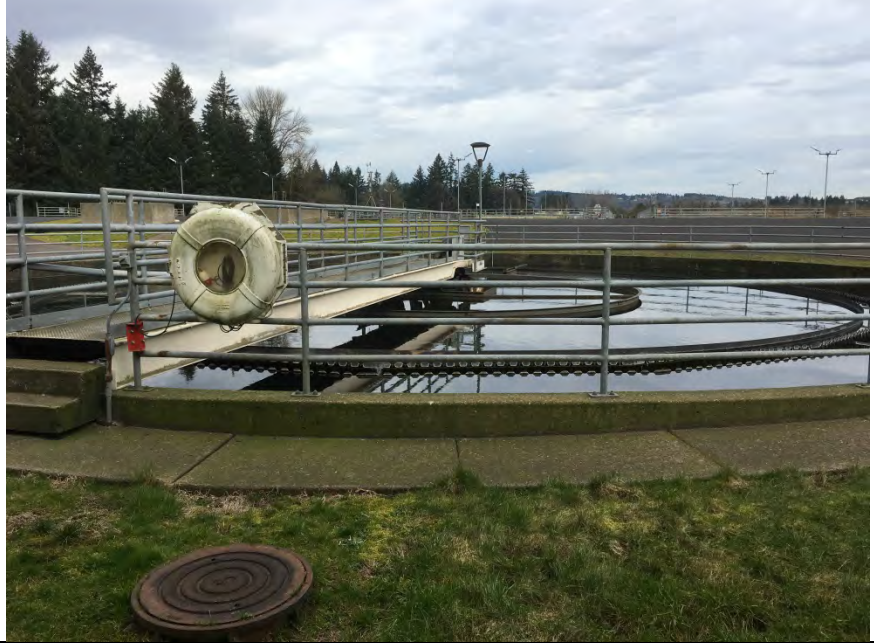
Photo 1 – Secondary Clarifier 2

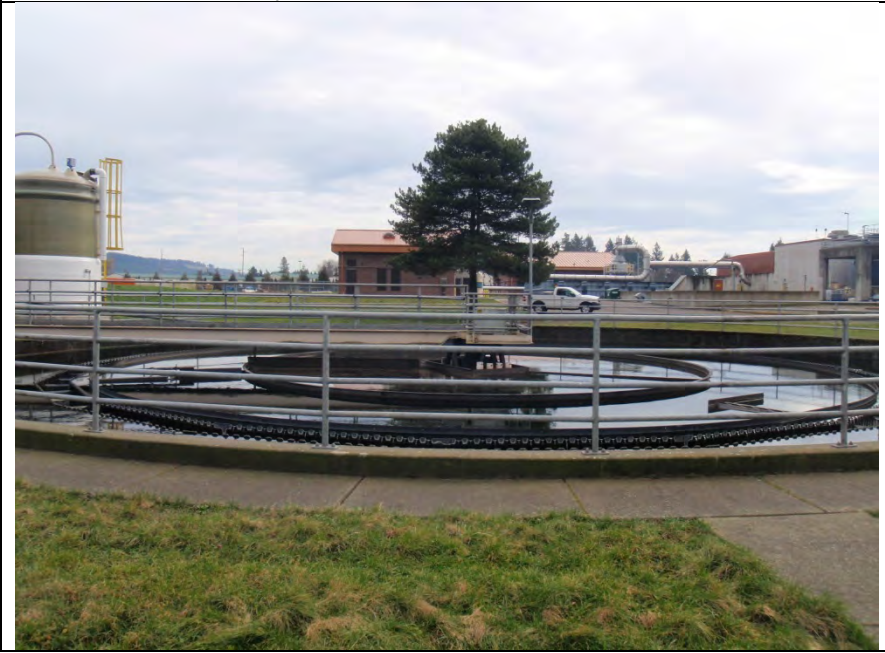
Photo 1 – Secondary Clarifier 3

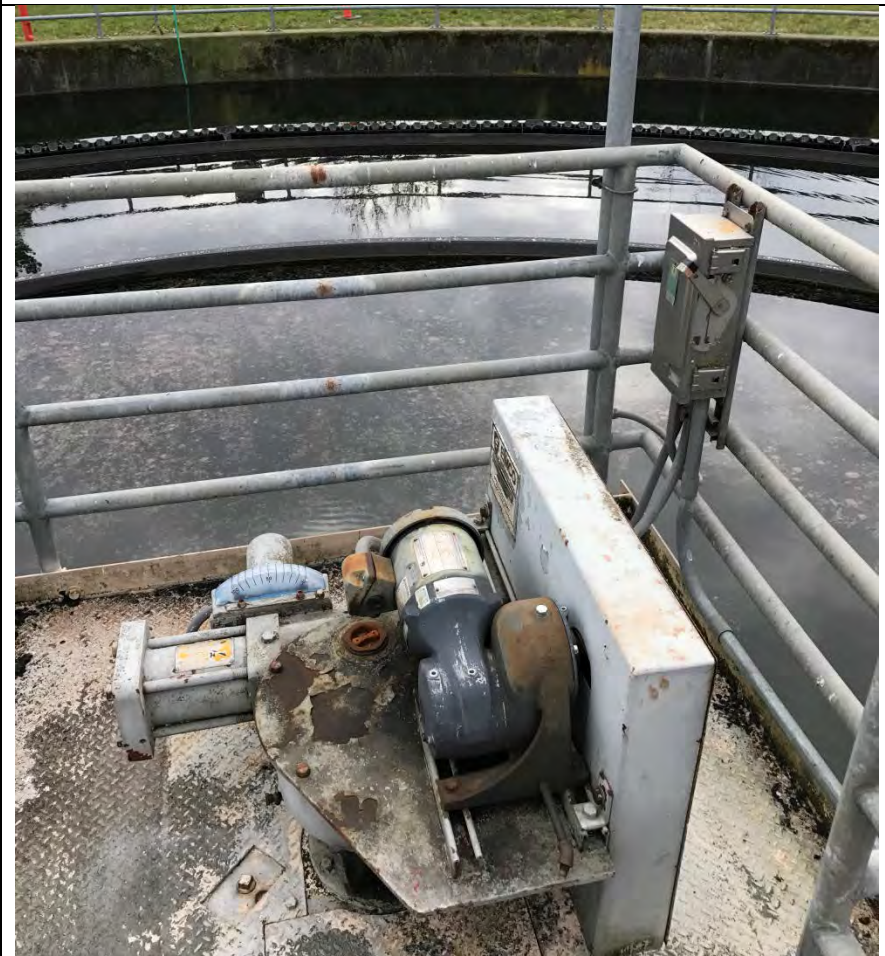
Photo 2 – Gear Box

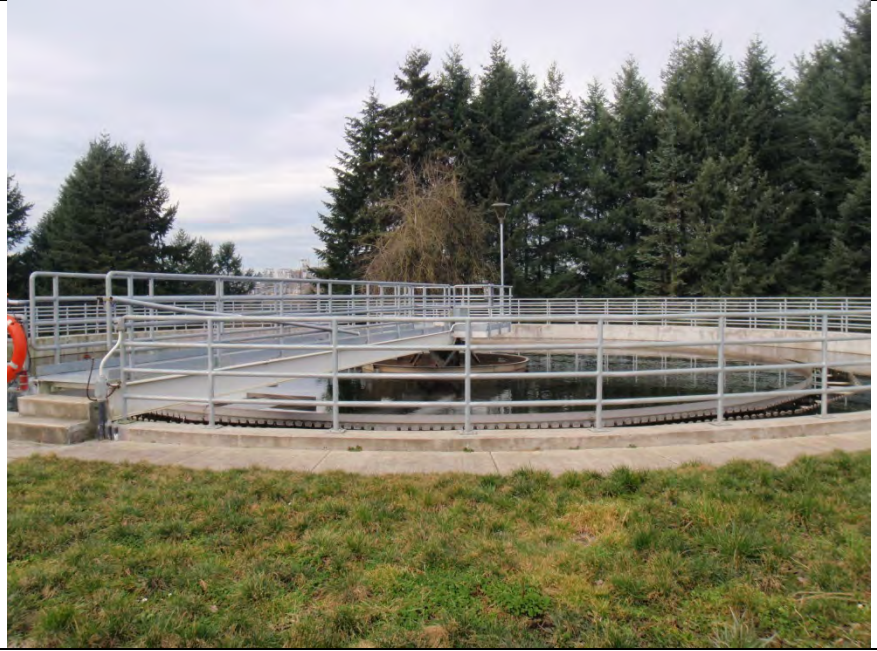
Photo 1 – Secondary Clarifier 4

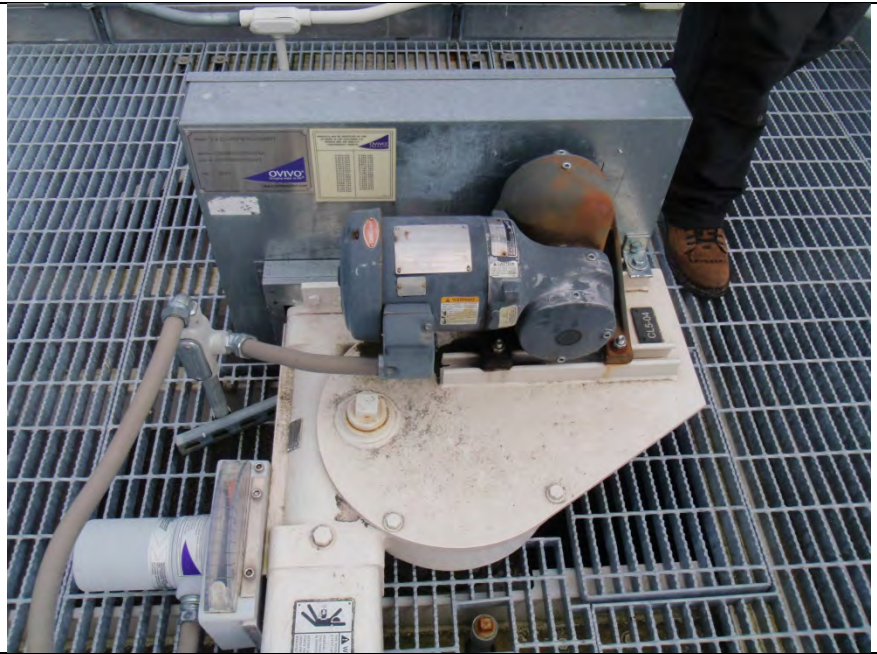
Photo 2 – Gear Box

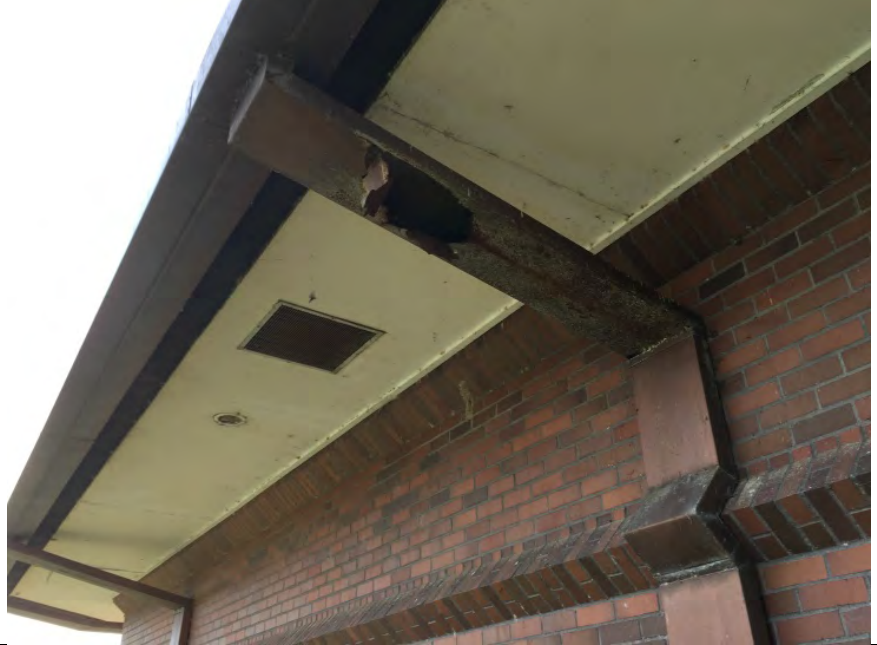
Photo 2 – Gutter Corrosion

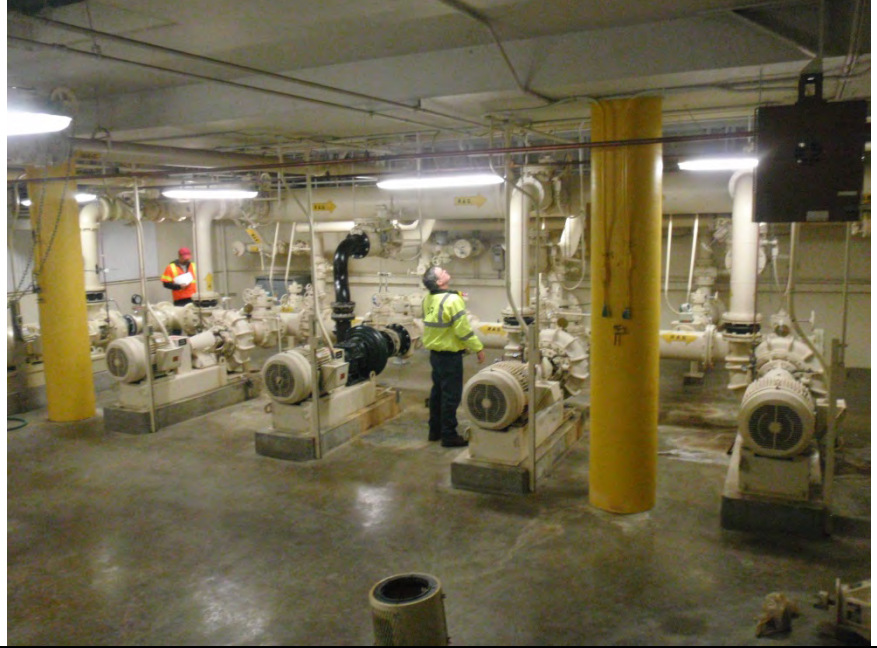
Photo 1 – RAS Pumps

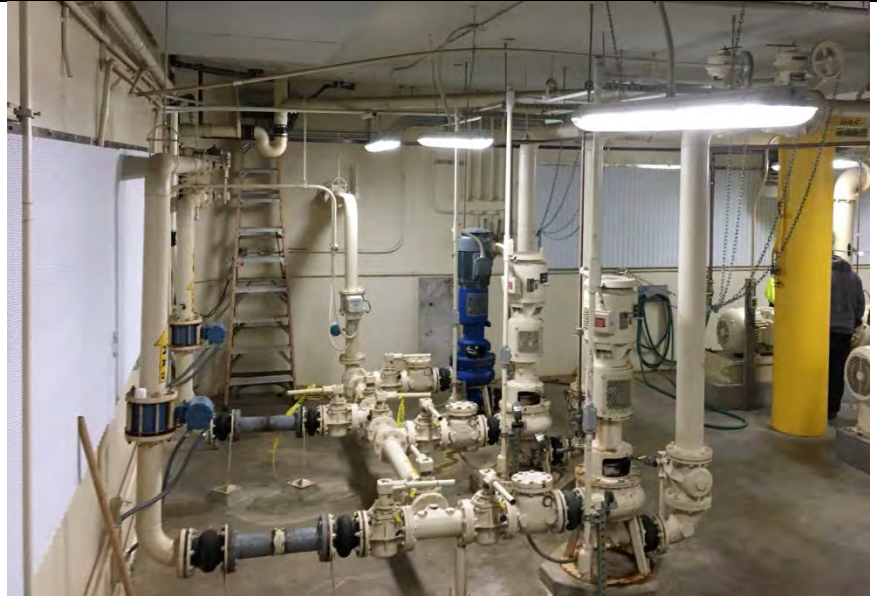
Photo 2 – WAS Pumps

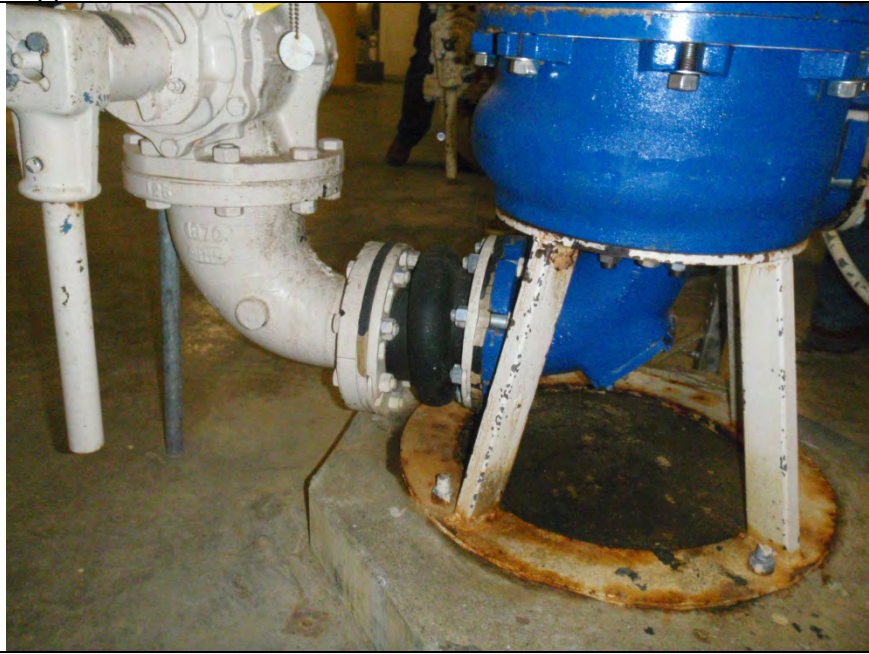
Photo 3 – WAS Pump 3 inlet piping misalignment and poor pipe support

Process or Mechanical Equipment	N/A	WAS flow meter to SST 1 needs clearing of grease.		
Pumping Systems	2	RAS Pump 3 – Some vibration present in the coupling alignment. Sounds of cavitation potential in pump. Recommend simplify the inlet piping to reduce losses on the suction. WAS Pump 2 – Recommend monitoring the slight sound in the motor starter. Recommend improvements to WAS Pump inlet alignment (see Photo 3). Recommend adding pipe support to all WAS pump inlet elbows. Single sump pump in a dual pump sump.		
Piping and Valves	3	Potential point of failure on WAS discharge piping (see Photo 4). Recommend rotating all plug valves to allow for flushing/clearing of plug valley. Recommend adding more bracing to the seal water piping to mitigate vibrations.		
HVAC	2	Condition rating based on age, no issues observed in field.		
Odor Control	N/A	N/A		
Other	2	PLC Control Panel wiring appears to be neat and organized. There are some old devices on the front of the control panel that don't appear to be functional and is probably no longer used.

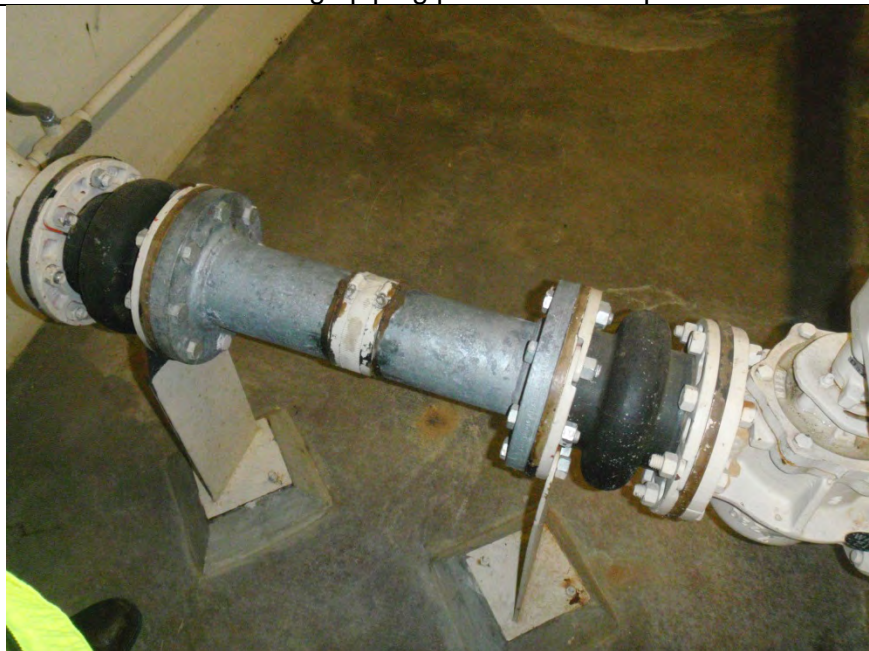
Photo 4 – WAS discharge piping potential failure point

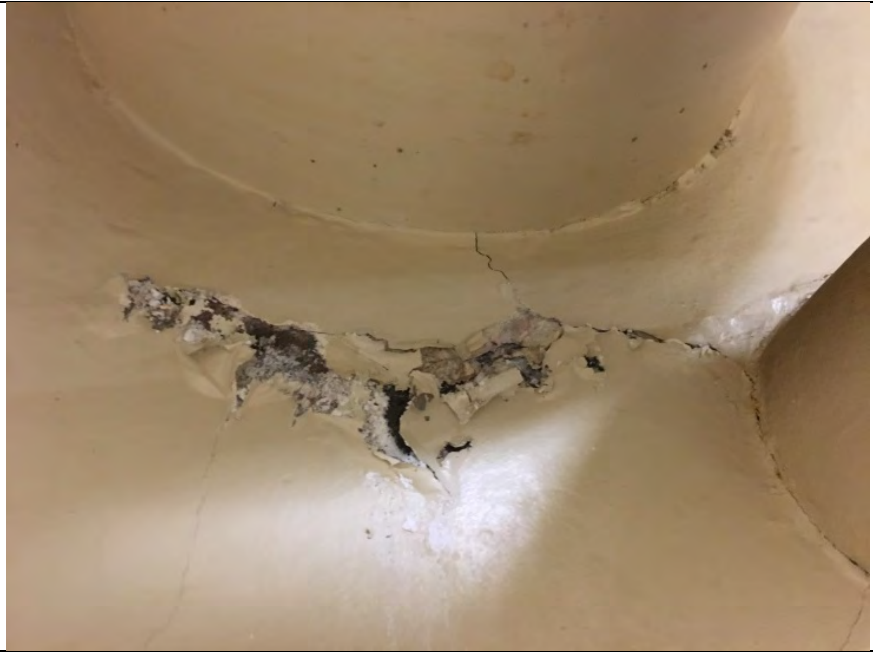
Photo 5 – Wall Crack 1

SYSTEM ASSETS	CR	COMMENTS		
Civil and Site	N/A	N/A		
Architectural	N/A	N/A		
Structural	3	Rating based primarily on age Some vertical cracking in CMU walls in above grade portion of structure. Lower level: general cracking of grout seal / concrete interface at most larger pipe penetrations. (see Photos 5 & 6)		
Power Distribution	2	A moderate level of dust found in some of the MCC cubicles.		
Electrical	2	A significant amount of dirt and debris observed in electrical room (on floor and on top of electrical cabinets. Should be cleaned to help keep it from being transferred into the electrical equipment causing premature failure. A moderate level of dust found in some of the VFD cabinets. The air filter on RAS Pump 5 VFD was observed to be very, very dirty. There are 6 Robicon VFD's that are still functional but appear to be beyond their estimated OUL. Plans should be made to replace these.		
Instrumentation/ Analyzers	2	Some of the RAS flow meters are still functional but they appear to be beyond their estimated OUL. Plans should be made to replace these. It is suspected that grease buildup in the lines are affecting WAS flow meter performance.

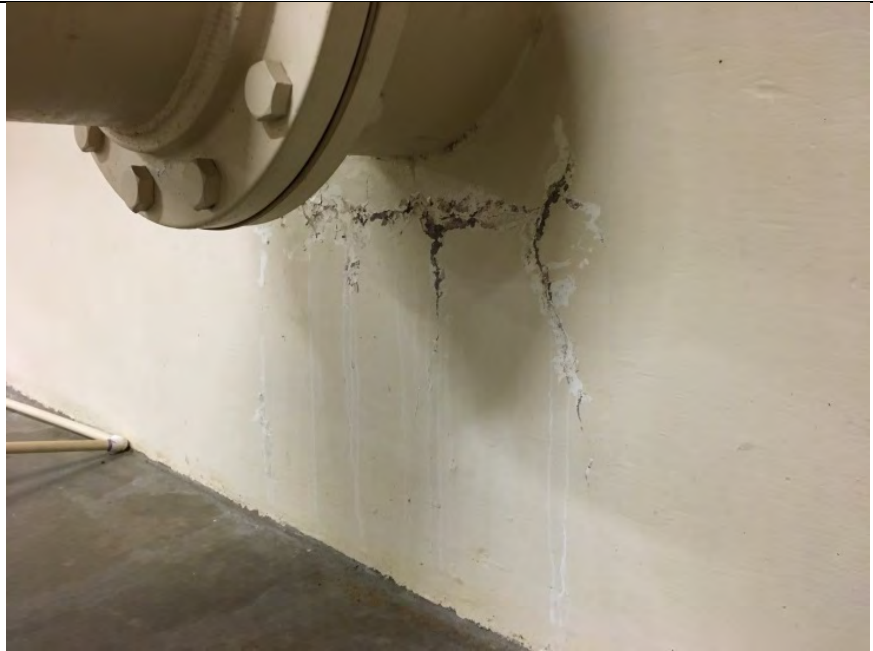
Photo 6 – Wall Crack 2

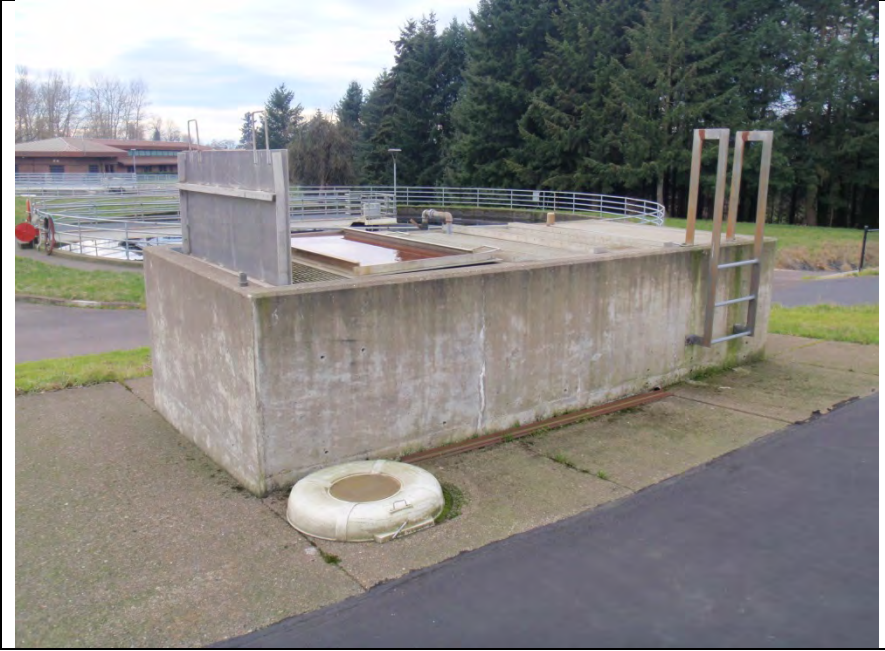
Photo 1 – RAS Distribution Box

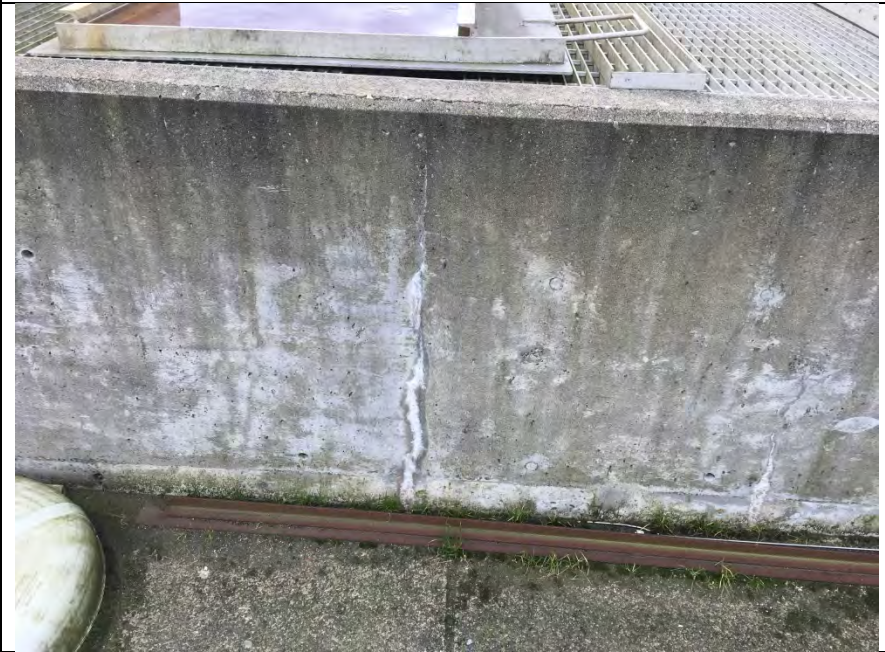
Photo 2 – Wall Crack

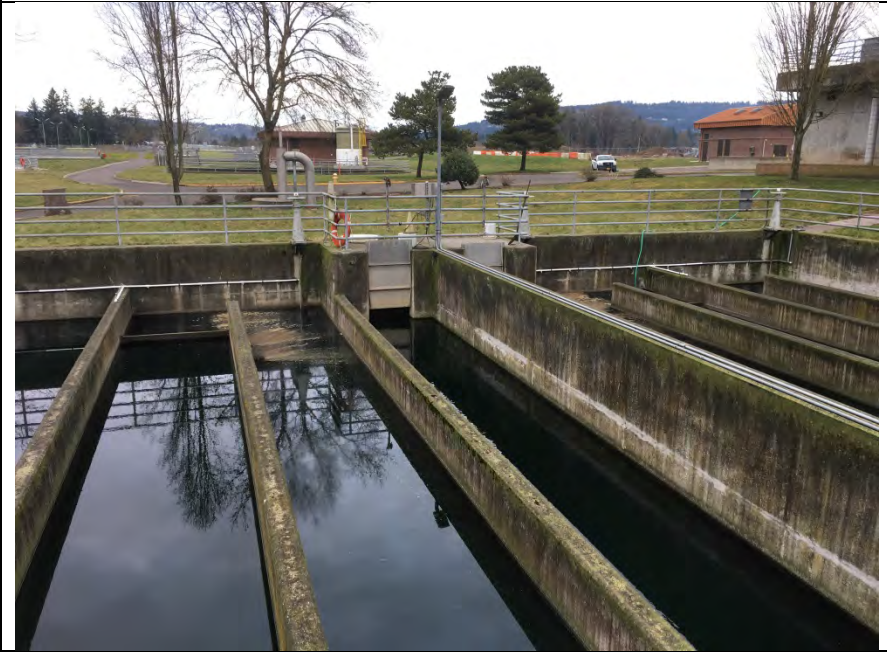
Photo 1 – CCB

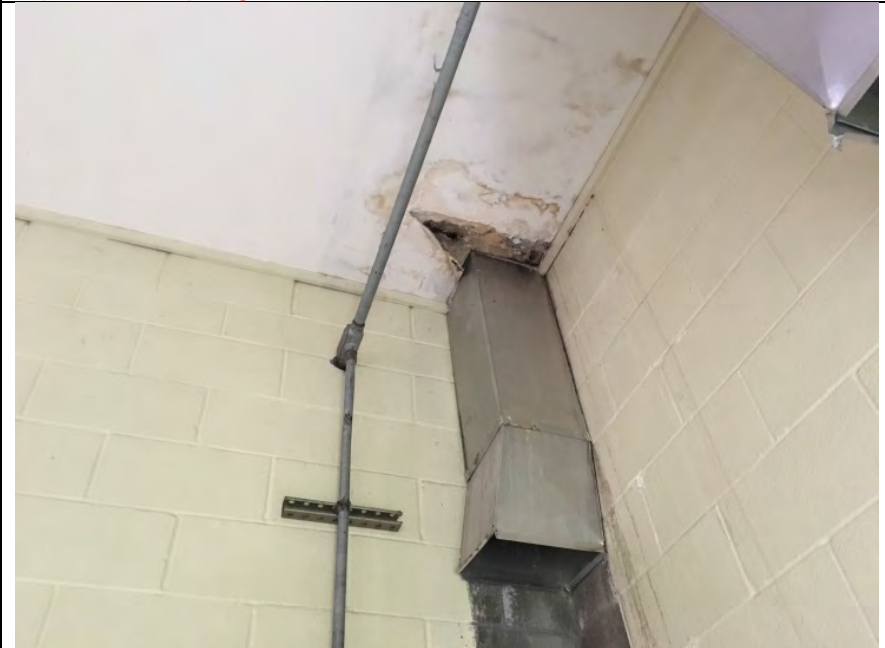
Photo 2 – Water Damage (water damaged sheetrock was replaced in Spring 2017)

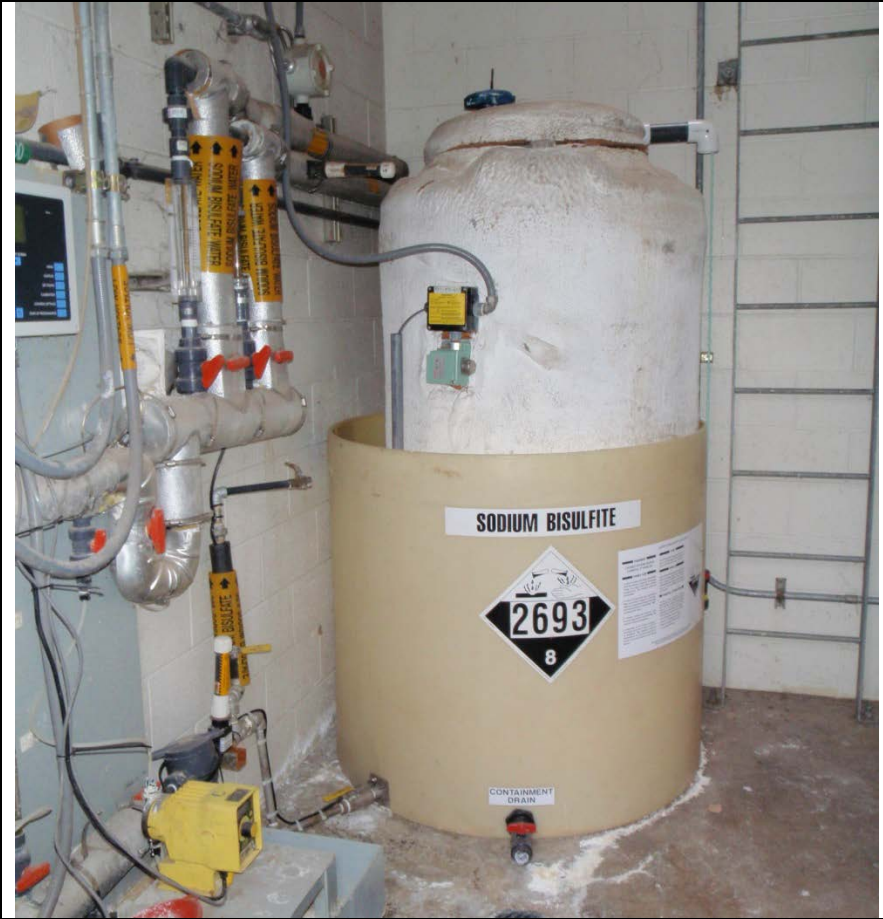
Photo 1 – Sodium Bisulfite System (System replaced in Summer 2017)

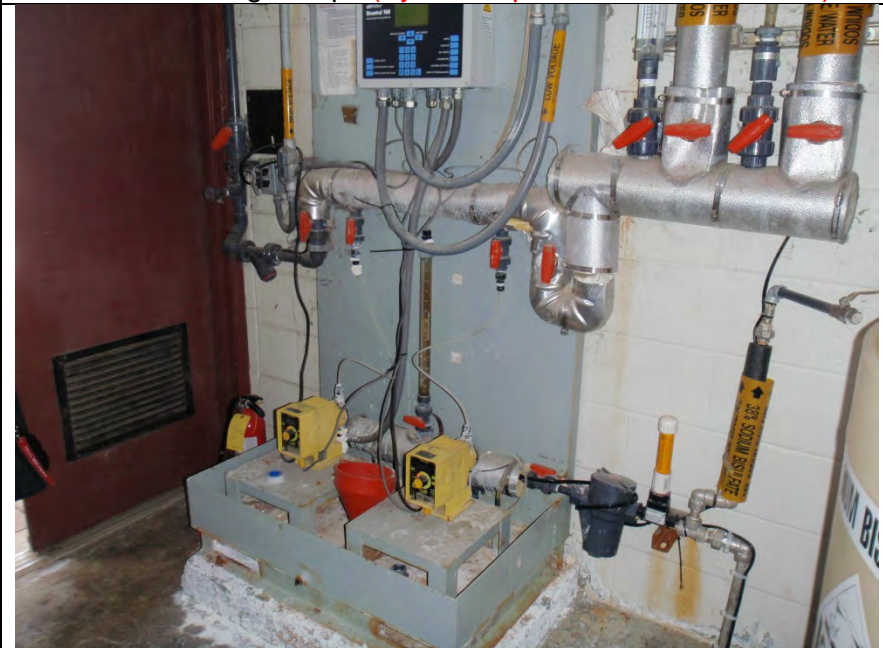
Photo 2 – Metering Pumps (System replaced in Summer 2017)

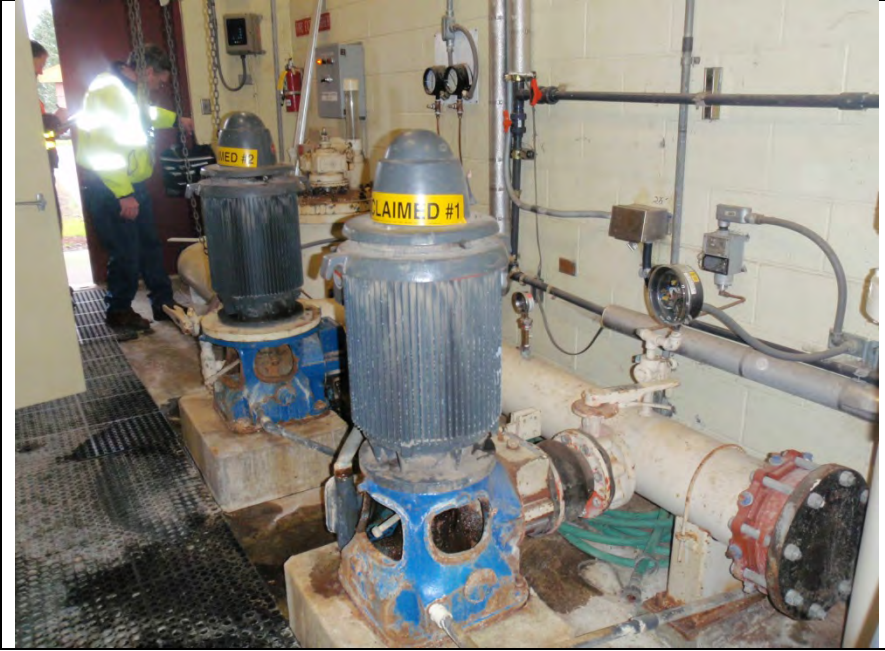
Photo 1 – Reclaimed Water Pumps

SYSTEM ASSETS	CR	COMMENTS		
Civil and Site	N/A	N/A		
Architectural	N/A	N/A		
Structural	N/A	N/A		
Power Distribution	2	A moderate level of dust found in some of the MCC cubicles.		
Electrical	3	A significant amount of dirt and debris was observed in electrical room (on floor and on top of electrical cabinets. Should be cleaned to help keep it from being transferred into the electrical equipment causing premature failure.		
Instrumentation/ Analyzers	2	It was reported that the control of the reclaim pumps can be erratic at times; they suspect that the pressure switches on the header may be causing the problem.		
Process or Mechanical Equipment	5	Reclaimed water strainer not in working order (see Photo 2). Bypass continuous left open.		
Pumping Systems	2	Reclaimed Water Pumps - condition rating based on age. Leaky packing gland observed. Corrosion on pump based. Reuse Water Pumps - condition rating based on age, not operational due to winter season.

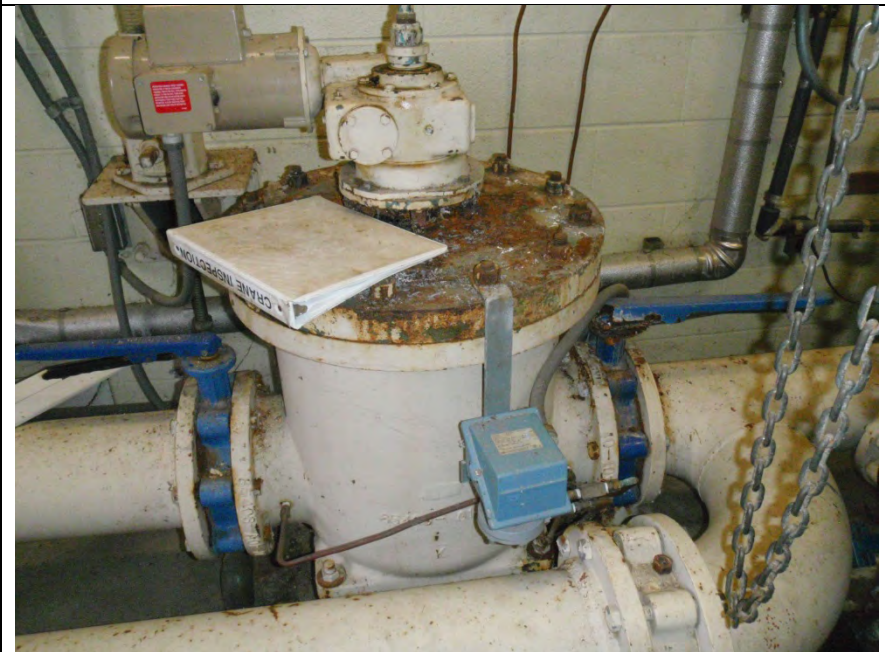
Photo 2 – Reclaimed Strainer

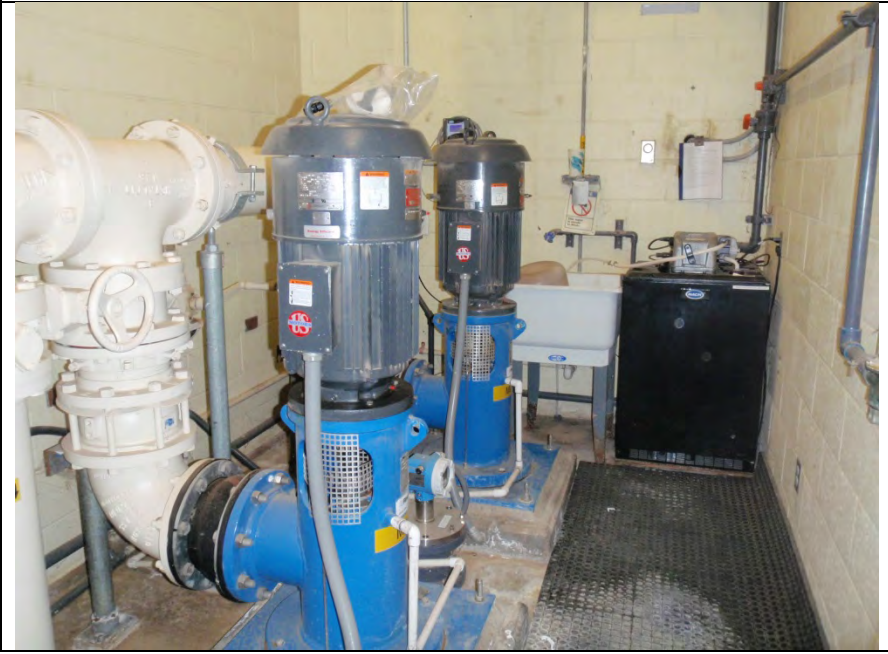
Photo 3 – Reuse Water Pumps

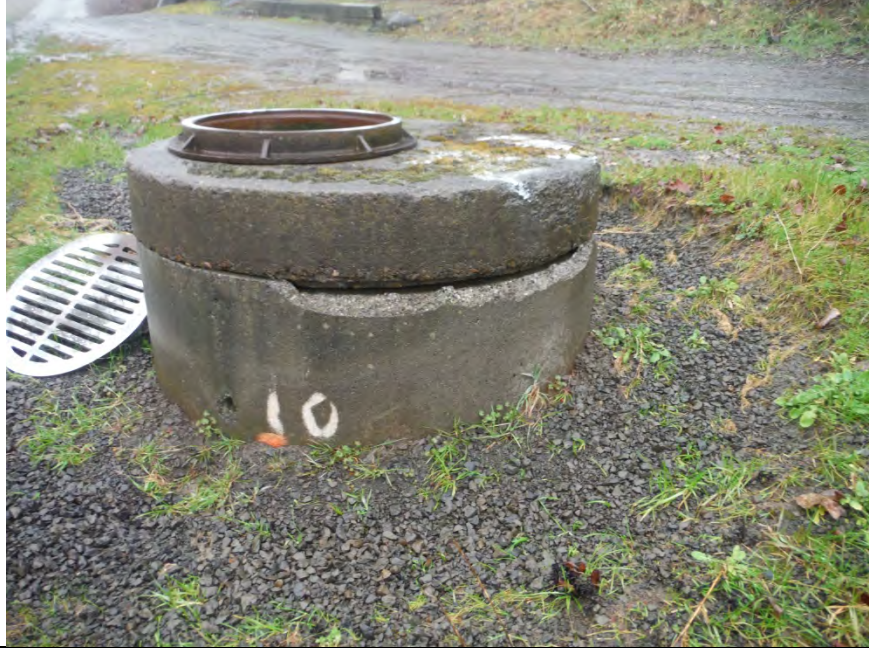
Photo 1 – Outfall final manhole

SYSTEM ASSETS	CR	COMMENTS		
Civil and Site	2	No site specific impacts or areas of concern identified.		
Architectural	N/A	N/A		
Structural	3	Visual damage to manhole lid (see Photo 1). Staff has noted that high flows can cause the entire manhole lid to pop off.		
Power Distribution	N/A	N/A		
Electrical	N/A	N/A		
Instrumentation/ Analyzers	N/A	N/A		
Process or Mechanical Equipment	N/A	Small amounts of foam spotted in the Willamette River near the outfall location, uncertain if associated with the WWTP.		
Pumping Systems	N/A	N/A		
Piping and Valves	2	Minor defects identified per CCTV inspection videos.		
HVAC	N/A	N/A		
Odor Control	N/A	N/A		
Other	N/A	N/A		
Overall Facility Rating	2.3	System asset criteria weighted equally		
CONDITION RATING LEGEND	0	Unknown	Original Useful Life (OUL)	
	1	New or Excellent Condition	100% OUL	Normal Preventive Maintenance
	2	Minor Defects Only	75% OUL	Normal Preventive Maintenance, Minor Corrective Maintenance

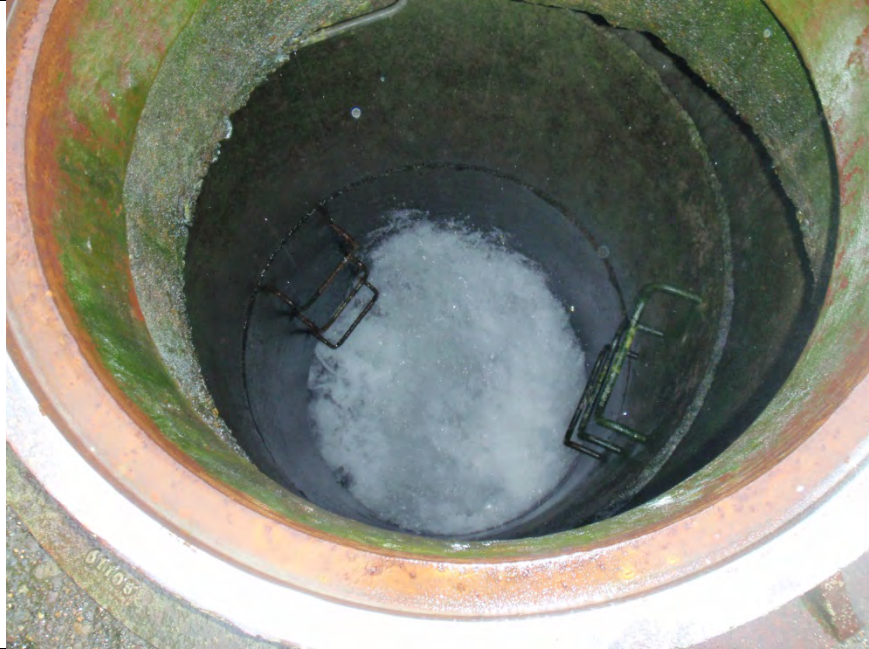
Photo 2 – Inside manhole at approximately 8 mgd

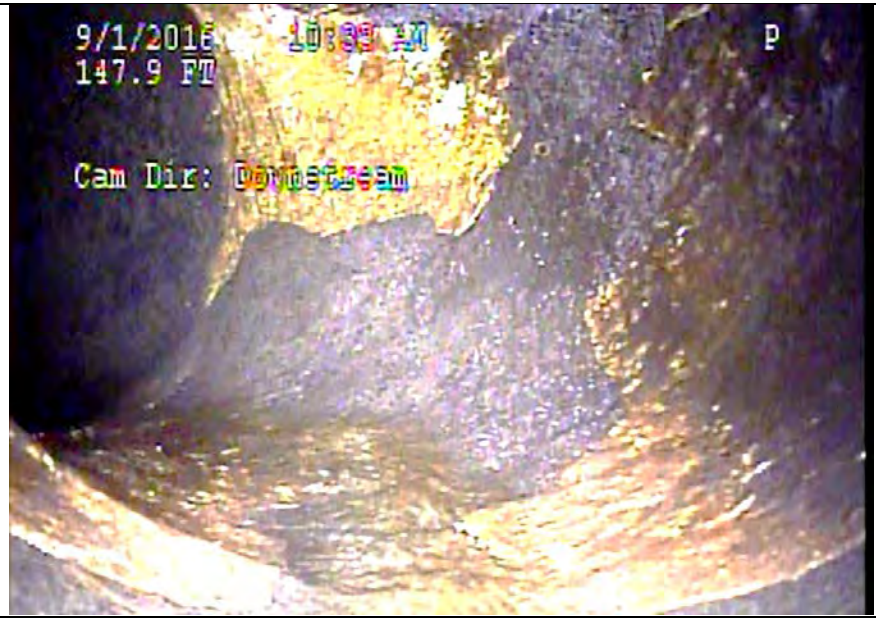
Photo 3 – CCTV of manhole

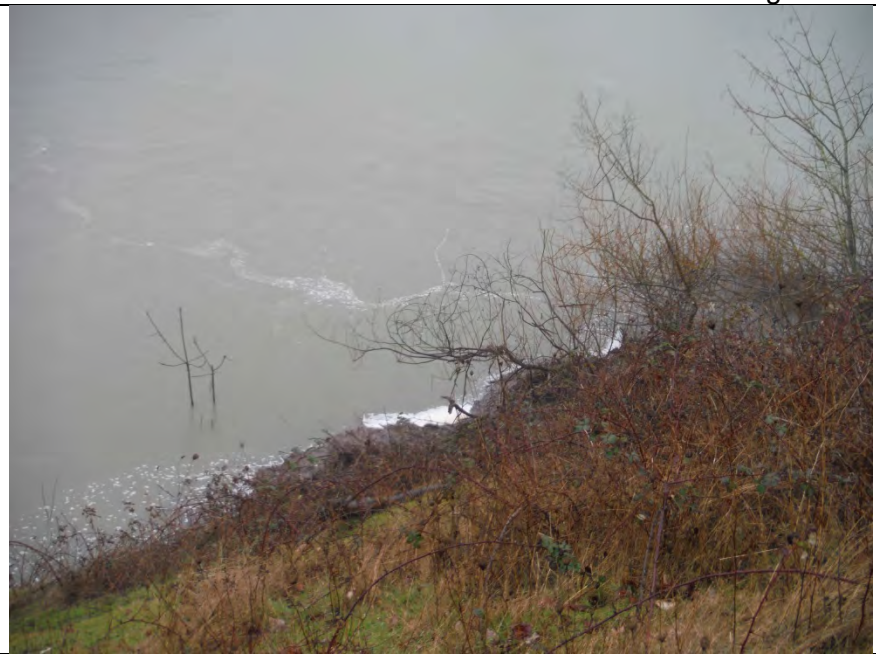
Photo 4 – Trace foam in Willamette River at outfall discharge
