REQUEST: A Resolution recommending City Council amend the 2018 Wastewater Master Plan incorporating the 2021 Riverfront Addendum into the Newberg Comprehensive Plan

Wastewater Master Plan

May 2018

*Technical Update May 2021
Addendum - Riverfront
Master Plan (Appendix K)*

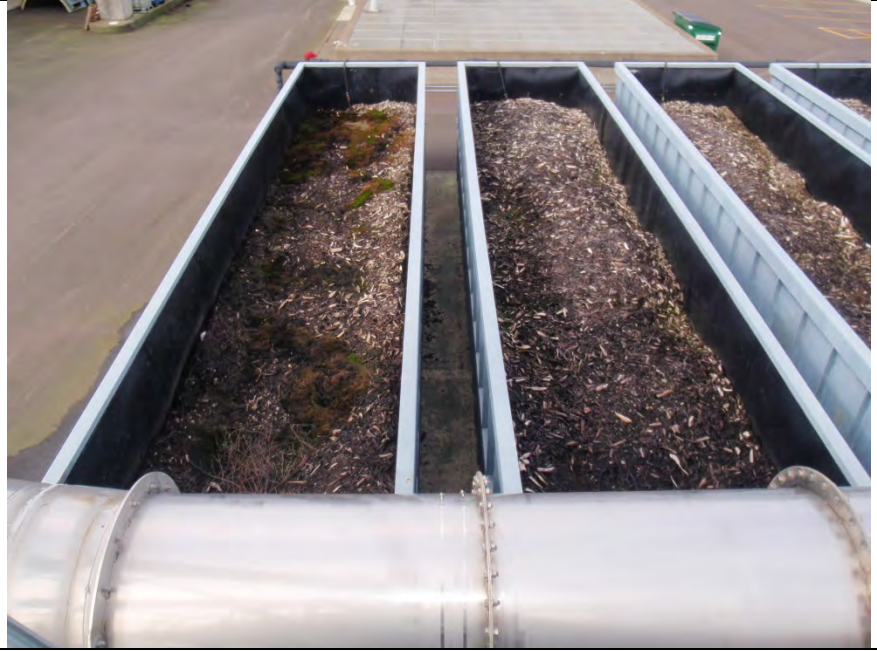
Photo 1 – Biofilter media

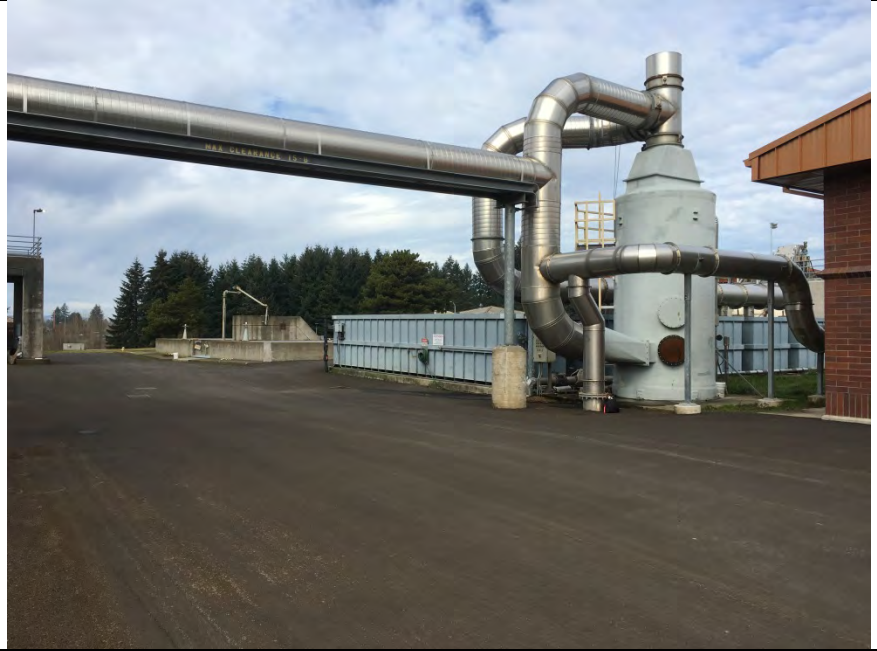
Photo 2 – Scrubber

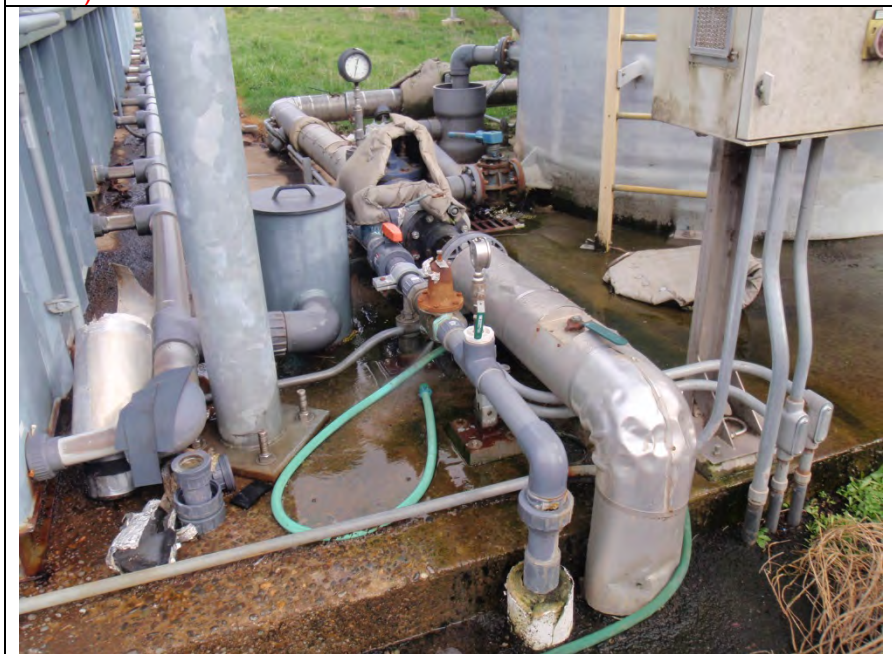
Photo 3 – Piping (Water piping improvements made in Summer 2017)

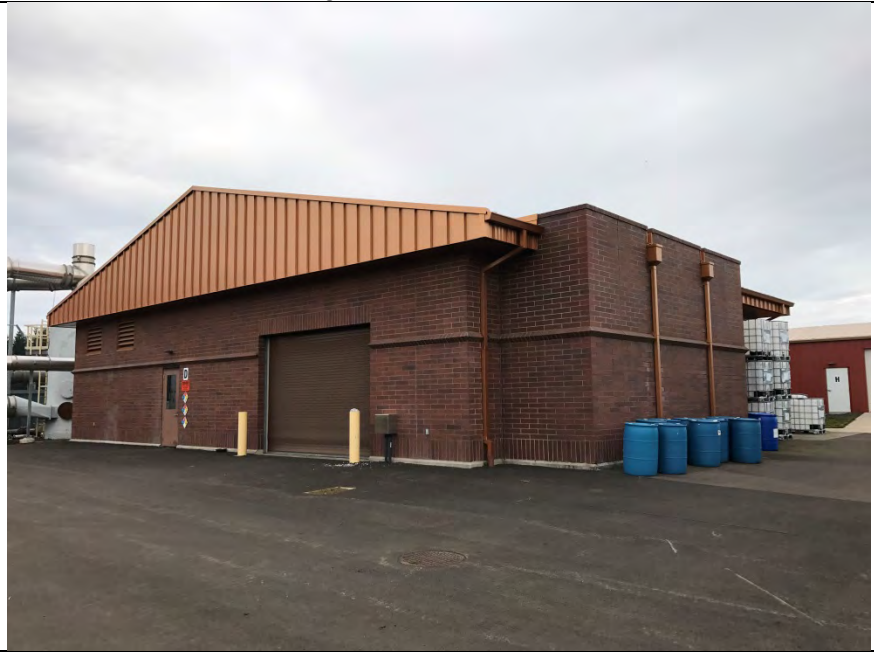
Photo 1 – Reuse Building

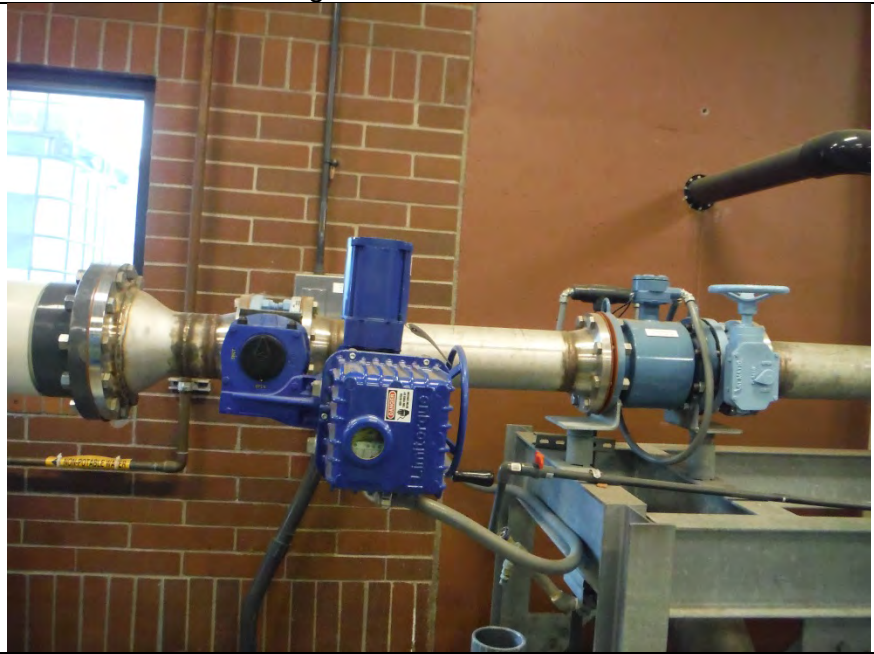
Photo 2 – Flow Metering

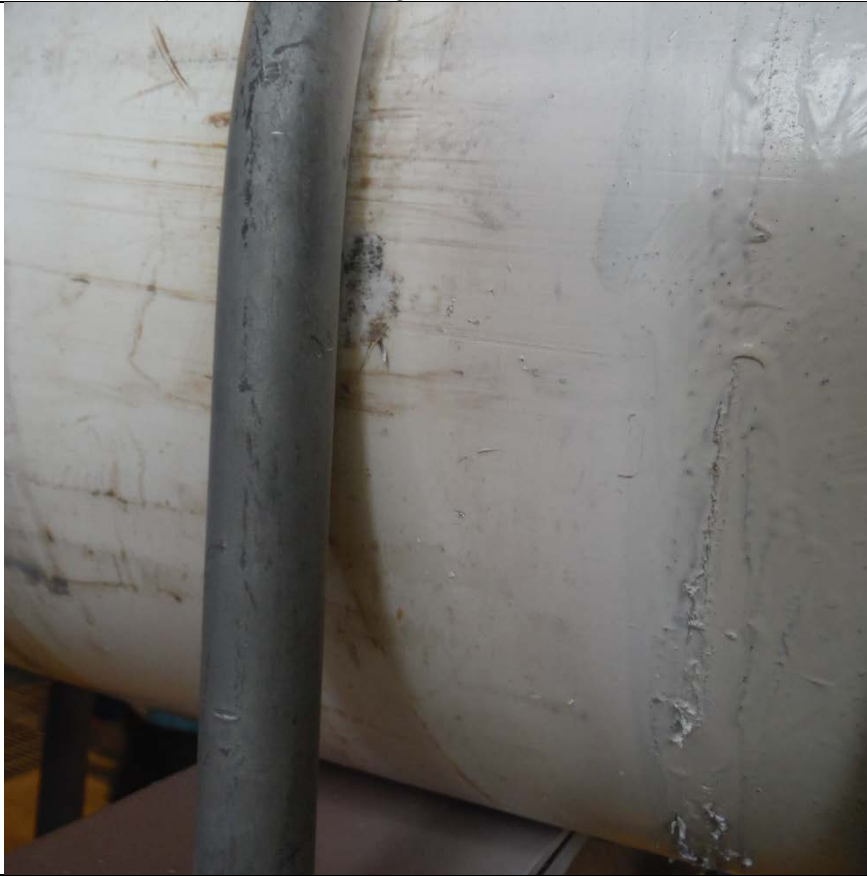
Photo 3 – Pipe support rubbing

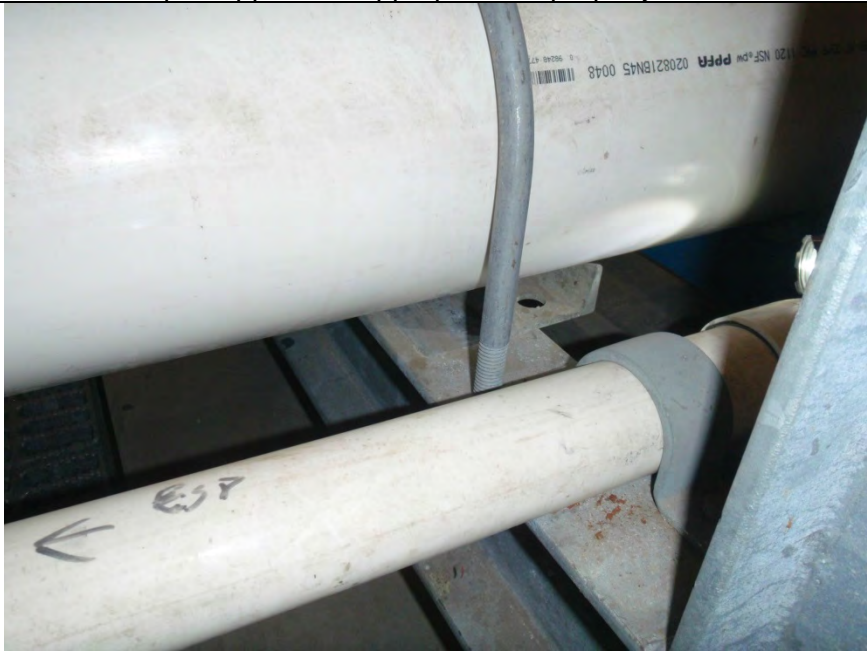
Photo 4 – Pipe support not appropriate or properly installed

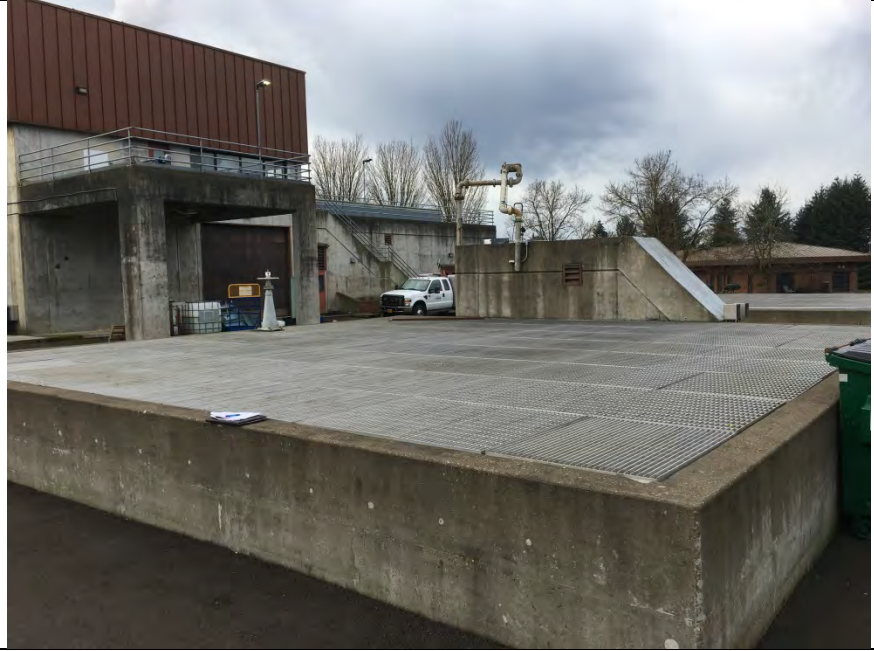
Photo 1 – Sludge Storage Tanks

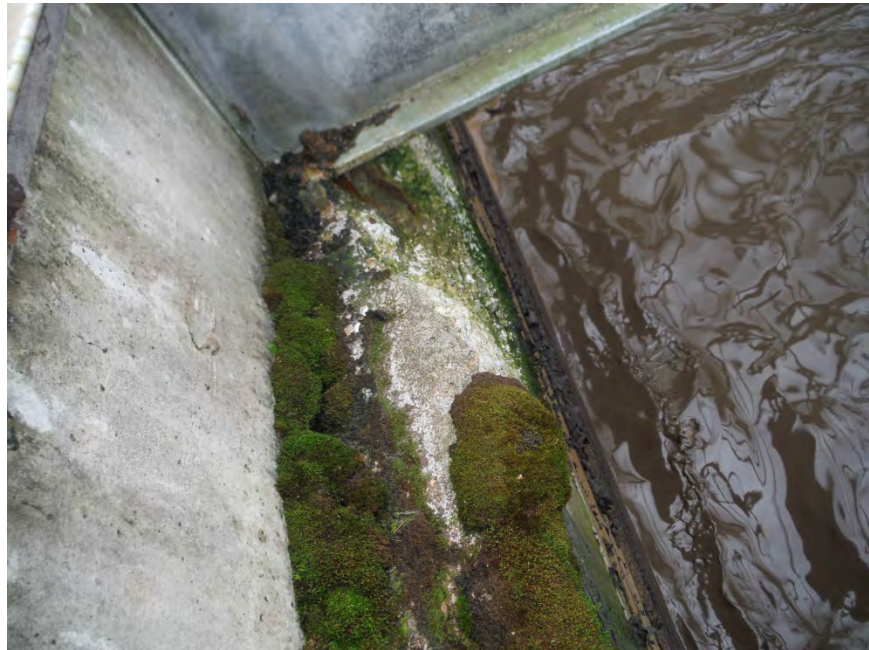
Photo 2 – Portion of concrete missing and buildup of moss

SYSTEM ASSETS	CR	COMMENTS		
Civil and Site	3	Settlement / heaving of concrete sidewalk sections around both tanks (See Photo 3)		
Architectural	N/A	N/A		
Structural	3	Primarily based on age. Moderate to severe corrosion of steel anchor bolts at grating support beam seats. One area with spalled concrete in wall below beam seat – likely due to concrete delamination due to corrosion of anchor bolts. (See Photo 4)		
Power Distribution	N/A	N/A		
Electrical	N/A	N/A		
Instrumentation / Analyzers	N/A	N/A		
Process or Mechanical Equipment	2	Rating based on City descriptions. Equipment not inspected.		
Pumping Systems	N/A	N/A		
Piping and Valves	2	Rating based on City descriptions. Equipment not inspected.		
HVAC	N/A	N/A		
Odor Control	N/A	N/A		
Other	N/A	Heavy buildup of sludge / moss limited visual inspection of concrete walls above water level. (See Photo 2)		
Overall Facility Rating	2.5	System asset criteria weighted equally

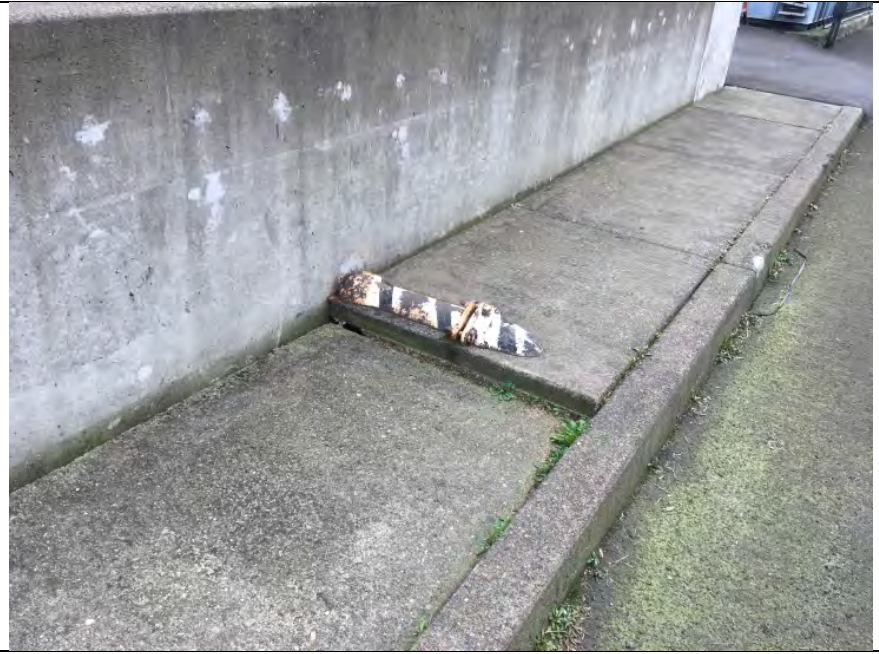
Photo 3 - Sidewalk Settlement

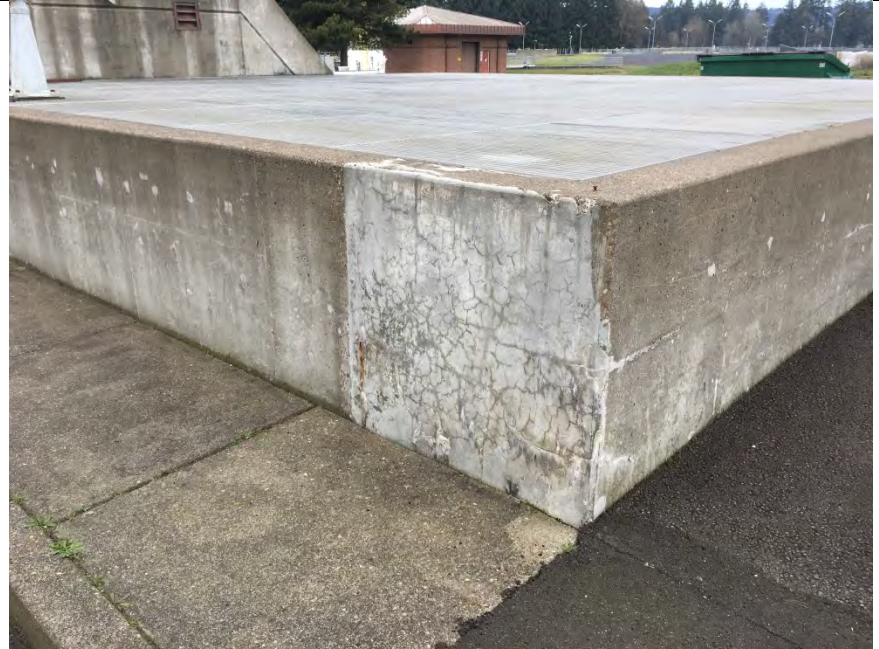
Photo 4 – Concrete Spalling

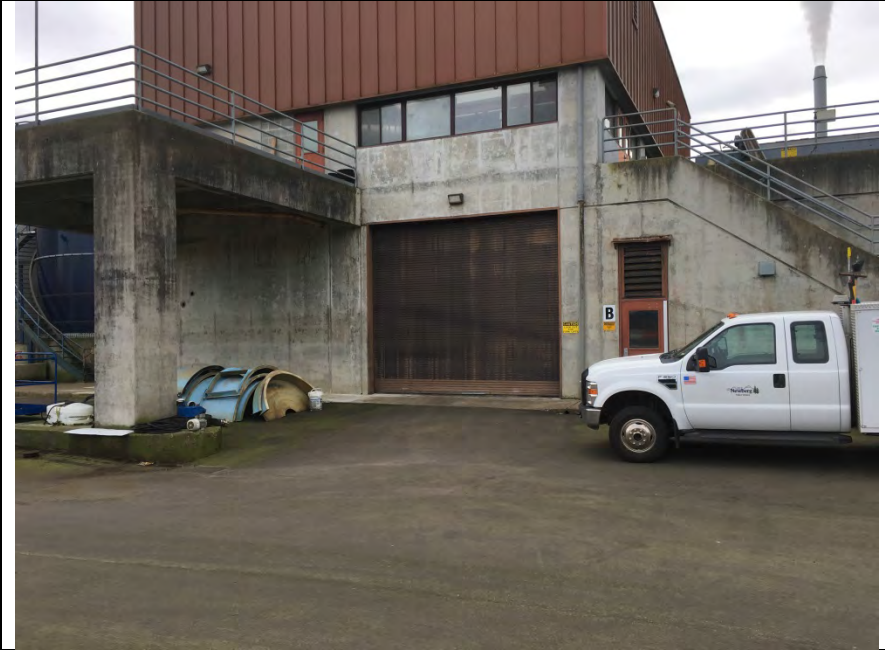
Photo 1 – Solids Building

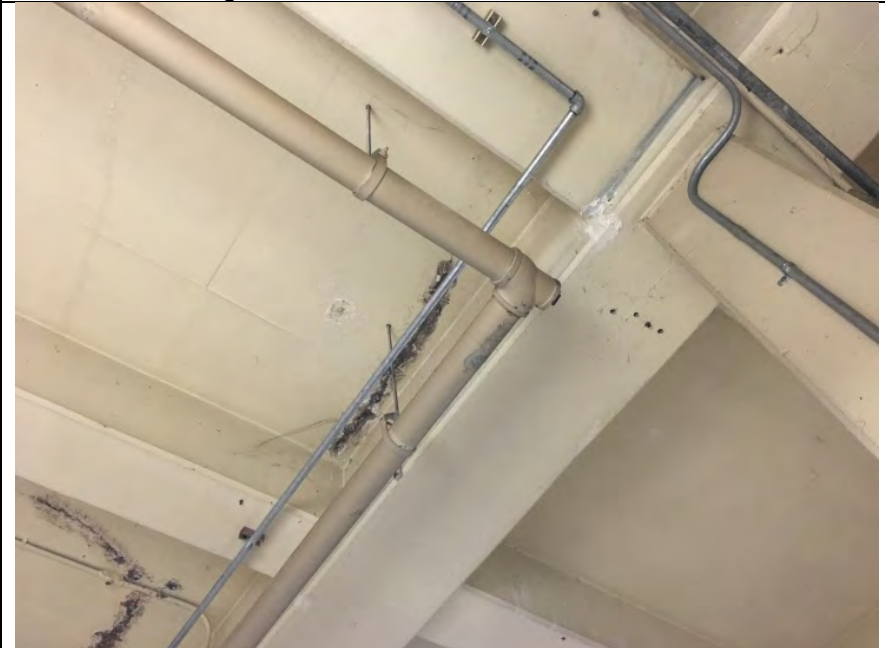
Photo 2 – Ceiling Cracks

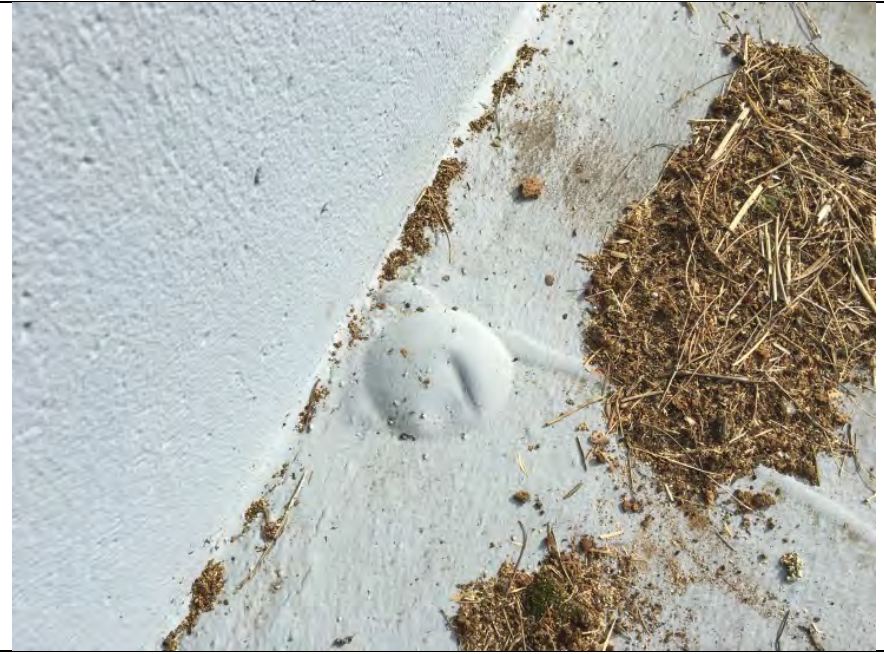
Photo 3 – Floor Coating Bubbles

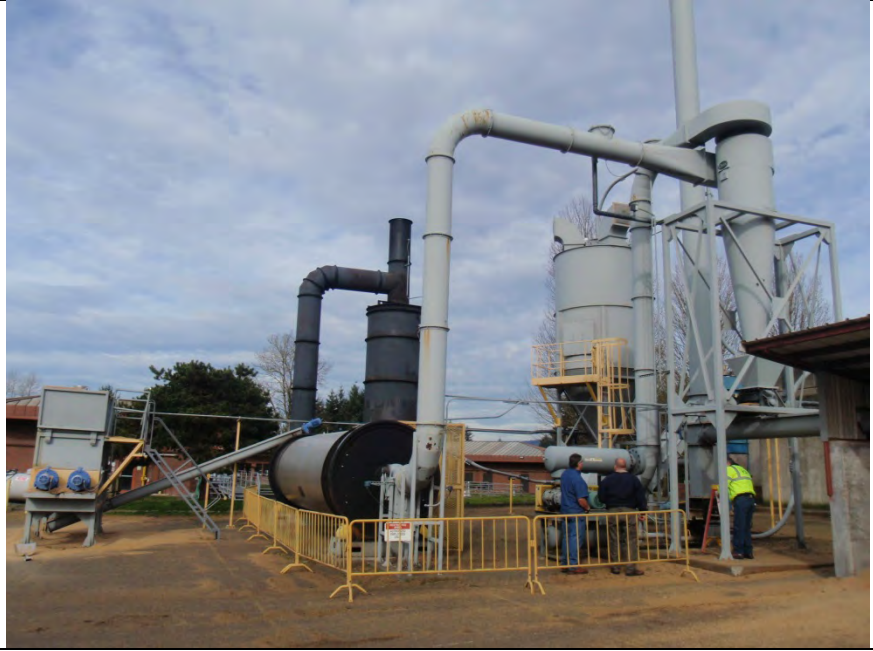
Photo 1 – Sawdust Dryer System

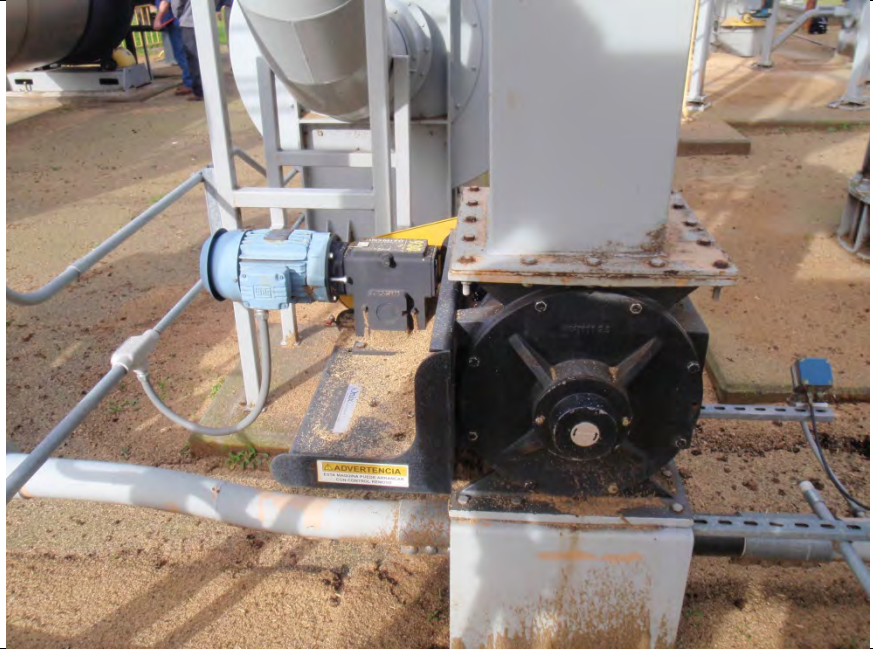
Photo 2 – Lower Air Lock (Air Lock replaced in Summer 2017)

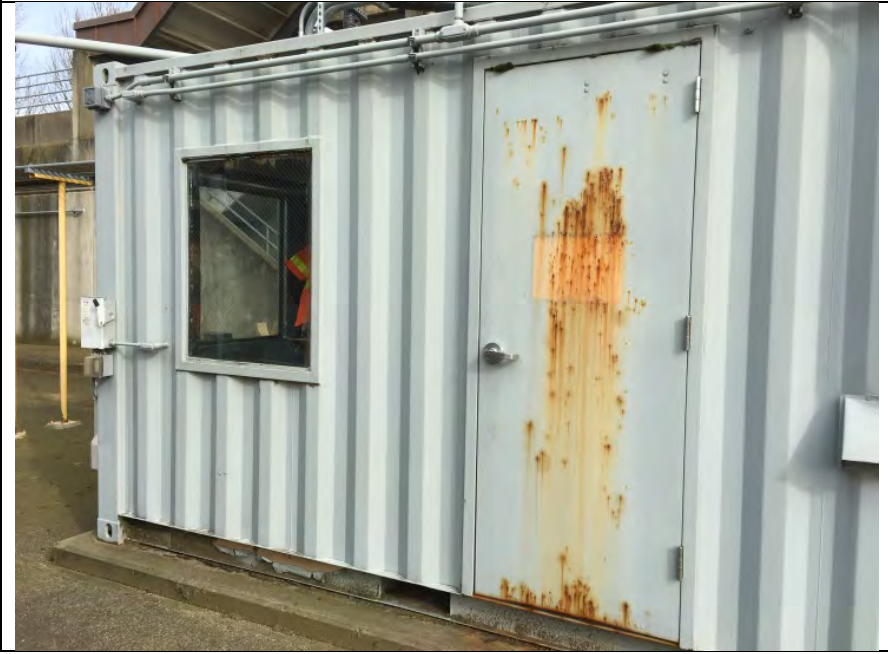
Photo 3 – MCC Container Corrosion

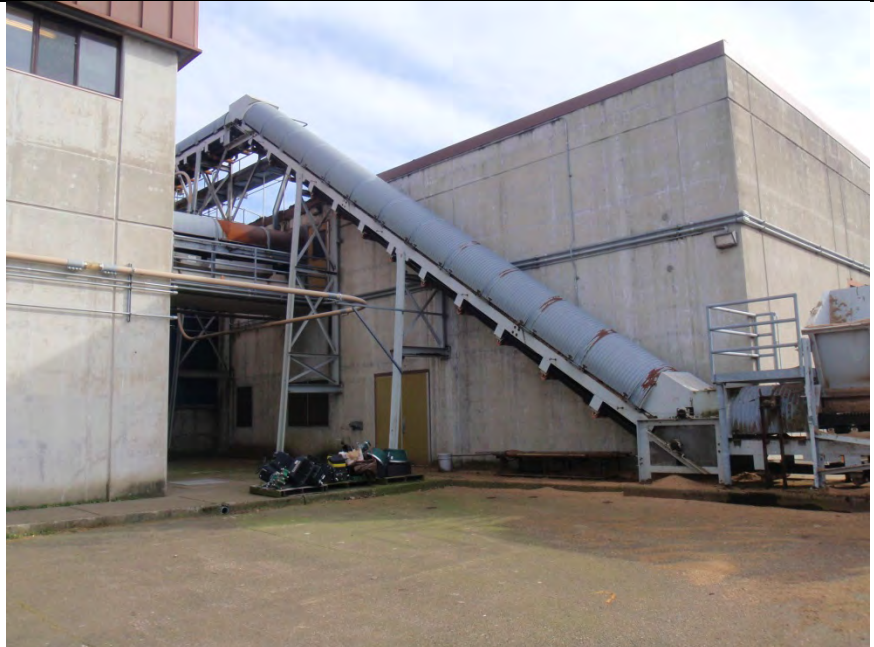
Photo 1 – Compost Building

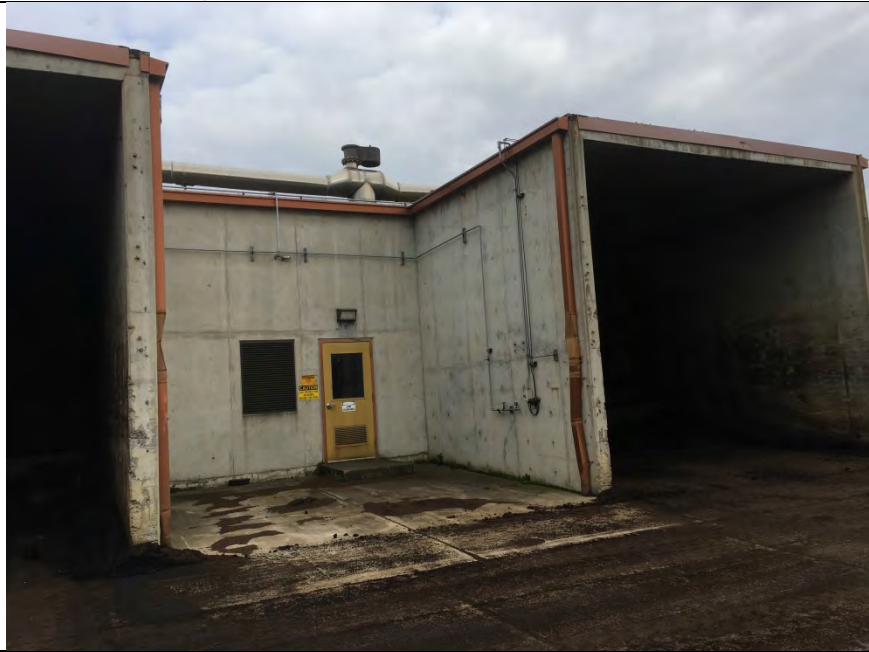
Photo 2 – Compost Reactors

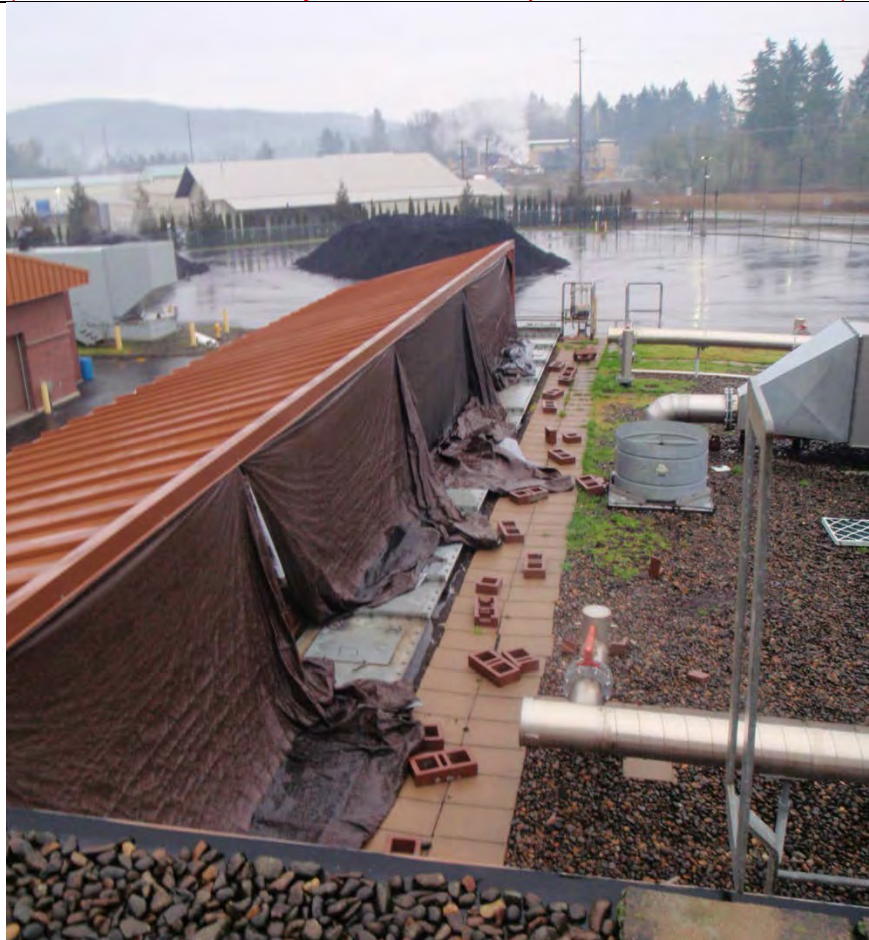
Photo 3 – CON8-05 with temporary tarp cover to prevent rain leak
(Cover added to conveyor in 2017 to help reduce water intrusion)

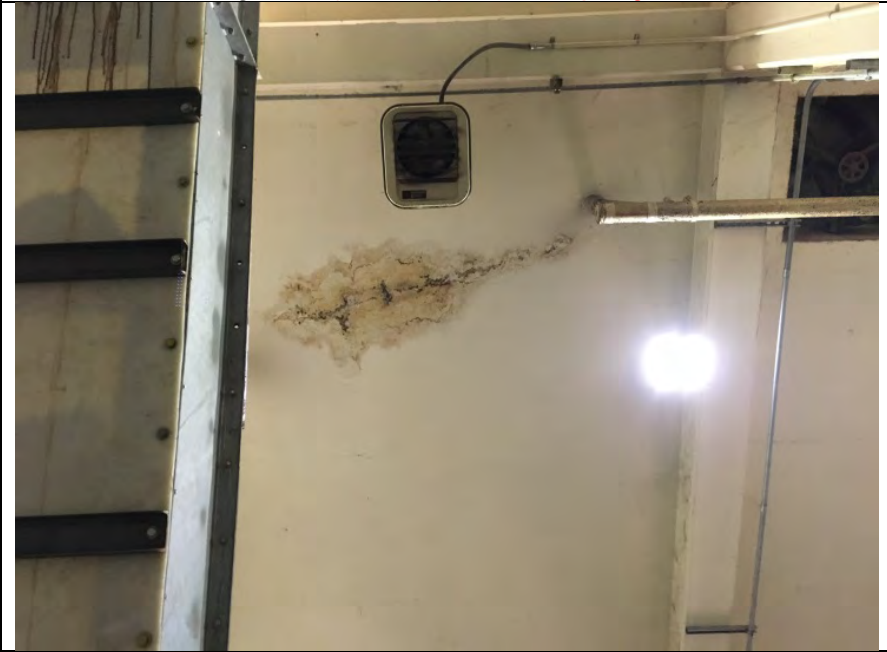
Photo 4 – Leaking Roof (Roof replaced in Spring 2017)

SYSTEM ASSETS	CR	COMMENTS
Civil and Site	2	Good condition overall, some areas of localized asphalt cracking in loader traffic areas.
Architectural	4 2.5	<p>Roof – evidence of widespread roof leakage based on active leaks in ceiling and several cracks with rust staining and efflorescence. Roof slated for replacement. (See Photo 4)</p> <p>Roof in room above control room: severe leakage around HVAC duct. Leaks into a trough with sump pump that discharges through window. (See Photos 5 & 6)</p> <p>Insulation / siding on east side of building has significant damage likely due to equipment hitting it. (See Photo 7)</p> <p>Roof was replaced in Spring 2017. Condition rating updated based on age.</p>
Structural	4	<p>Rating based primarily on condition.</p> <p>Walls on both sides of compost compaction / loadout tunnel have signs of cracking and leakage of compost tainted liquid behind sound proofing panels.</p> <p>Significant cracking at upper walls and ceiling concrete adjacent to tunnel walls and between tunnel walls (possibly due to differential thermal expansion of tunnel walls with respect to ceiling – tunnel walls subject to 70 degrees C. while ceiling exposed to ambient air). (See Photos 8 & 9)</p> <p>Storage area in SW corner of building: Concrete roof above storage area used to store some heavier equipment (augers, an oven, misc. smaller equipment). Most equipment is stored near perimeter but some is located near middle of roof. Some signs of flexural cracking noted in underside of roof slab. Some equipment has been removed from the concrete roof above the storage area to reduce loading.</p>

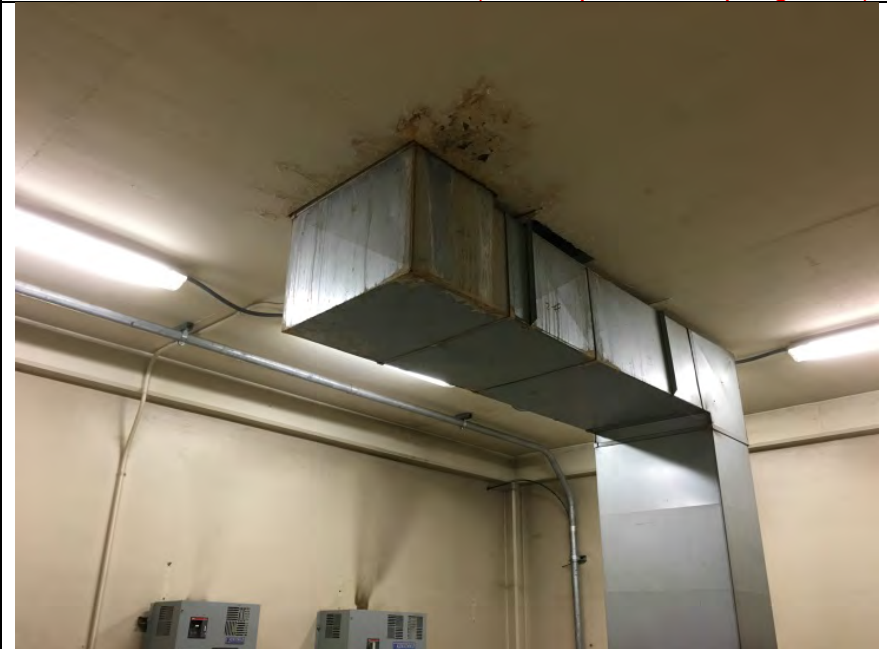
Photo 5 – Leak around HVAC duct (Roof replaced in Spring 2017)

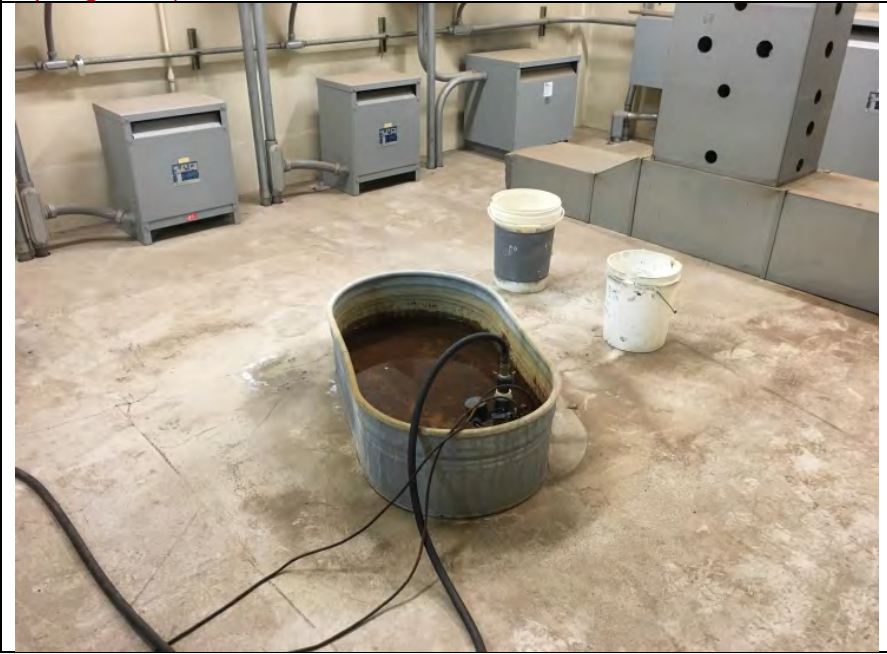
Photo 6 – Collection of water from roof leak (Roof replaced in Spring 2017)

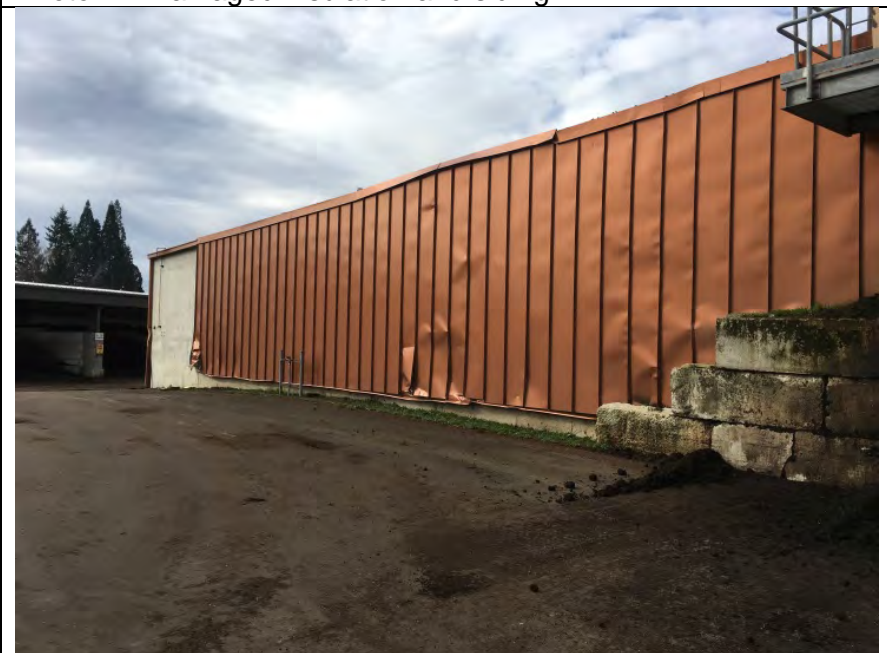
Photo 7 – Damaged insulation and siding

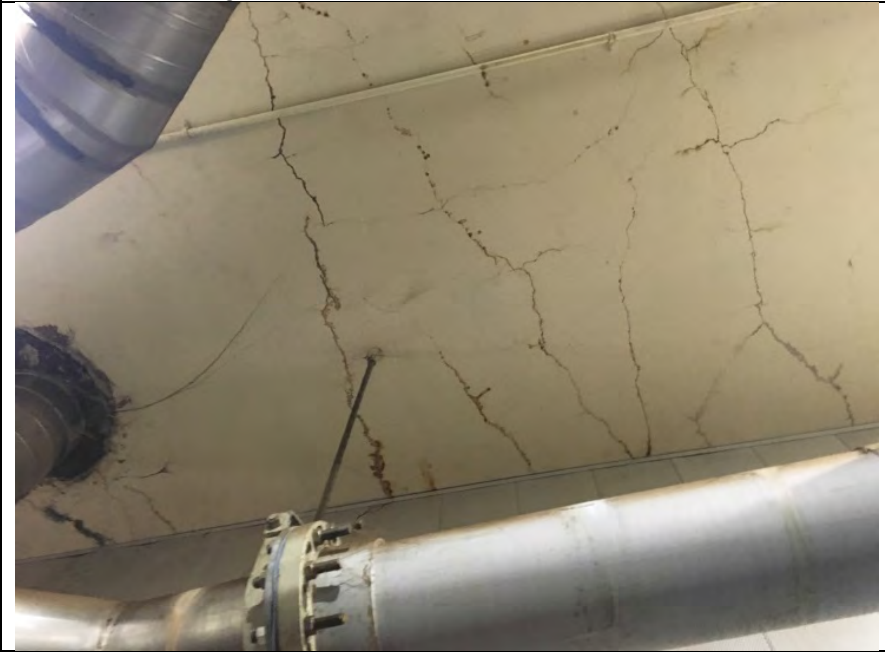
Photo 8 – Ceiling Cracks 1

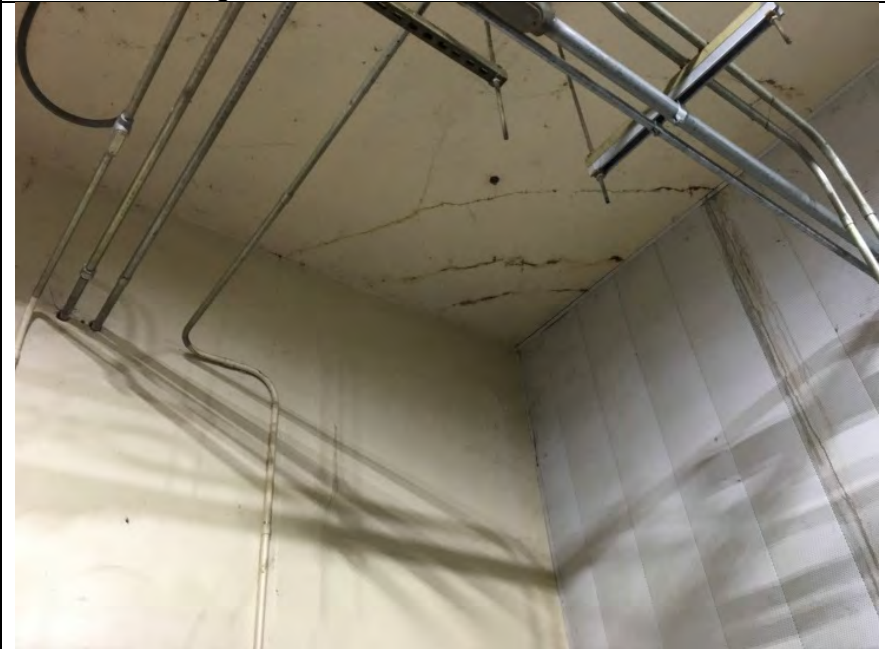
Photo 9 - Ceiling Cracks 2

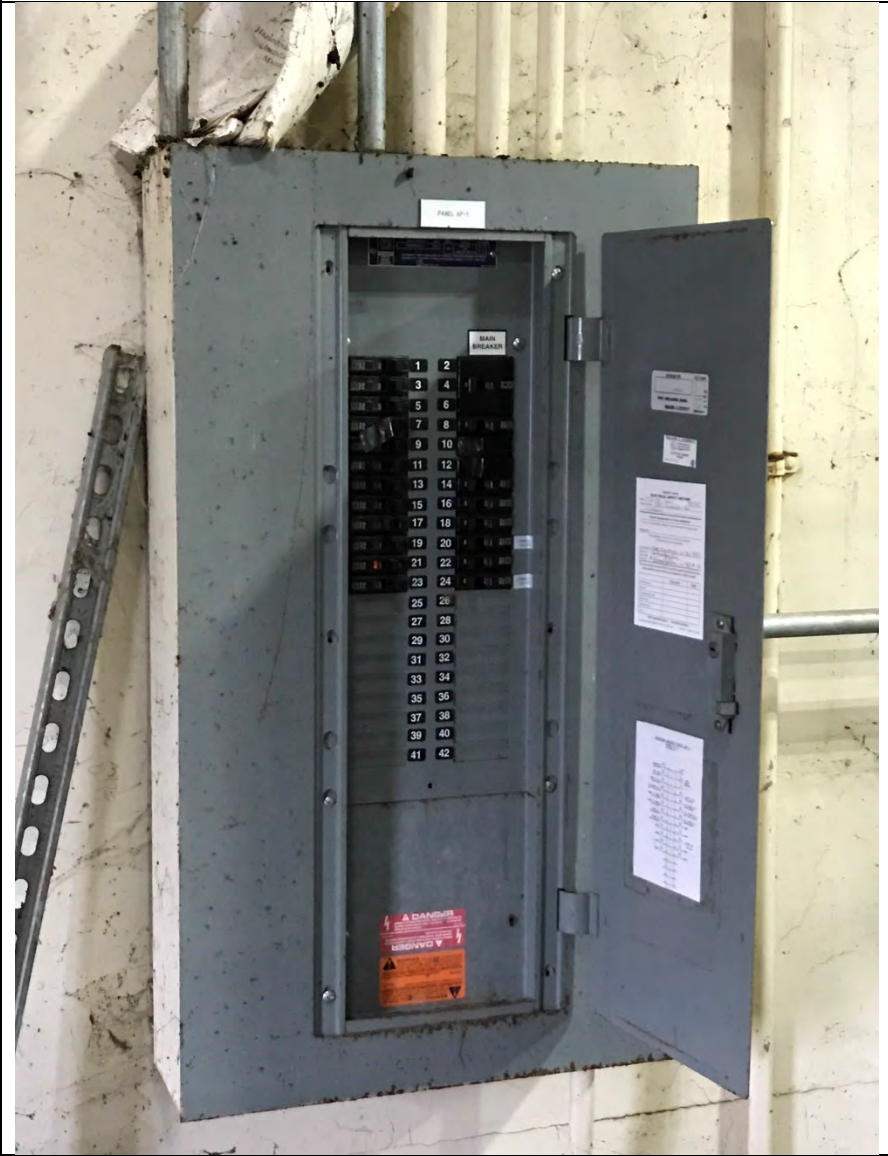
Photo 10 – Panel AP-1

Power Distribution	2	no comments
Electrical	3	<p>A significant amount of dirt and debris observed in electrical room (on floor and on top of electrical cabinets. Should be cleaned to help keep it from being transferred into the electrical equipment causing premature failure.</p> <p>There is an electrical panel board (Panel AP-1) located between the tunnels that was installed in 2004. It does not have an enclosure that is suitable for the environment that it was installed. The cabinet shows significant signs of corrosion, and plans should be made to replace this panel. (See Photo 10)</p> <p>There are 6 Robicon VFD's that are still functional but appear to be beyond their estimated OUL. One of the VFD's (Sludge Hopper Discharge South) has a failing operator interface display. Plans should be made to replace these</p> <p>Corrosion observed on conduit, conduit fittings, and conduit fasteners.</p>

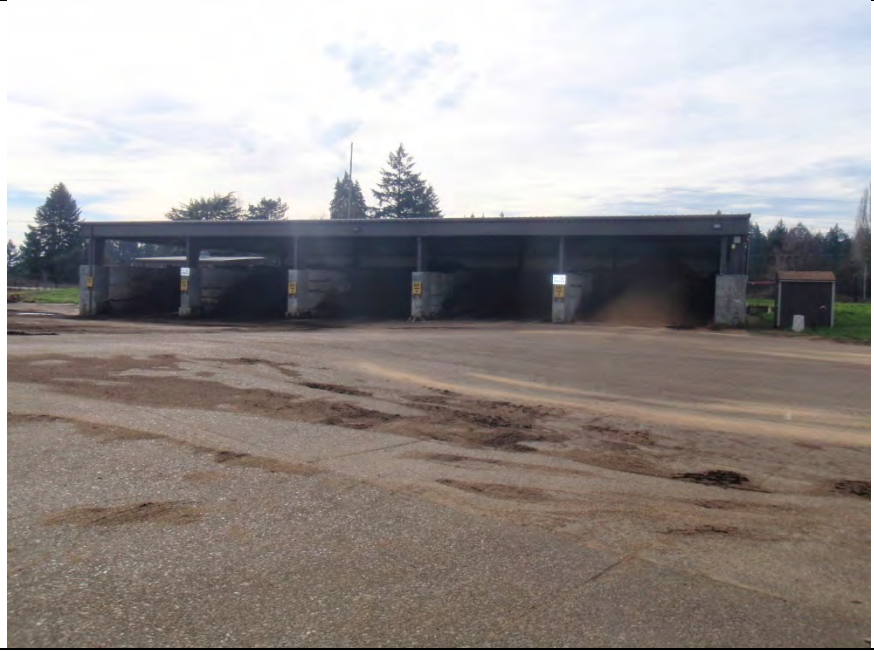
Photo 1 – Compost Curing Bays

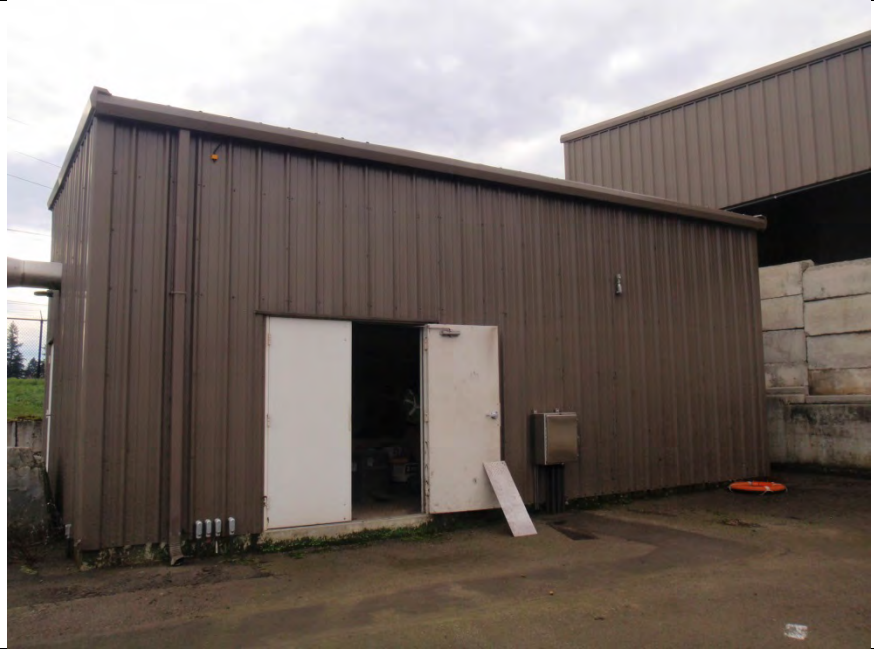
Photo 2 – Blower Building

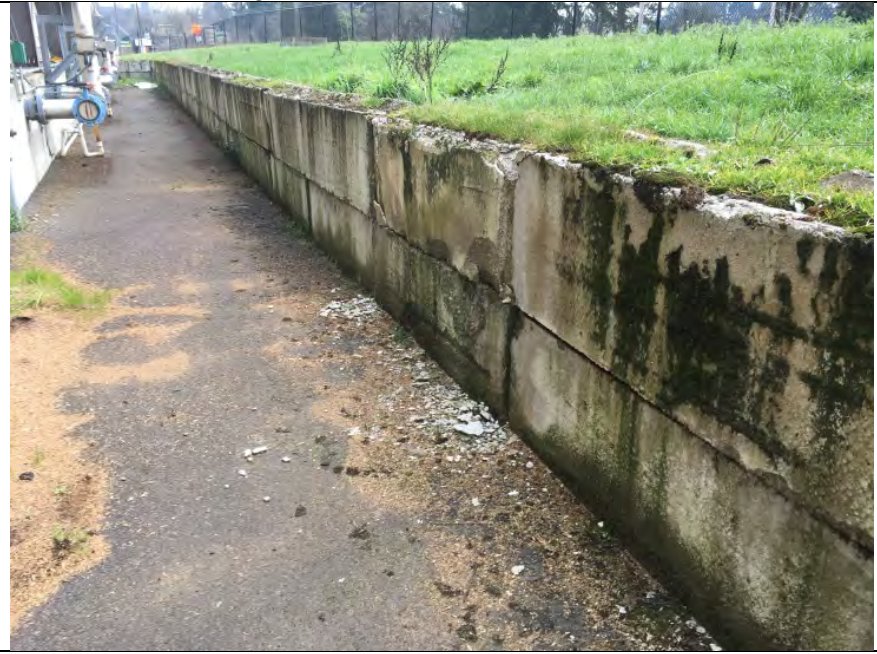
Photo 3 – Retaining wall deterioration

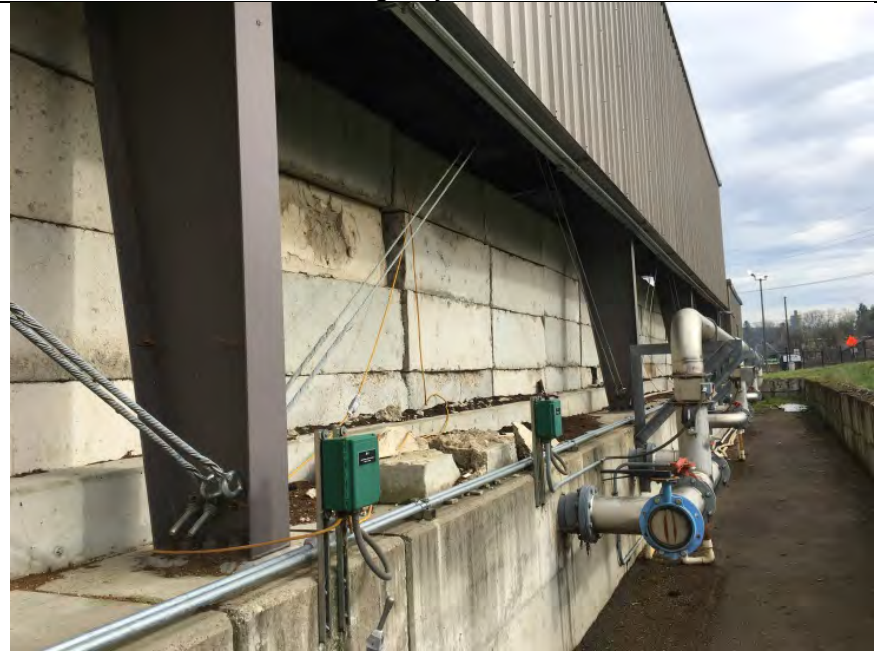
Photo 4 – Backside of Curing Bays

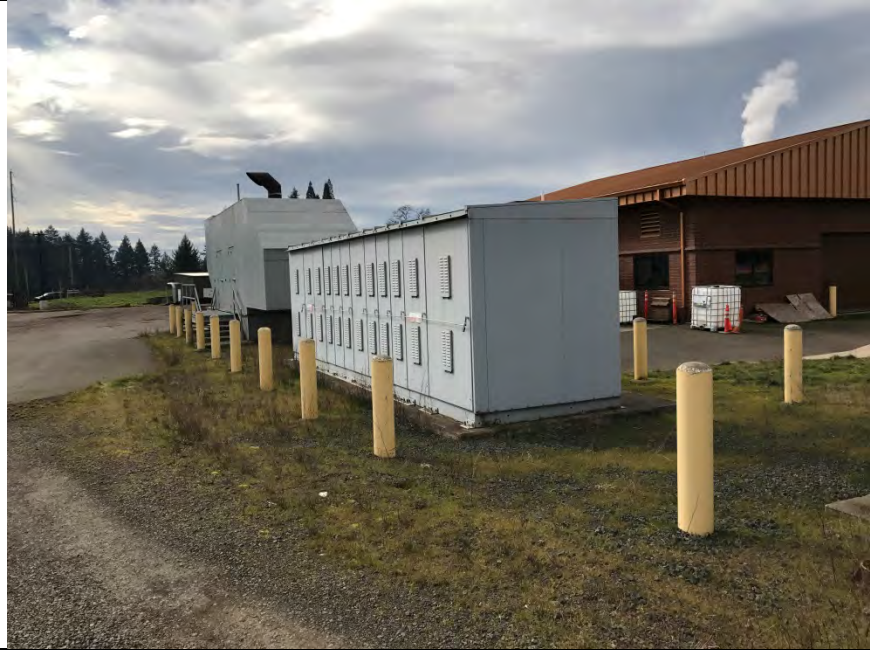
Photo 1 – Switchgear and Generator

FACILITY NAME	Plant Power Supply, Distribution, and Generator	TYPE OF FACILITY	plant power
CONSTRUCTION DATE	1986	DATE INSPECTED	2/14/2017
YEAR UPGRADED	2008	TIME ARRIVED ON SITE	0800
ITEM UPGRADED	Plant switchgear and generator replaced.	RUNNING (YES/NO)	YES

SYSTEM ASSETS	CR	COMMENTS		
Civil and Site	1	Generally good condition overall		
Architectural	N/A	N/A		
Structural	1	Equipment pads in good condition.		
Power Distribution	2	Minor corrosion observed on the SWGR enclosure. Dirt/debris observed on the inside of the SWGR enclosure; and the air filters appear to need changing. Peeling paint observed on the Genset sub-base fuel tank.		
Electrical	1	no comments		
Instrumentation/ Analyzers	N/A	N/A		
Process or Mechanical Equipment	N/A	N/A		
Pumping Systems	N/A	N/A		
Piping and Valves	N/A	N/A		
HVAC	N/A	N/A		
Odor Control	N/A	N/A		
Other	N/A	N/A		
Overall Facility Rating	1.3	System asset criteria weighted equally		
CONDITION RATING LEGEND	0	Unknown	Original Useful Life (OUL)	
	1	New or Excellent Condition	100% OUL	Normal Preventive Maintenance
	2	Minor Defects Only	75% OUL	Normal Preventive Maintenance, Minor Corrective Maintenance
	3	Moderate Deterioration	50% OUL	Normal Preventive Maintenance, Major Corrective Maintenance

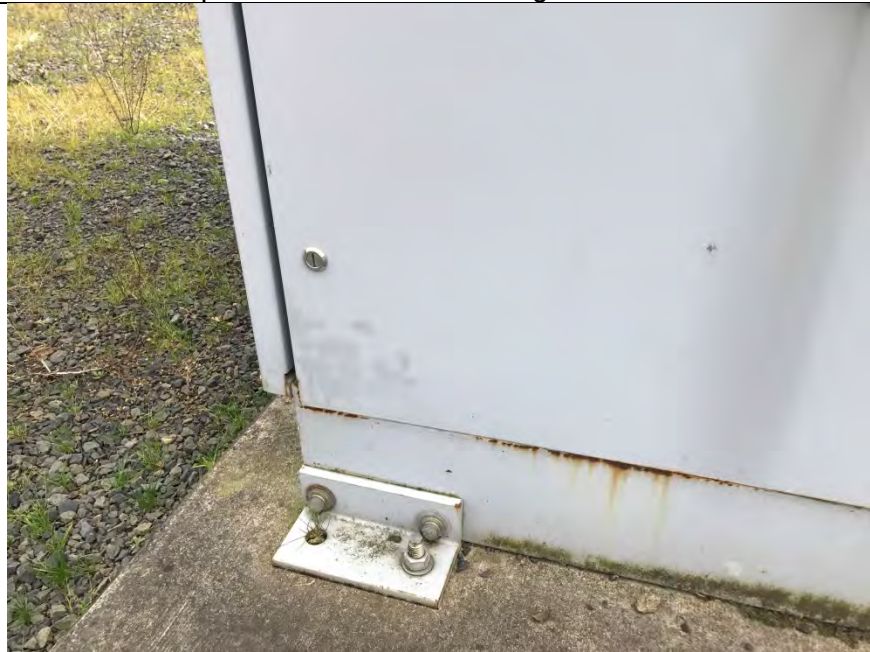
Photo 2 – Sample of corrosion on switchgear

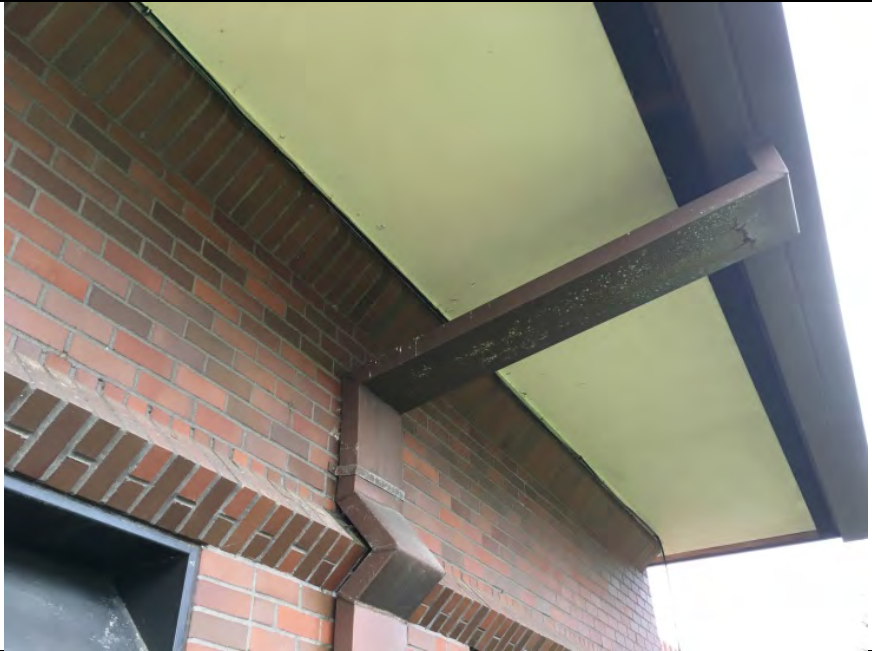
Photo 2 – Gutter Damage

SYSTEM ASSETS	CR	COMMENTS		
Civil and Site	2	Generally good condition overall		
Architectural	4	Based primarily on age of major components (roof and gutter system). Roof / gutter to be replaced in coming year. (See Photo 2) Doors and windows in generally good condition. Evidence of roof leakage in lab		
Structural	3	Rating based primarily on age. No major issues identified outside of some localized cracking of CMU walls.		
Power Distribution	N/A	N/A		
Electrical	2	no comments		
Instrumentation/ Analyzers	N/A	N/A		
Process or Mechanical Equipment	N/A	N/A		
Pumping Systems	N/A	N/A		
Piping and Valves	N/A	N/A		
HVAC	2	Condition rating based on age, no issues observed in field. Recommend independent HVAC system for the lab.		
Odor Control	N/A	N/A		
Other	2	PLC Control Panel wiring appears to be neat and organized.		
Overall Facility Rating	2.5	System asset criteria weighted equally		
CONDITION RATING LEGEND	0	Unknown	Original Useful Life (OUL)

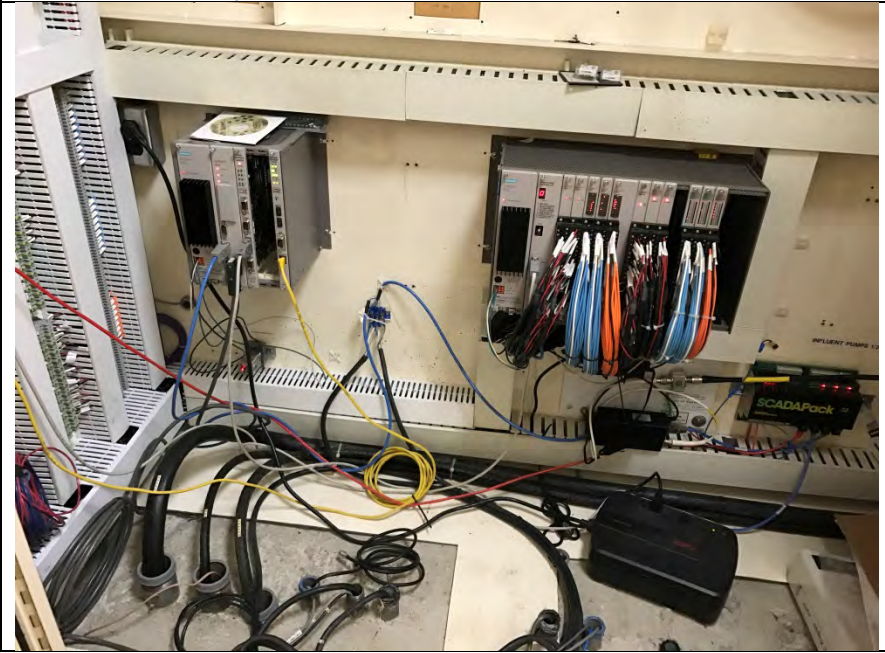
Photo 1 – PLC System

FACILITY NAME	PLC Control System	TYPE OF FACILITY	process equipment
CONSTRUCTION DATE	1986	DATE INSPECTED	2/14/2017
YEAR UPGRADED	N/A	TIME ARRIVED ON SITE	0800
ITEM UPGRADED	N/A	RUNNING (YES/NO)	YES
