REQUEST: A Resolution recommending City Council amend the 2018 Wastewater Master Plan incorporating the 2021 Riverfront Addendum into the Newberg Comprehensive Plan

Wastewater Master Plan

May 2018

*Technical Update May 2021
Addendum - Riverfront
Master Plan (Appendix K)*

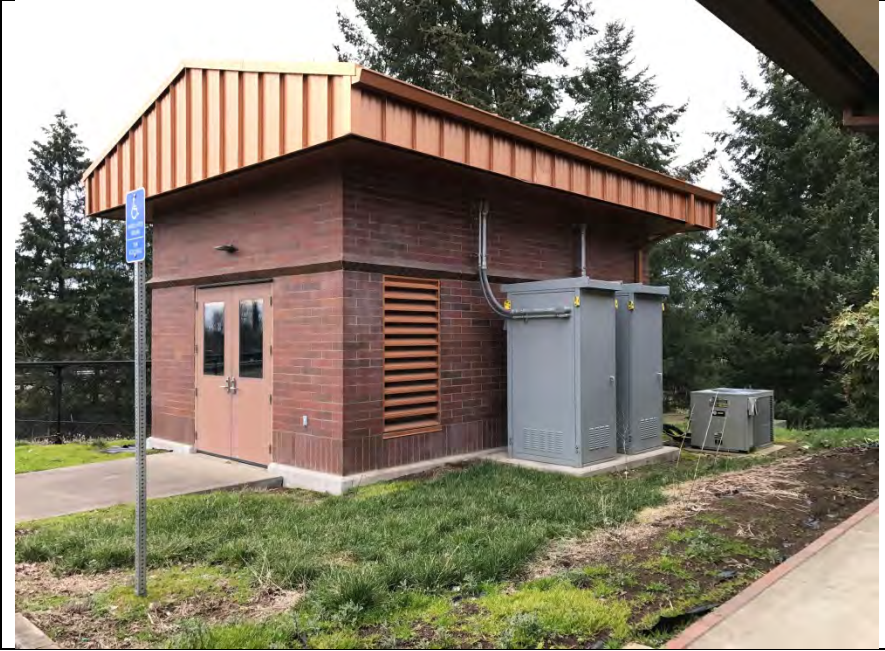
Photo 1 – Electrical Building

FACILITY NAME	Electrical Building	TYPE OF FACILITY	building
CONSTRUCTION DATE	2008	DATE INSPECTED	2/14/2017
YEAR UPGRADED	N/A	TIME ARRIVED ON SITE	0800
ITEM UPGRADED	N/A	RUNNING (YES/NO)	YES

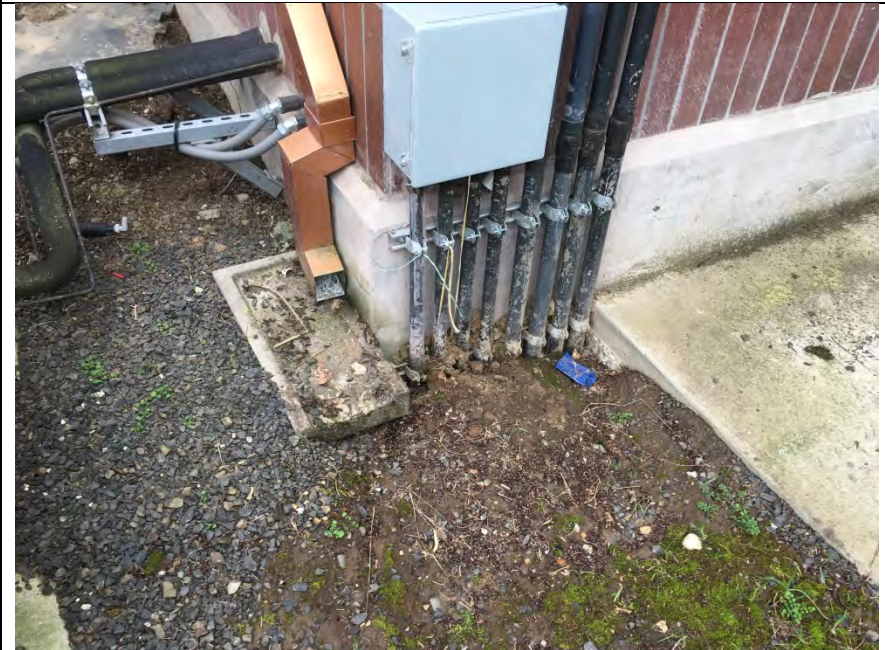
Photo 2 – Gutter splashing causing erosion around electrical conduits

SYSTEM ASSETS	CR	COMMENTS		
Civil and Site	2	Splash blocks at downspouts should be re-configured as they are not completely functional and allow for water to erode the surrounding area. (See Photo 2)		
Architectural	1	No major issues identified		
Structural	1	No major issues identified		
Power Distribution	2	no comments		
Electrical	3	A significant amount of dirt and debris observed in the room (on floor and on top of electrical cabinets. Should be cleaned to help keep it from being transferred into the electrical equipment causing premature failure. There are 3 Robicon VFD's that are still functional but appear to be beyond their estimated OUL.		
Instrumentation/ Analyzers	N/A	N/A		
Process or Mechanical Equipment	N/A	N/A		
Pumping Systems	N/A	N/A		
Piping and Valves	N/A	N/A		
HVAC	1	Condition rating based on age, no issues observed in field.		
Odor Control	N/A	N/A		
Other	N/A	N/A		
Overall Facility Rating	1.7	System asset criteria weighted equally

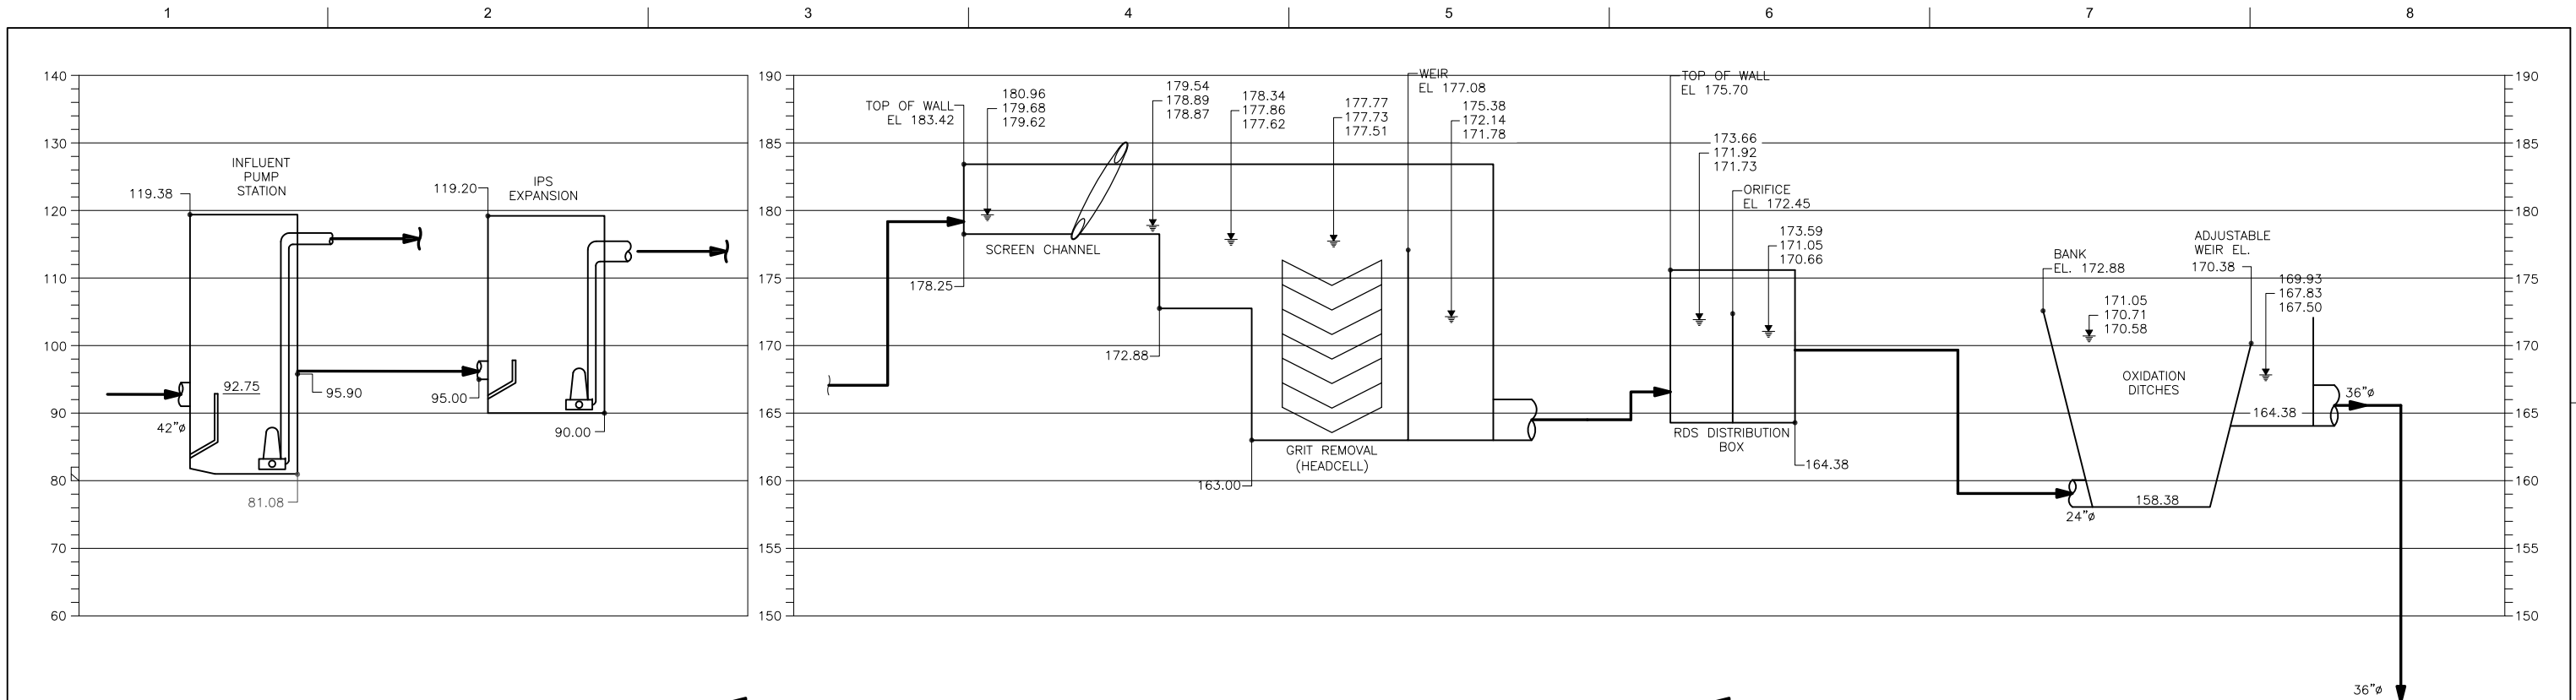
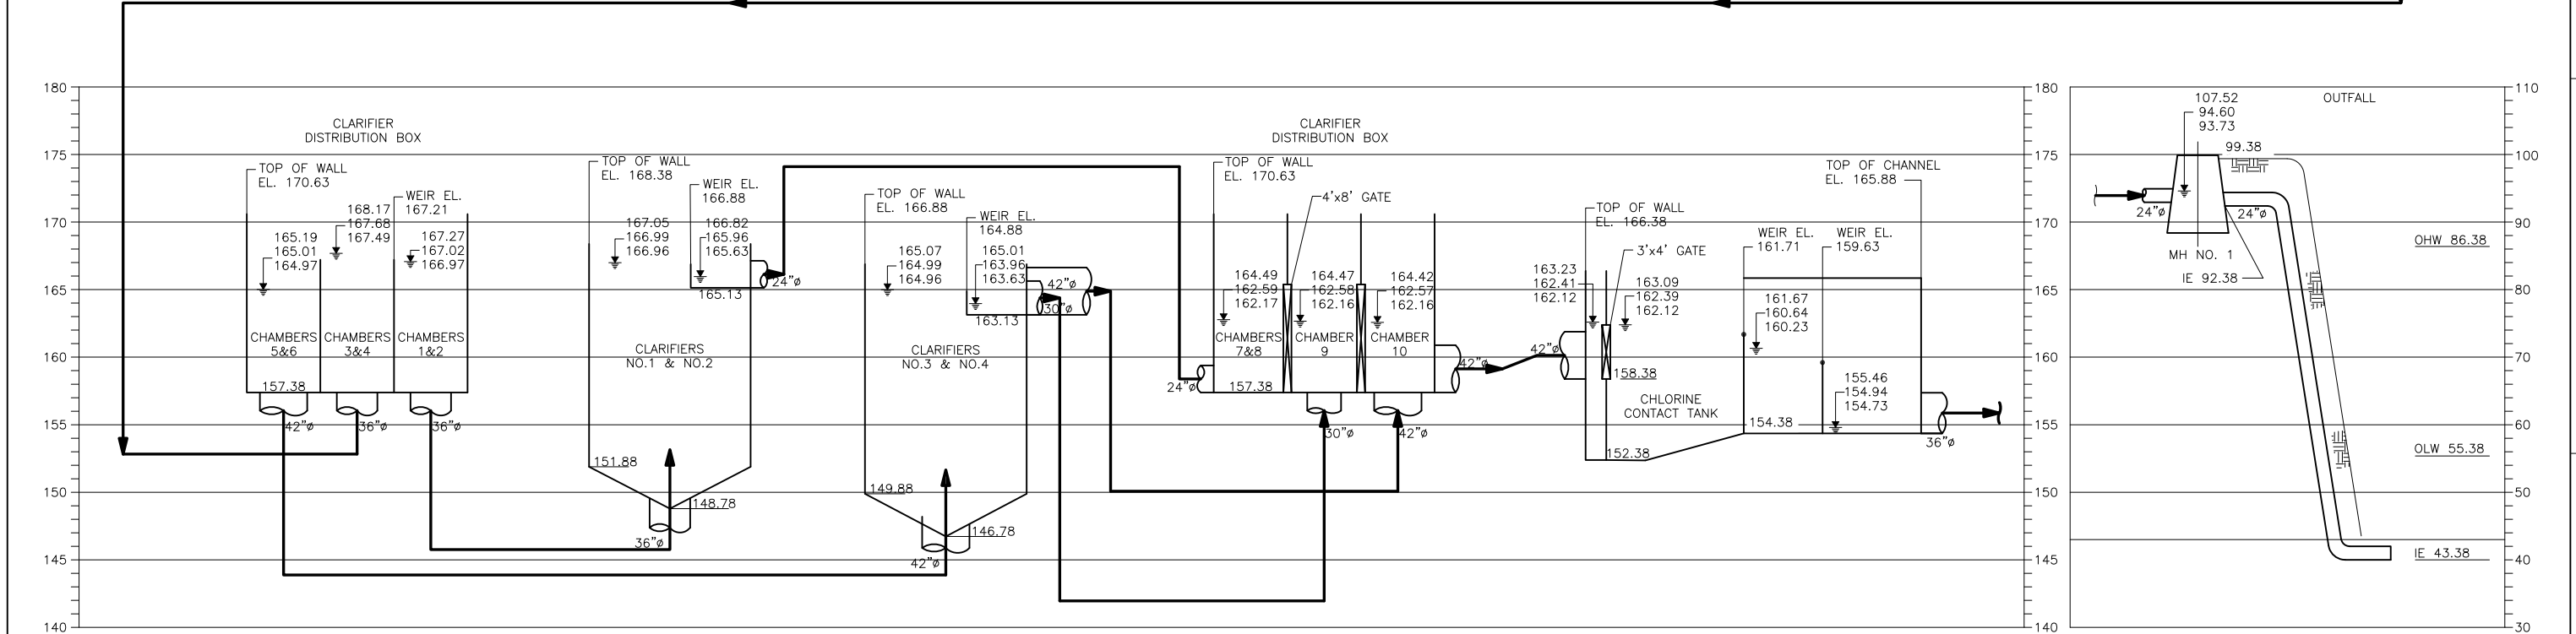
FILENAME: G-01.dwg
SCALE: AS NOTED

- NOTES:
1. WATER SURFACE ELEVATIONS SHOWN CORRESPOND TO THE FOLLOWING FLOWS:
 - 28.2 MGD - PIF
 - 9.81 MGD - MMWWF
 - 4.49 MGD - AADF
 2. WATER LEVEL GRAPHICALLY SHOWN IS AT MMWWF CONDITION OF 9.81 MGD.
 3. THE FOLLOWING ASSUMPTIONS APPLY TO THE FLOW SCENARIOS INDICATED:

2017 AADF: 4.49 MGD 1 SCREEN IN SERVICE 1 HEADCELLS IN SERVICE 2 OXIDATION DITCHES IN SERVICE 4 CLARIFIERS IN SERVICE 2 CHLORINE CONTACT TANKS IN SERVICE 2.2 MGD RAS FLOW	2017 MMWWF: 9.81 MGD 2 SCREENS IN SERVICE 1 HEADCELLS IN SERVICE 2 OXIDATION DITCHES IN SERVICE 4 CLARIFIERS IN SERVICE 2 CHLORINE CONTACT TANKS IN SERVICE 4.9 MGD RAS FLOW	2017 PIF: 28.2 MGD 2 SCREENS IN SERVICE 2 HEADCELLS IN SERVICE 2 OXIDATION DITCHES IN SERVICE 4 CLARIFIERS IN SERVICE 2 CHLORINE CONTACT TANKS IN SERVICE 14.1 MGD RAS FLOW
--	--	---
