## PACP Inspection and Scoring

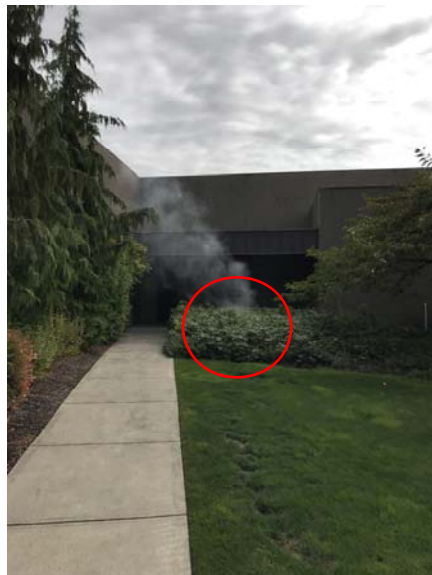
Address: Unmarked MH (east of MH H95012)

Description: MH rim and lid smoking excessively, storm covers.

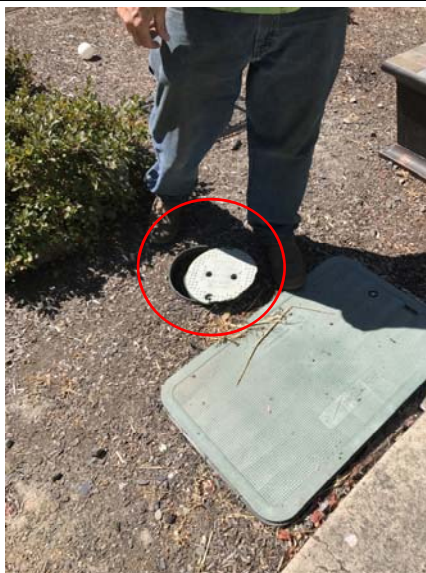
Address: 1000B Pennington Ct

Description: Smoking around cleanout.

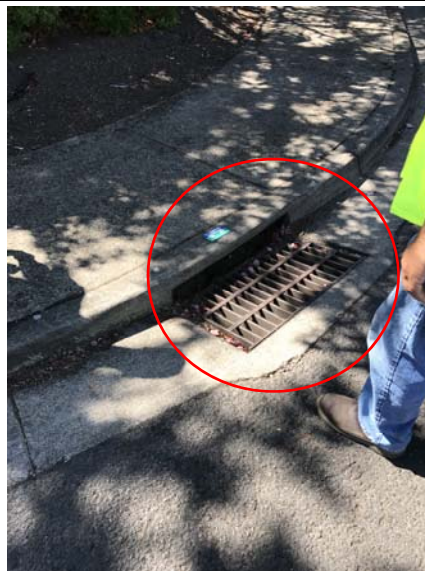
Address: Intersection of S Pennington Dr and Hoskins St

Description: All 4 catch basins smoking.

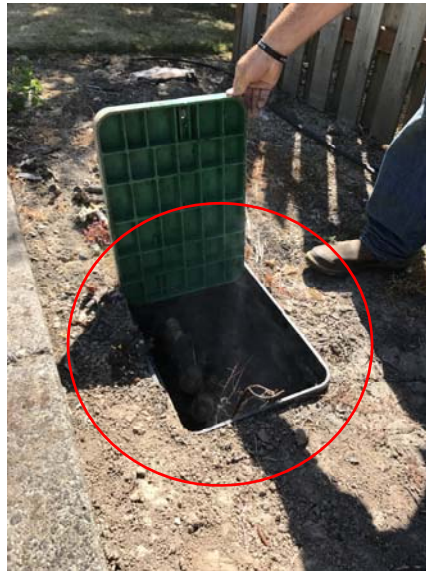
Address: 1020 Sierra Vista Dr

Description: Coming from inside irrigation control valve box and next to water meter box/sidewalk.

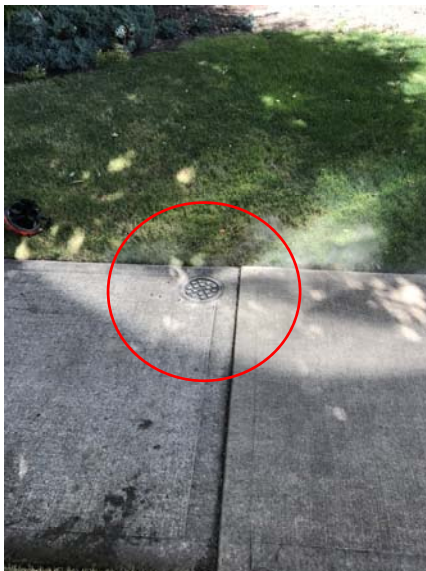
Address: 534 The Greens Ave

Description: Smoking along sidewalk edge with grass and in sidewalk joint.

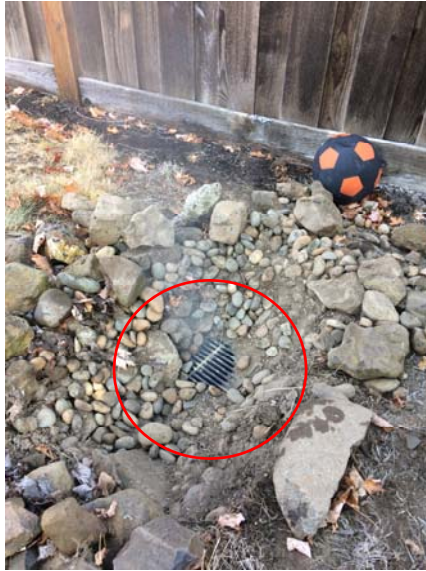
Address: 5270 Wedgewood Lp

Description: Area drain in backyard under rocks smoking excessively.

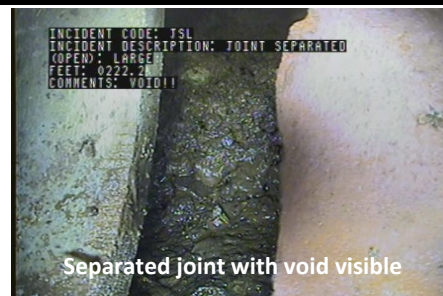
Gravel deposits

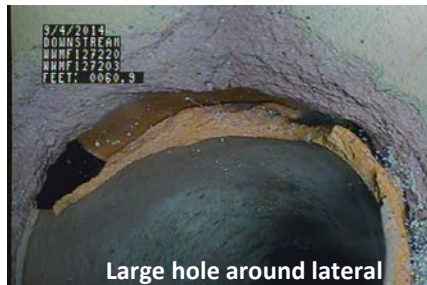
- Approximately 1082' of 1166' video inspected
- Broken with soil visible
- Hole with void visible
- Broken lateral pipe
- Broken lateral connection
- Infiltration gusher at tap (water entering pipe "under pressure")
- Large hole around lateral
- Couple of cracks; one with roots visible
- Large chunk of asphalt in pipeline camera cannot pass

Large hole around lateral

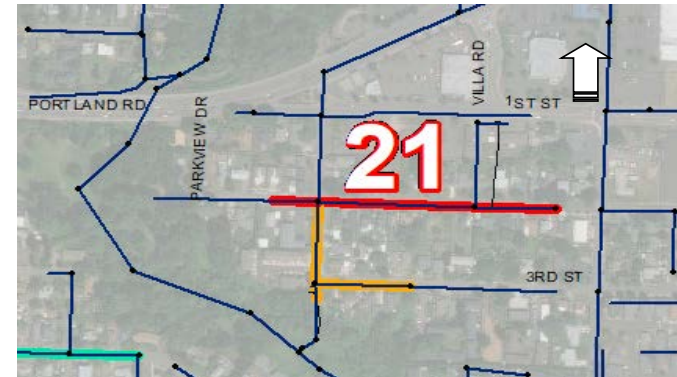
E 2nd St from S Church St to S Everest St

- Approximately 275' of 791' video inspected
- Broken twice with void visible
- Cracked lateral cap
- Broken pipe at lateral connection
- Infiltration drip
- Intruding tap
- Need to see CCTV Inspection videos for all pipe segments

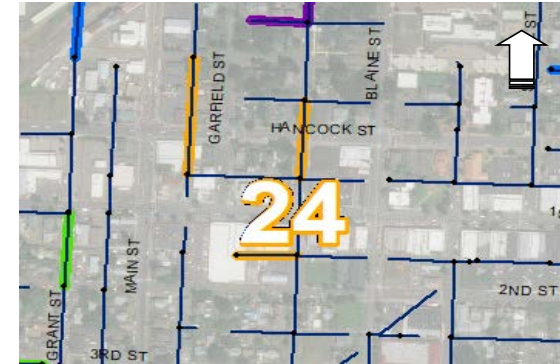
Alley west of N Garfield north and south of E Hancock St  
Washington St, allies north and south of E Hancock St  
Alley north of E 2nd St from S Washington St to the west

- Approximately 778' of 963' video inspected
- Two grade 4 fractures
- Couple of smaller fractures and cracks
- Broken lateral
- Intruding tap camera cannot pass (wwgm1601)
- Roots in joints
- Gravel deposits
- Root ball

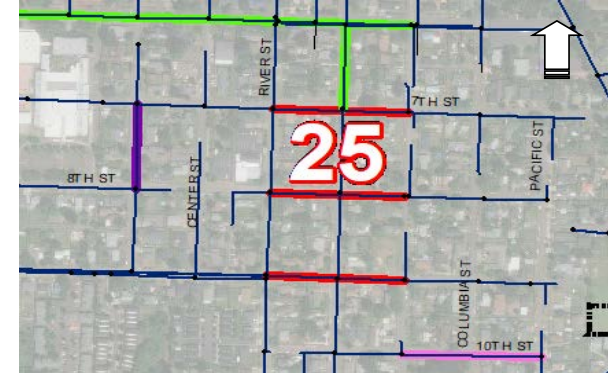
E 9th St from S River St to S Willamette St

- Broken
- Two grade 4 fractures
- A few other fractures and cracks
- Broken lateral cap
- Hole in lateral
- Intruding tap
- Grout stuck in the joints along wwgm1351
- Need to see CCTV inspection video for wwgm1352
